# AZTEC PROPERTY INSPECTIONS

## PROPERTY INSPECTION REPORT

1234 Oribia Rd  
Del Mar, CA 92014

07/22/2026

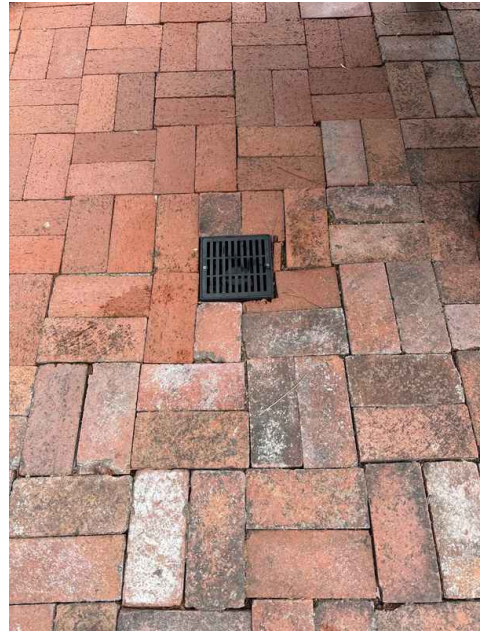
## **SURFACE DRAINS**

Surface drains were noted and the inside of the drains could not be evaluated. Inquire with the seller as to the termination point(s) of the surface drains.

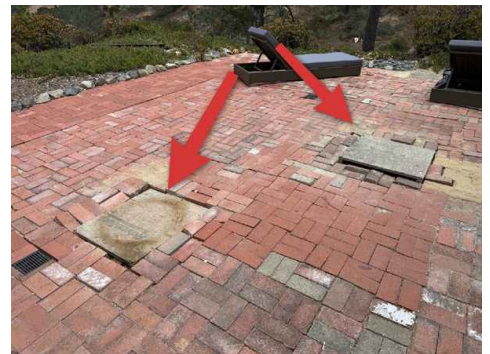
### **TRIPPING HAZARD - OBJECT**

An object was installed presenting a trip hazard noted in one or more areas. We recommend that a qualified contractor repair as necessary for improved safety.

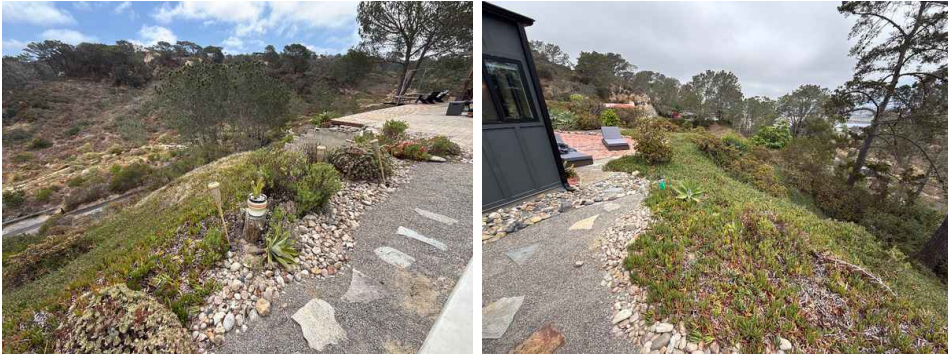
4.1.2 Driveways, Sidewalks, Patios

### **WALK OFF HAZARD(S) NOTED**

A walk off or drop off hazard was noted in one or more areas. Recommend installing guardrails for added safety. A qualified professional is recommended for further evaluation and/or repairs.

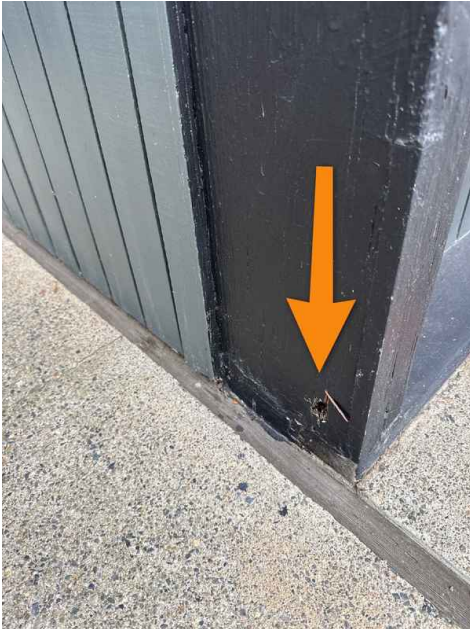
#### 4.3.1 Exterior Walls / Trim

### **DAMAGED WOOD - TERMITE INSPECTION RECOMMENDED**

Damaged, soft and or deteriorated wood was noted in one or more areas. Further evaluation is recommended by a qualified and licensed pest control specialist.

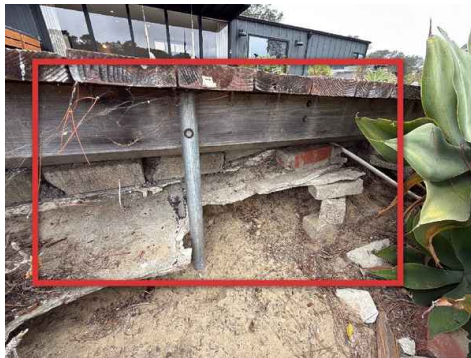
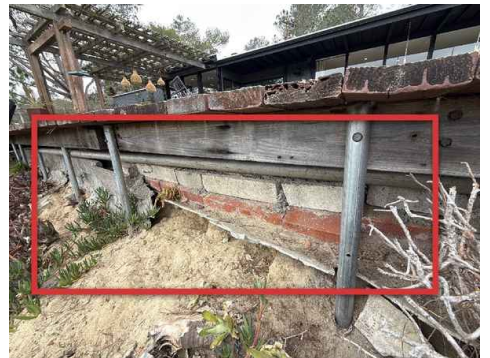
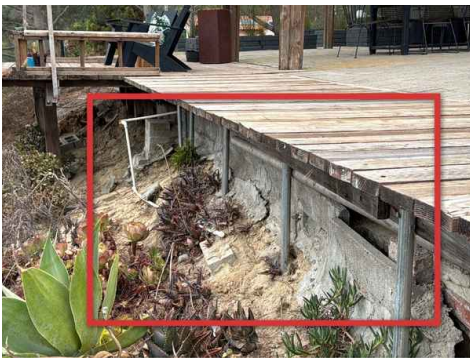
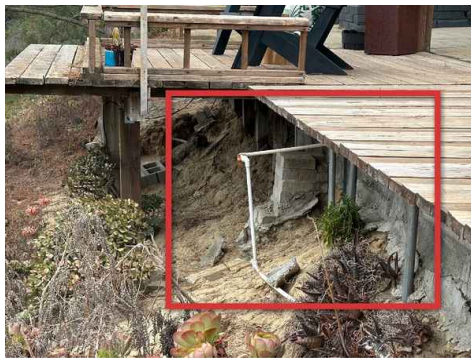
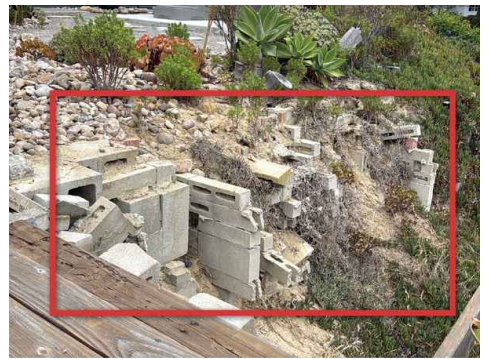
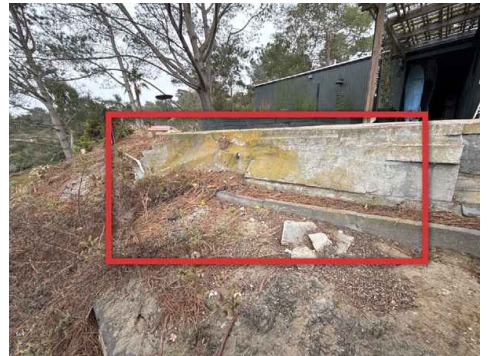
#### 4.6.4 Retaining Wall(s)

### RETAINING WALL CRACKS-SIGNIFICANT

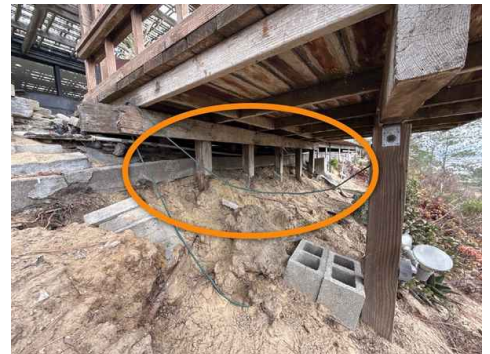
## 4.7.6 Decks / Balconies / Stairs

**FOOTING DAMAGED /  
DETERIORATED / SUBSTANDARD**

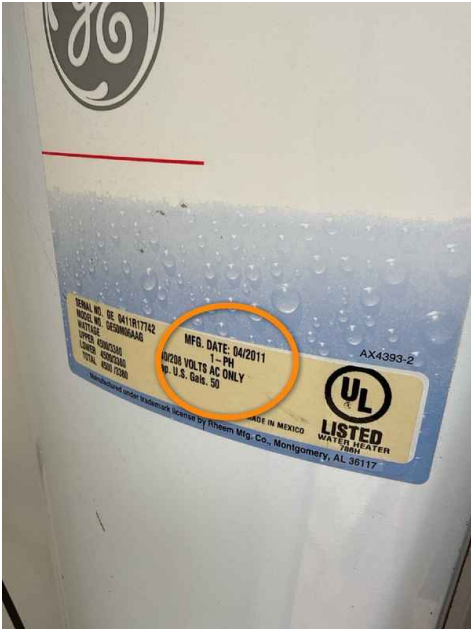
The water heater appeared to be functional at the time of inspection. However, it appears to be an older unit (10 years+), and repairs or even failure can be expected. You should consider replacing this water heater as a preventive measure.

Recommendation  
Contact a qualified professional.

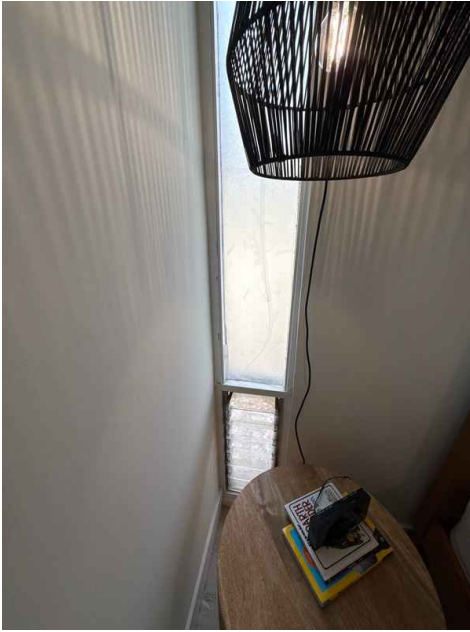
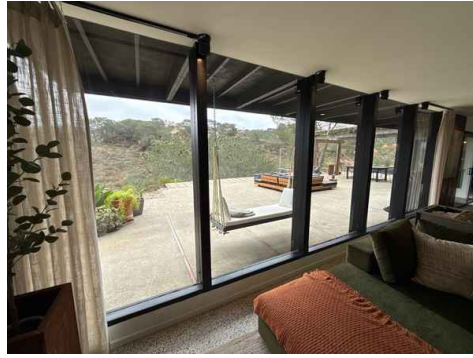
**SINGLE PANE WINDOWS**

Single pane windows were noted. These windows are not energy efficient and replacement should be considered.

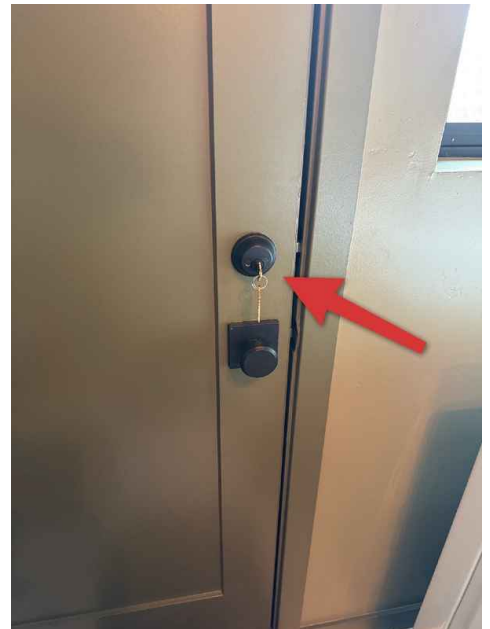
## 11.2.2 Exterior Doors

**KEYED DEADBOLT INSIDE**

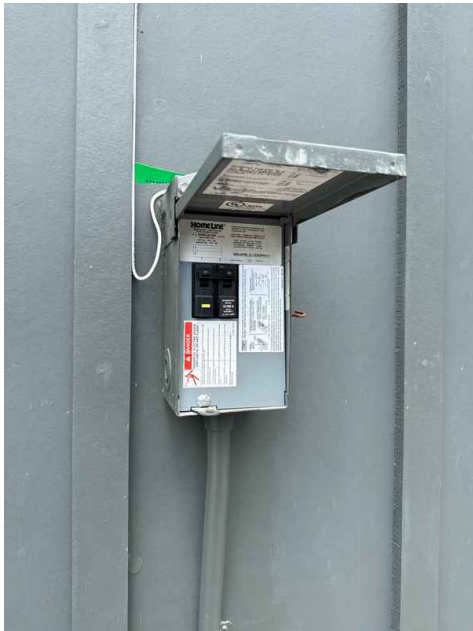
The main disconnect for the hot tub was properly located and appeared to be in serviceable condition. It was not operated.
