INSPECTION REPORT

72806 Fleetwood Cir  
Palm Desert CA 92260

Hank Myll  
HSH Inspections  
Inc. DBA Home  
Sweet Home  
Inspections

📅 4/21/2026  
🕒 09:00 AM

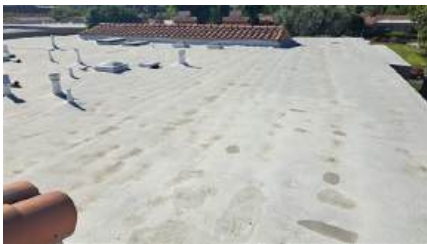
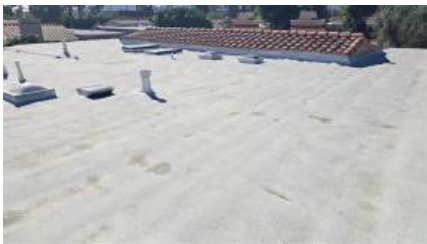
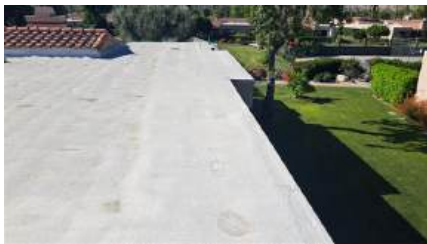
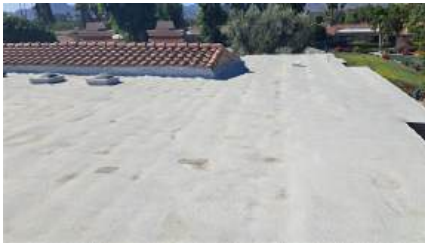
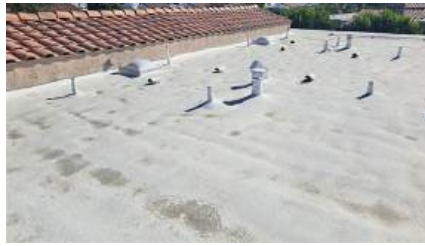
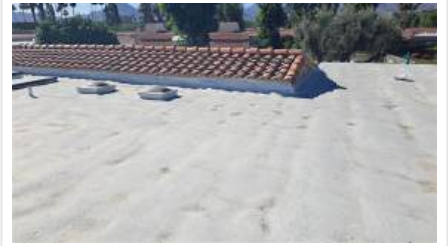
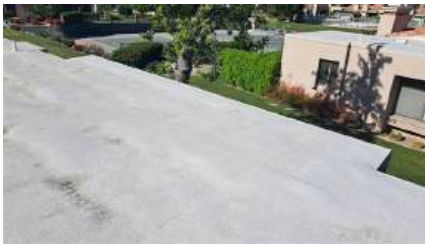
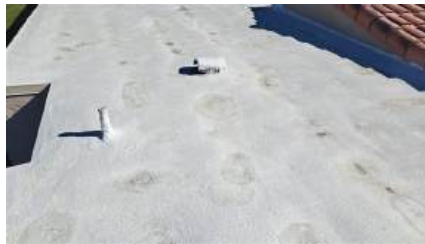
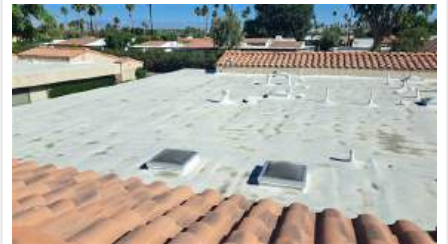
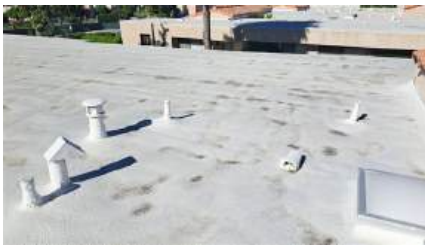
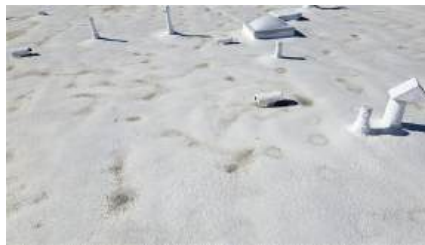
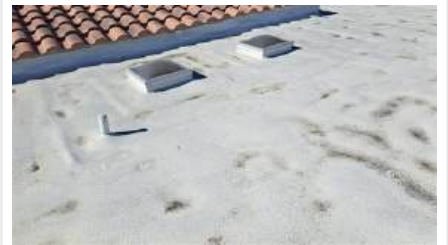
📋 POOR

(3) Noted past roof repair. Recommend further evaluation as desired.

(4) Noted bubbling / cracking / deterioration on flat roof. Recommend evaluation/repair by roofing contractor.

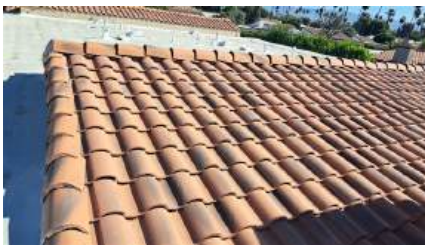
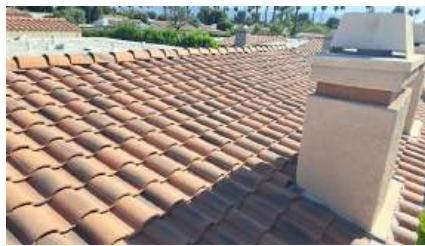
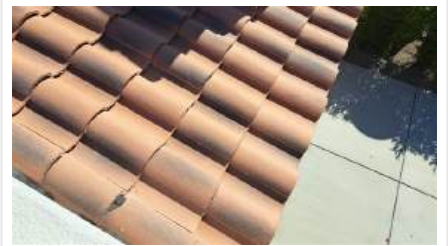
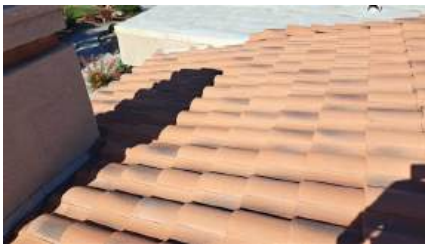
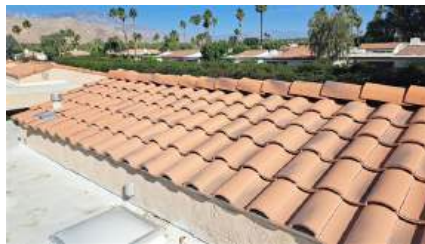
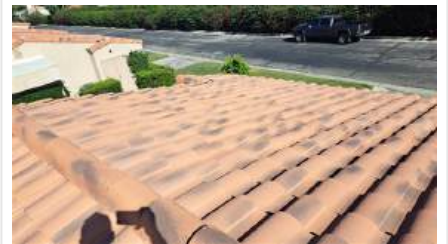
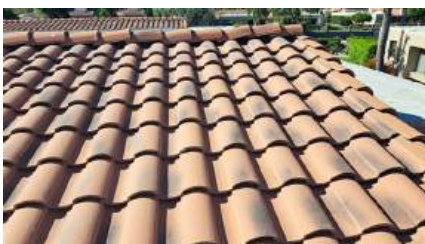
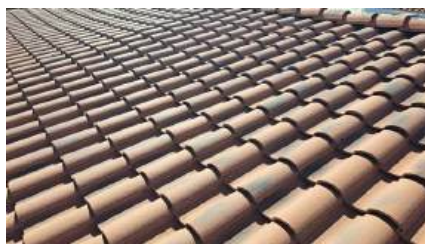
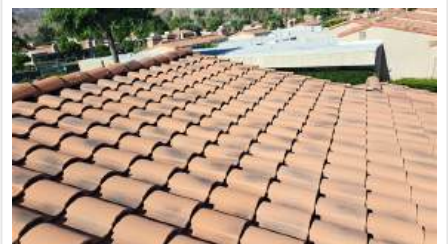
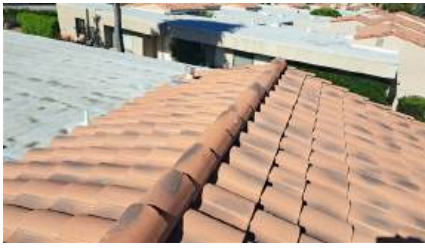
FAIR

**Roof appeared functional at time of inspection and is rated fair due to indeterminate age. Recommend further evaluation as desired.**

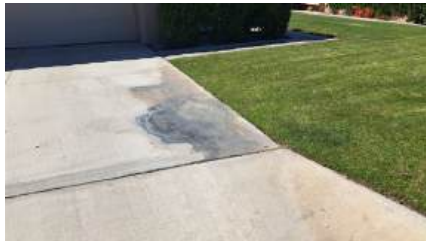
2.0 Item 1 (Picture)

**Noted staining possible past ponding on driveway. Recommend further evaluation/repair by contractor as desired.**

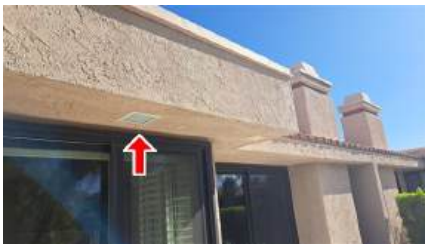
3.1 Item 1 (Picture)

**Noted inoperative fixture. Recommend bulb replacement and further evaluation if necessary.**

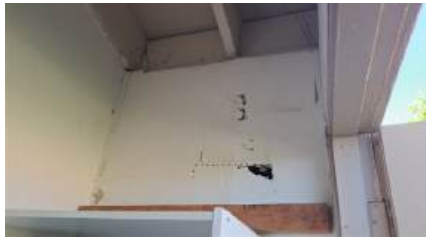
3.4 Item 1 (Picture)

(1) **Noted dry wall damage/holes. Recommend evaluation/repair as nestler.**

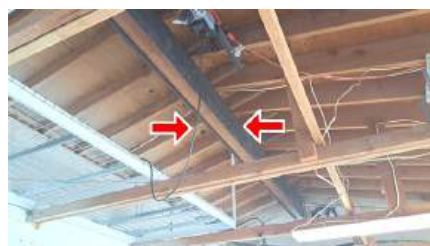
4.0 Item 1 (Picture)

**Noted beam between two large metal brackets. Appears to be a brace. Recommend further evaluation/repair as necessary by contractor.**

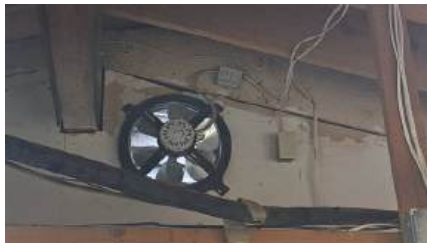
4.12 Item 1 (Picture)

**Thermostatic-type control appears to be present for the garage ventilator. Garage ventilator not operating during inspection and therefore not inspected.**

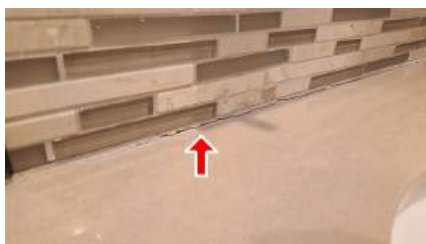
5.2 Item 1 (Picture)

**Noted countertop grout cracking. Recommend grout repair as desired.**

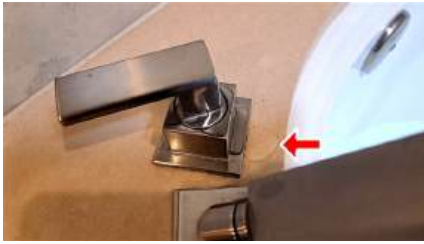
5.4 Item 1 (Picture)

- (1) **Tub slow to drain at time of inspection. Recommend piping cleaning and further evaluation/repair by plumbing contractor if necessary.**
- (2) **Noted faucet handle leakage. Recommend evaluation/repair by plumbing contractor.**

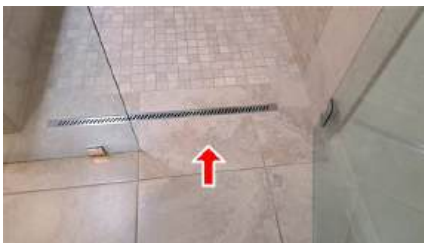
5.5 Item 1 (Picture)

- (1) The waterproof covering (surround) at the tub/shower must be maintained to prevent damage. All surfaces should be checked and repaired as needed. Leakage can damage to substrate and prevent proper attachment.
- (2) **Low fall shower noted. Low fall showers are NOT water tested and a shower dam may be required. Recommend confirmation of proper operation by plumbing contractor as desired. Low fall showers are only tested for hot water with the shower head against the wall.**

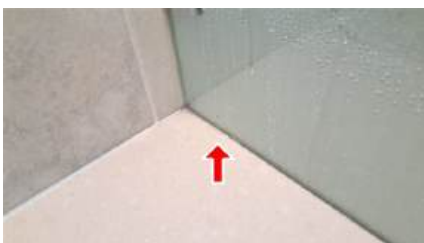
5.5 Item 2 (Picture)

- (3) **Surround glass leakage noted when water tested. Recommend caulking / evaluation/repair by contractor.**

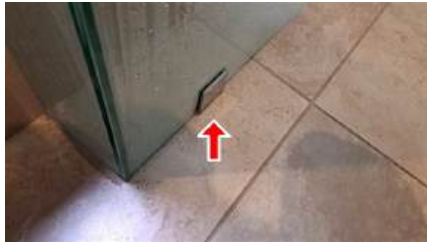
5.8 Item 1 (Picture)

**Noted cracked floor tile. Recommend evaluation/repair as desired.**

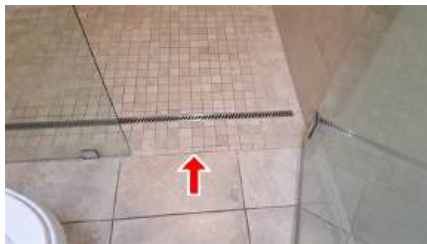
5.17 Item 1 (Picture)

(2) **Low fall shower noted. Low fall showers are NOT water tested and a shower dam may be required. Recommend confirmation of proper operation by plumbing contractor as desired. Low fall showers are only tested for hot water with the shower head against the wall.**

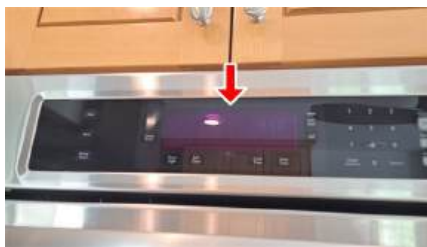
6.3 Item 1 (Picture)

- (1) **Functional at time of inspection and rated fair due to indeterminate age.**
- (2) **Noted oven display is dim. Recommend further evaluation/repair as necessary.**

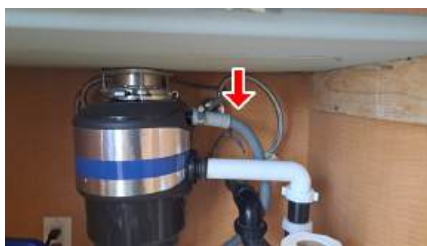
6.4 Item 1 (Picture)

- (1) **Functional at time of inspection and rated fair due to indeterminate age.**
- (2) **Noted air gap/loop has not been installed. Recommend the installation of an air gap or drain loop.**

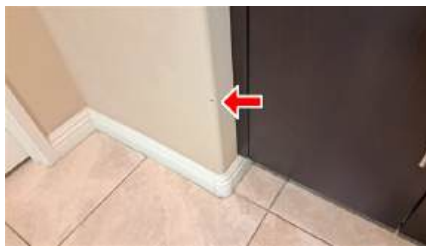
7.1 Item 2 (Picture)

(3) **Minor wall damage noted. Recommend evaluation / repair as desired.**

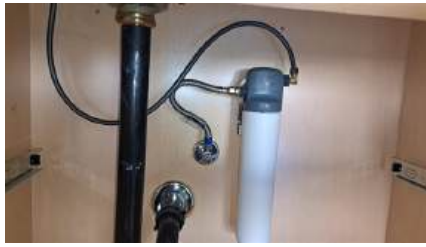
7.7 Item 1 (Picture)

- (1) **No hot water noted. Recommend evaluation/repair as necessary.**
- (2) **Water filtration system not inspected. Areas under filtration system not visible for inspection. Recommend evaluation by specialist as desired.**

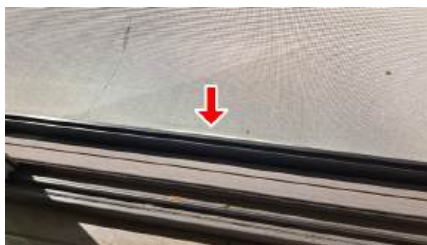
7.11 Item 1 (Picture)

**Slider screen damage/holes noted. Recommend repair/replacement as desired.**

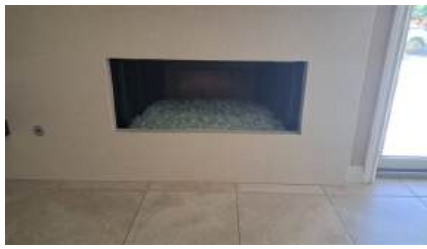
7.13 Item 1 (Picture)

(2) **Noted missing or not installed C-Clamp for fireplace flue damper. Although the C-Clamp is commonly removed so that the flue may be closed. Recommend C-Clamp be installed per the Gas Company in order to keep the flue damper open at all times.**

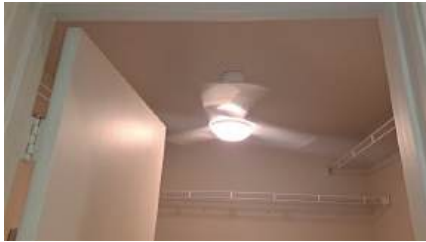
7.19 Item 1 (Picture)

- (1) **Noted fan(s) wobbling on high speed. Recommend evaluation/adjustment as desired.**

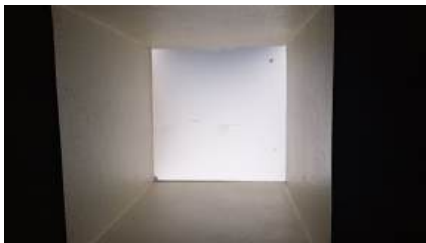
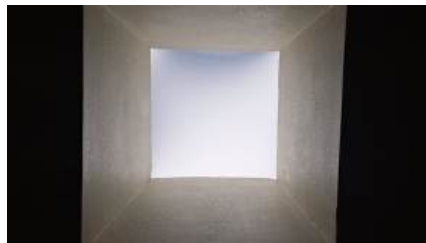
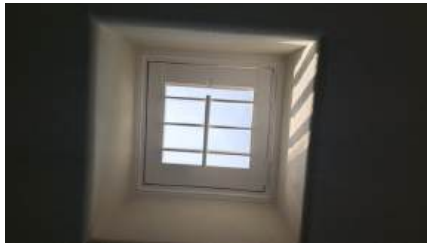
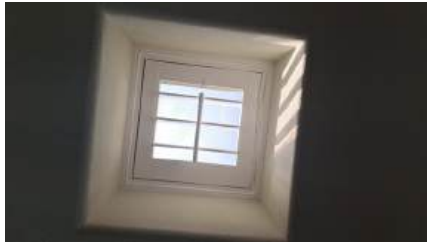
*Skylights are particularly prone to leakage and may need periodic repair and or re-sealing. The integrity of the flashings is generally the first point to consider when leakage occurs. Surface damage or loss of the seal on insulated glazing can occur, but such a defect may not be readily apparent during an inspection.*

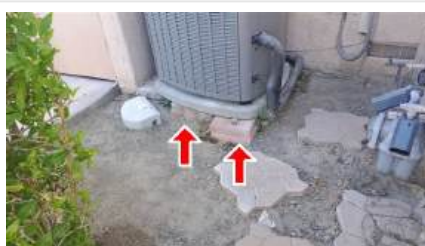
9.1 Item 2 (Picture)

**The outdoor unit base is hanging, being supported by bricks/pavers. Recommend evaluation/repair by HVAC contractor as desired.**

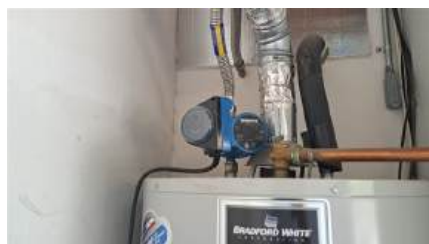
12.2 Item 1 (Picture)

**Circulator pump on a timer/clock and was not on during inspection. Recommend confirmation of proper operation.**
