650 Columbia St
Unit 411
San Diego CA 92101

John Robinson's Inspection Group

Cover Page 1
Table of Contents..... 2
Intro Page 3
1 Built-In Kitchen Appliances..... 7
2 Plumbing System 10
3 Interiors 17
4 Electrical System 23
5 Insulation and Ventilation 26
6 Roofing 27
7 Exterior 28
8 Structural Components 30
9 Heating / Central Air Conditioning 32
10 General Pictures..... 35
General Summary 40
Invoice..... 44
Agreement 45

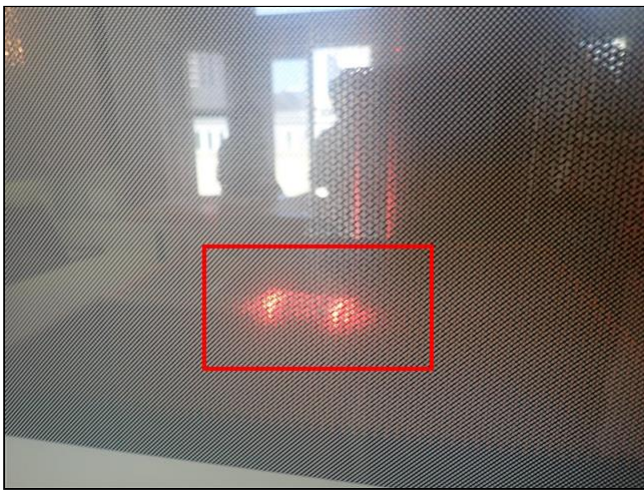
1.4 Item 1(Picture)

The operation of the microwave was tested using a microwave tester. This unit appeared functional at the time of inspection.

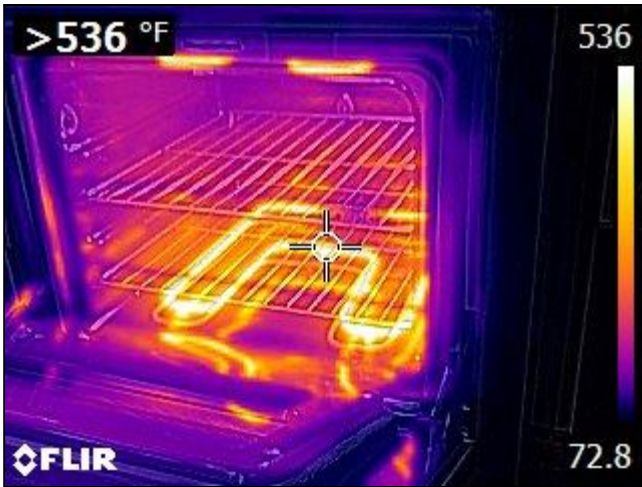
1.5 Item 1(Picture) Thermal image of oven working.

Infrared picture of oven in operation. This unit appeared operational.

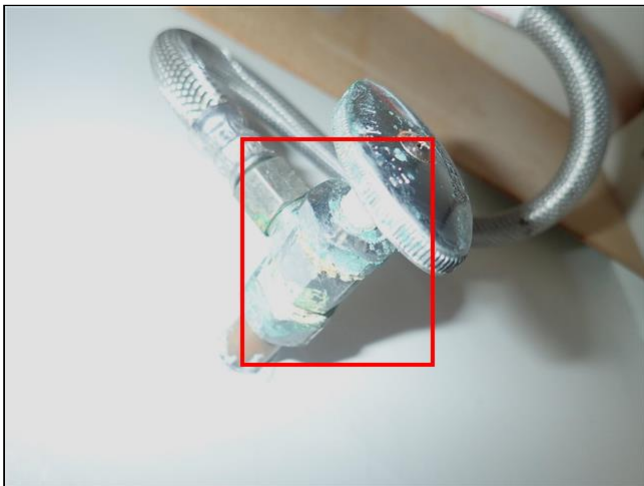
2.2 Item 1(Picture) Master bathroom.

(1) Some of the angle stops/shut off valves and/or supply lines under the sinks or behind the toilets are corroding, have mineral deposits or rusted. This is indicative of a previous leak that has sealed itself. Recommend replacing these valves to prevent future leaks.

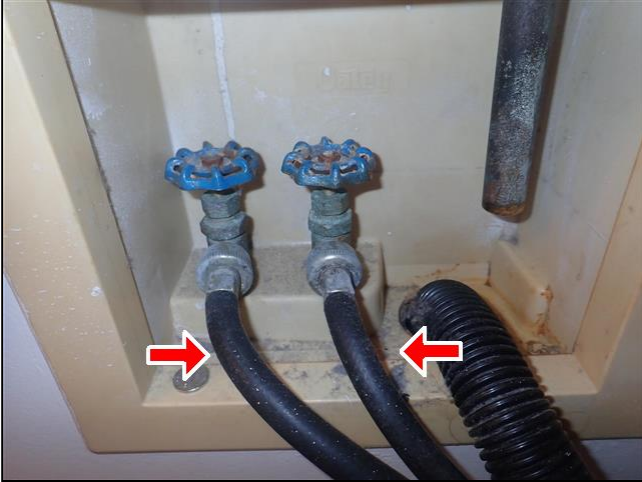
2.2 Item 2(Picture)

(2) The laundry area is equipped with rubber supply lines. This type of line is prone to dry rot and failure. Advise having a licensed plumbing contractor upgrade to new steel braided hoses to prevent this condition.

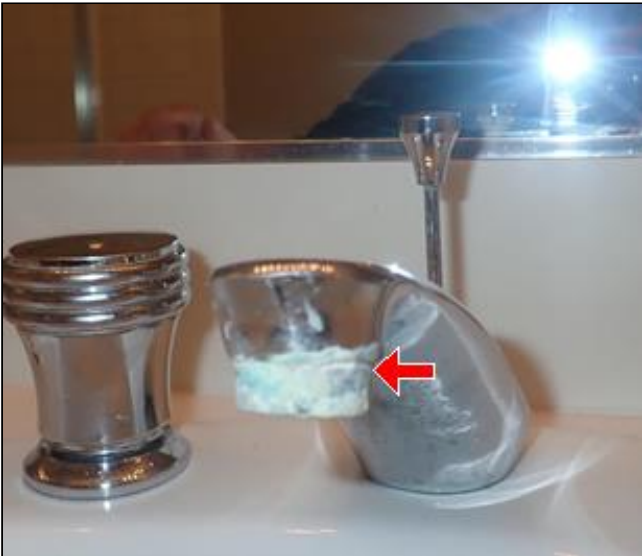
2.2 Item 3(Picture) Master bathroom.

(3) Rust, corrosion or calcification noted at one or more faucet. Advise replacement to prevent future leaks. Until then, these fixtures should be closely monitored.

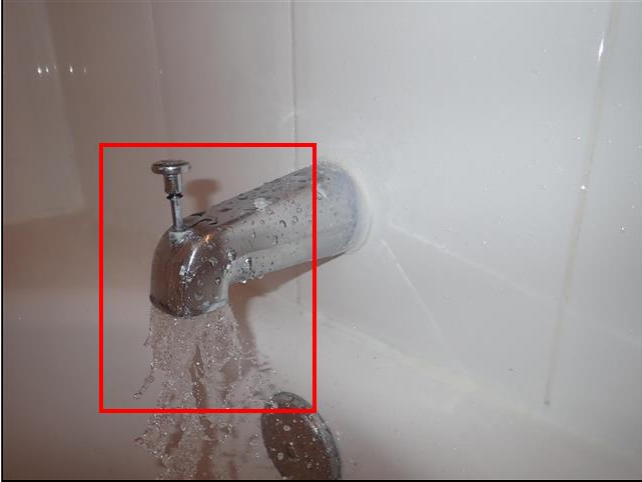
2.3 Item 1(Picture)

(2) The tub diverter did not function properly at the time of the inspection. Water sprays from shower head and tub spout at the same time. This is typically due to corrosion and or hard water build-up. Recommend further evaluation by a licensed plumber or a qualified expert.

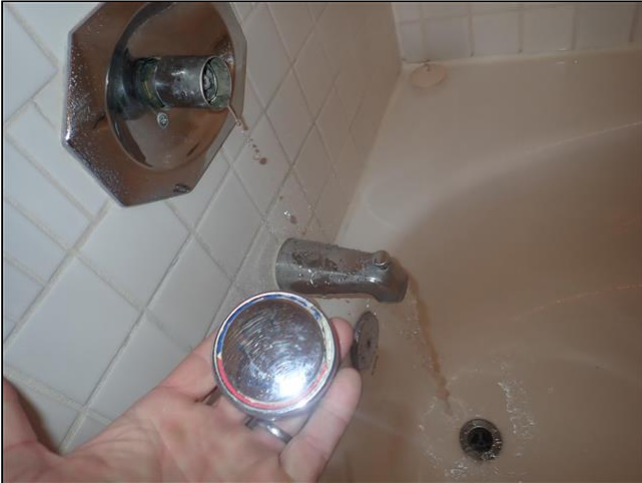
2.3 Item 2(Picture)

(3) The 2nd bedroom bathroom valve handle was noted broken at the time of the inspection. Recommend further evaluation by a licensed plumber and repair as needed.

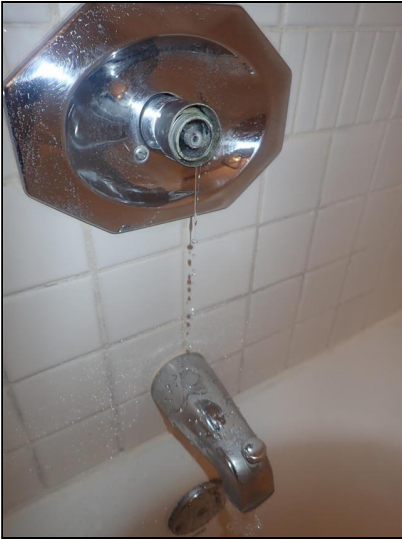
2.3 Item 3(Picture)

(4) The 2nd bedroom bathroom valve is leaking. This condition can allow water to drain behind the wall. There may be water-related damage behind the wall which is not visible or accessible. Any existing damage within the wall cavity can only be determined with destructive testing, which is beyond the scope of a home inspection. Advise immediate repair by a licensed plumber.

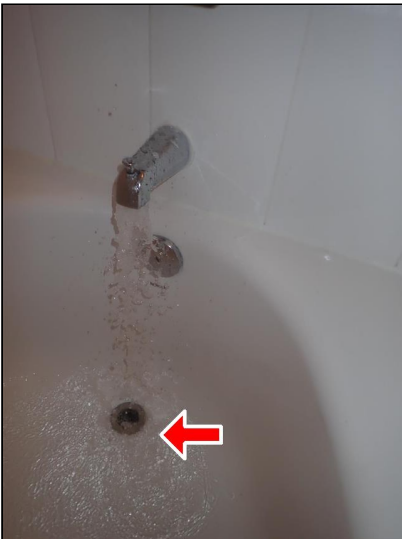
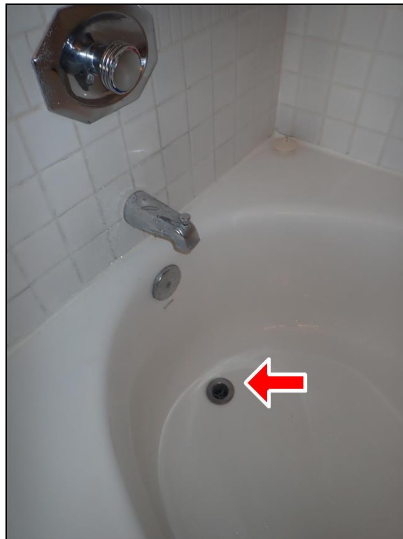
2.3 Item 4(Picture)

(5) One or more tub stop was noted missing at the time of the inspection. Advise repair.

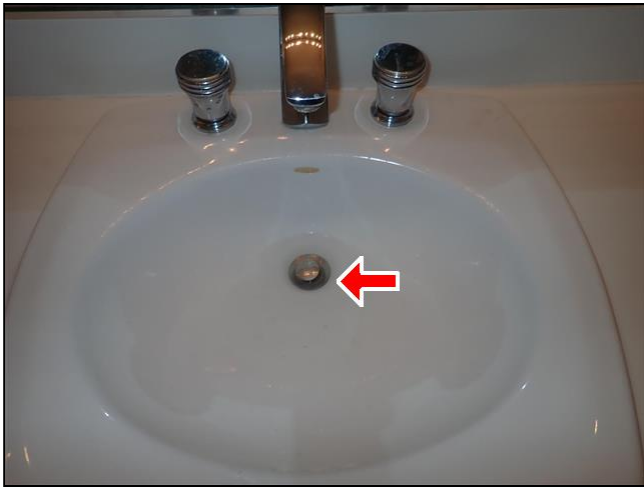
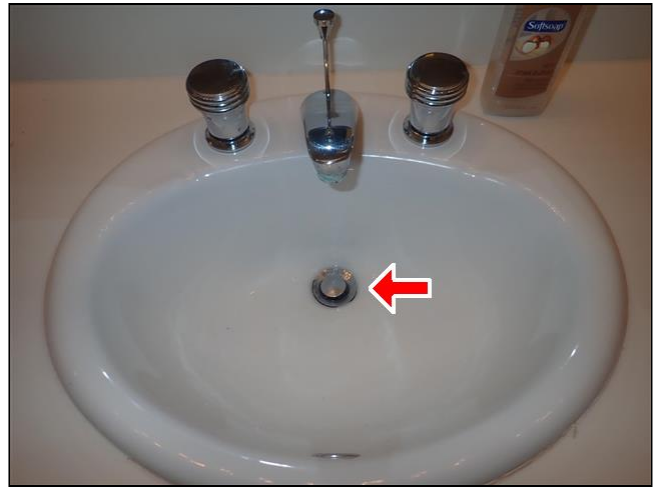
2.4 Item 1(Picture) Master bathroom.

(1) Slow drainage was noted at the sinks in the master and 2nd bedroom bathroom.. Advise professional cleanout or necessary corrections by a licensed plumber.

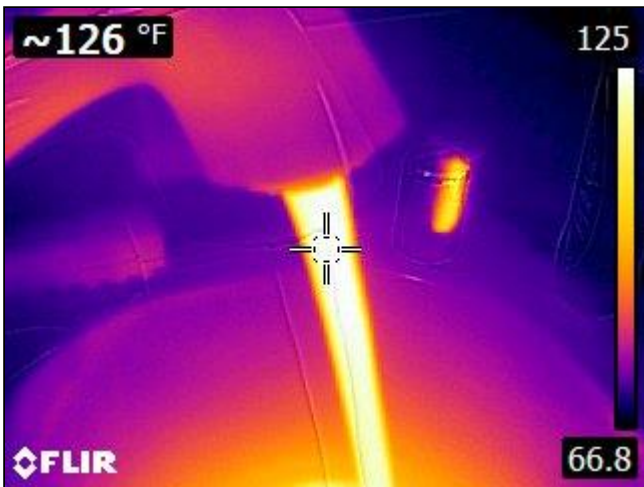
2.5 Item 1(Picture) Thermal image of water heater producing hot water.

There appears to be a community hot water system. This hot water unit was not inspected.

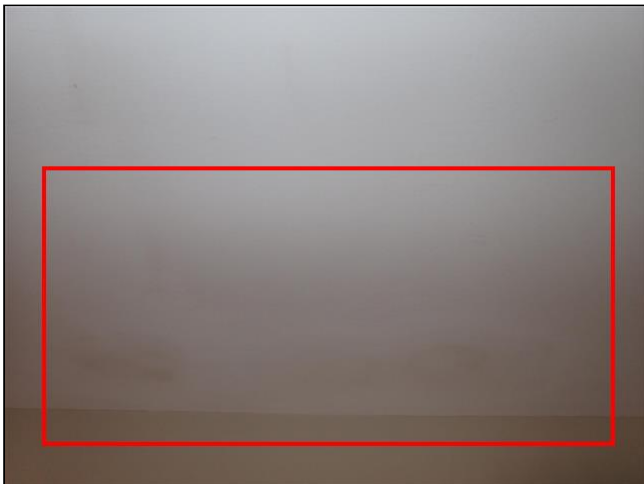
3.1 Item 1(Picture) Kitchen ceiling.

Moisture staining noted on the ceiling in the kitchen. This could be indicative of a previous leak. The area appeared dry at the time of the inspection. Recommend asking seller/HOA about any leaking in the is area and/or have further evaluated by a licensed contractor to determine if repairs are needed at this time. Please note: determining if damage exist behind the walls of any surface is beyond the scope of this inspection.

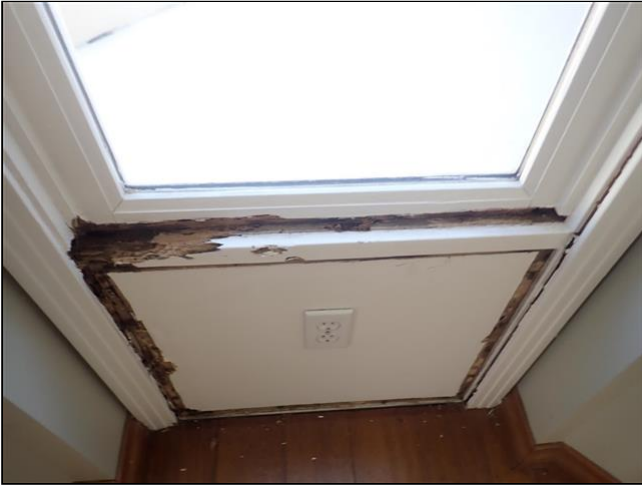
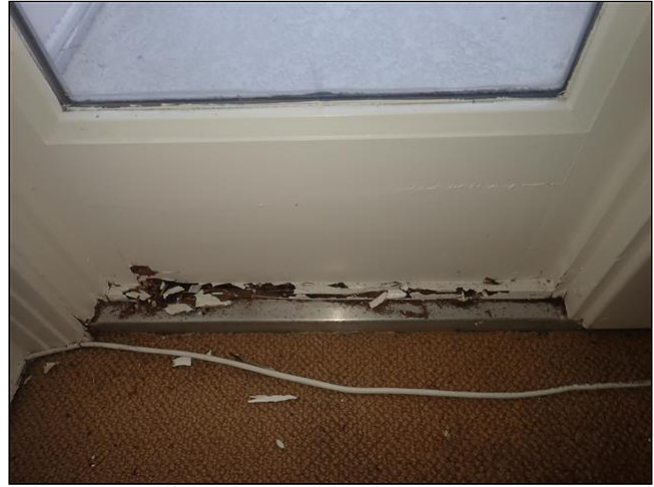
3.2 Item 1(Picture)

(1) Moisture damaged wood, evidence of wood destroying organisms noted. Recommend consulting the termite inspection report for corrective actions needed.

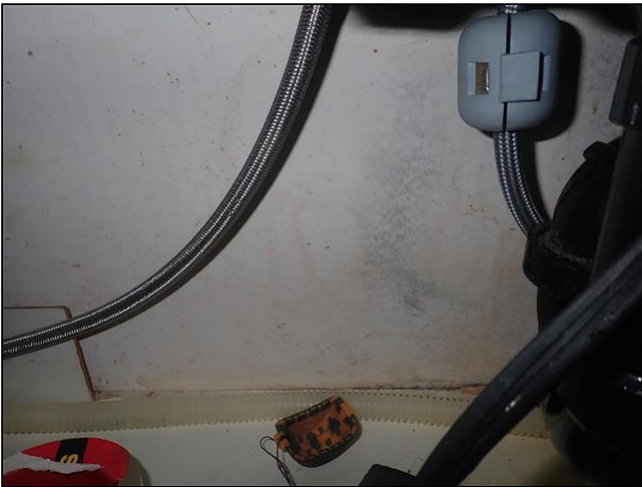
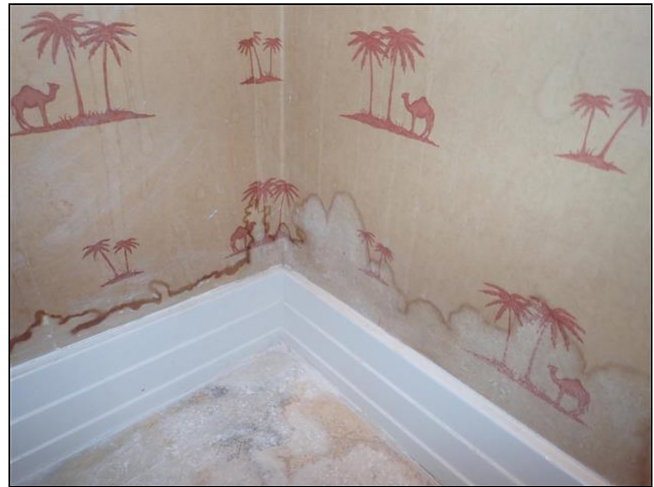
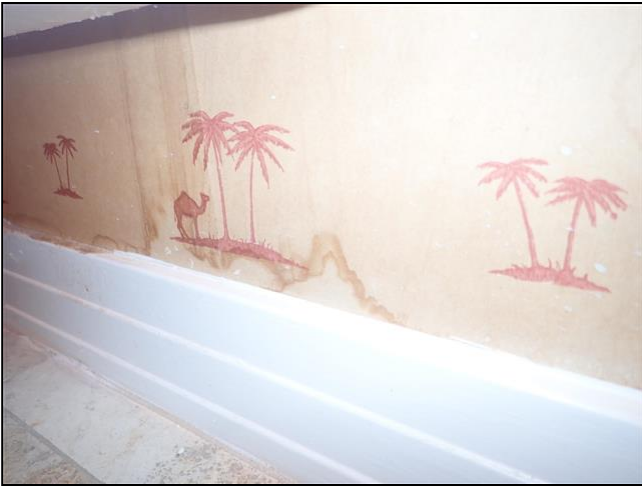
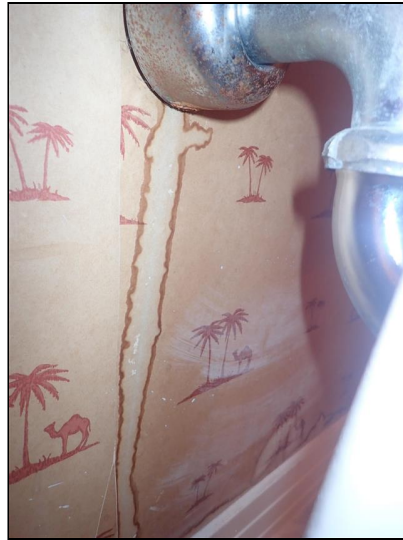
3.2 Item 3(Picture) Under kitchen sink.

(2) Moisture staining noted on the wall in the kitchen and half bathroom. This could be indicative of a previous leak. The area appeared dry at the time of the inspection. Recommend further evaluation by a licensed contractor to determine if repairs are needed at this time. Please note: determining if damage exist behind the walls of any surface is beyond the scope of this inspection.

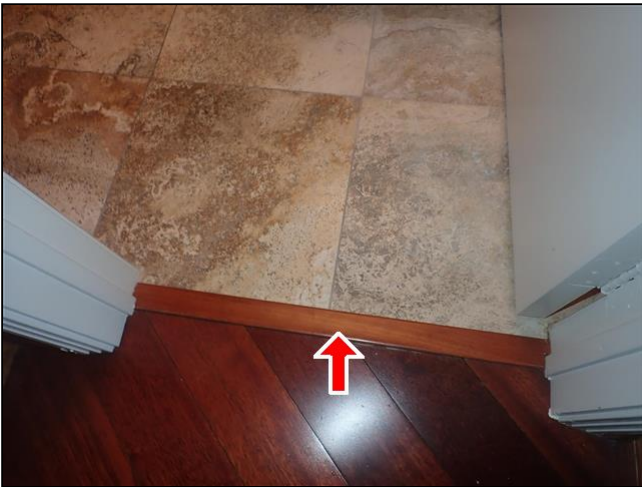
3.3 Item 1(Picture)

Loose threshold noted at one or more area. Advise repair.

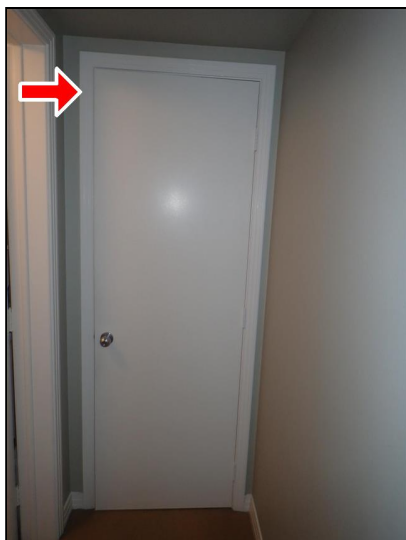
3.6 Item 1(Picture) Master bedroom.

(1) Interior door sticks in one or more areas. Advise correcting and maintenance as needed.

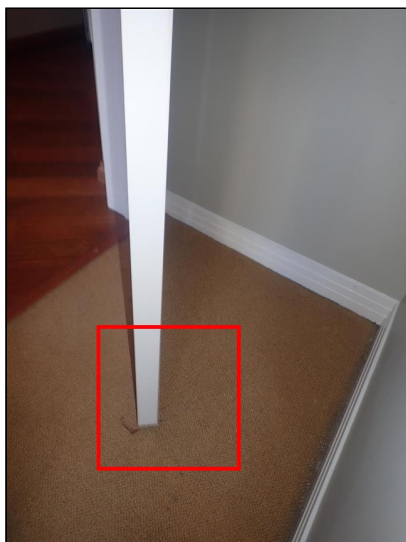
3.6 Item 2(Picture)

(2) One or more door stop is missing/damaged. Advise repair to prevent damage to the adjacent wall.

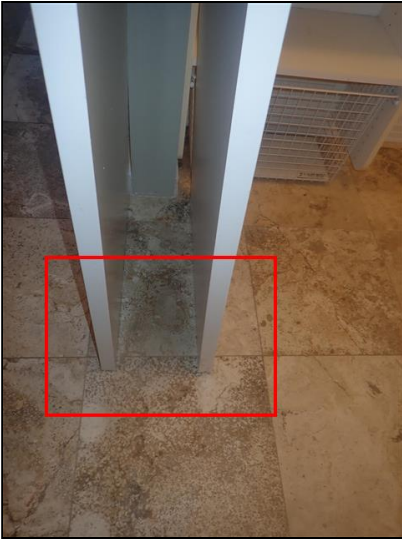
3.6 Item 3(Picture)

(3) One or more closet door appeared to be missing it's plastic floor guide. This could prove to be a pinching hazard for small children. Advise repair.

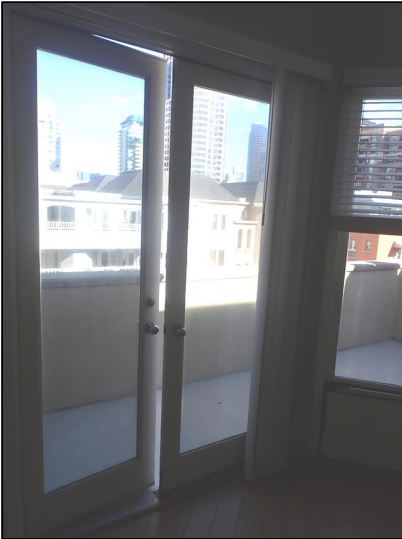
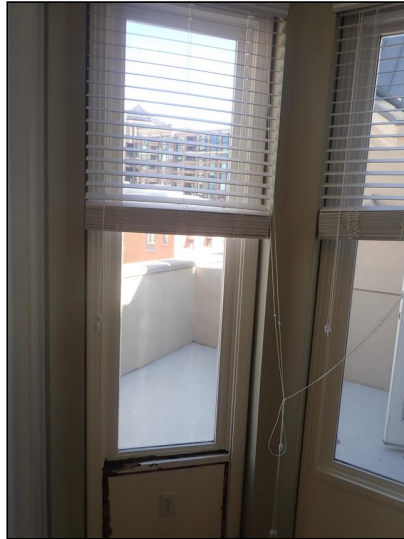
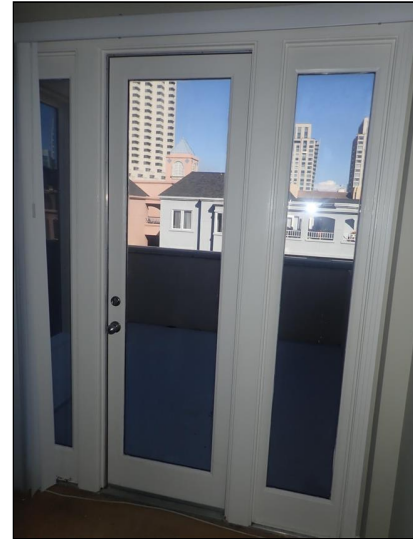
3.7 Item 1(Picture)

(1) One or more fogged window noted. This is indicative of failed hermetic seals. This condition will reduce the visibility and thermal efficiency of these windows. Recommend further evaluation by a licensed window contractor to determine repairs needed at this time.

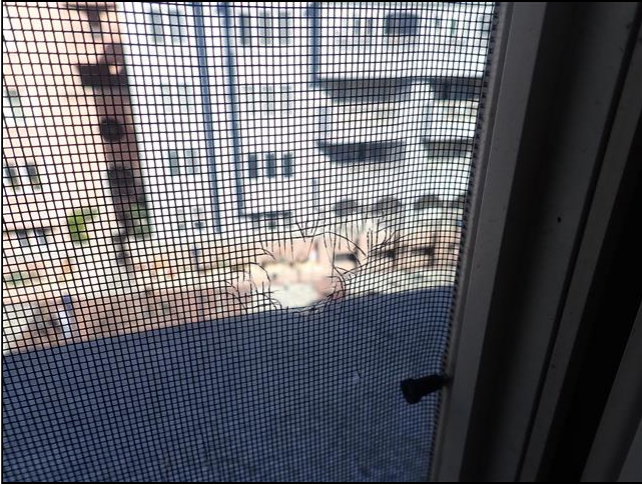
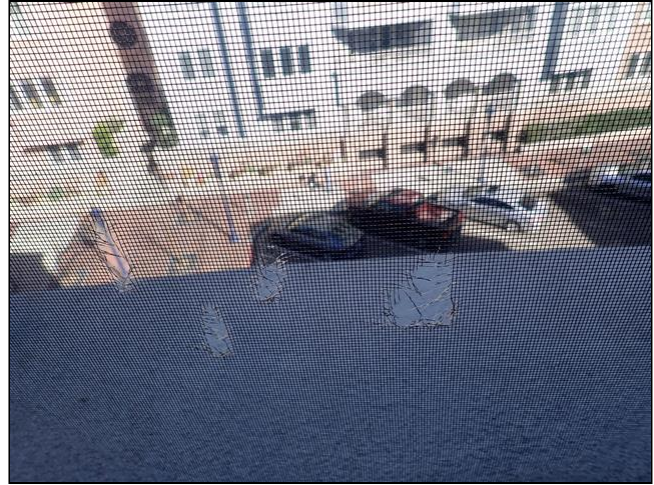
3.7 Item 4(Picture)

(2) One or more screen is loose, missing, bent or damaged. Advise repairing as needed.

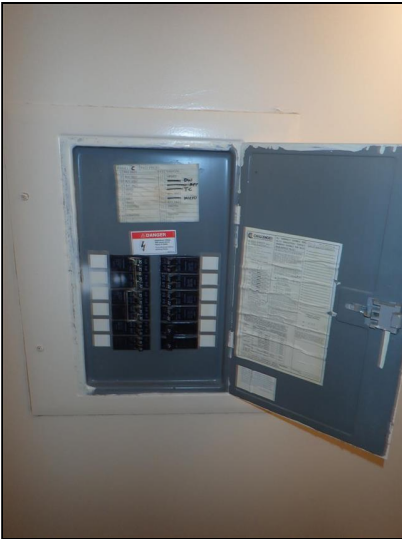
4.0 Item 1(Picture)

Pictures of electrical panel.

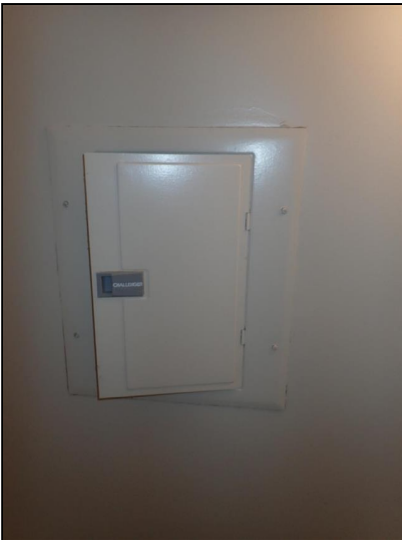
4.2 Item 1(Picture)

The sub-panel is located in the laundry room.

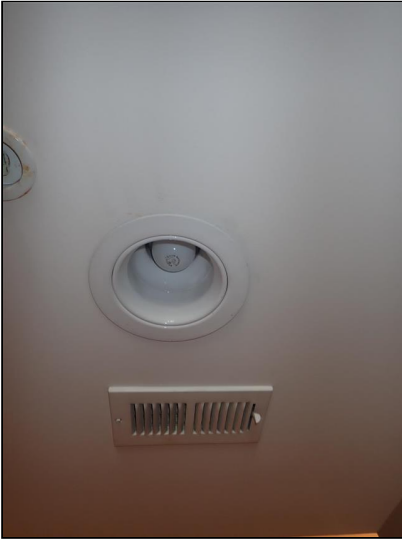
4.5 Item 1(Picture) Master bathroom.

One or more light is inoperable; possibly due to bulb. Advise replacing bulbs and checking the operation of these fixtures. If light fails to work, further evaluation by a licensed electrician is recommended.

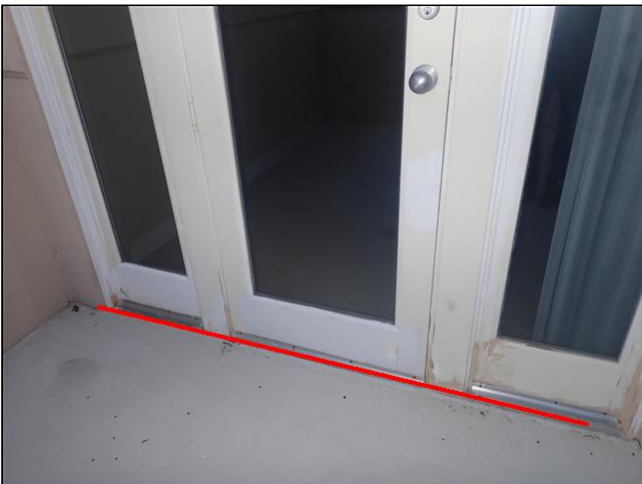
7.3 Item 1(Picture)

Moisture damaged wood noted at the exterior master bedroom door. Recommend consulting the termite inspection report for corrective actions needed.

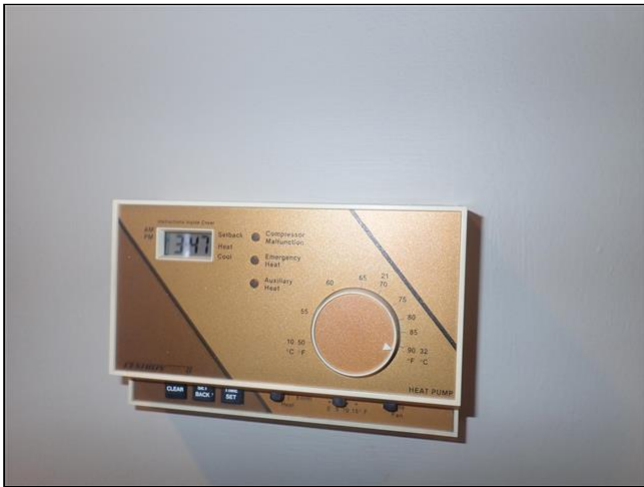
9.1 Item 1(Picture)

The thermostat is located in the hall.

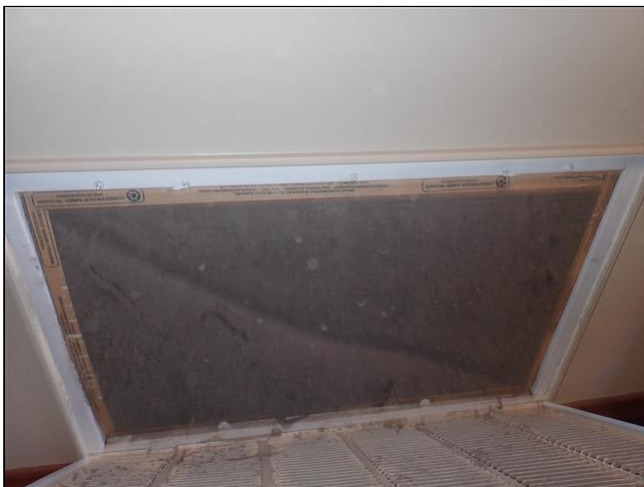
9.5 Item 1(Picture)

(1) The filter is dirty and needs to be cleaned and/or replaced.
