360 HOME INSPECTION

CONDO/TOWNHOME

1730 Avenida Del Mundo 1503  
Coronado, CA 92118

01/08/2025

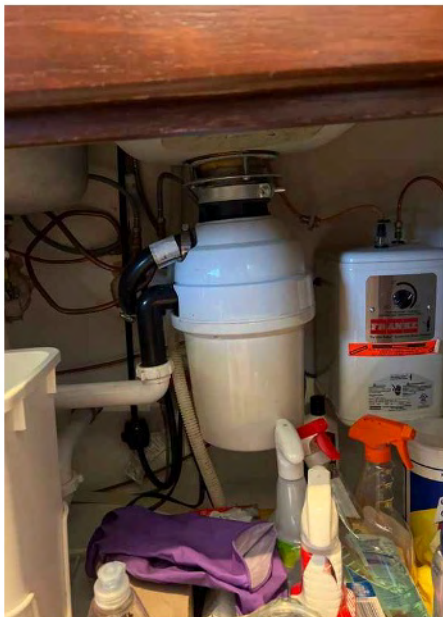
#### Garbage Disposal: Turned On Garbage Disposal

I turned on the garbage disposal and inspected for defects.

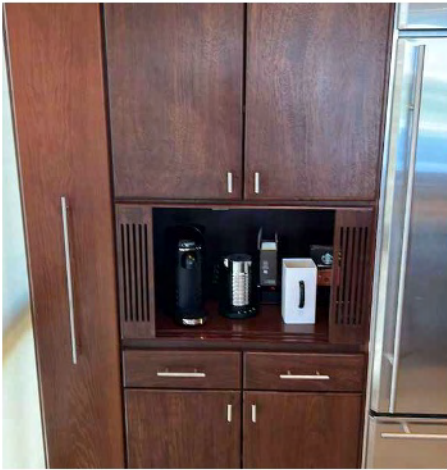
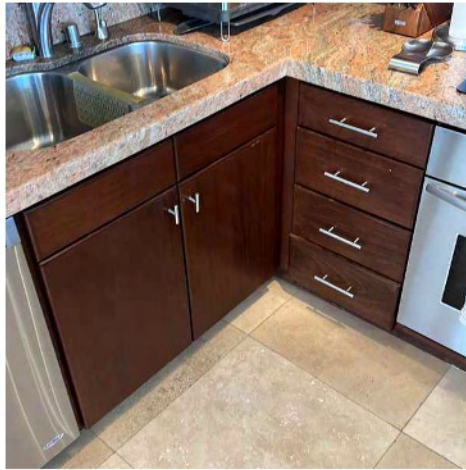
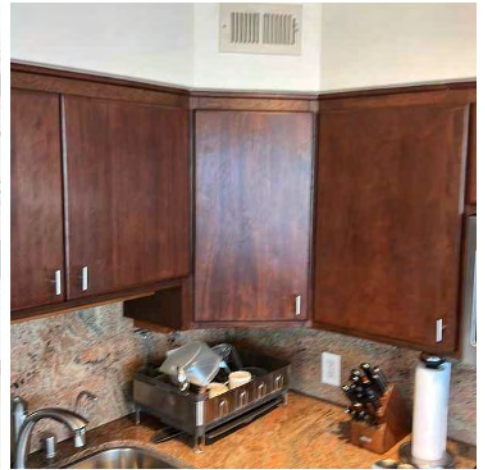
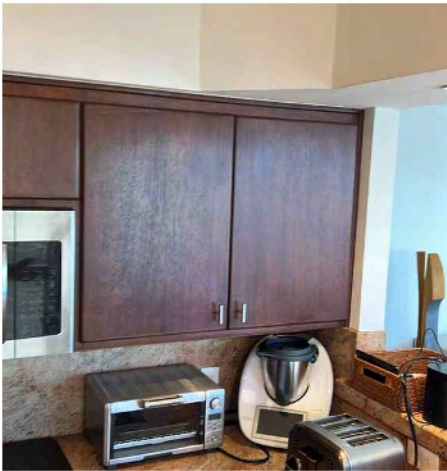
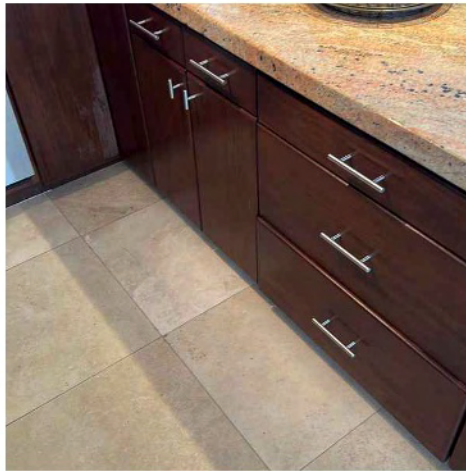
## Countertops & Cabinets: Inspected Cabinets & Countertops

I inspected a representative number of cabinets and countertop surfaces.

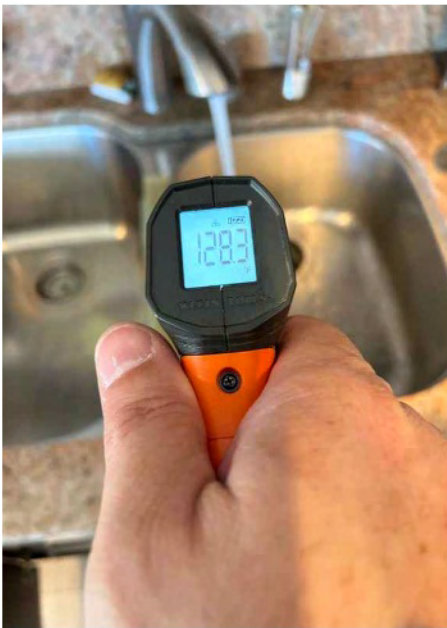
## Kitchen Sink: Ran Water at Kitchen Sink

Ran water at the kitchen sink. Inspected for defects at the sink, plumbing lines and faucet. I also checked the water temperature.

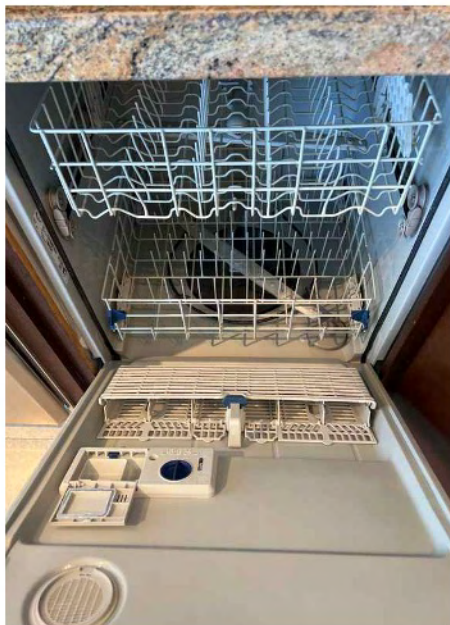
### Dishwasher: Inspected Dishwasher

I inspected the dishwasher by turning it on and letting it run a short cycle.

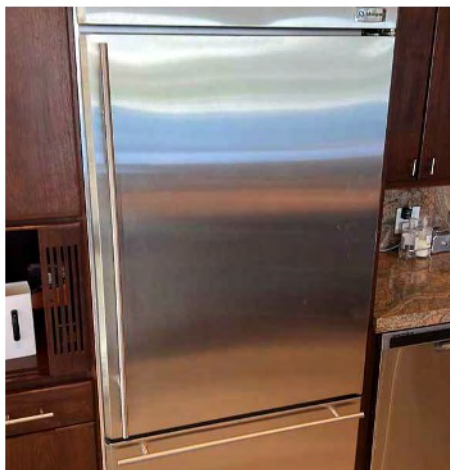
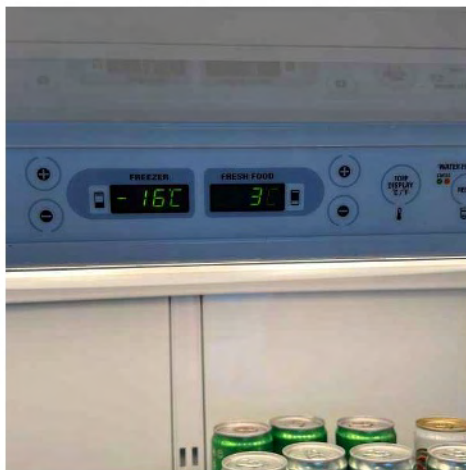
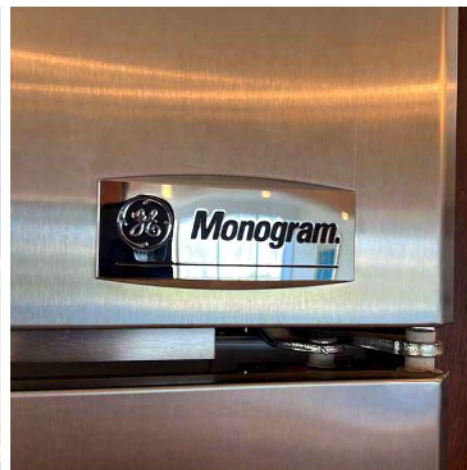
### Refrigerator: Refrigerator Was On

I checked to see if the refrigerator was on. The interior temperatures of refrigerator and freezer were observed using a thermal camera and the refrigerator appeared to be functional. This is not an exhaustive test and does not verify the efficiency of the refrigerator. Appliances are not moved to inspect the walls/floors/other components behind them. We recommend that keep a good home warranty in place which covers the appliances.

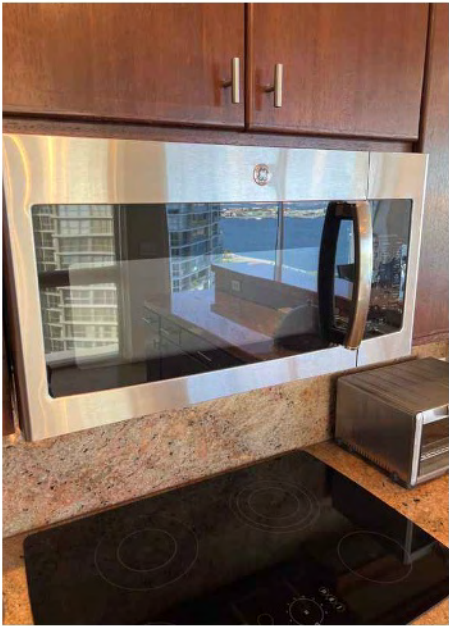
**Built-in Microwave: Microwave Turned On**

I observed that the microwave turned on and was functional at time of the inspection. This is not an exhaustive test, and does not predict the performance of the microwave.

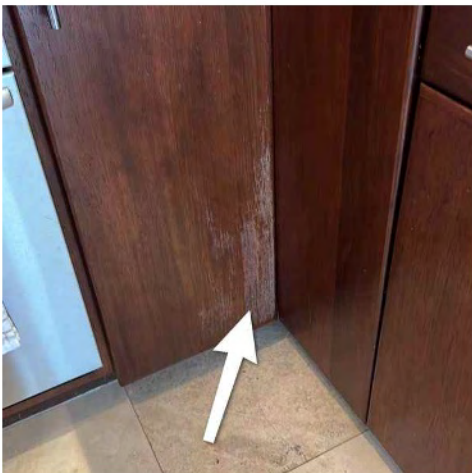
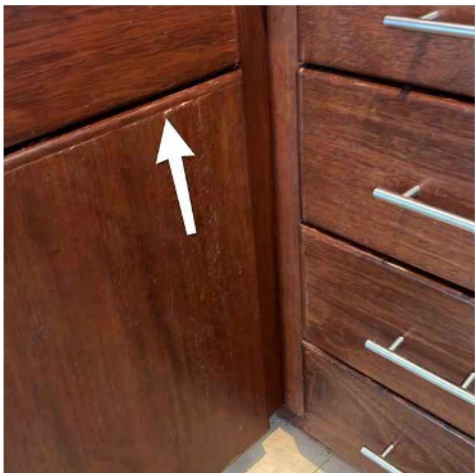
2.2.1 Countertops & Cabinets

**WORN AREAS AT CABINETS**

I observed worn areas at a few of the cabinets. Recommend repairs so that the cabinets will function as intended.

Contact a qualified handyman.

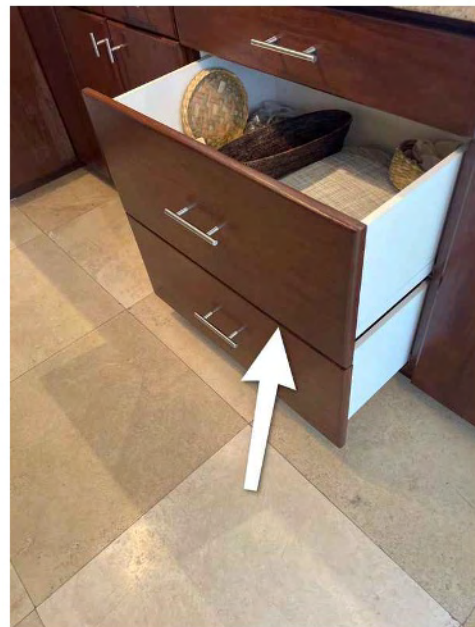
2.2.2 Countertops & Cabinets

**DRAWER DEFECT**

A few of the cabinet drawers are not operating properly or the hardware is defective. Repairs are recommended so that they will function as intended.

Contact a qualified handyman.

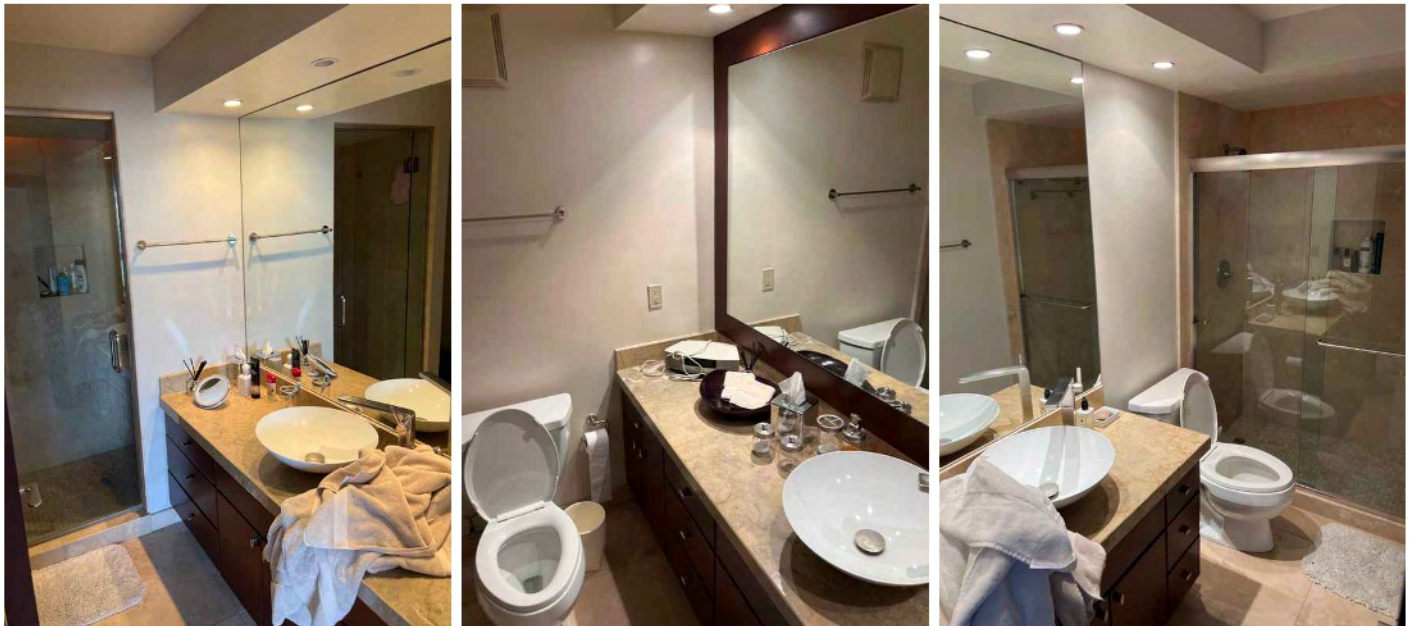
#### Bathrooms Inspected: Bathroom Inspected.

*I inspected the bathroom area, including but not limited to the cabinets, countertops, appliances, walls, floors, electrical, plumbing, and ventilation. The following items were inspected and observed, with any recommended actions noted:*

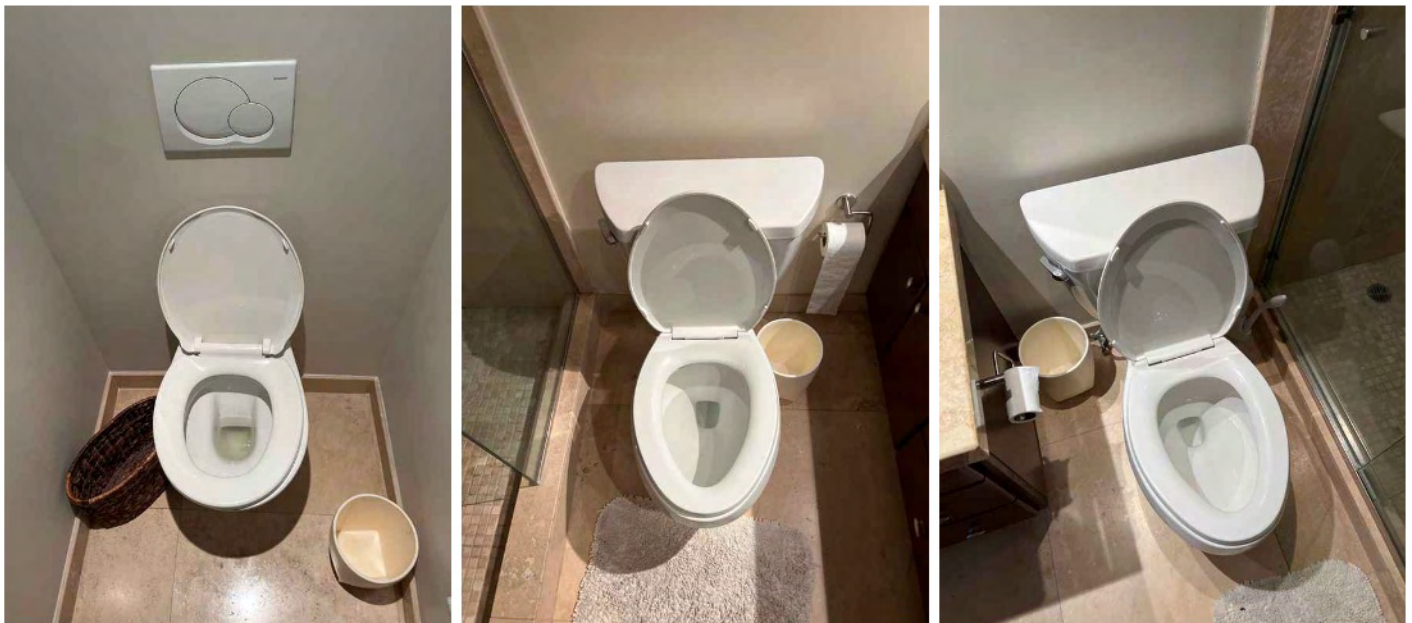
#### Bathroom Toilets: Toilets Inspected

I flushed all of the toilets, checked for proper installation and leaks with the infrared camera.

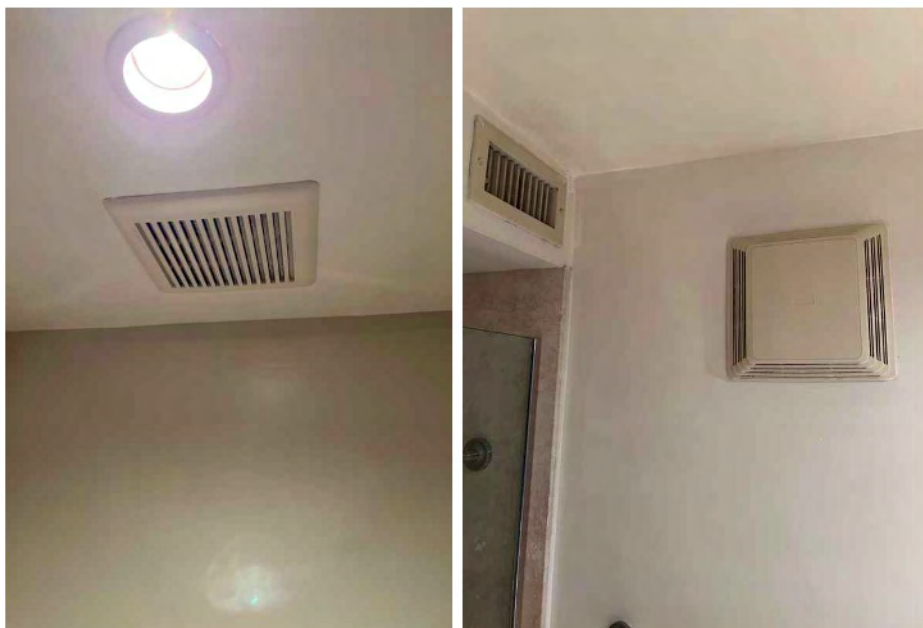
**Bathroom Exhaust Fan / Window: Inspected Bath Exhaust Fans**

I inspected the exhaust fans of the bathroom(s). All mechanical exhaust fans should terminate outside. Confirming that the fan exhausts outside is beyond the scope of a home inspection.

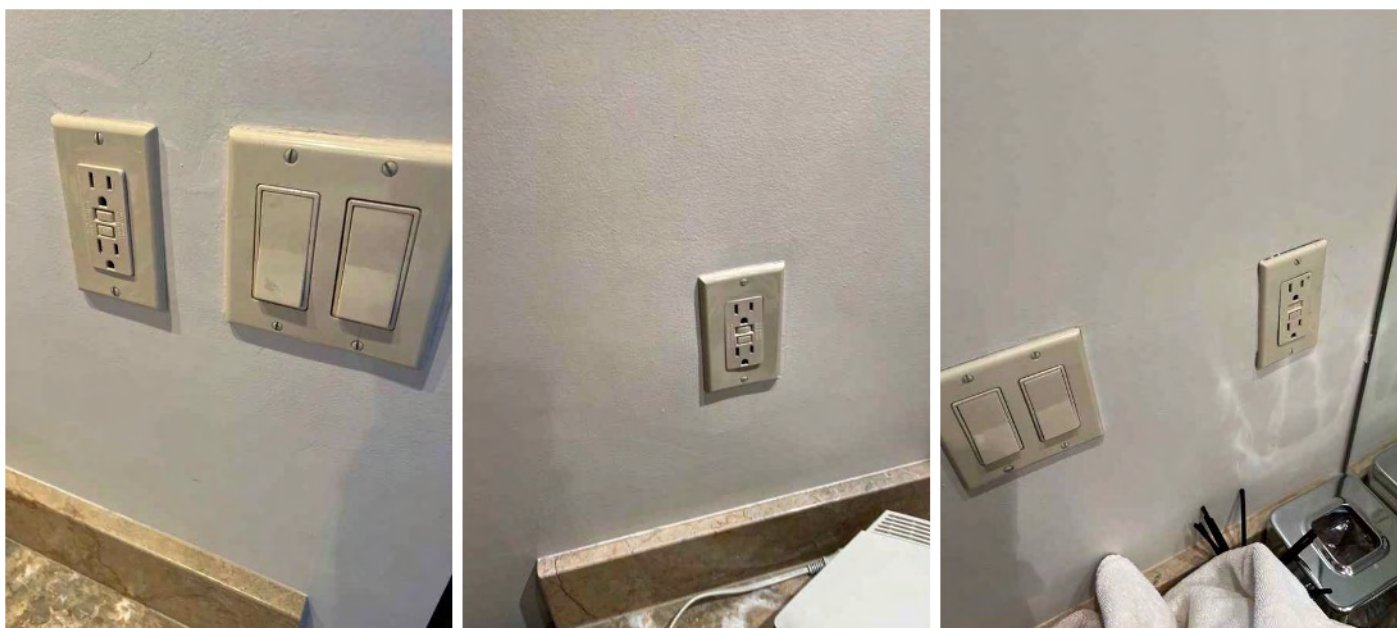
**Electric in Bathroom: Electrical Fixtures Inspected**

I inspected the electrical fixtures, receptacles and switches in the bathrooms.

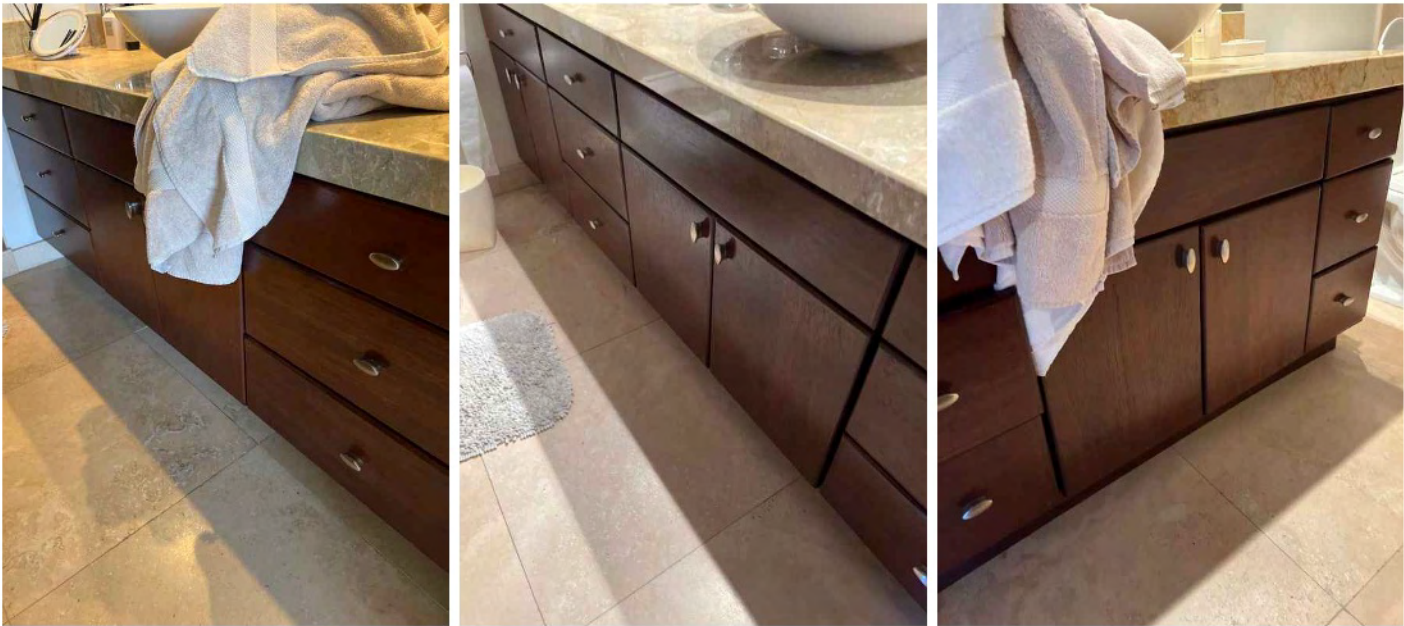
Cabinetry, Ceiling, Walls & Floor: Bathroom Walls, Ceiling, & Cabinetry Inspected

I inspected the conditions of the bathroom walls, ceilings and cabinetry for defects.

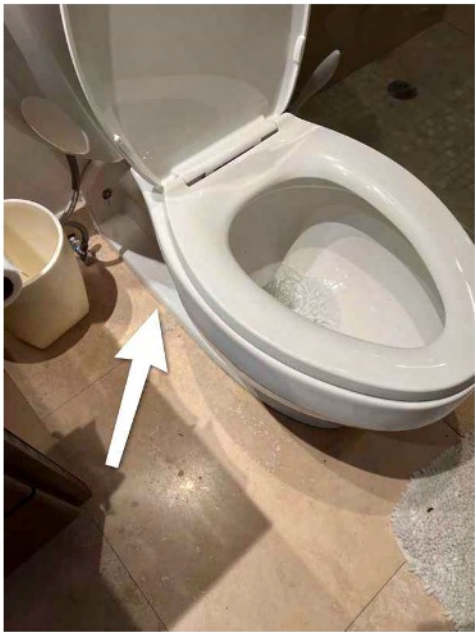
3.2.1 Bathroom Toilets

TOILET BASE LOOSE

Toilet is not properly secured to the floor. This could lead to leaks including sewer gas and waste materials. Repairs are recommend to prevent sewer gas and leaks into the bathroom.

Loose toilet

Contact a qualified plumbing contractor.

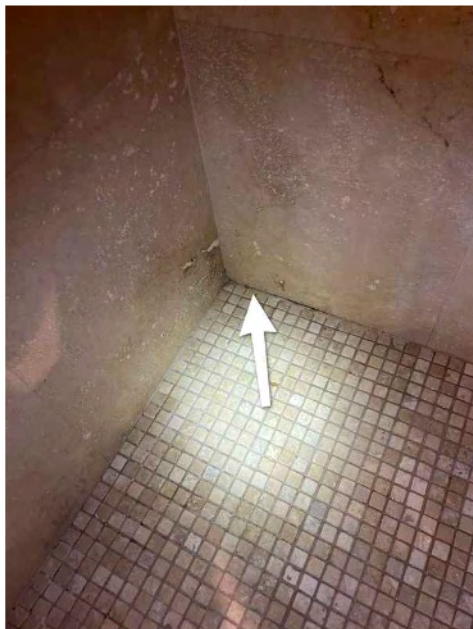
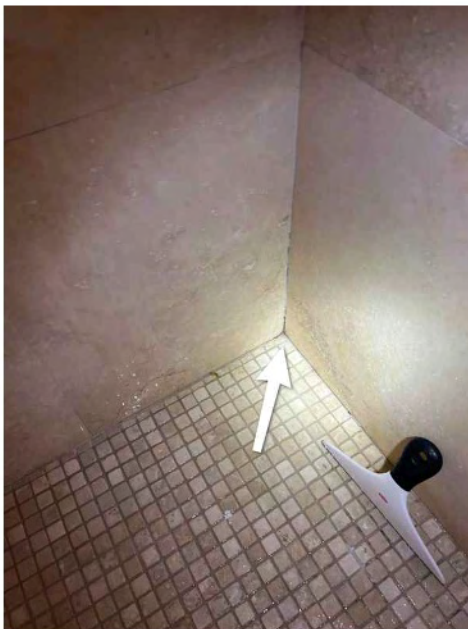
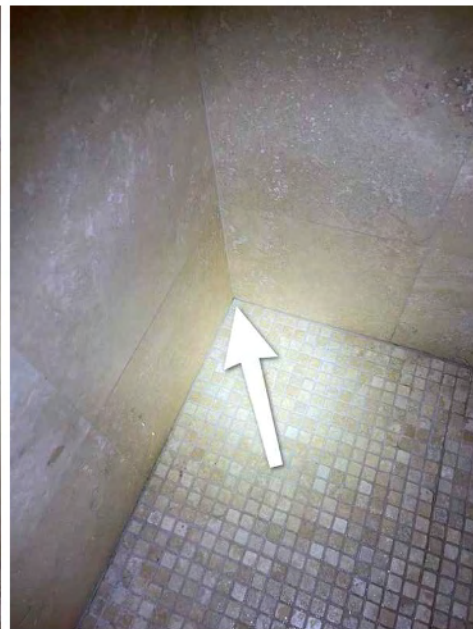
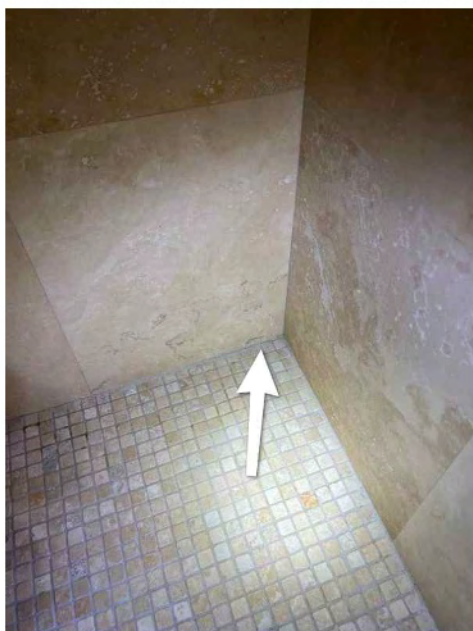
## 3.3.1 Sinks, Tubs &amp; Showers

**CAULKING DEFECT**

Caulking/grout in the shower is cracked and failing. Recommend repairs to prevent moisture problems.

Contact a qualified handyman.

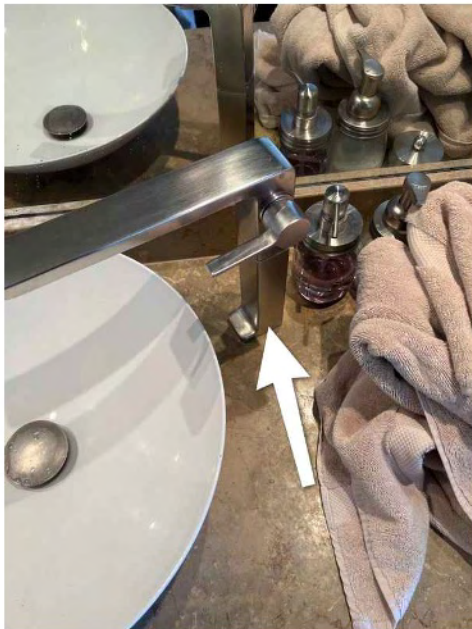
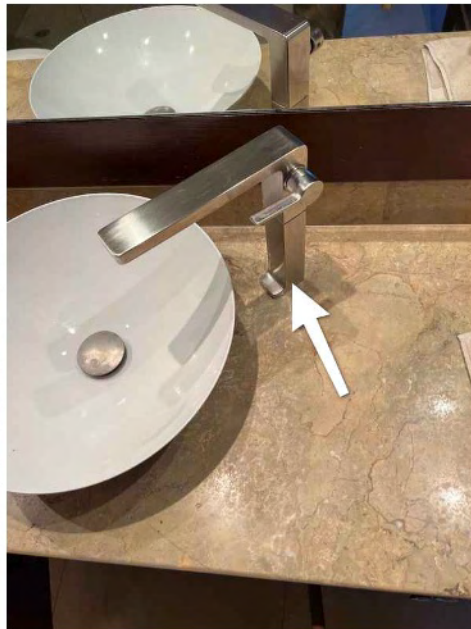
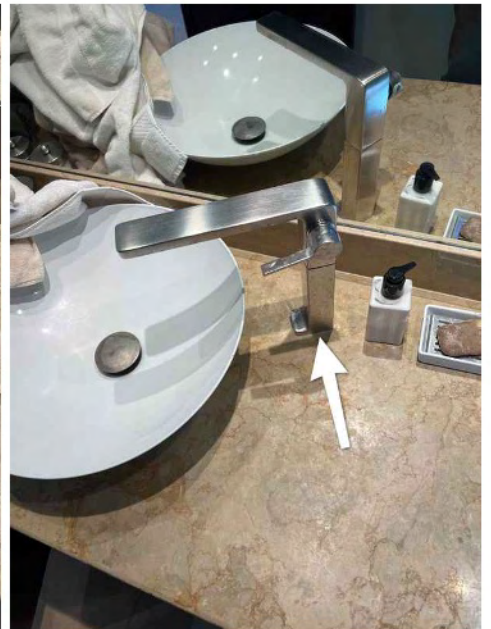
## 3.3.2 Sinks, Tubs &amp; Showers

**LOOSE FIXTURE**

Fixture handle is loose. Recommend further evaluation and repairs to prevent moisture issues or damage to the fixture.

Contact a qualified plumbing contractor.

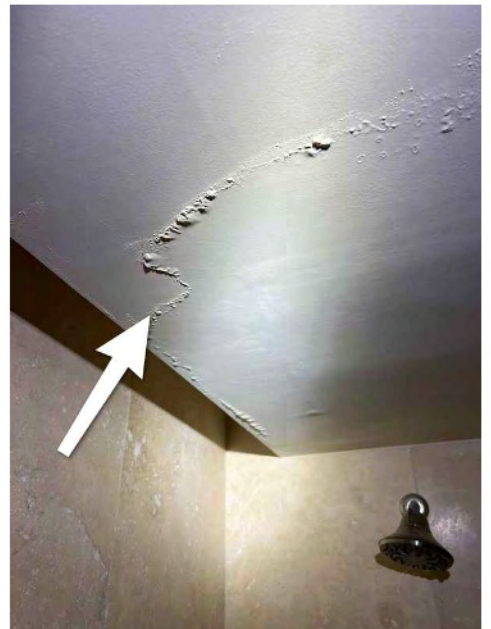
### 3.3.3 Sinks, Tubs & Showers

#### **SHOWER CEILING DEFECT**

I observed moisture damage to the paint surface at the shower ceiling. Recommend repair to prevent moisture damage.

Contact a qualified handyman.

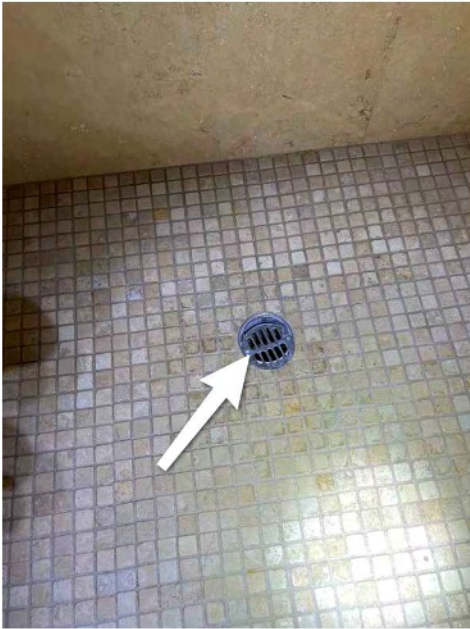
### 3.3.4 Sinks, Tubs & Showers

#### **SHOWER DRAIN COVER IS LOOSE**

Shower drain cover is loose and appears to be missing a fastener. Recommend repairs to avoid injury.

Contact a qualified handyman.

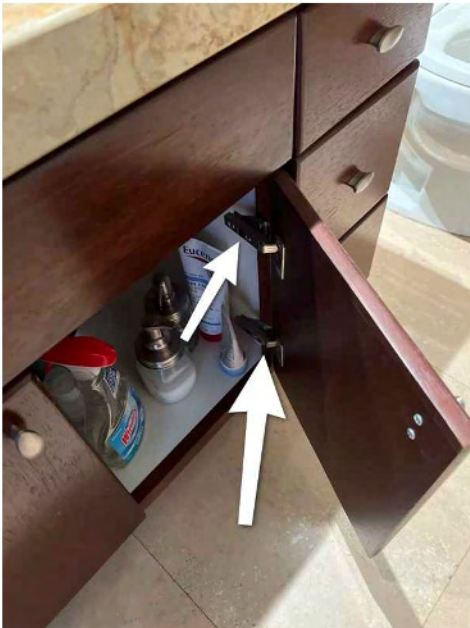
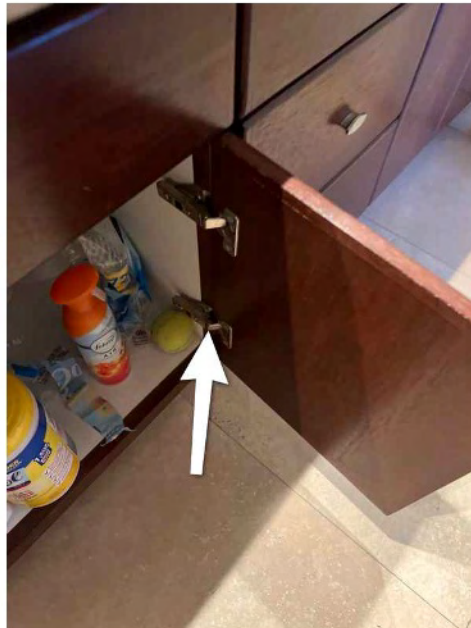
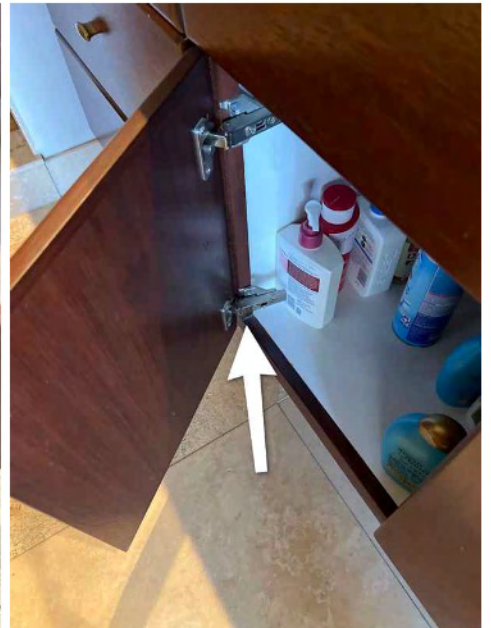
### 3.6.1 Cabinetry, Ceiling, Walls & Floor

#### **CABINET HARDWARE DEFECT**

Cabinet door hardware is loose and not operating as intended. Repairs recommended.

Contact a qualified handyman.

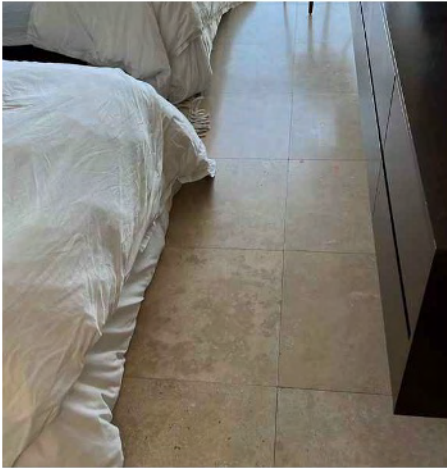
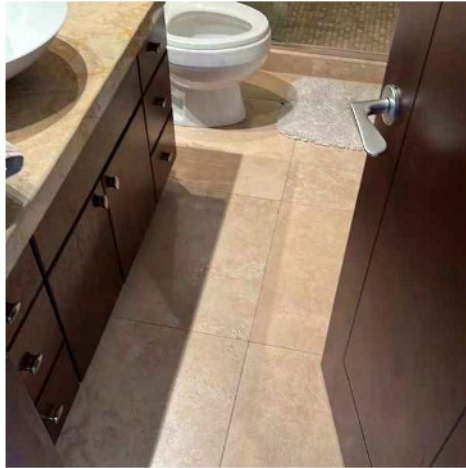
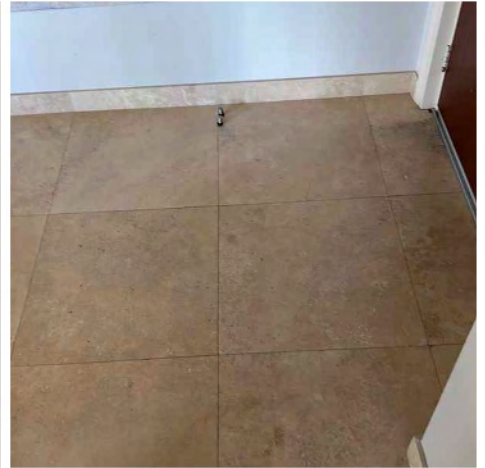
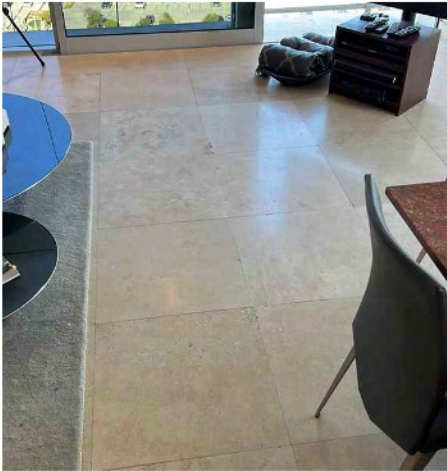
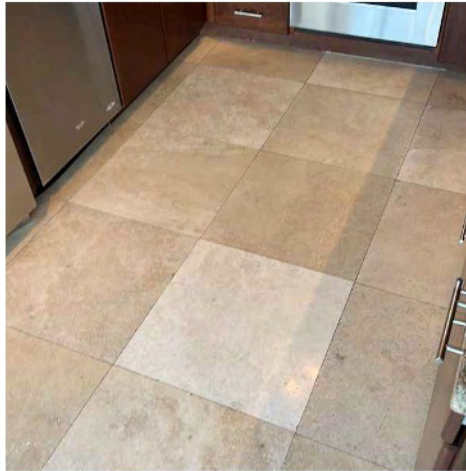
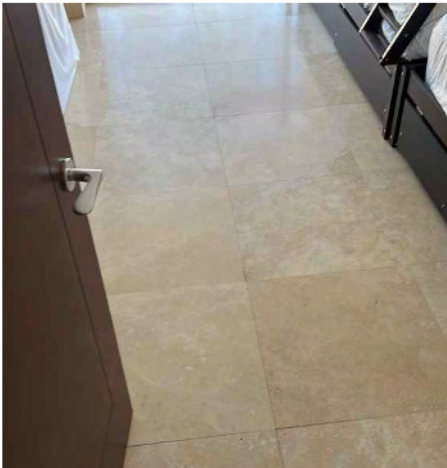
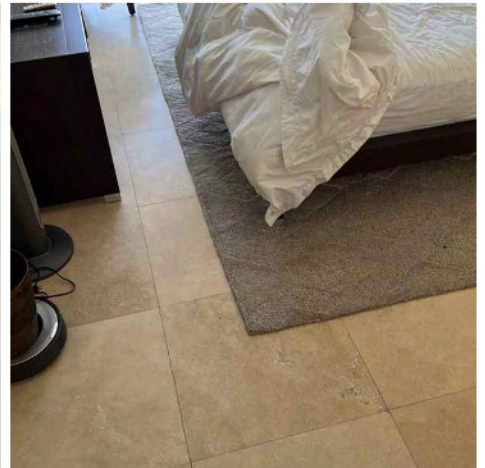
## Flooring: Flooring Inspected

I inspected the condition of the flooring throughout the home.

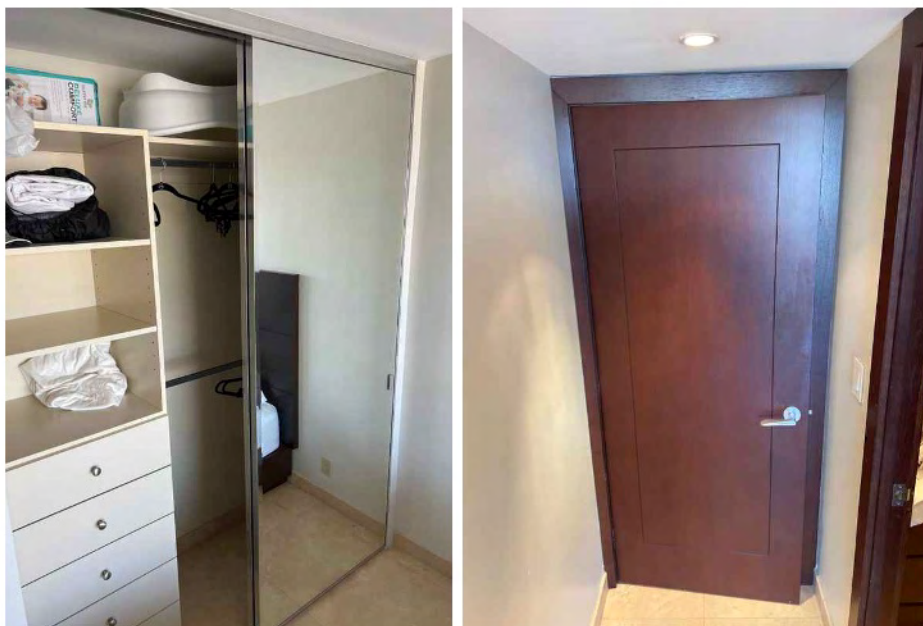
## Interior Doors: Interior Doors Inspected

Doors were operated and tested for proper operation including whether the door rubs, latches engage, and the general condition of doors.

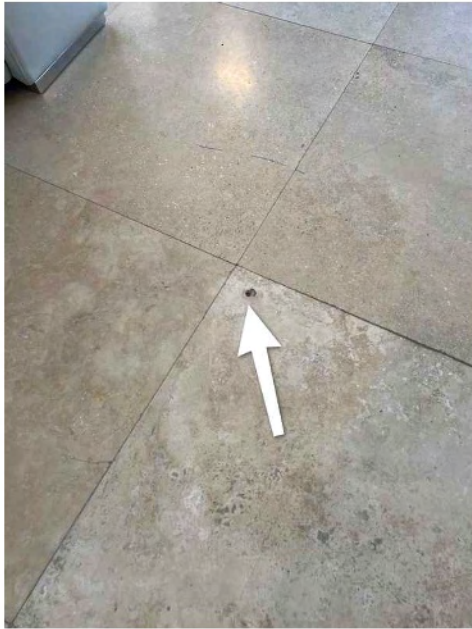
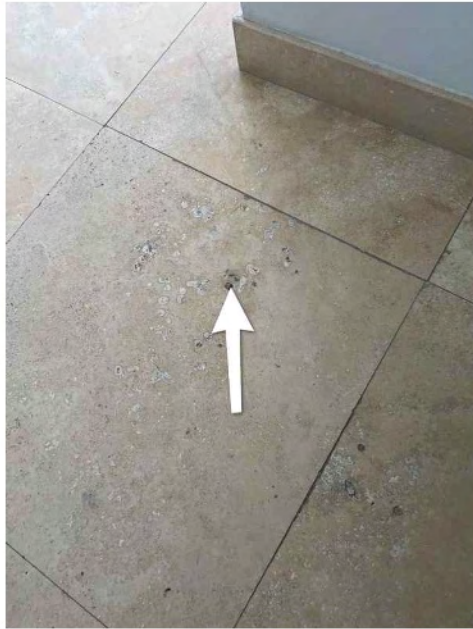
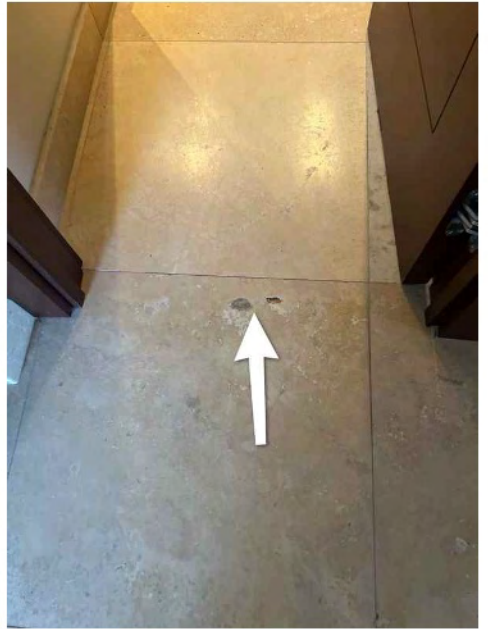
### FLOOR TILE DEFECTS

Filled areas at the tile floors are missing at a few areas. Recommend a qualified contractor make repairs.

Contact a qualified flooring contractor

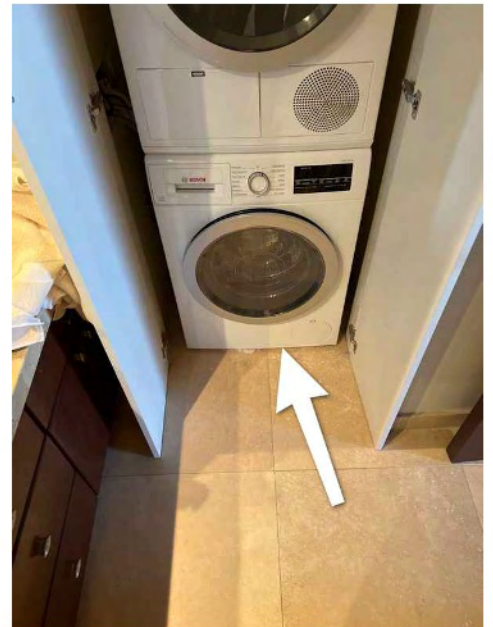
**MISSING CATCH PAN**

Missing water catch pan underneath the washing machine.  
Recommend installation of a catch pan or moisture sensor to prevent water damage if there is a water leak.

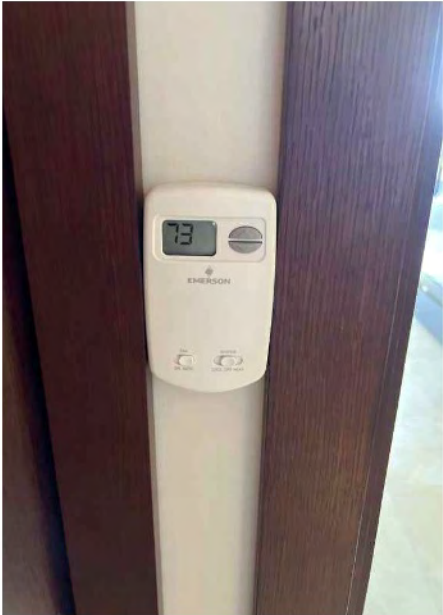
Hallway

The thermostat was inspected when used to operate the HVAC system.

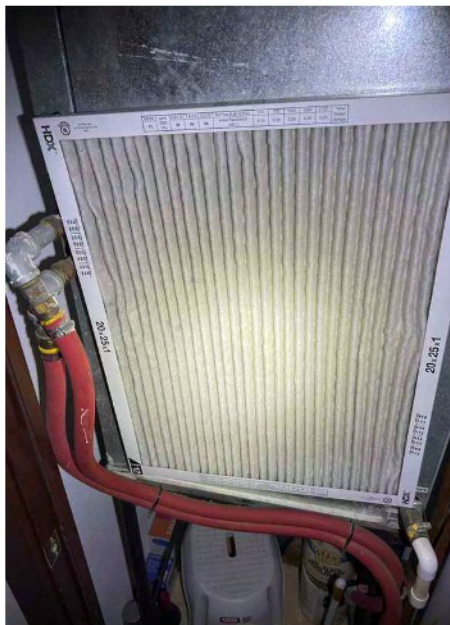
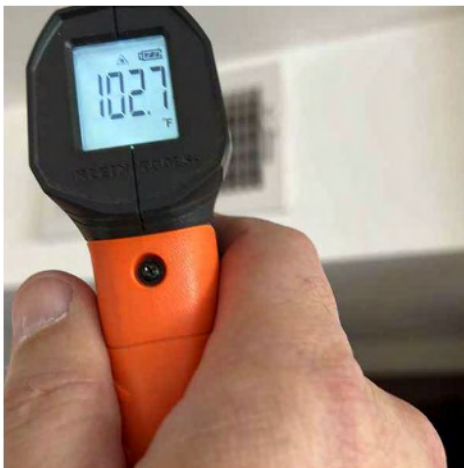
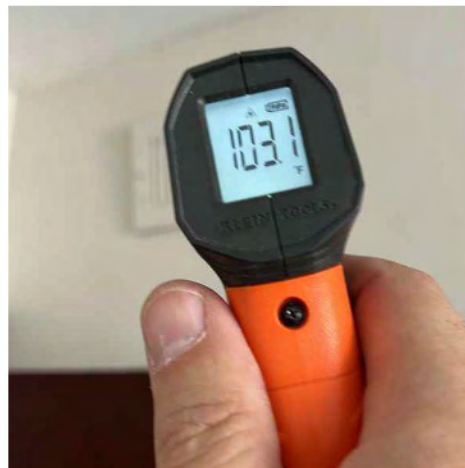
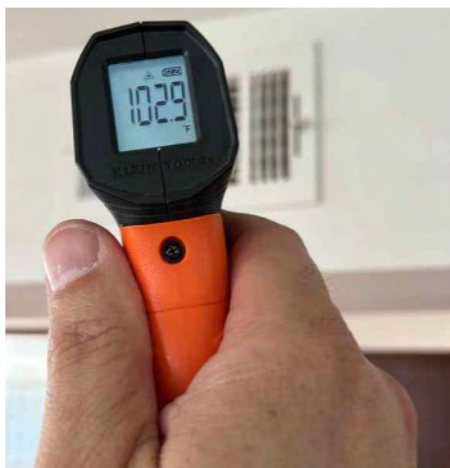
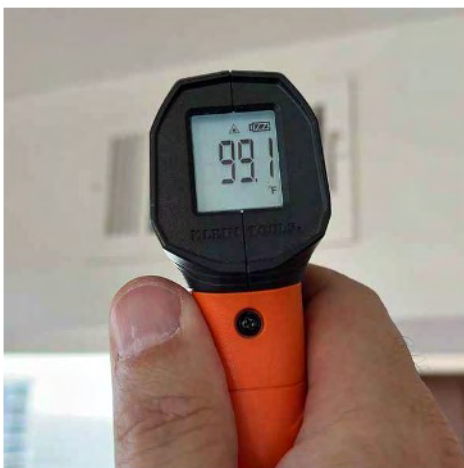
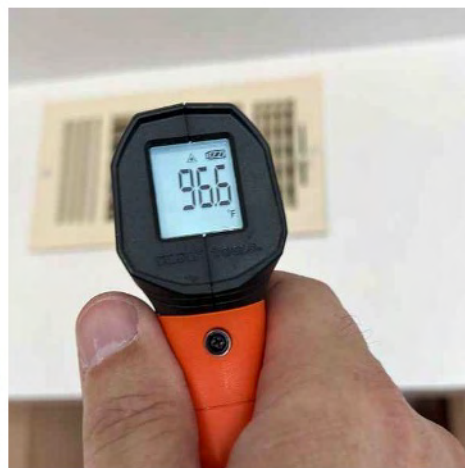
## Heating System Information: Heating

*The heating unit was tested and checked for safety and efficiency. We recommend you get the HVAC system inspected and serviced every year. We recommend changing the filter when you move in and replacing them twice a year. The following items were inspected and observed, with any recommended actions noted:*

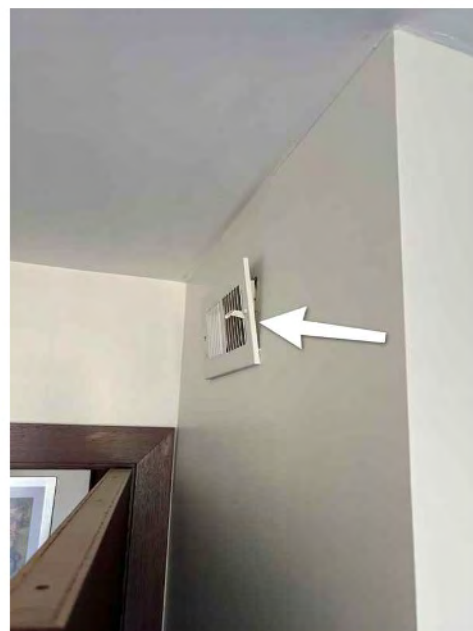
#### LOOSE REGISTER

I observed a loose register. A register is a grille with moving parts, capable of being opened and closed and the air flow directed, which is part of a building's heating, ventilation, and air conditioning (HVAC) system. Repairs recommended to prevent damage or injury.

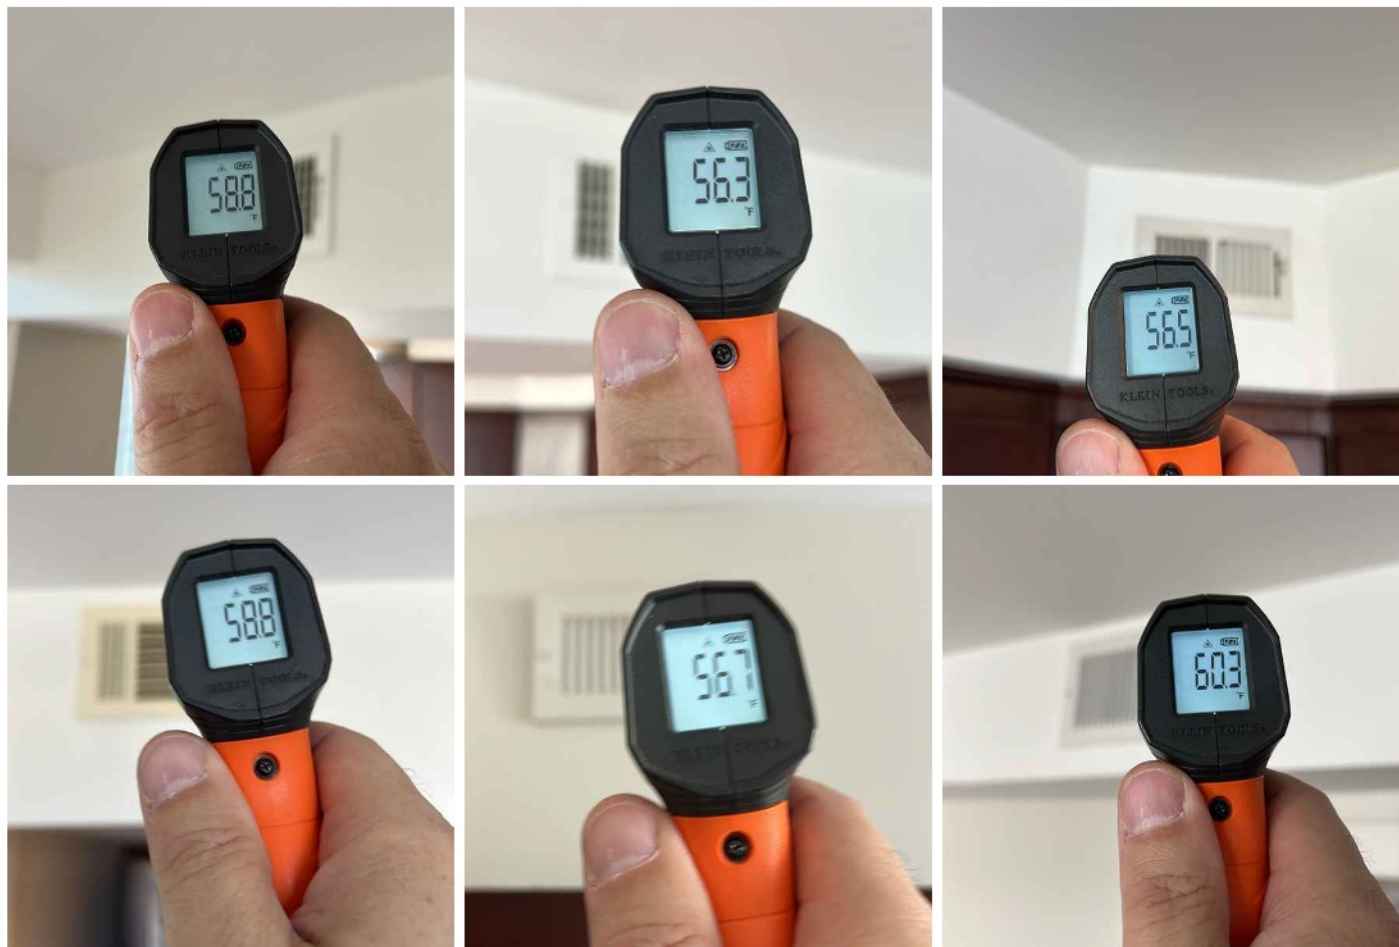
*An ambient air test was performed by using a thermal scanner on the AC system to determine if the difference in temperatures of the supply and return air are between 14 degrees and 22 degrees which indicates that the unit is cooling as intended. This indicates that the range in temperature drop is normal.*

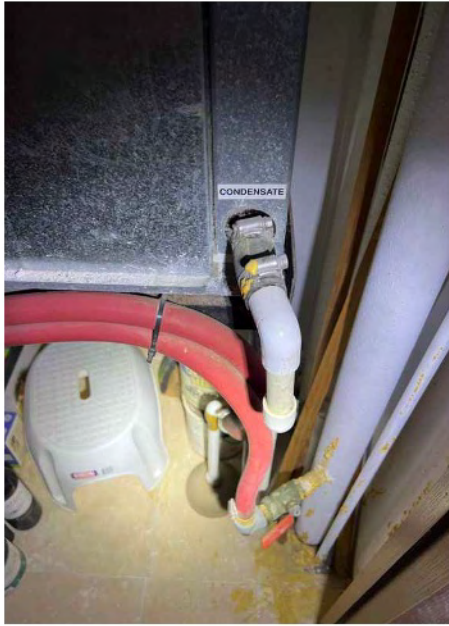
I observed a discharge pipe connected to the condensate pump installed at the cooling system.

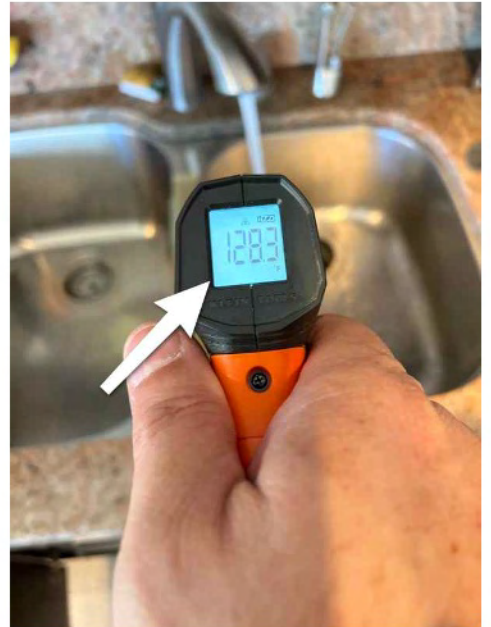
The temperature of the hot water in the home exceeded 120 degrees. This condition could lead to scalding and injury. Recommend adjusting the hot water heaters thermostat to keep water temperature below 120 degrees.

Contact a qualified plumbing contractor.

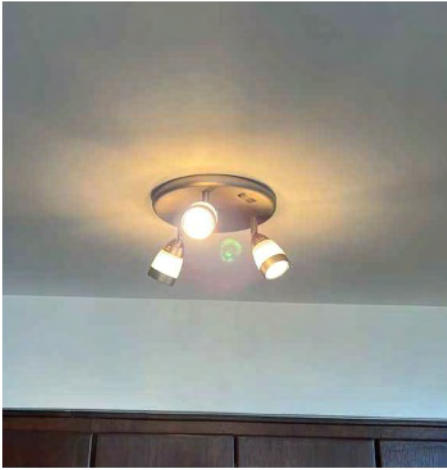
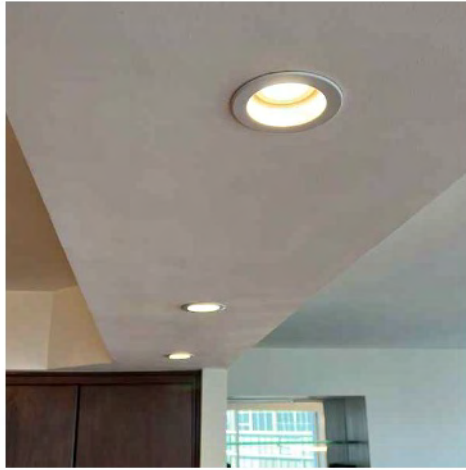
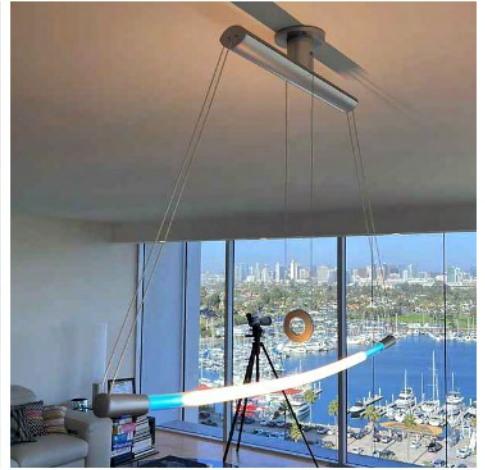
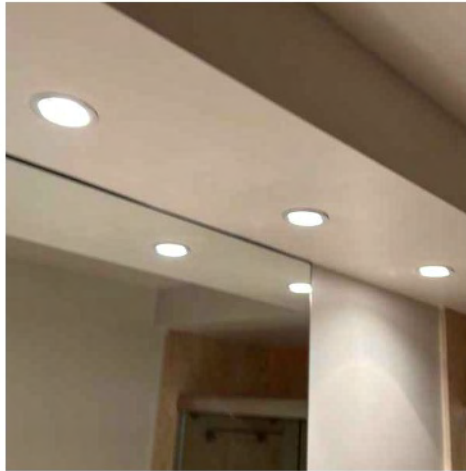
## Fixtures: Lighting Fixtures Inspected

I inspected a representative number of lighting fixtures in the home.

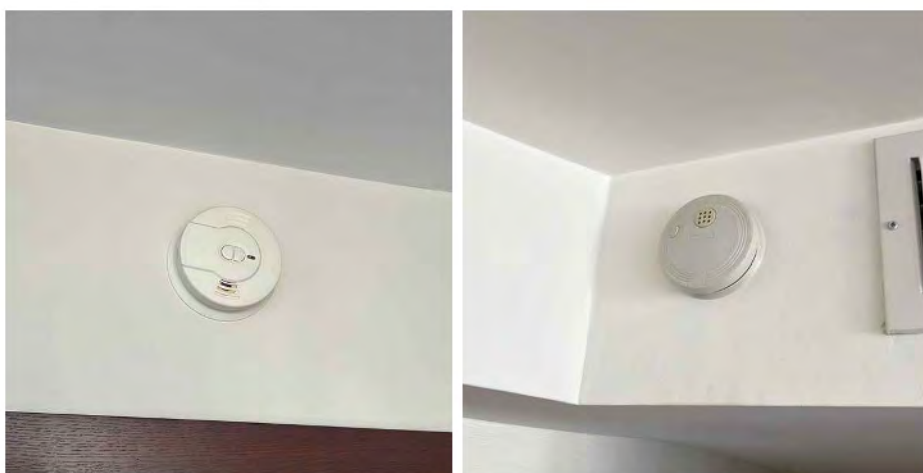
## Presence of Smoke and CO Detectors: Inspected for Presence of Smoke and CO Detectors

I inspected for the presence of smoke and carbon-monoxide detectors.

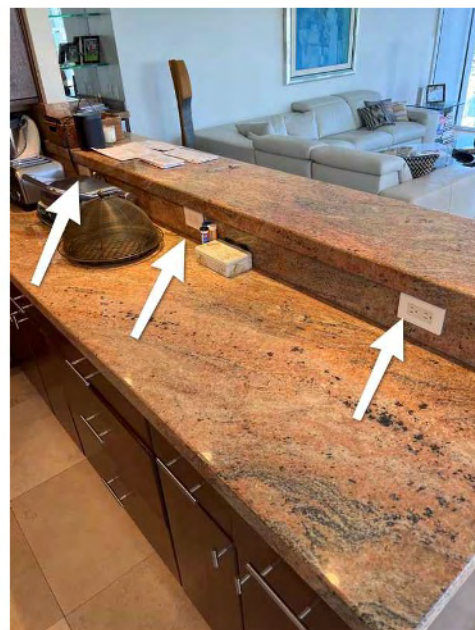
## 9.6.1 GFCIs

**MISSING GFCI**

GFCI is missing in an area that is required to keep people safe.

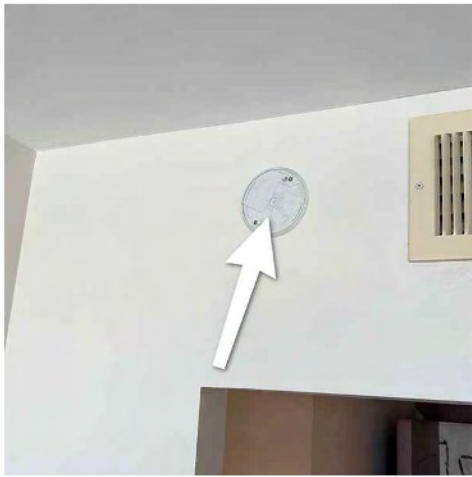
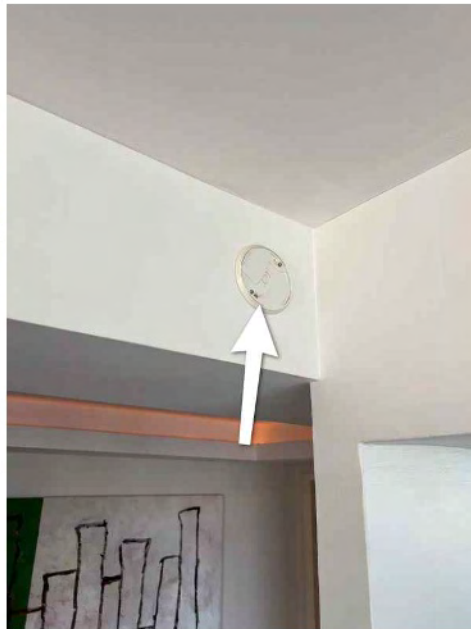
## 9.8.1 Presence of Smoke and CO Detectors

**MISSING SMOKE DETECTOR**

Missing smoke detector. This is a health and safety hazard. There should be a smoke detector in every sleeping room, and outside of every sleeping room, and one every level of a house.

10 year smoke detectors are recommended for safety of the occupants.

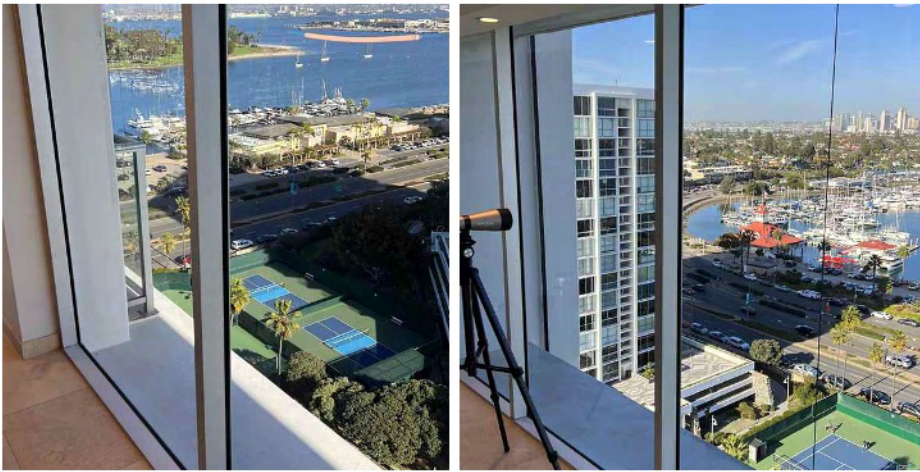
### Windows: Windows Inspected

A representative number of windows were inspected.
