360 HOME INSPECTION

CONDO/TOWNHOME

1730 Avenida Del Mundo 1503  
Coronado, CA 92118

01/08/2025

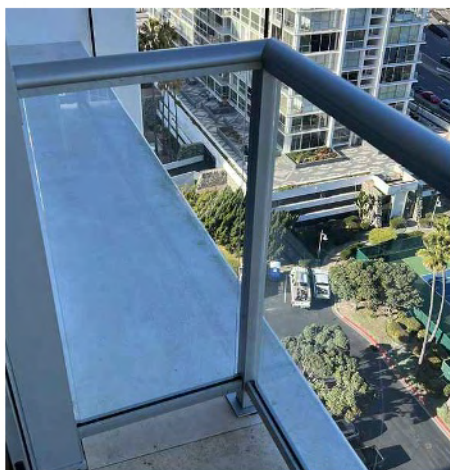
## Railings, Guards & Handrails: Railings, Guards & Handrails Were Inspected

I inspected the railings, guards and handrails that were within the scope of the home inspection.

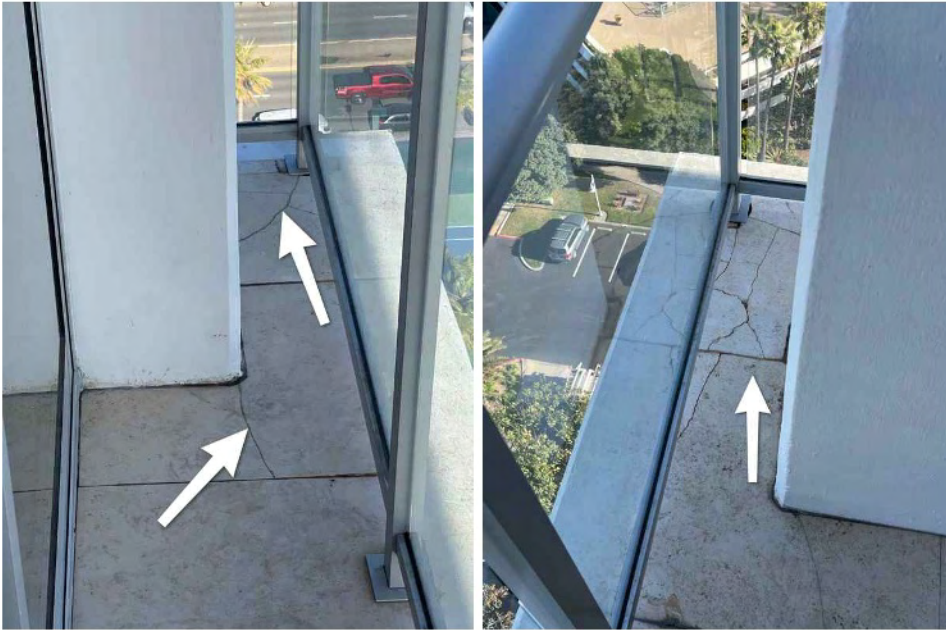
### CRACKED TILES AT THE BALCONY

I observed cracked tiles at the balcony. Correction is recommended to prevent further damage or hazards.

Contact a qualified tile contractor
