# JOHN ROBINSON'S INSPECTION GROUP

## RESIDENTIAL INSPECTION

5162 Pirotte Dr  
San Diego CA 92105

Sara Munoz  
FEBRUARY 9, 2021

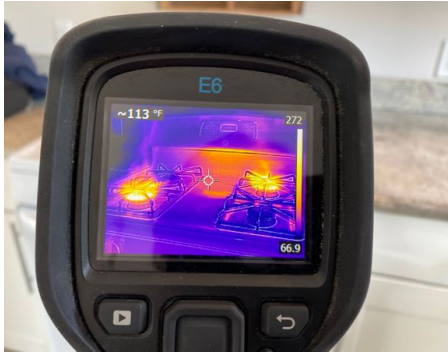
## RANGES AND COOKTOPS: Thermal Image Showing Range Working

Infrared picture of range/cooktop in operation. This unit appeared to be functional at the time of the inspection.

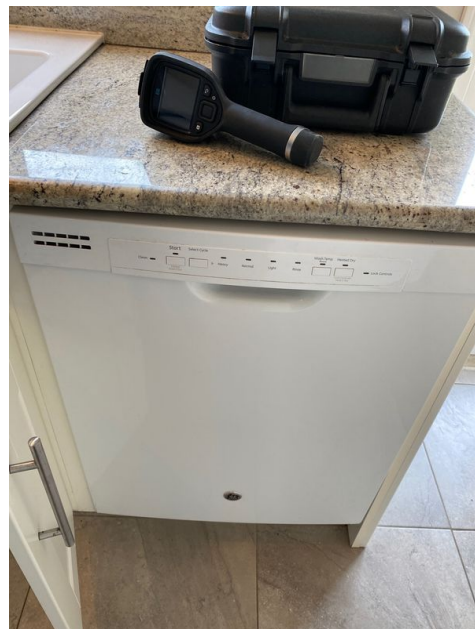
#### DISHWASHER TURNED ON - INSPECTION LIMITED

The dishwasher turned on and appeared to complete a wash cycle at the time of the inspection. However, this is not a guarantee that this unit will not leak at some time in the future. We recommend purchasing a home warranty to cover the unit and any possible damages that may result from a leak.

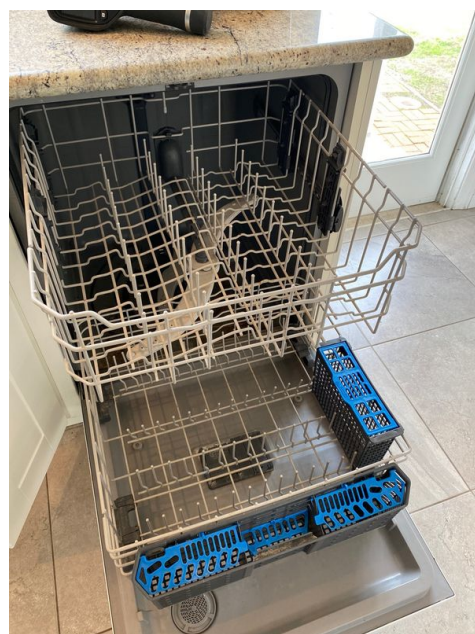
### DISHWASHER TEST - LIMITED REVIEW

We test the dishwasher to introduce a load on the plumbing drain and waste system. We do not use soap. It is not intended to determine how well the dishwasher will clean and dry dishes. **Please note:** We cannot see behind or below the dishwasher. Past and/or current leaks can occur behind or below the dishwasher that would not be visible without removing the dishwasher which is outside the scope of this inspection.

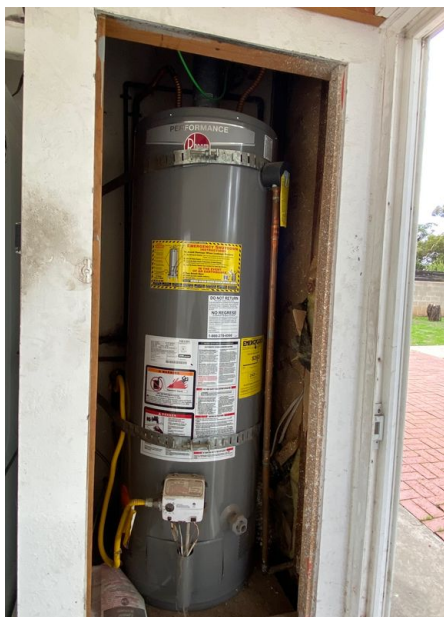
**WATER HEATERS, CONTROLS, FLUES AND VENTS: Picture of Water Heater**

Picture of water heater(s).

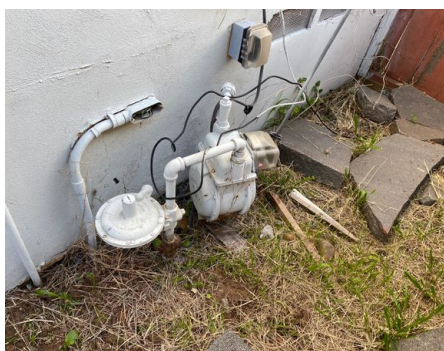
**MAIN GAS SHUT OFF VALVE (Describe Location): Main Gas Shut-Off Location**

Left side of building

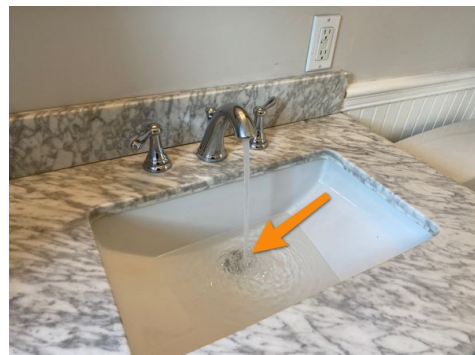
Example Noted at Hall Bathroom

#### 3.3.2 FIXTURES AND CONNECTED DEVICES

Contact a qualified plumbing contractor.

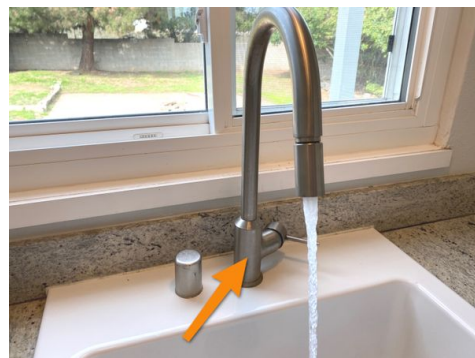
Example Noted at Kitchen

### 3.3.3 FIXTURES AND CONNECTED DEVICES

Contact a qualified plumbing contractor.

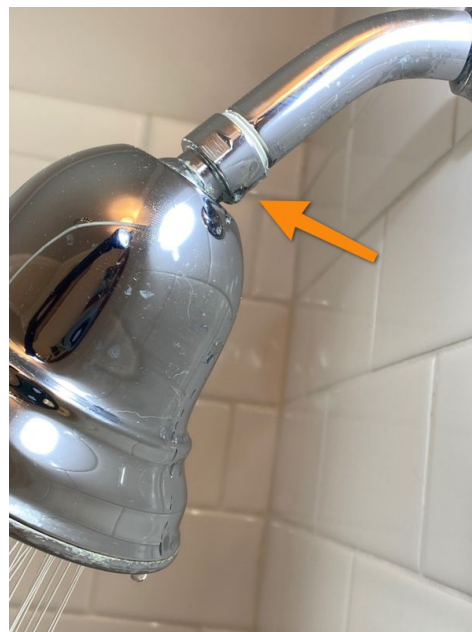
Example Noted at Hall Bathroom

### 3.4.2 TUB/SHOWER FIXTURES

#### SHOWER HEAD LEAK

#### Recommendation

Contact a qualified plumbing contractor.

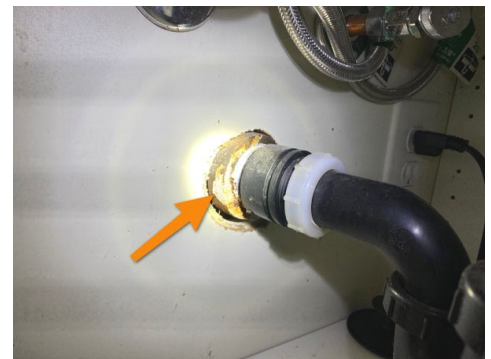
Example Noted at Kitchen

## 3.6.5 PLUMBING DRAIN, WASTE AND VENT SYSTEMS

**CAST IRON - IN USE**

Contact a qualified plumbing contractor.

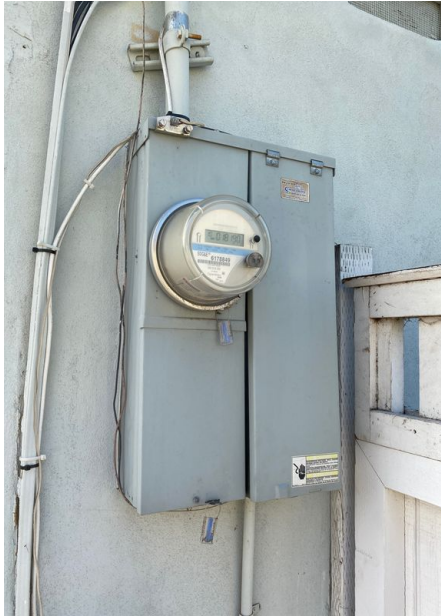
**LOCATION OF MAIN AND DISTRIBUTION PANELS: Main****Panel Location**

Right Side of the Building

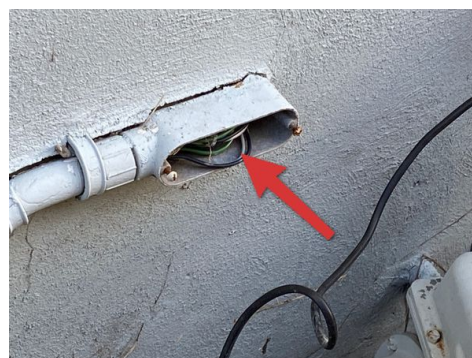
Example Noted at Left Side Yard

## 4.7.1 BRANCH CIRCUIT CONDUCTORS

**OPEN JUNCTION BOX**

Contact a qualified electrical contractor.

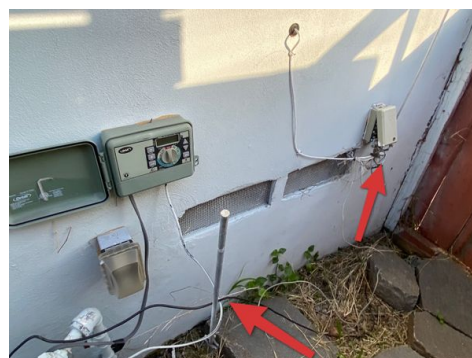
Example Noted at Left Side Yard

## 4.7.2 BRANCH CIRCUIT CONDUCTORS

Contact a qualified electrical contractor.

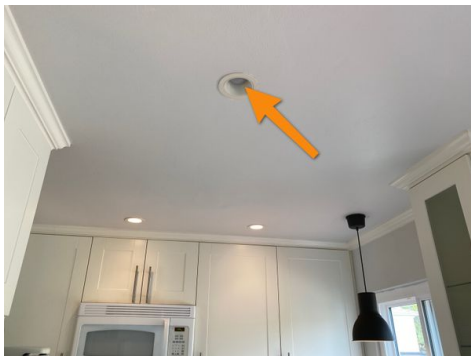
Example Noted at Kitchen

#### 4.8.1 FIXTURES AND CONNECTED DEVICES

Contact a qualified electrical contractor.

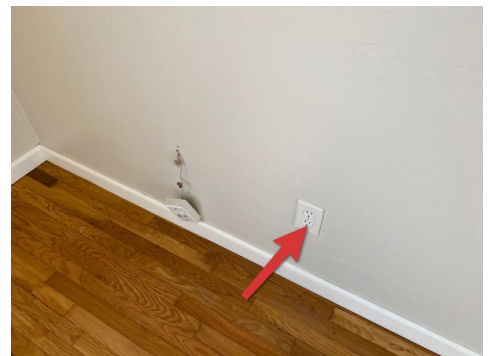
Example Noted at Master Bedroom

#### 4.8.3 FIXTURES AND CONNECTED DEVICES

Recommendation

Contact a qualified electrical contractor.

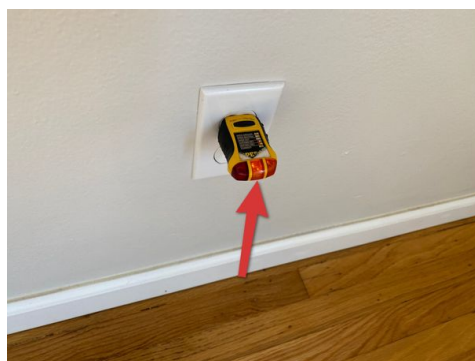
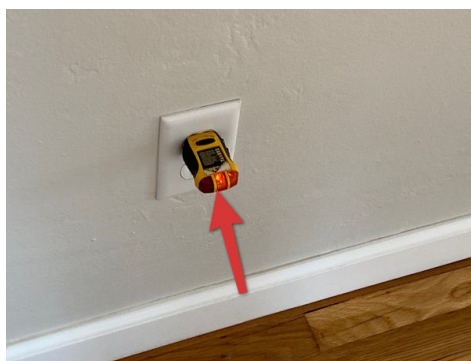
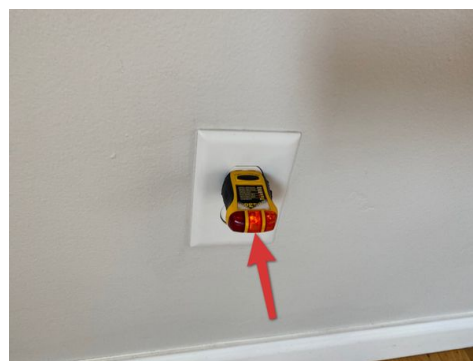
## 4.10.1 POLARITY AND GROUNDING OF RECEPTACLES

Example Noted at Bedroom #2

Example Noted at Master Bedroom

Example Noted at Living Room

Recommendation

Contact a qualified electrical contractor.

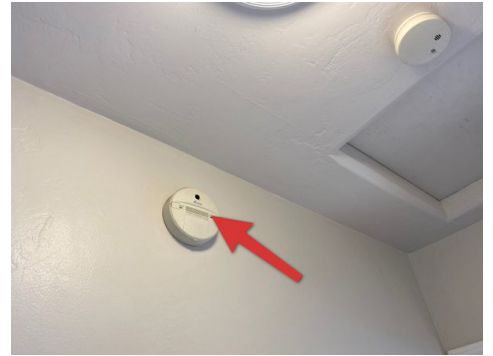
Example Noted at hallway

## 4.13.1 SMOKE DETECTORS

Contact a qualified professional.

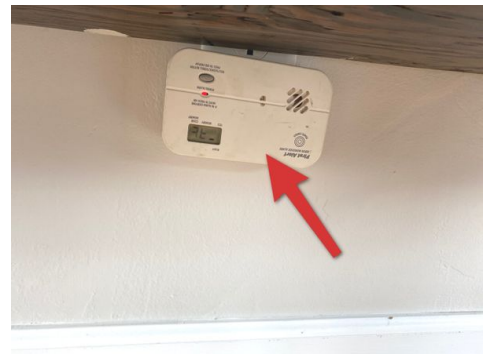
Example Noted at Living Room

## 4.14.1 CARBON MONOXIDE DETECTORS (Describe number and location)

Contact a qualified professional.

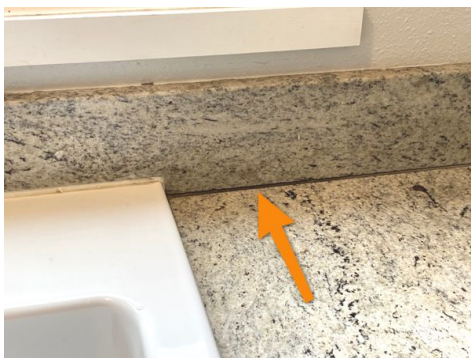
Example Noted at Kitchen

### 5.6.1 COUNTERS AND A REPRESENTATIVE NUMBER OF CABINETS

Contact a qualified professional.

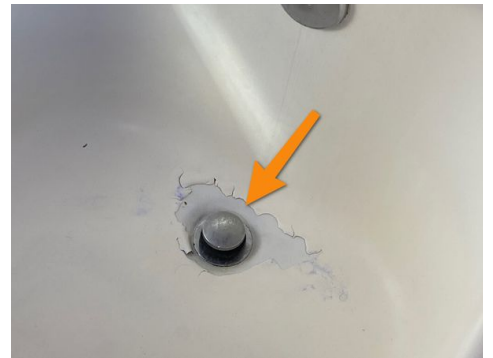
Example Noted at Hall Bathroom

## 5.7.1 TUB/SHOWER ENCLOSURES

Contact a qualified professional.

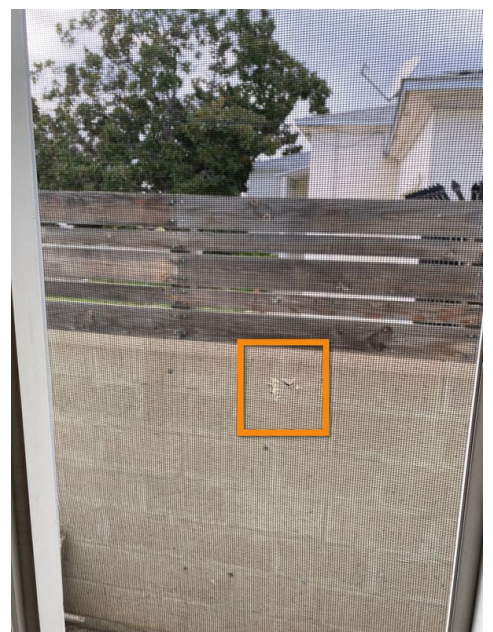
Example Noted at Master Bedroom

## 5.9.1 WINDOWS (REPRESENTATIVE NUMBER)

Contact a qualified professional.

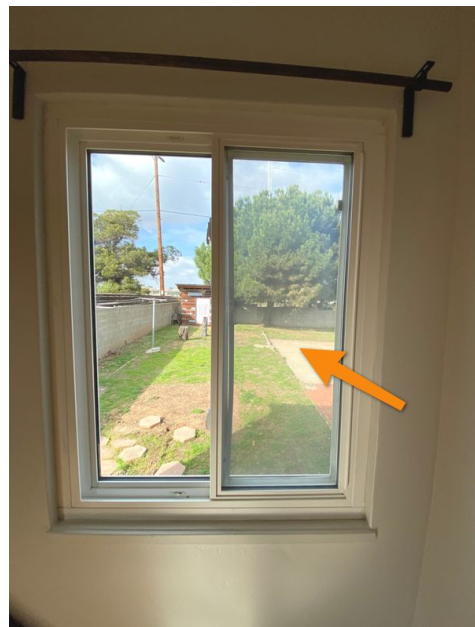
Example Noted at Bedroom #2

## 5.9.2 WINDOWS (REPRESENTATIVE NUMBER)

Contact a qualified window repair/installation contractor.

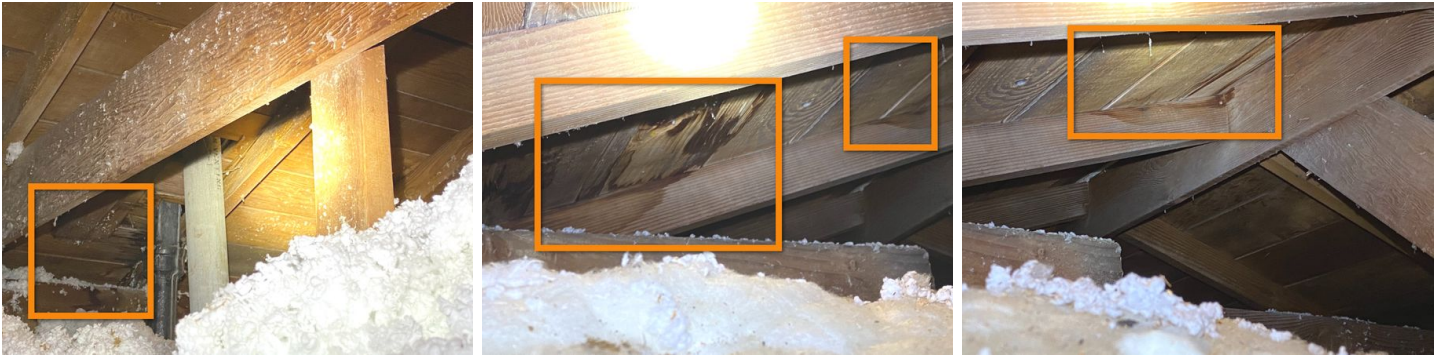
## 5.10.2 ATTICS

**MOISTURE STAINS AT SHEATHING**

Contact a qualified roofing professional.

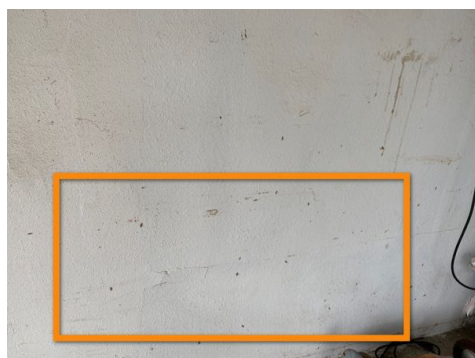
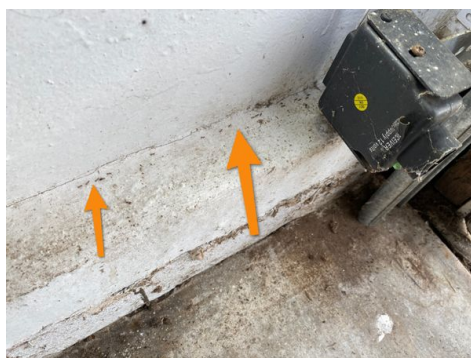
#### 7.3.1 GARAGE CEILINGS/ROOF FRAMING

#### OVERHEAD STORAGE RACKS

Overhead storage was noted present in the garage. Storing weight on the roof structure of the garage can promote damage and sagging of the roof structure. Recommend consulting a licensed general contractor for further evaluation to determine if corrections are necessary at this time.

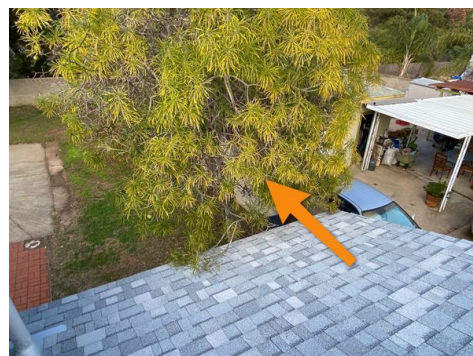
Vegetation is growing on or overhanging the roof. Leaves and debris can slow or obstruct drainage and cause leaks. Vegetation can also be a pathway for pests. Recommend trimming back the vegetation by a qualified tree service company. You may also wish to have this roof further explored by a licensed roofing contractor before the removal of contingencies to determine if latent defects exist.

Contact a qualified tree service company.

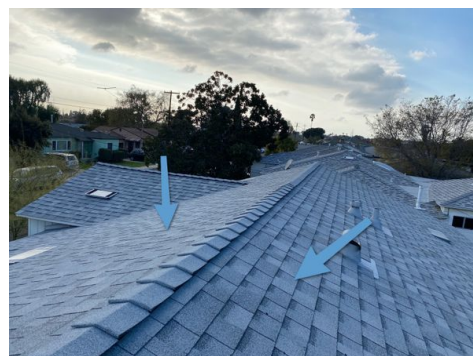
### 8.2.2 ROOF COVERINGS

#### NON-ORIGINAL ROOF

The roof installed on this home does not appear to be original. Replacing a roof requires permits and must be done per manufacturers installation guidelines. We recommend asking the sellers for documentation showing the roof was permitted, and installed by a licensed roofing contractor per the manufacturers installation requirements. Many roof manufacturers will warranty a product for up to 30 years, however this is not a warranty or guarantee on the workmanship, which is typically the cause for issues/leaks and may not be covered by the manufacturer warranty. If documentation cannot be produced, you should contact the roof manufacturer for warranty details and have a licensed roofing contractor further evaluate the roof to determine if this installation meets the manufacturers installation requirements, before the removal of contingencies.

Contact a qualified roofing professional.

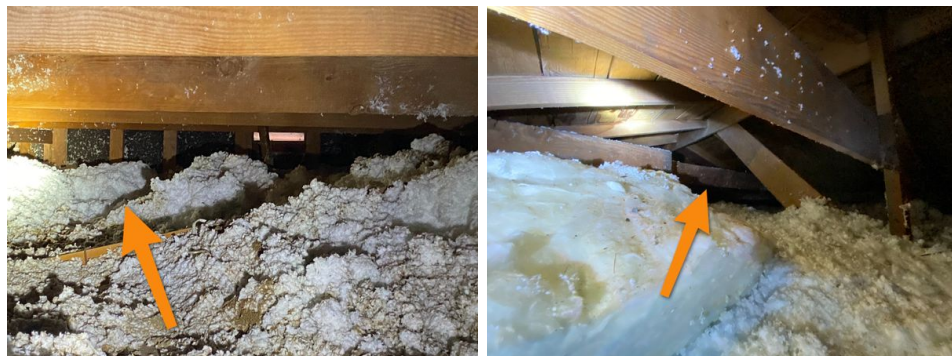
## 8.3.1 ROOF SHEATHING (As Observable From Attic)

The attic space was not fully accessible. We were not able to access the entire attic space to inspect the roof sheathing, structure and other components. It is advisable to have this area further explored by a licensed roofing contractor prior to the removal of contingencies to determine if latent defects exist.

Contact a qualified roofing professional.

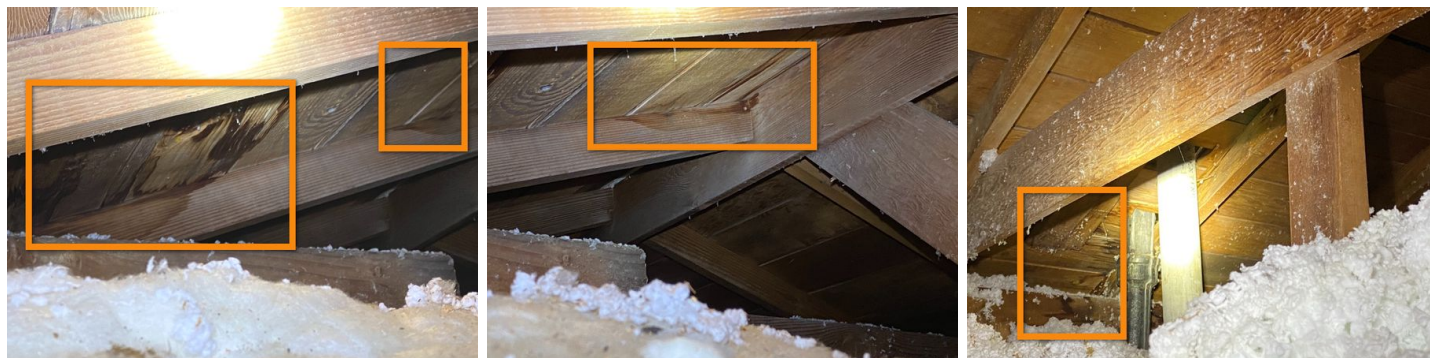
## 8.3.2 ROOF SHEATHING (As Observable From Attic)

**STAINS AT SHEATHING/FRAMING**

Stain(s) noted at the roof sheathing and/or framing structure in one or more locations. Determining if these stains are due to an active or past leak is outside the scope of this standard home inspection. Recommend asking the seller if repairs have been performed, and/or further evaluation by a licensed roofing contractor prior to the removal of contingencies to determine if repairs are necessary at this time.

Contact a qualified roofing professional.

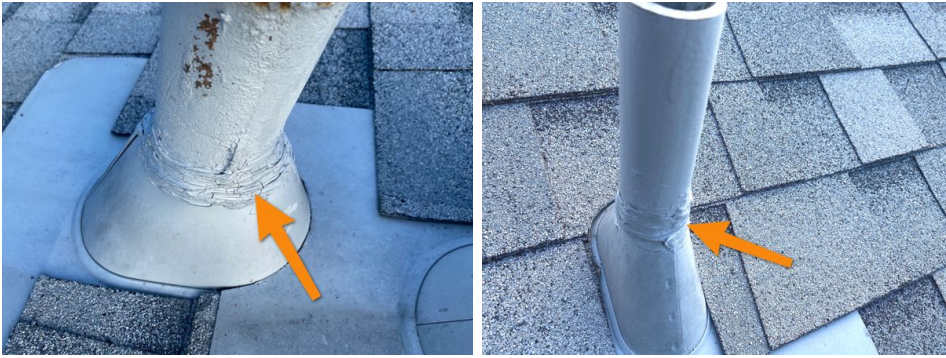
## 8.4.1 FLASHINGS, ROOF PENETRATIONS, CHIMNEYS AND SKYLIGHTS

The plumbing vent pipe(s) and/or roof penetration(s) need sealing around the perimeter of the flashing where sealant is aged or failing. Recommend repair by a licensed roofing contractor as necessary at this time to prevent leaks from occurring.

Contact a qualified roofing professional.

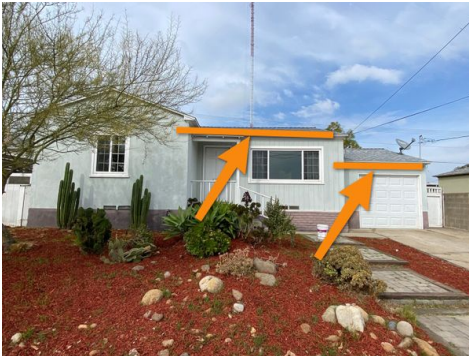
Example Noted at Front Yard

## 8.5.1 ROOF DRAINAGE SYSTEMS

**GUTTERS - NOT INSTALLED**

The home is not equipped with a full system of roof gutters and downspouts/drain lines. Gutters and drain lines are recommended or erosion and/or water intrusion may occur. Recommend further evaluation by a licensed gutter contractor to determine corrections or upgrades possible at this time.

Contact a qualified gutter contractor

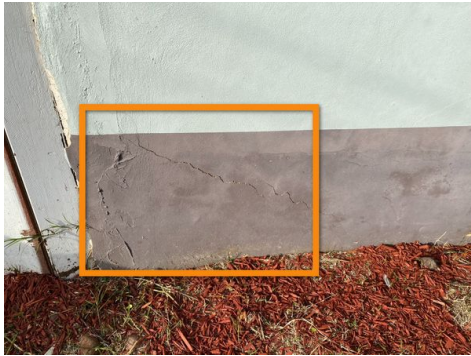
Example Noted at Front Yard

#### STUCCO - TYPICAL CRACKS

There are typical cracks in the stucco, which you should view for yourself. All cracks result from movement, and are structural in that respect, but the vast majority of them have only a cosmetic significance. Recommend monitoring conditions, and repair/upgrade as necessary, by a licensed stucco contractor.

Contact a stucco repair contractor

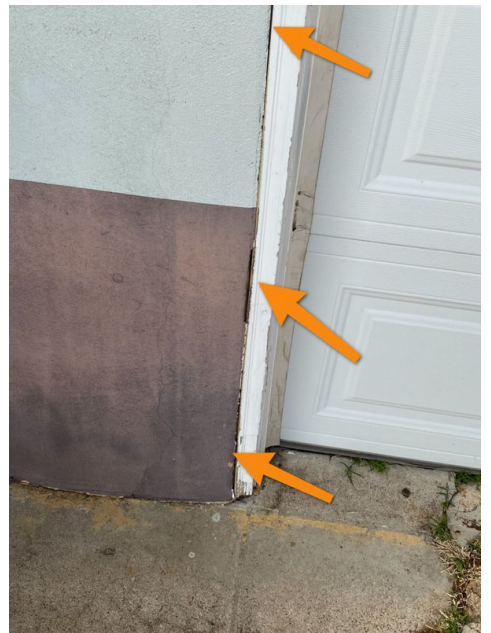
Example Noted at front of garage

### 9.2.2 WALL CLADDING, TRIM AND FLASHING

Gap(s) noted in the siding at one or more locations. These gaps can allow water to flow behind the siding causing damage. Recommend sealing any gaps as necessary at this time to prevent moisture intrusion.

Contact a qualified siding specialist.

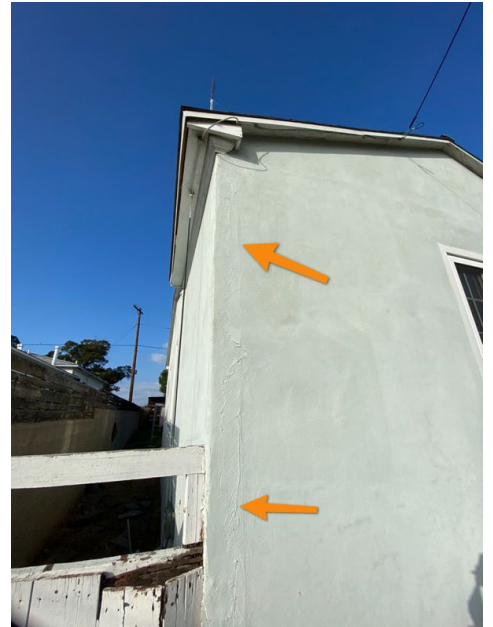
Example Noted at Front Yard

### 9.2.3 WALL CLADDING, TRIM AND FLASHING

#### STUCCO - PREVIOUS REPAIRS

Contact a stucco repair contractor

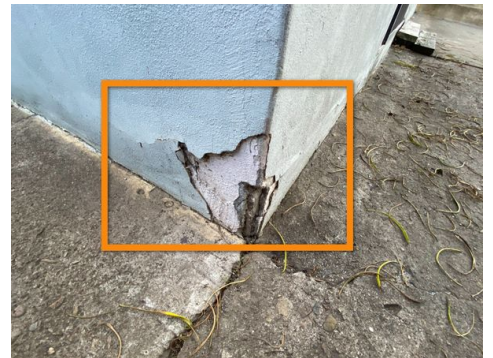
Example Noted at Backyard

## 9.2.4 WALL CLADDING, TRIM AND FLASHING

**STUCCO - PHYSICAL DAMAGE**

Contact a stucco repair contractor

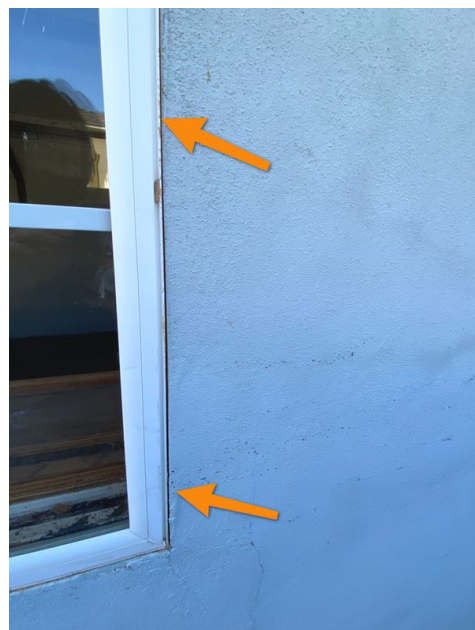
Example Noted at Right Side Yard

**CAULKING - AGED/FAILING**

Contact a qualified window repair/installation contractor.

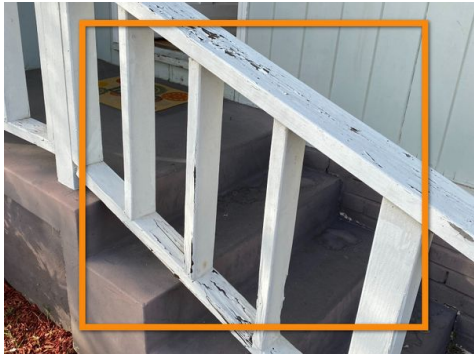
Example Noted at Front Yard

9.7.2 DECKS, BALCONIES, STOOPS, STEPS, AREAWAYS, PORCHES, PATIO/COVERS AND APPLICABLE RAILINGS

Moisture damaged wood and/or evidence of wood destroying organism activity noted. Recommend further evaluation by a licensed termite inspector and licensed general contractor to determine corrections or repairs necessary at this time.

Recommendation  
Contact a qualified pest control specialist.

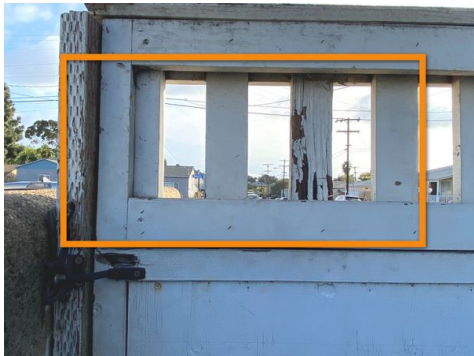
Example Noted at Right Side Yard

9.9.1 FENCING AND GATES

Evidence of wood damage/wood destroying organisms noted at the fencing in multiple locations. Recommend consulting a licensed fence contractor to determine the scope of any repairs necessary at this time.

Recommendation  
Contact a qualified fencing contractor

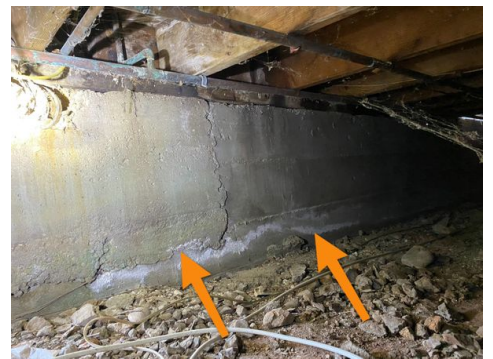
### EFFLORESCENCE

White efflorescence (powder substance) on concrete walls indicates moisture is in contact with the masonry. This does not necessarily indicate that intrusion will occur, (efflorescence is found on many homes without water intrusion occurring inside the home) however, it should alert you to the possibility that future steps may be necessary. This is typically a result of over-watering, poor downspout termination points or improper site drainage. Recommend further evaluation by a licensed foundation contractor, waterproofing contractor and/or grading and drainage contractor to determine repairs necessary at this time. We also recommend installing gutters if this home is not currently equipped with them.

Recommendation

Contact a foundation contractor.

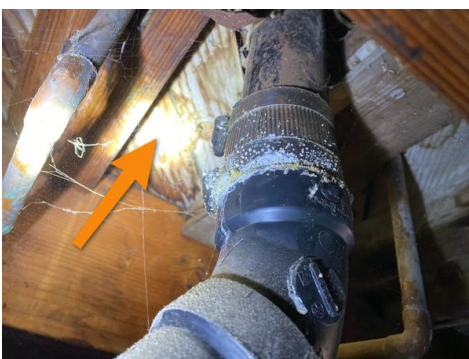
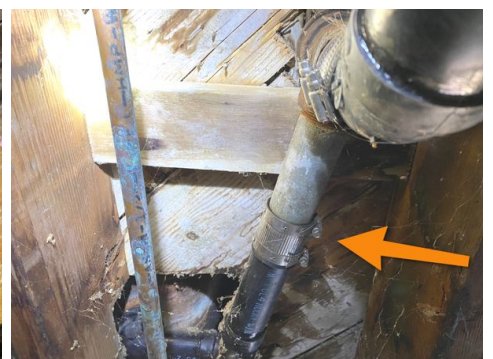
## 10.5.2 FLOORS (Structural)

**MAKESHIFT REPAIRS**

Contact a foundation contractor.

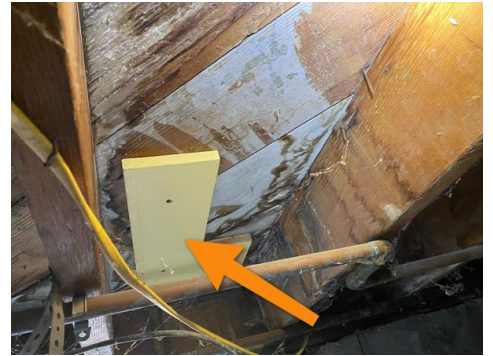
## 10.5.3 FLOORS (Structural)

**FLOORING UNDER SUPPORTED**

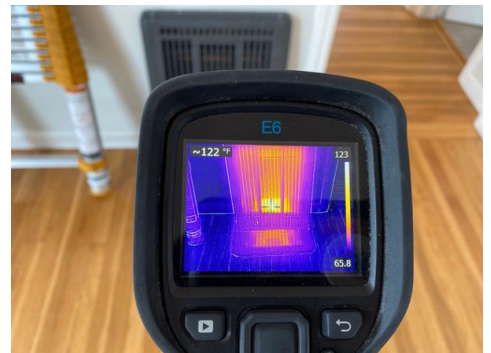
The furnace(s) appeared to turn on and produce heat at time of inspection. However, due to the many components that are not visible (like the heat exchanger and the entire length of the flue pipe), our inspection of the system(s) is limited. Because of this, we recommend further evaluation/safety check be performed by a licensed HVAC contractor or the local gas company before the removal of contingencies.

## Recommendation

Contact a qualified heating and cooling contractor

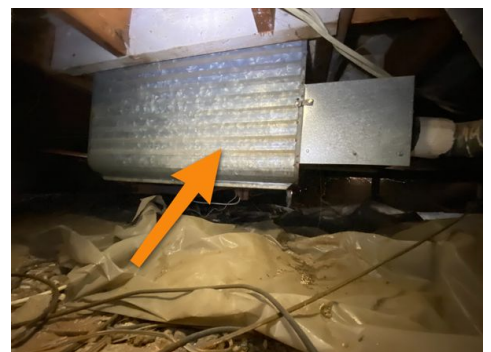
## 11.2.2 HEATING EQUIPMENT

**FURNACE AGED (APPROACHING END OF LIFE)**

The furnace installed in this home appeared to be in use beyond its expected service life. As furnaces age, they can develop issues with the heat exchanger which can prove to be a carbon monoxide safety concern. We strongly recommend having this furnace further evaluated by a licensed HVAC contractor prior to the removal of contingencies to determine its life remaining.

## Recommendation

Contact a qualified heating and cooling contractor
