PROPERTY INSPECTION REPORT

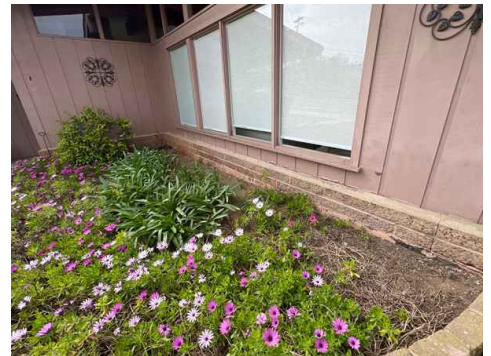
Planters in one or more areas do not appear to have the proper clearance (2") from the house. Correction is recommended.

Recommendation

Recommend monitoring.

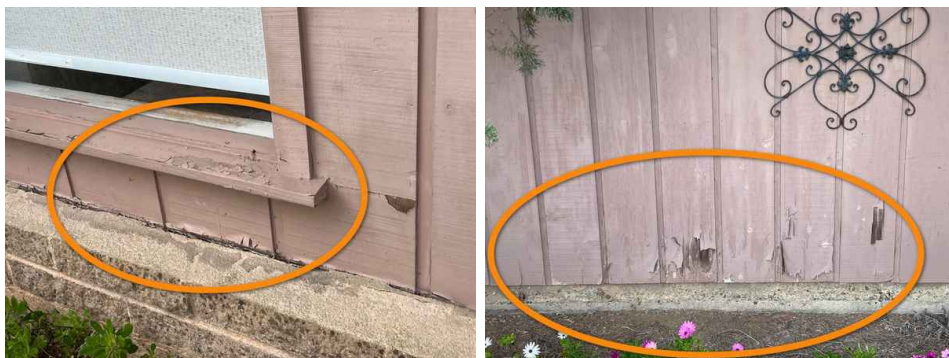
4.4.1 Exterior Walls / Trim

PAINT DETERIORATION NOTED

Paint was flaking and/or deteriorated in one or more areas. Touch up paint is recommended

Recommendation

Contact a qualified professional.

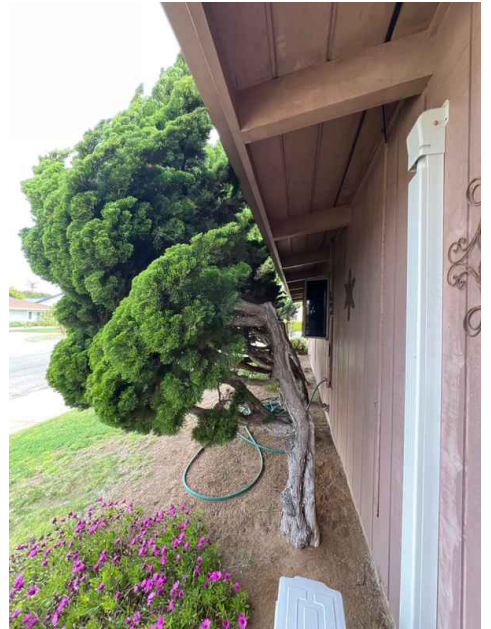
4.5.1 Vegetation

VEGETATION CONTACT / CLEARANCE

Vegetation was in contact with and/or too close to the structure's exterior. This is a conducive condition for wood destroying organisms. Recommend pruning or removing vegetation as necessary so there is at least a one foot gap between all vegetation and the structure's exterior.

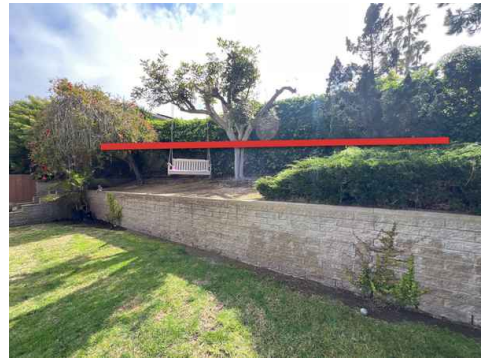
4.6.1 Retaining Wall(s)

WALK OFF HAZARD(S) NOTED

A walk off or drop off hazard was noted in one or more areas. Recommend installing guardrails for added safety. A qualified professional is recommended for further evaluation and/or repairs.

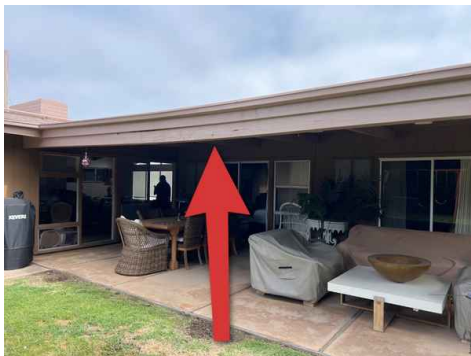
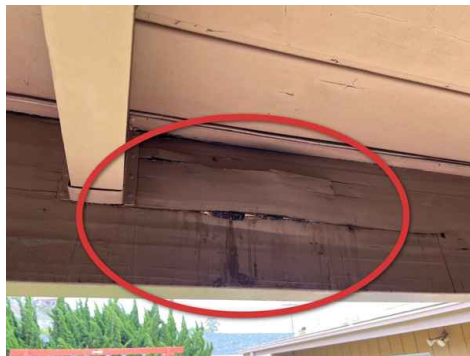
4.7.1 Patio Cover(s) / Trellis(es)

SUPPORT FRAMING BOWED / WARPED

The support framing for the patio cover was bowed and/or warped. Recommend further evaluation and needed repairs be made by a qualified licensed contractor.

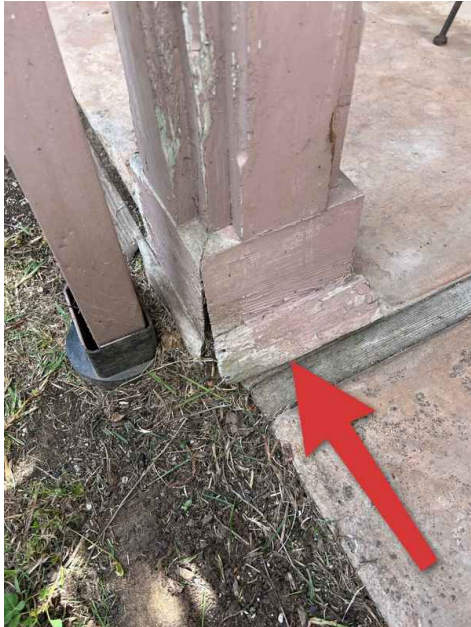
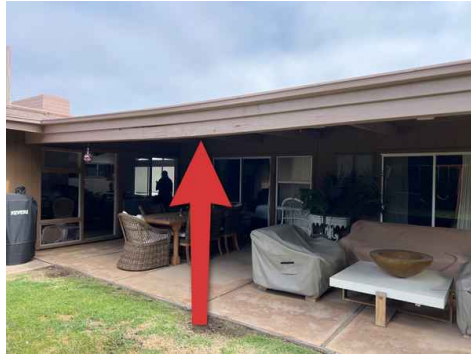
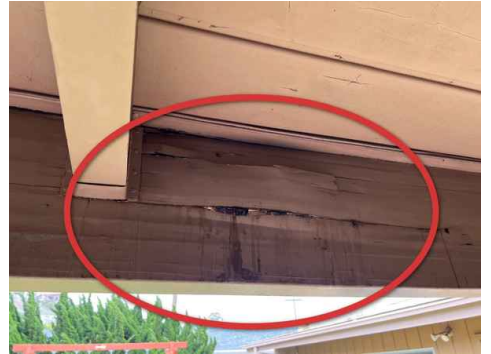
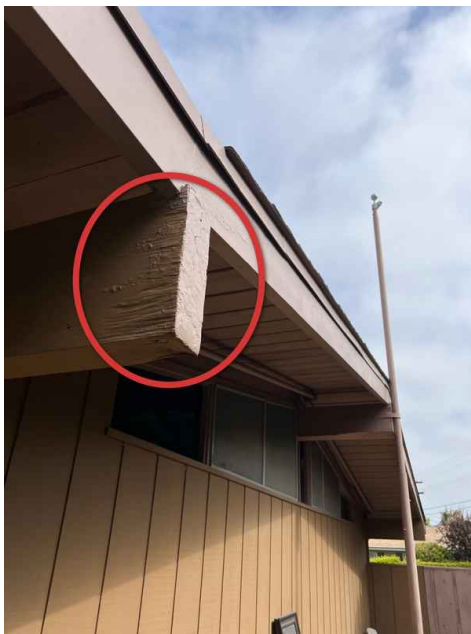
4.7.2 Patio Cover(s) / Trellis(es)

TERMITE INSPECTION RECOMMENDED - DAMAGED WOOD

Damaged wood (could be from many different causes) was noted in one or more areas and a termite inspection is recommended.

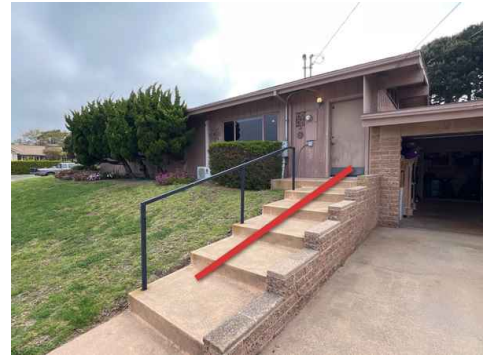
4.8.1 Decks / Balconies / Stairs

RAILING(S) MISSING

Handrail(s) and/or guardrail(s) were missing in one more areas (required when more than 3 stairs). This is a safety concern. A qualified professional is recommended for further evaluation and/or repairs.

Recommendation

Contact a qualified general contractor.

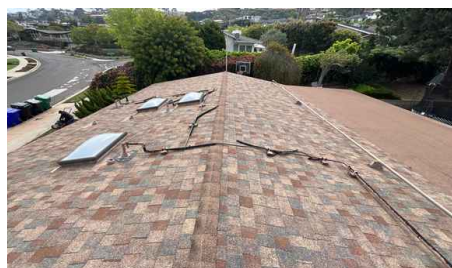
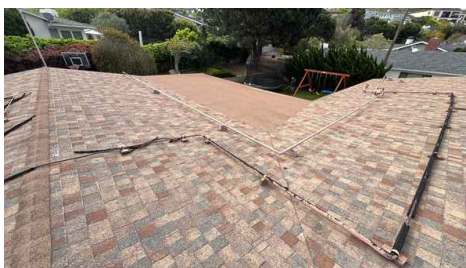
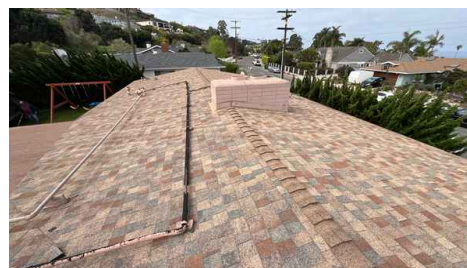
General: View of Roof

View of roof.

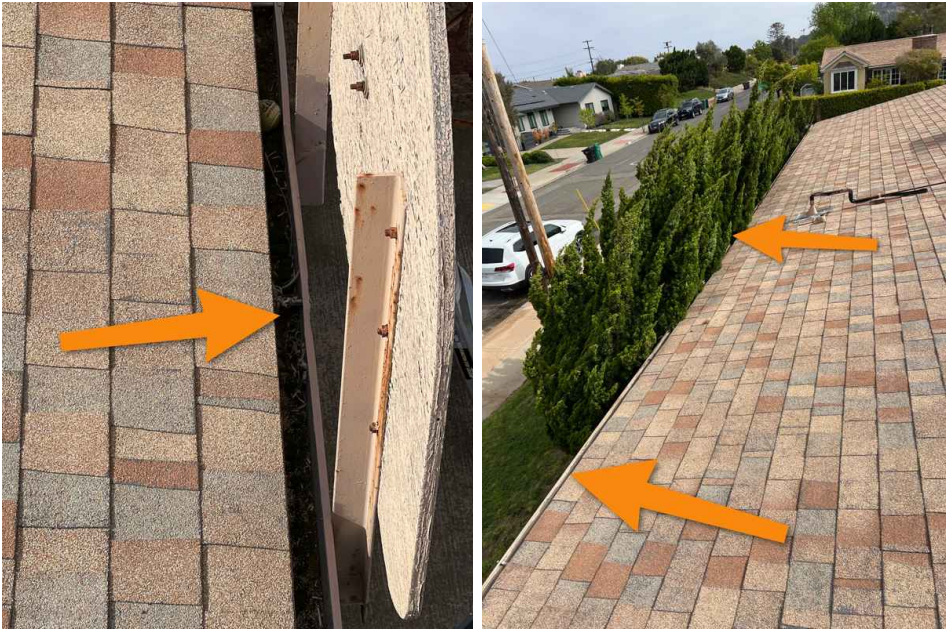
6.5.1 Roof Drainage Systems

DEBRIS IN GUTTER(S) AND/OR DOWNSPOUT(S)

Recommendation

Contact a handyman or DIY project

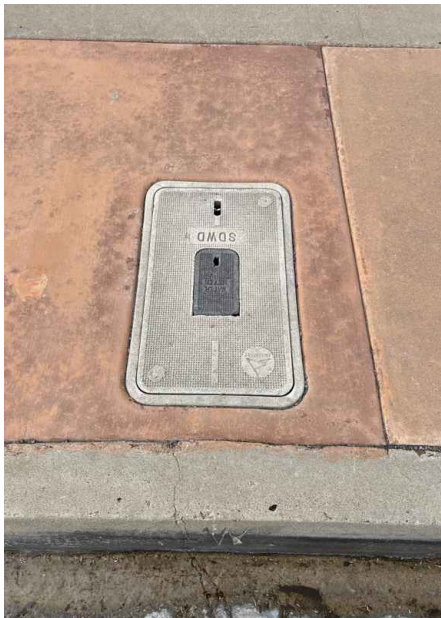
Service: Water meter location

By street

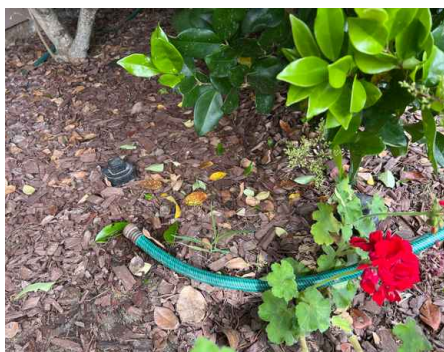
Drain, Waste, & Vent Systems: Clean-out Location(s)

Exterior

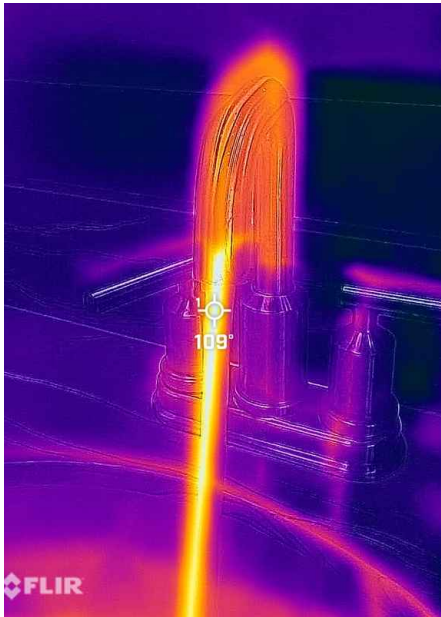
Water Heater(s): Thermal Image - Water Heater Operational

Thermal image of the water heater producing hot water.

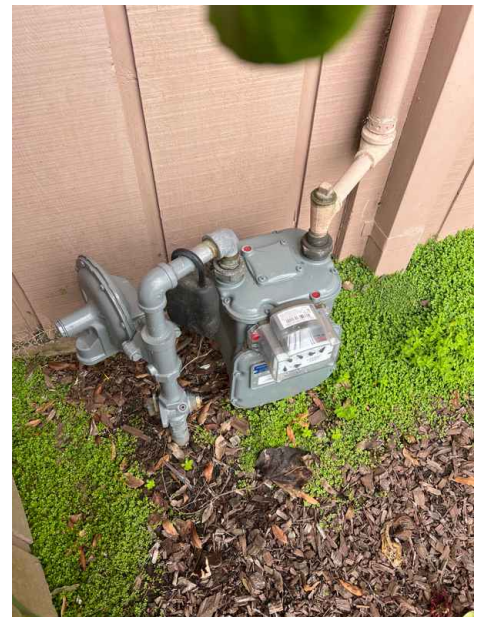
Fuel Systems: Equipment Photo

Fuel Systems: Fuel Service Type
Natural Gas

**Fuel Systems: Main Gas Shut-off
Location**
Exterior Left Side

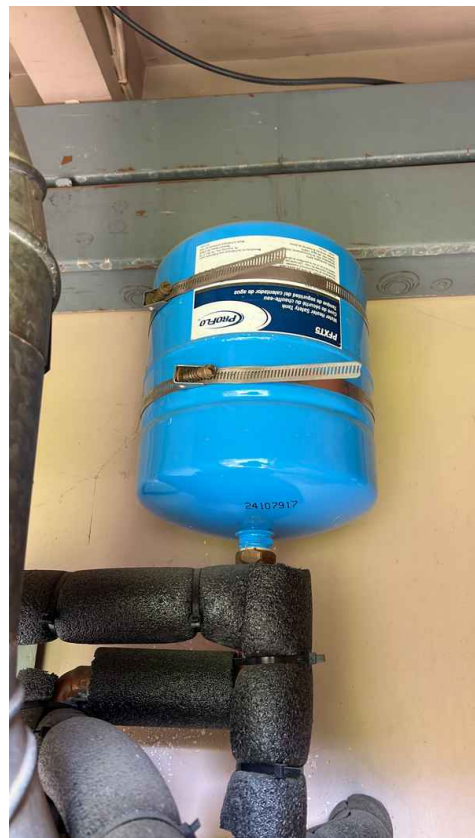
RECIRCULATING PUMPS / EXPANSION TANKS NOT INSPECTED

Hot water recirculating pumps and or expansion tanks are outside the scope of a home inspection. Recommend asking seller about this and/ or have further evaluated by a licensed plumber to determine if any corrections are needed at this time.

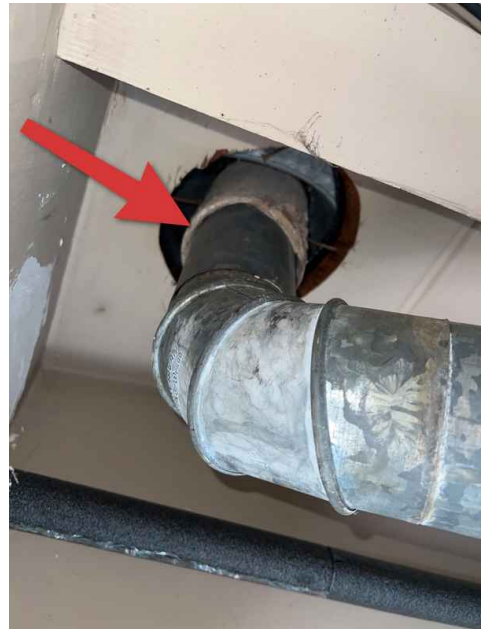
7.5.1 Water Heater(s)

VENT - TRANSITE (ASBESTOS) AND METAL

Recommendation

Contact a qualified plumbing contractor.

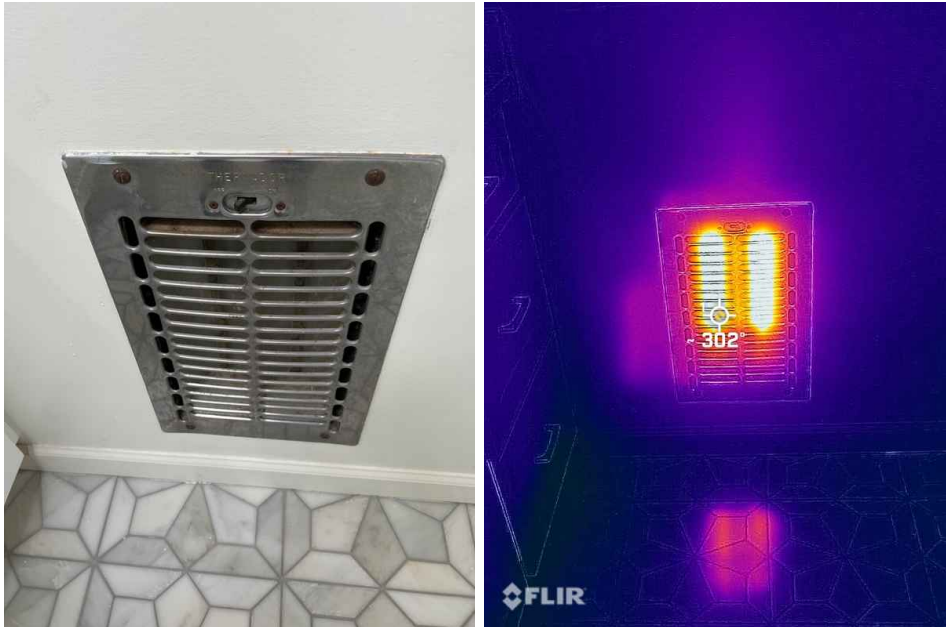
ELECTRIC BATHROOM HEATERS

Electric heat wall units in close proximity of water is not a good idea. Caution is recommended when using these units.

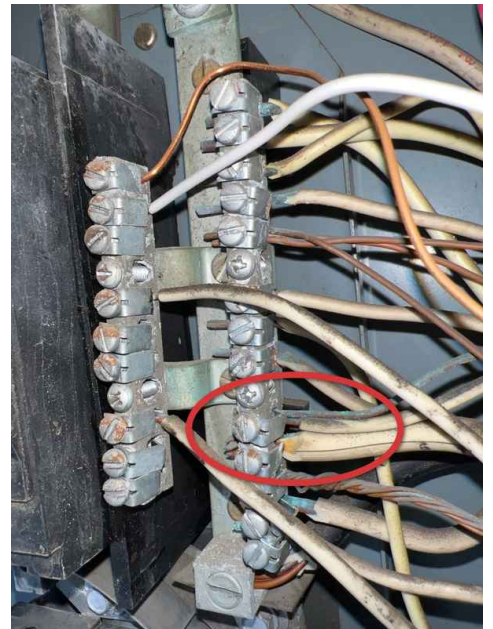
8.4.3 Breakers & Panel Wiring

DOUBLE TAP NEUTRAL

Recommendation

Contact a qualified electrical contractor.

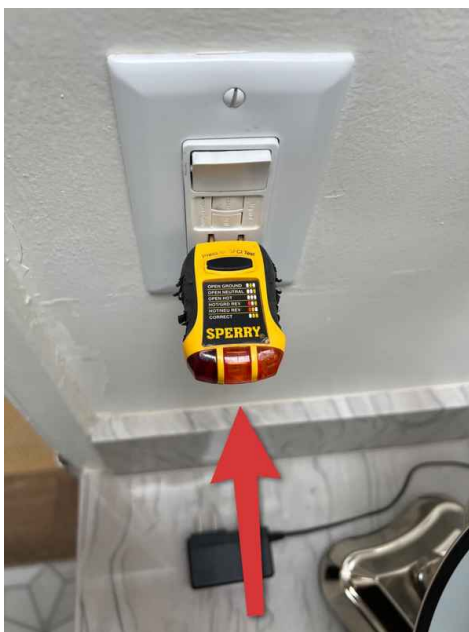
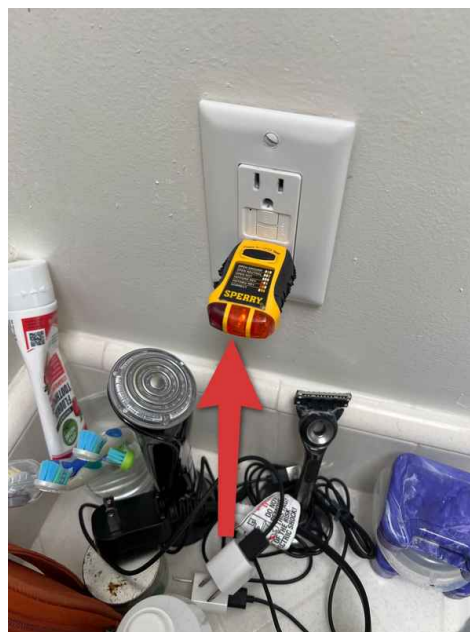
8.5.1 GFCI / AFCI Protection

GFCI READING OPEN GROUND

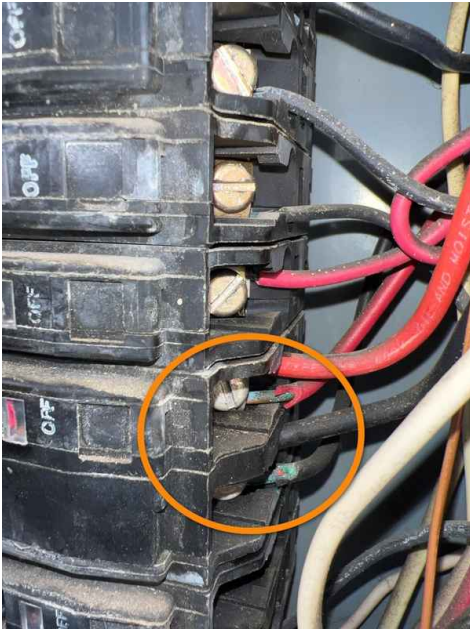
8.6.3 Electrical Wiring

DISCOLORED COPPER NOTED

Recommendation

Contact a qualified electrical contractor.

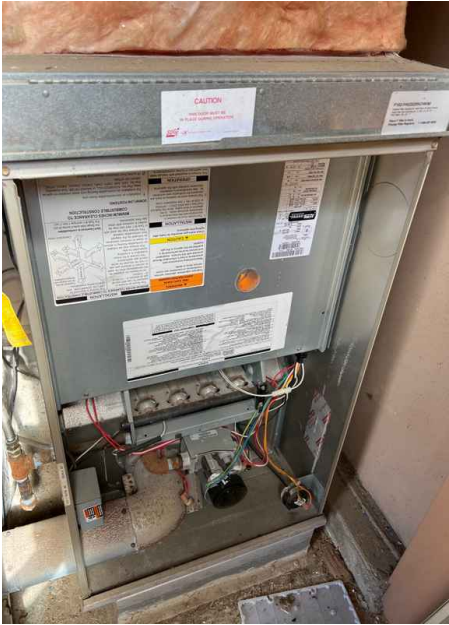
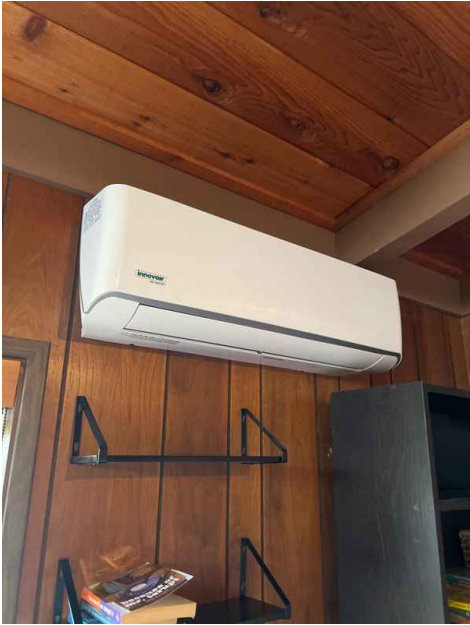
Heating (Forced Air): Equipment Photos

Natural gas, Heat Pump

2012, 2020

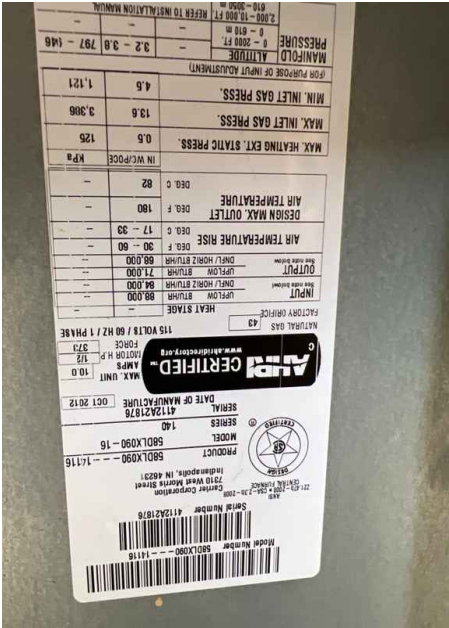
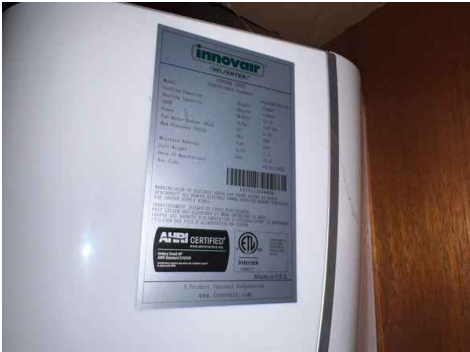
Heating (Forced Air): Appears Functional

Heat system appears to be in working order.

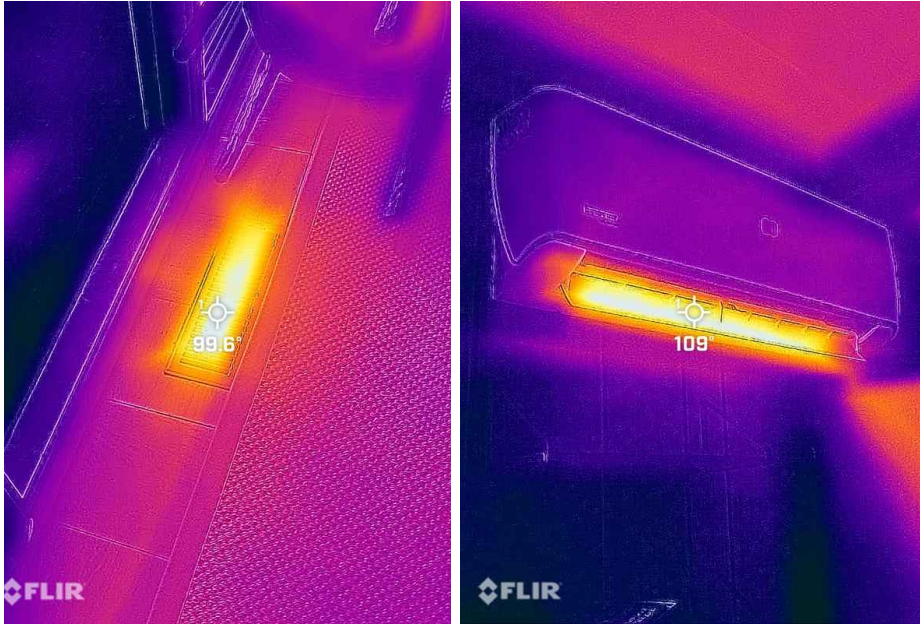
Heating (Forced Air): Replaced HVAC

The heating unit installed in this home is not original. The unit appeared functional at the time of inspection. However, we recommend asking the sellers for documentation showing that the unit was installed by a licensed HVAC contractor per the manufacturers installation requirements. The documents cannot be produced I recommend this unity further explored by a licensed HVAC contractor for safety.

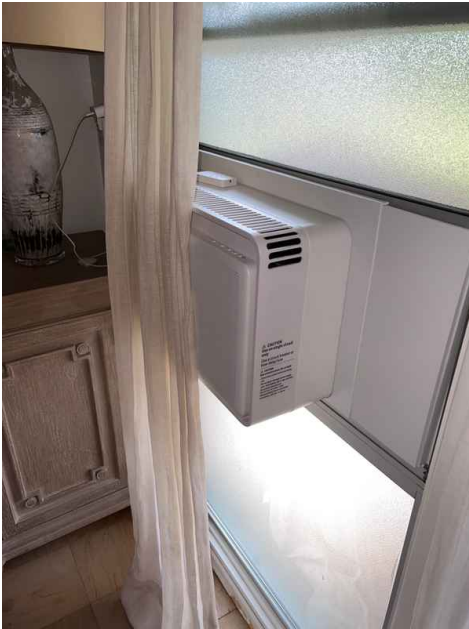
BEDROOM #1

One or more window units were noted. These units are beyond the scope of a home inspection.

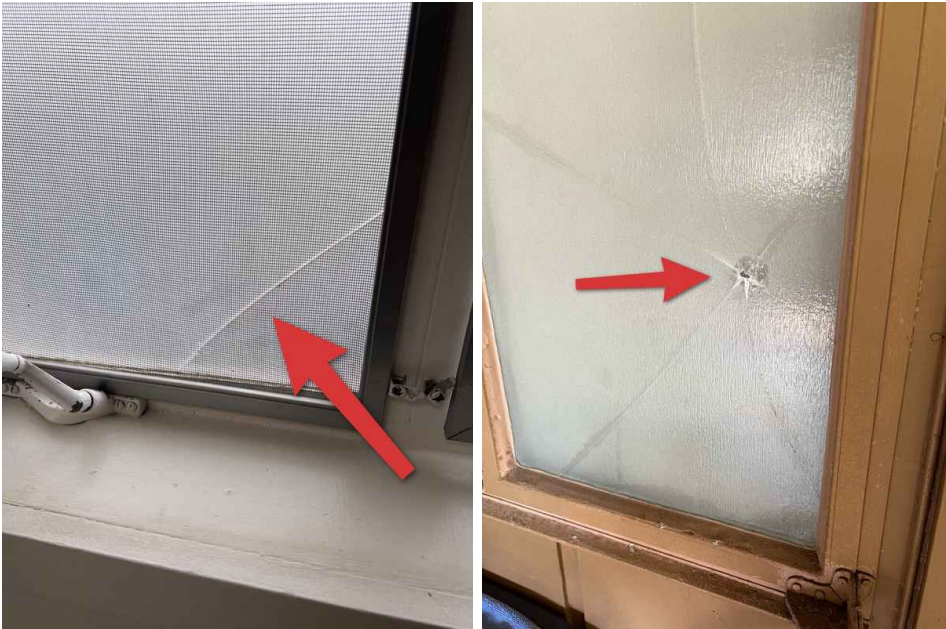
10.4.2 Windows

**BROKEN / CRACKED / CHIPPED WINDOW(S)**

Broken and or damaged glass was noted in one or more areas. Further evaluation is recommended by a licensed specialist.

Contact a qualified window repair/installation contractor.

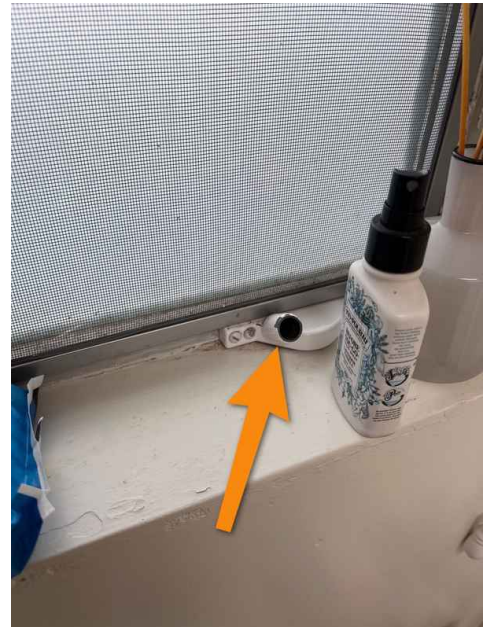
10.4.3 Windows

CRANK HANDLES MISSING

One or more crank handles for windows were loosely secured, damaged and/or missing. Recommend that a qualified person replace handle covers as necessary.

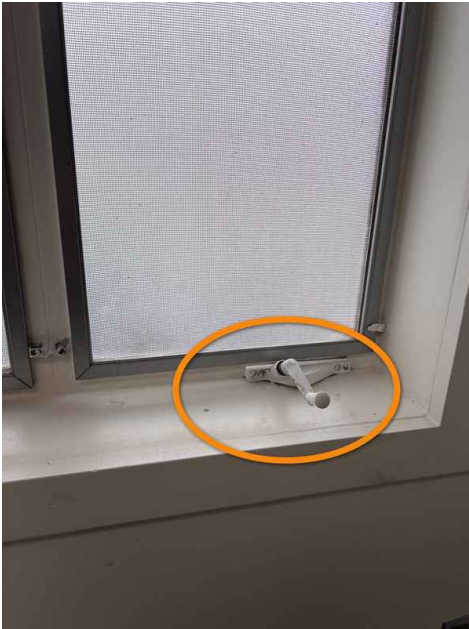
10.4.4 Windows

CRANK(S) NOT OPERATIONAL

Window cranks were not properly operational in one or more areas. Recommend repair by a qualified window contractor.

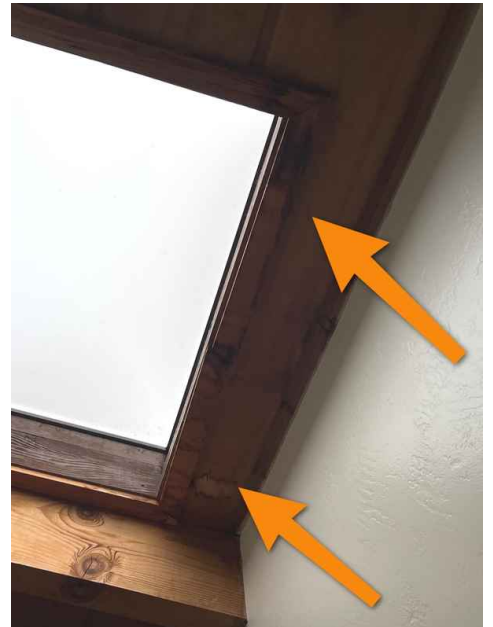
10.5.1 Ceiling

WATER STAINS (DRY)

Stains were found at the ceilings in one or more locations. The stains appeared dry when tested by the infrared camera and/or moisture meter. It is unknown if the issue causing the stains has been resolved. Inquire with the seller, and further evaluation by a qualified contractor may be desired.

Contact a qualified professional.

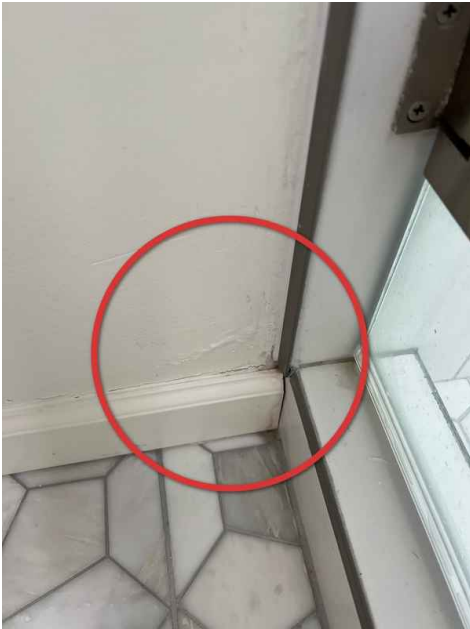
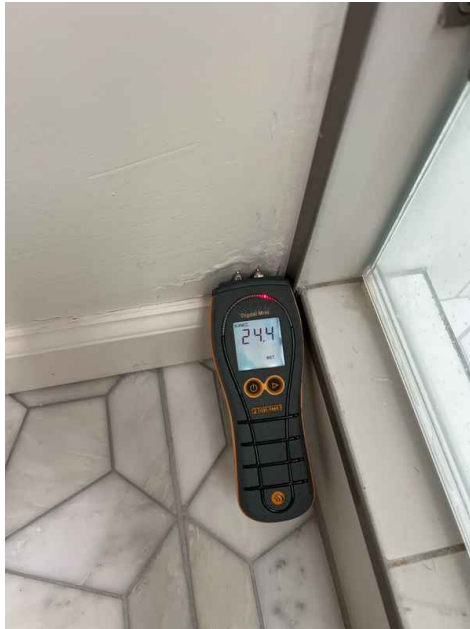
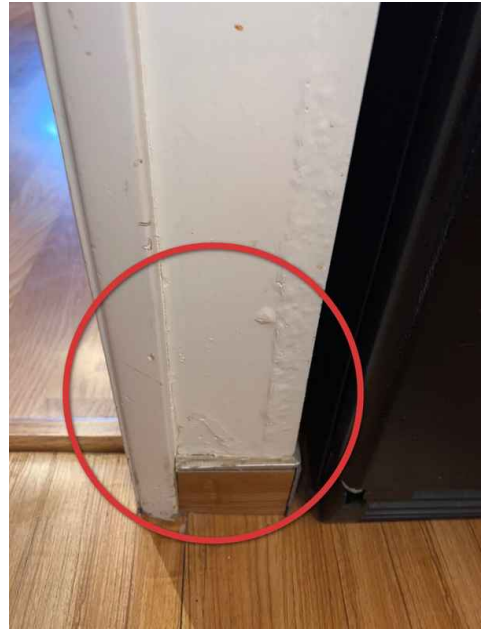
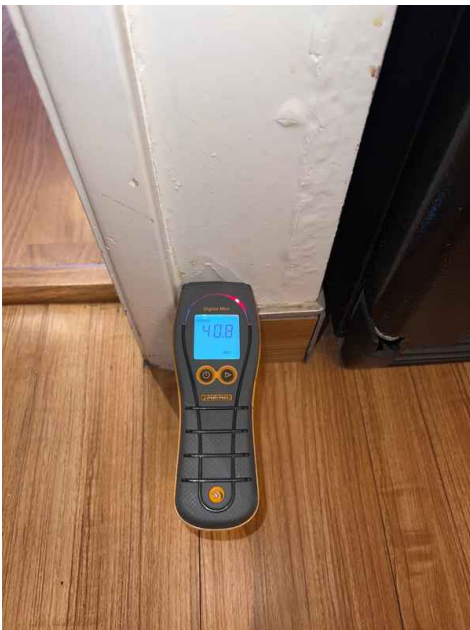
10.6.1 Walls

ELEVATED MOISTURE NOTED

Elevated moisture levels (beyond what is typical) were found in one or more areas. This appears to be due to an active plumbing leak and/or moisture intrusion issue. Hidden damage and or mold like substances are possible (areas not accessible to the inspector). A qualified professional is needed for further evaluation and/or repairs.

Contact a qualified professional.

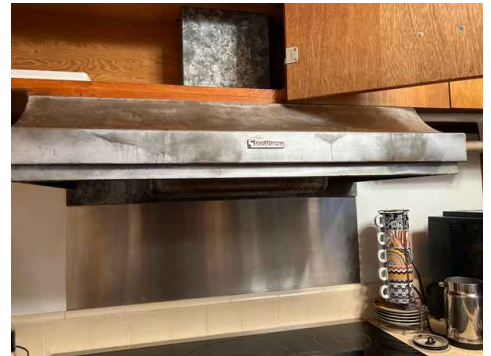
11.1.2 General

OLD APPLIANCES

Contact a qualified professional.

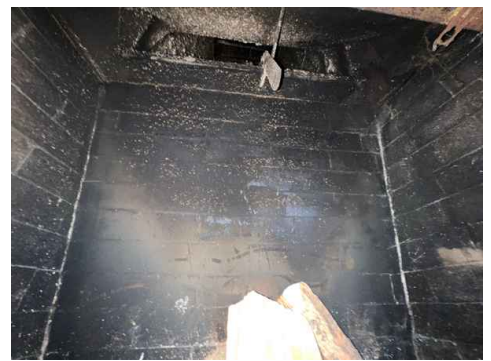
CREOSOTE BUILD UP NOTED

Creosote build up was noted which could be combustible. Recommend cleaning, inspections and repairs as necessary by a qualified licensed chimney contractor.

Contact a qualified professional.

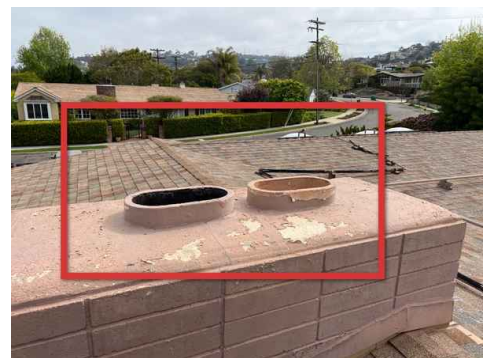
To prevent fireplace embers from leaving the chimney, a spark screen or rain cap is needed at one or more chimney flues. A spark screen will also prevent pests and debris from entering the chimney. A rain cap is essential in preventing corrosion, damage and/or rust in the flue and firebox. A qualified professional is recommended to install a spark screen and/or rain cap where needed.

Contact a qualified chimney contractor.

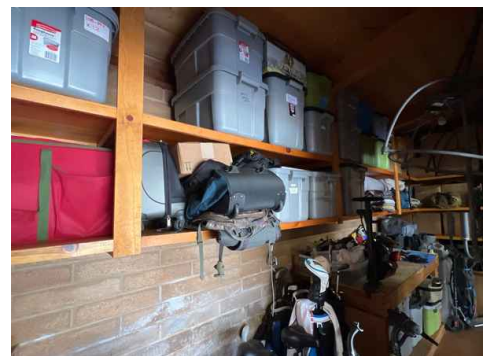
Shelving was installed which could pose a safety hazard due to collapse. Recommend removing shelving, or repair/modification as necessary by a qualified person.

Contact a qualified handyman.

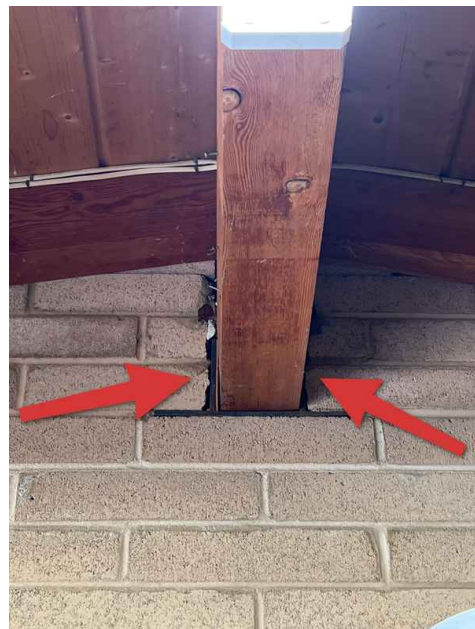
13.4.3 Floor, Walls, Ceiling

FIRE WALL GAPS, HOLES, DAMAGE

Recommendation

Contact a qualified drywall contractor.

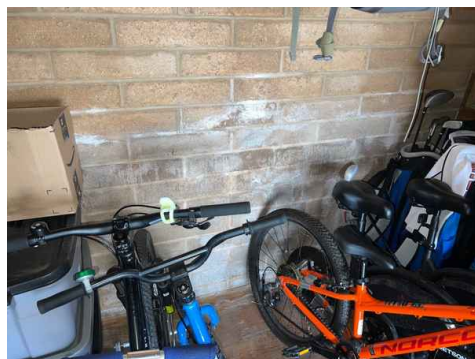
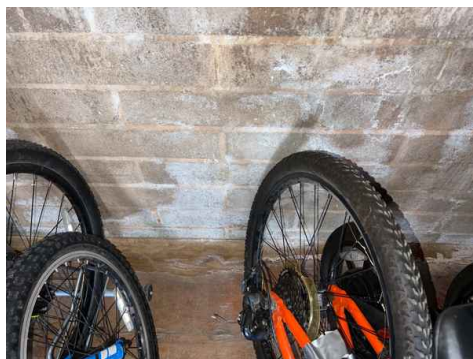
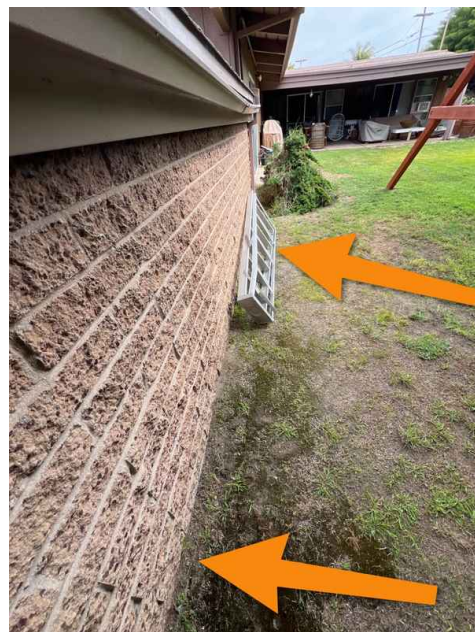
13.4.4 Floor, Walls, Ceiling

EVIDENCE OF WATER INTRUSION

Recommendation

Contact a qualified professional.

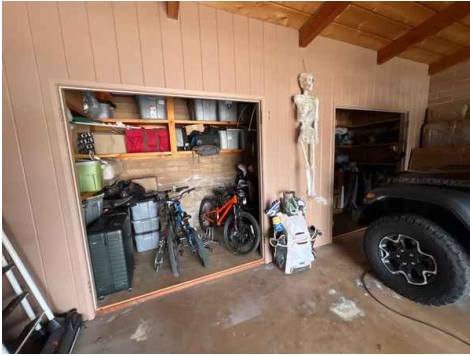
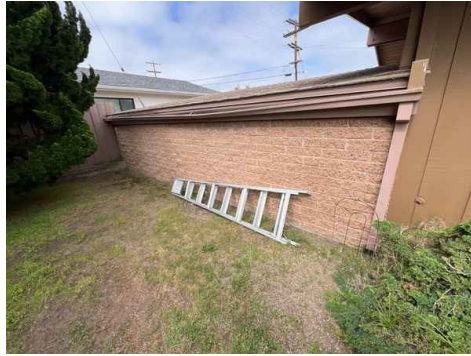
13.4.5 Floor, Walls, Ceiling

BELOW EXTERIOR GRADE

Recommendation

Contact a qualified professional.
