CONFIDENTIAL INSPECTION REPORT

6959 Colorado Avenue, La Mesa, CA 91942

1/14/2025 9:00 am to 12:00 pm

Inspected by: Ron Cantor

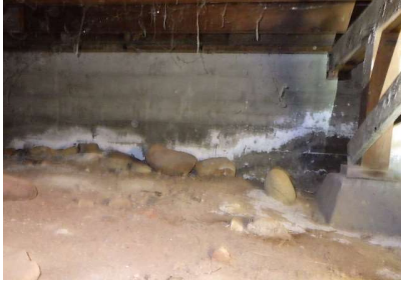
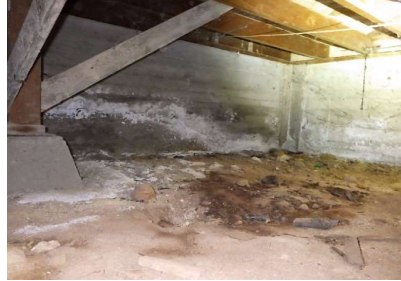
1.10 - There is efflorescence on the stem wall in the raised foundation areas, which confirms that moisture has penetrated the area and activated minerals that form a white powdery formation of salt crystals. With the recent concerns about mold, this is a condition that should be monitored, and one that could produce musty odors.

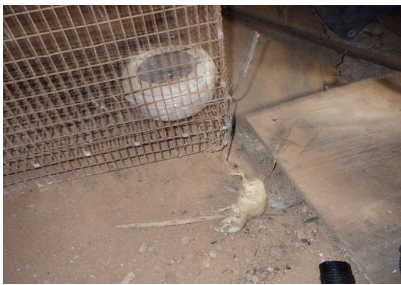
1.11 - The crawl space is contaminated by rodents, which is a significant health hazard, and should be evaluated by an exterminator as soon as possible. Rodents can compromise not only the crawlspace and its various components, such as ducts and insulation, but can eventually contaminate the living space as well. Consequently, we disclaim any further responsibility for evaluating the crawlspace and its components.

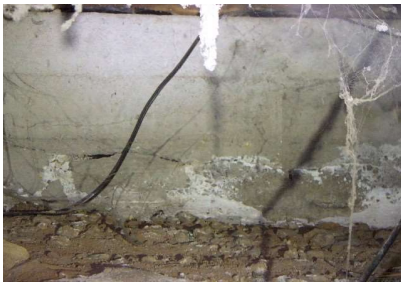
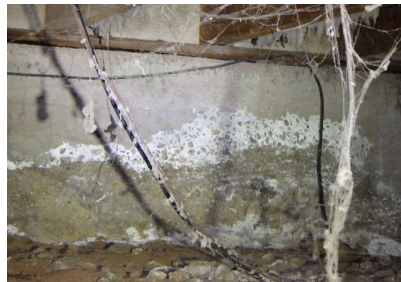
1.14 - There is a horizontal crack and or exposed rusty rebar noted in the concrete foundation at the front of the crawl space. Further evaluation and repair by a licensed foundation contractor is advised.

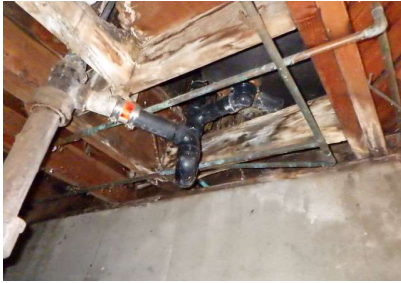
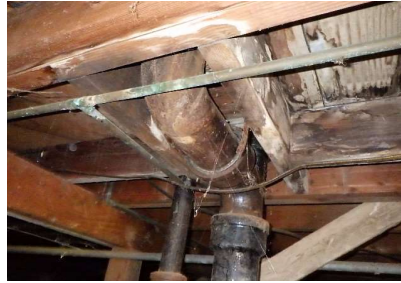
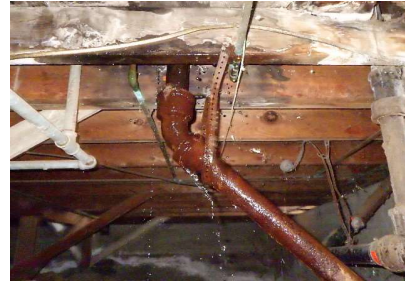
1.16 - There are stains or moisture damage to the sub-floor beneath the floors in the bathrooms and kitchen of the home. Further evaluation and repair by a licensed Pest Control Operator and or contractor is advised.

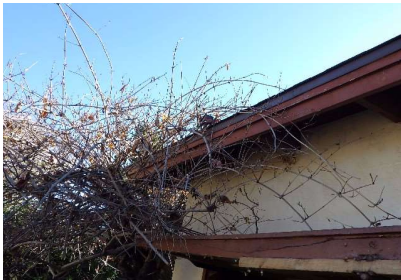
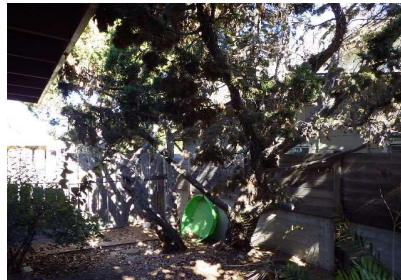
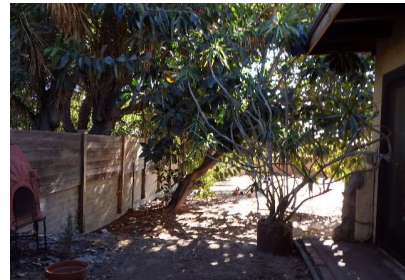
2.2 - One or more tree limbs are threatening the roof and or eaves, and should be removed by an arborist before they damage the roof and or eaves.

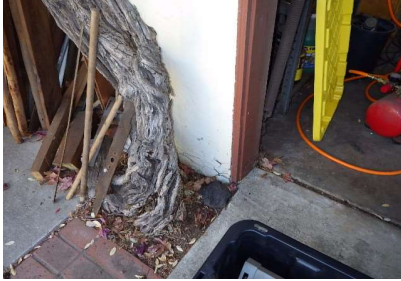
2.3 - A tree or trees that are adjacent to the foundation should be monitored for any growth that might affect the foundation.

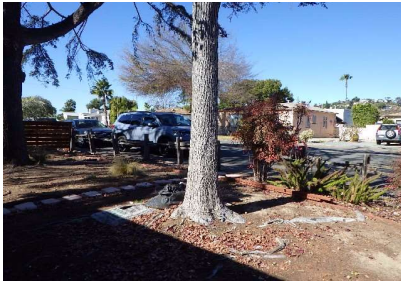
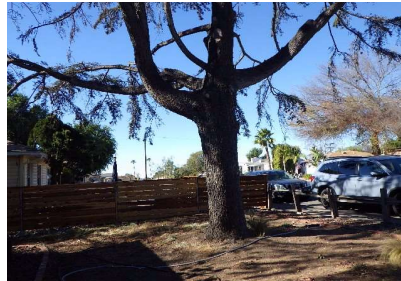
2.4 - The roots of mature trees could have an adverse effect on either the water main or the sewer pipe, and you may wish to consult an arborist who could predict future growth potential.

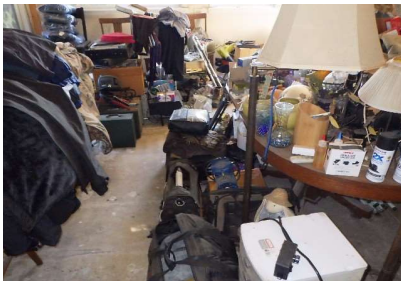
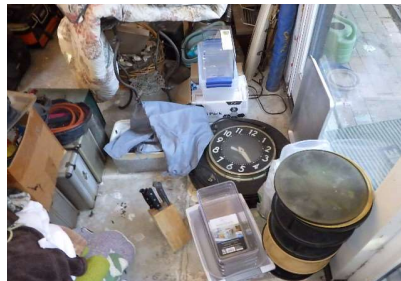
2.7 - Excessive personal items throughout the home and garage extremely limited the inspection. Further evaluation of these areas when fully visible and before the close of escrow is advised.

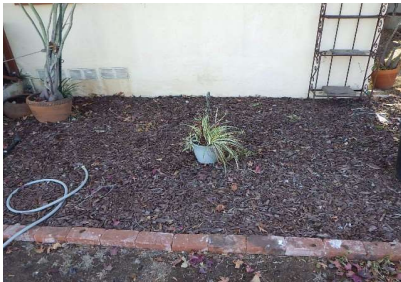
2.13 - There are areas where water will be directed toward the foundation instead of away from it, as recommended. This not only allows for the possibility of moisture intrusion, but also differential settling, et cetera. Further evaluation and repair by a licensed foundation-drainage contractor is advised.

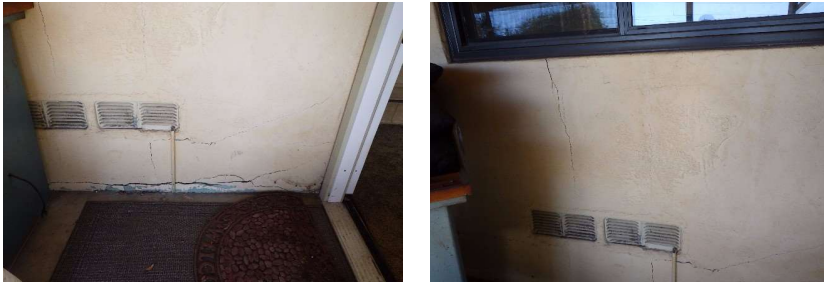
2.17 - There are atypical cracks in the stucco at the rear of the home. Further evaluation and repair by a licensed contractor is advised.

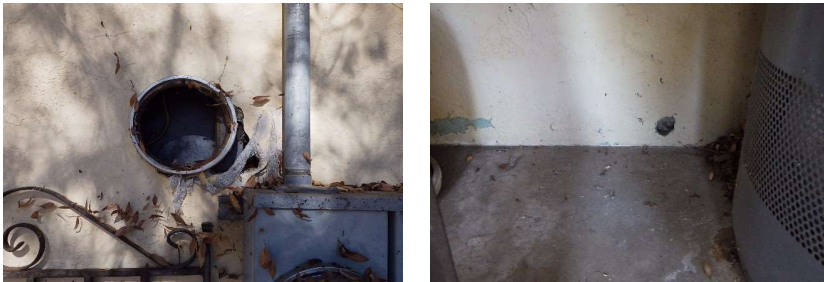
2.19 - There are small holes and or damage in the stucco at various locations throughout the home, that should be properly repaired by a licensed contractor.

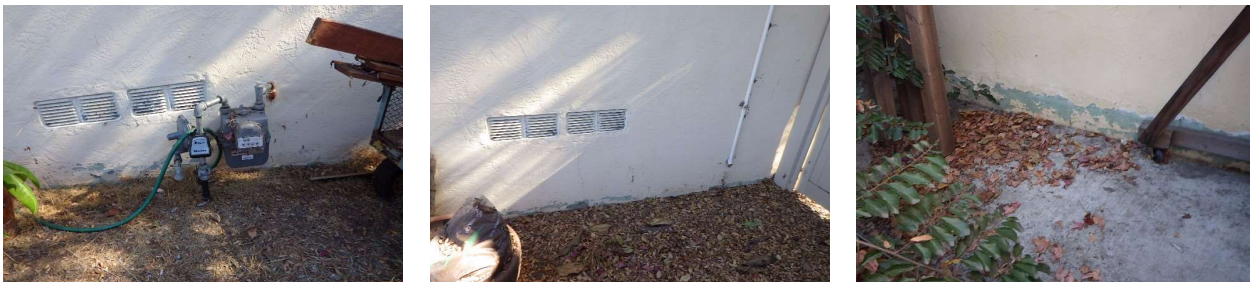
2.20 - There are moisture stains and or damage in the stucco at the base of the walls, at various locations around the home. This is a cosmetic defect which is caused by poorly aimed sprinklers, roof run-off, and or improper soil height. Further evaluation and repair by a licensed contractor is advised.

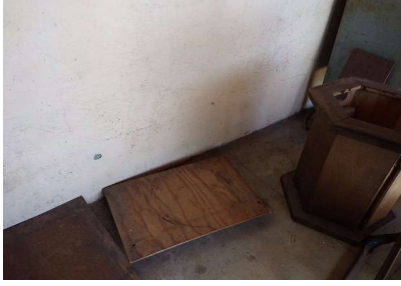
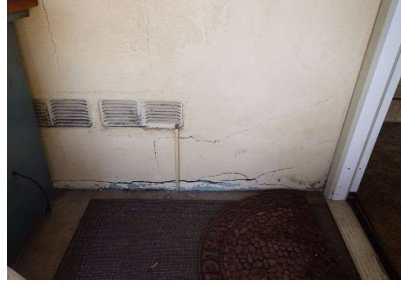
2.21 - There are horizontal cracks in the stucco at the base of the walls, which appear to be common. These cracks are at the intersection of the foundation and framed wall and occur due to minor settlement and or movement. There does not appear to be any structural significance to these cracks, however, you may wish to have a licensed foundation contractor confirm this.

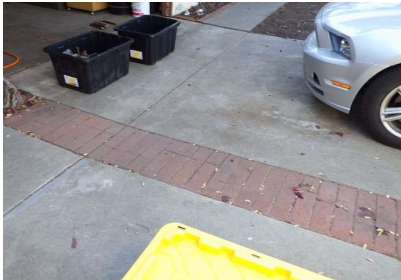
2.25 - Improper drainage was observed, which will direct water towards the garage. Further evaluation and proper repair by a licensed foundation contractor is advised.

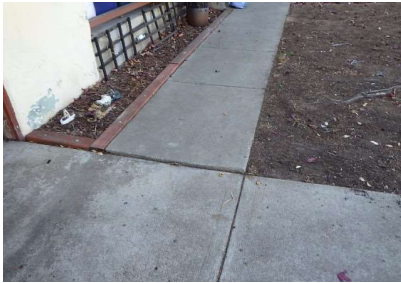
There are cracks and or offsets in the walkways that could prove to be trip-hazards - *Continued*

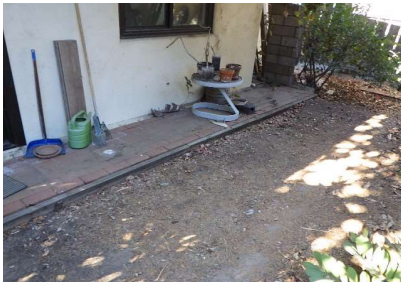
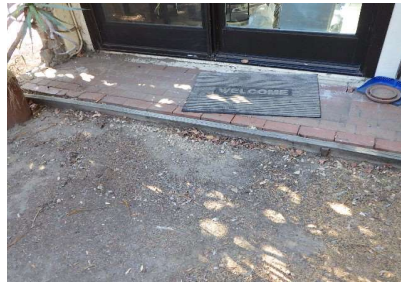
2.28 - The brick style walkways are functional, however, are slightly uneven and or displaced, which may pose as a trip hazard.

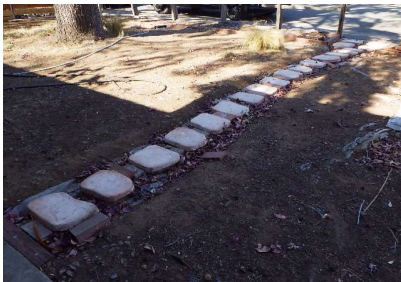
2.29 - There is an uneven paver stone walkway at the front of the home that may pose as a possible trip hazard.

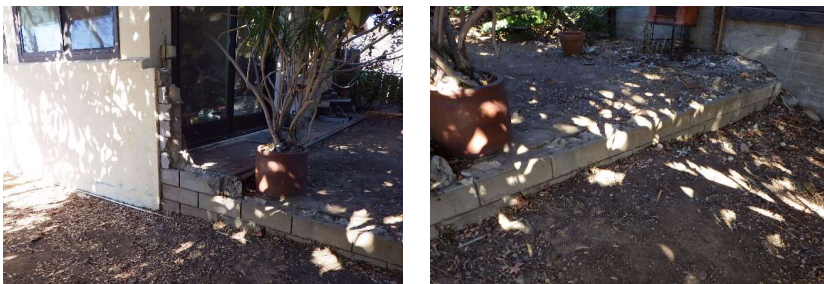
2.32 - There are damaged and or partially removed yard walls noted at the rear of the home. Further evaluation and repair by a licensed masonry contractor is advised.

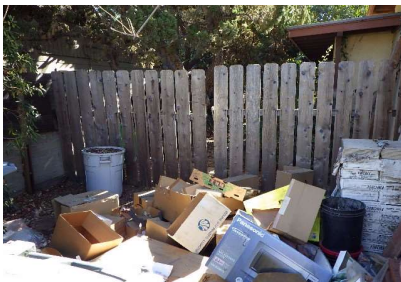
2.35 - The gates needs typical maintenance-type service to open and close and or latch properly.

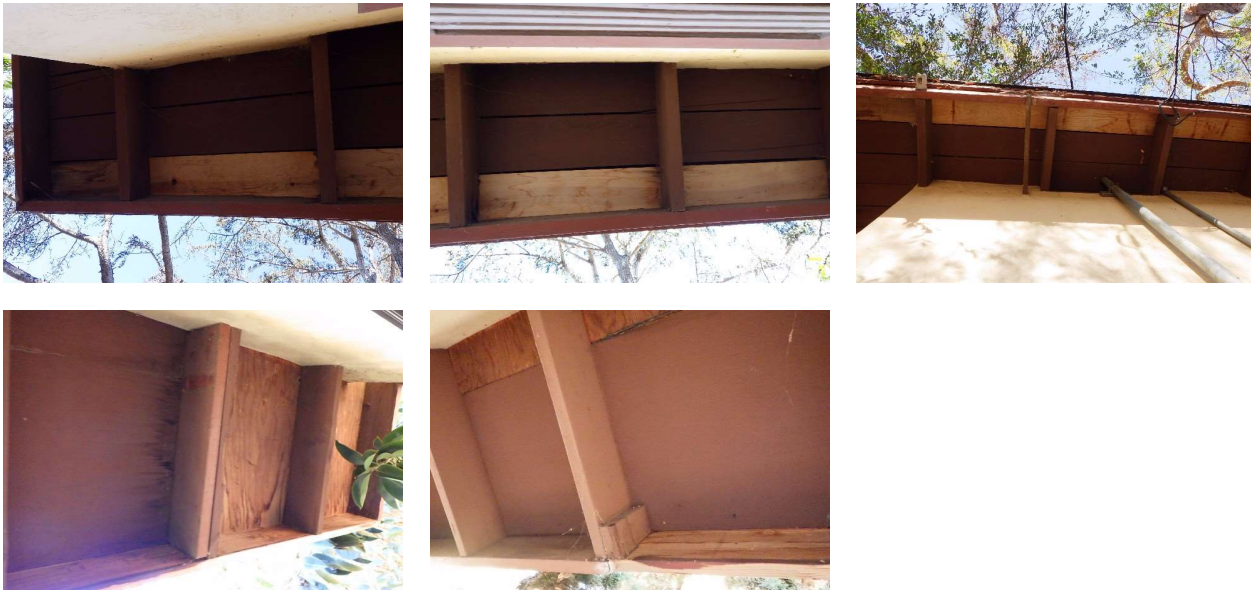
2.36 - Sections of the fascia and trim need maintenance type service, and particularly on the South facing side where they are exposed to direct sunlight.
2.37 - There are signs of previous leaks and stains on the under side of the eaves in several locations. Further evaluation and repair by a licensed contractor is advised.

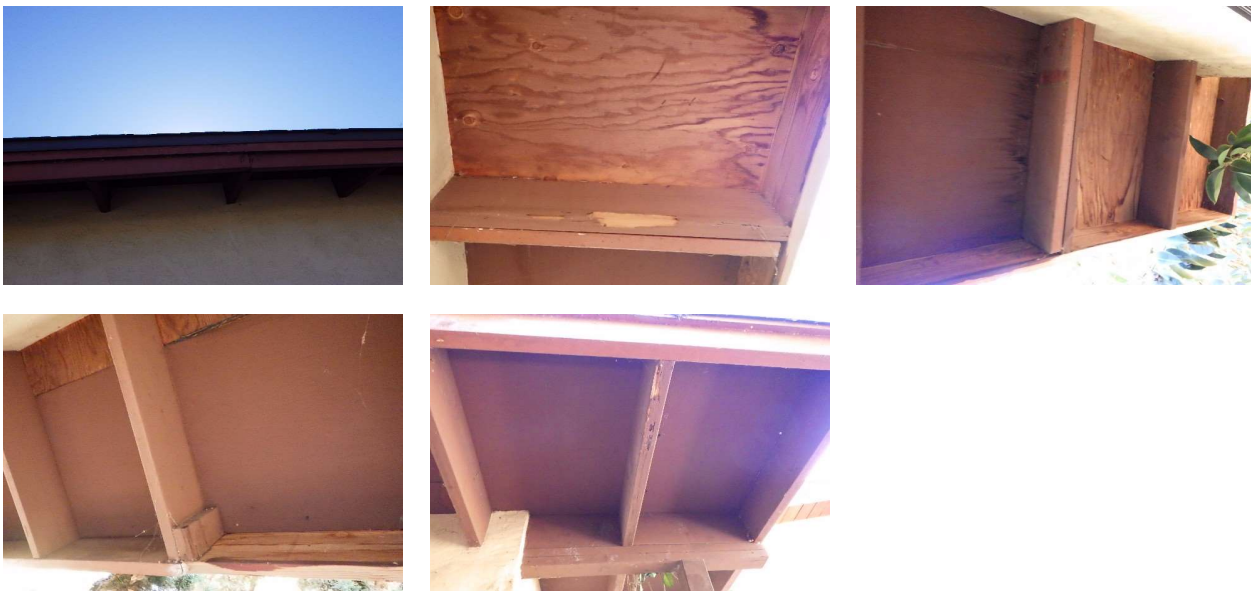
2.38 - There is possible moisture and or termite damage noted in the wood trim, fascia boards, and or eaves at various locations throughout the building. Further evaluation and repair by a licensed Pest Control Operator is advised.

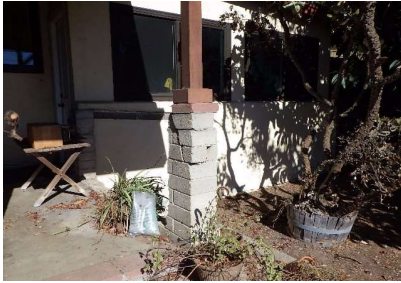
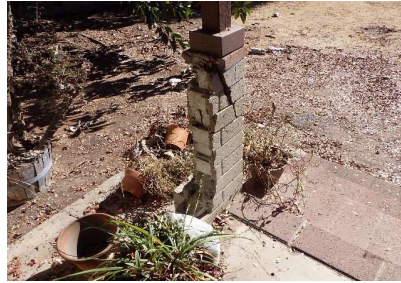
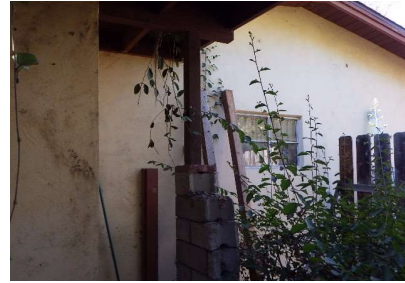
2.42 - The rear and left side patio cover posts are bearing poorly on piers that are improperly made out of damaged concrete block. Further evaluation and repair by a licensed contractor is advised.

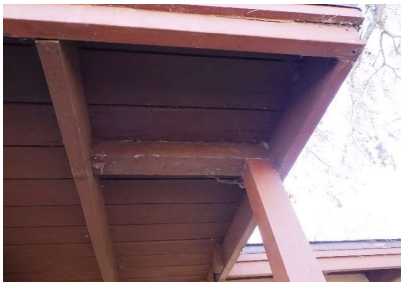
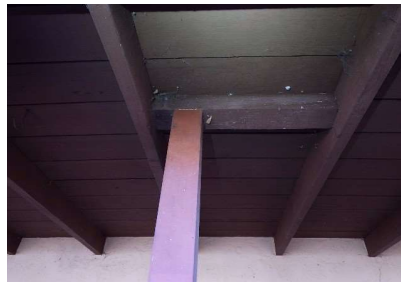
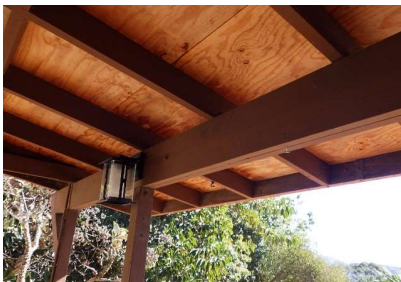
2.43 - The front porch and rear patio covers have substandard aspects, which imply that they could have been built without the benefit of a required building permit. We can elaborate on this issue, but you should request the building permit from the sellers, or seek a second opinion from a licensed contractor.

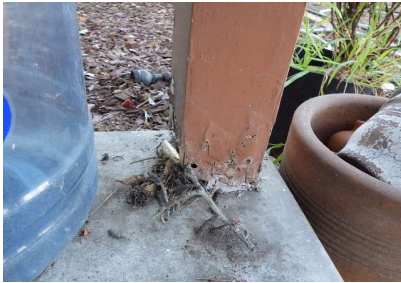
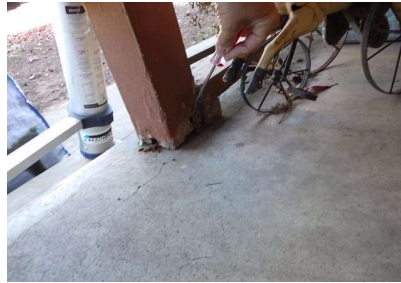
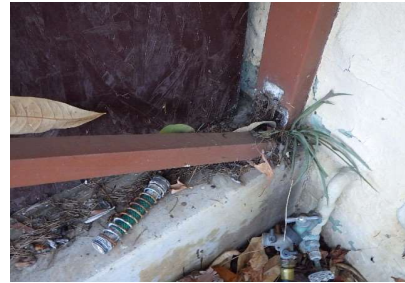
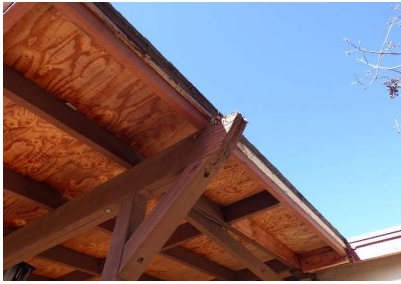
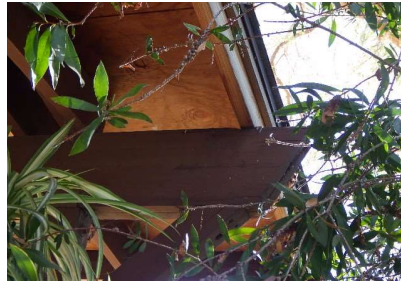
2.44 - There is possible termite and or moisture damage to the front porch and rear patio covers, that should be further evaluated and repaired by a licensed Pest Control Operator.

There is possible termite and or moisture damage to the front porch and rear patio covers - *Continued*

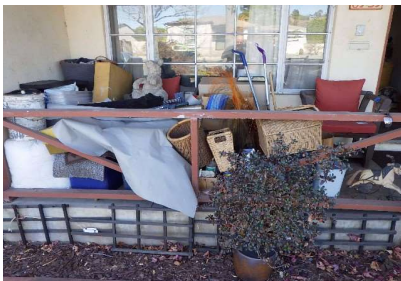
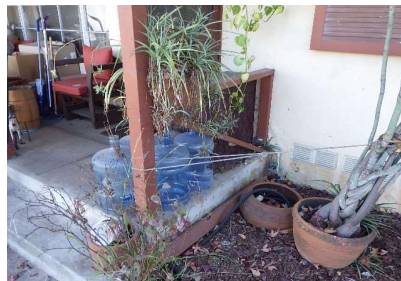
2.47 - The front porch guardrails do not conform to current standards. They should be a minimum of forty-two inches high with pickets spaced no more than four inches for child safety, and you may wish to have them brought into compliance.

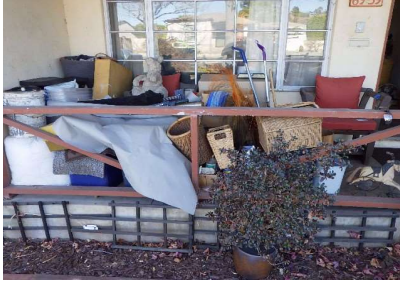
2.48 - Personal items limited the inspection of the front porch, which should further evaluated when the porch is fully visible and during the contingency period.

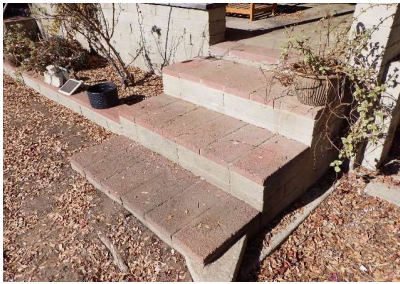
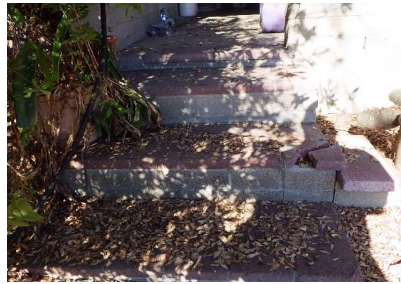
2.51 - The risers are unequal in height, which could prove to be a trip-hazard. The rise should not be less than 4 inches, nor greater than 7 inches. In addition, the dimensions of the risers should not exceed 3/8 of an inch from the smallest dimension on the entire run of the stairs.

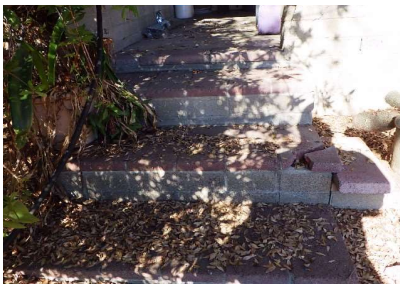
2.52 - There are cracked and or damaged steps at the rear patio. Proper repair by a licensed contractor is advised.

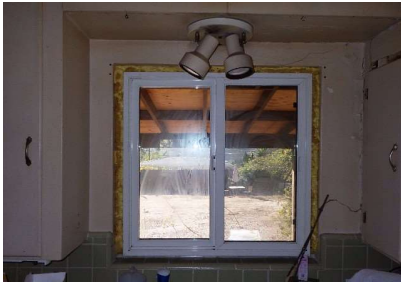
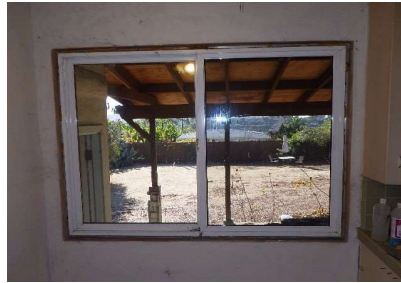
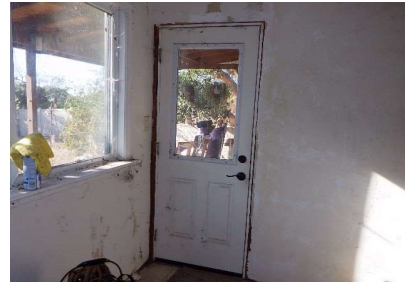
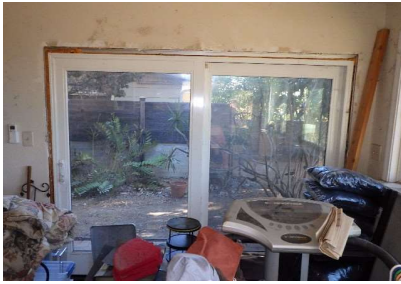
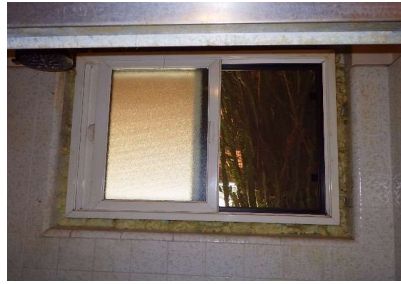
The replacement windows and doors appear to be improperly installed and or are incomplete throughout the home - *Continued*

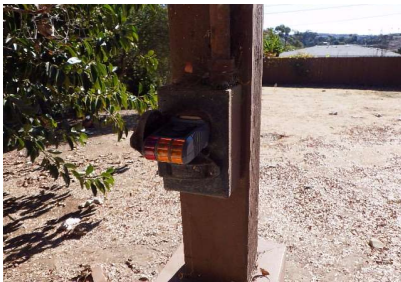
2.58 - One or more of the exterior outlets that were tested are functional, however, do not include ground-fault protection. Adding ground fault protection to the outlets is advised by a licensed electrician.

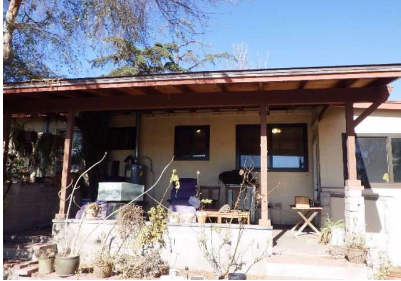
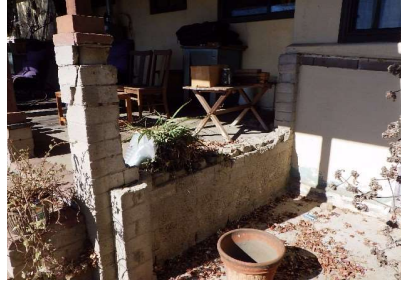
2.63 - It appears that a block wall around the perimeter of the rear patio was removed, which has created a possible fall hazard. Proper repair by a licensed contractor is advised.

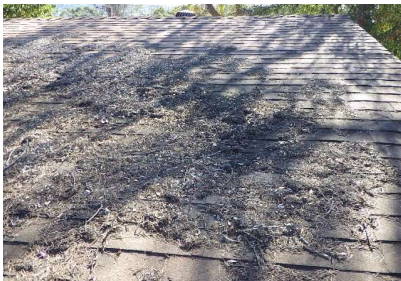
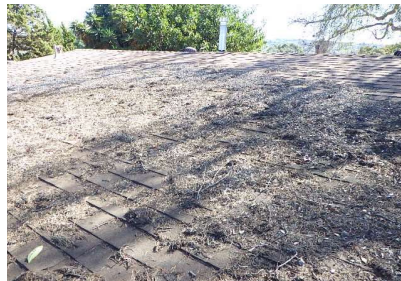
3.3 - Debris was noted on the roof, that should be removed now and on a regular basis, which also limited the inspection.

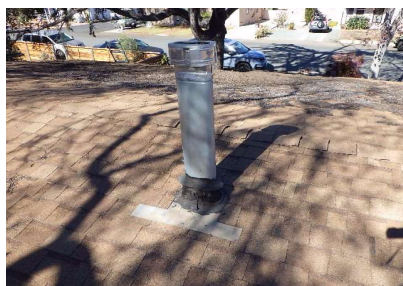
3.7 - Mastic has been coated on one or more of the roof vent pipes and ventilation flashings, which may indicate previous leaks. Further evaluation and repair by a licensed roofer is advised.

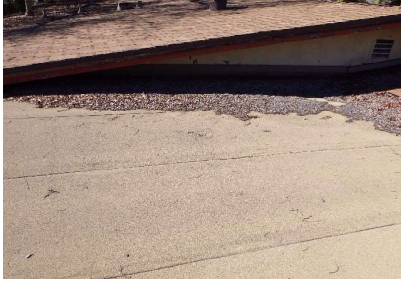
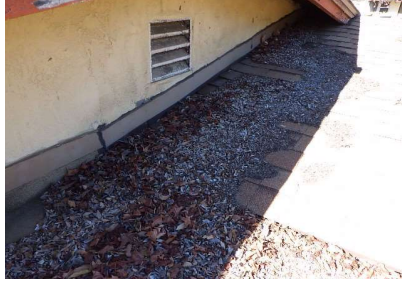
3.11 - Debris and or vegetation was noted on the roof, which limited the inspection and should be removed.

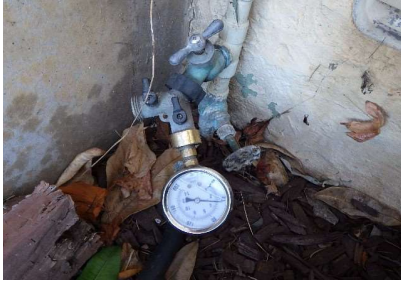
4.2 - The pressure at the street is 40 to 42 PSI and a regulator is not required on the plumbing system, however, it is always advisable to have a pressure regulator installed on the system.

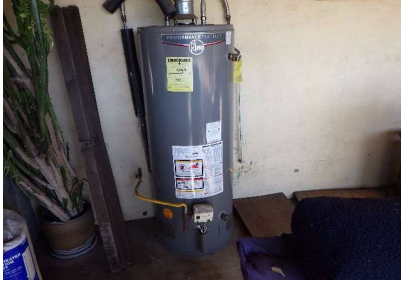
The water heater that is located on the rear patio of the home - *Continued*

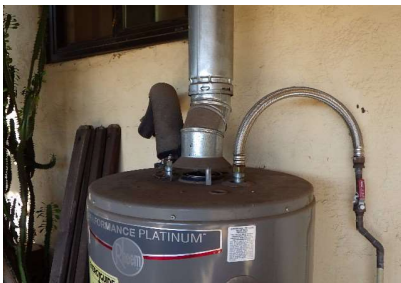
4.15 - The vent pipe is not well seated and or is missing screws securely attaching all connections, and should be serviced.

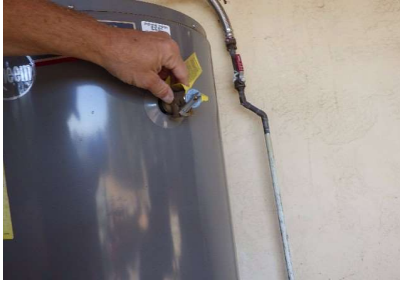
4.17 - The pressure relief valve on the water heater does not have a discharge pipe. A TPR pipe should be installed that terminates approximately six inches above grade by a licensed plumber. Further evaluation and repair by a licensed plumber is advised.

The pressure relief valve on the water heater does not have a discharge pipe - *Continued*

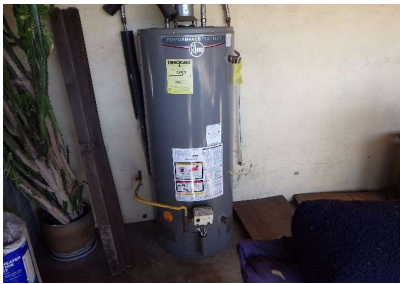
4.20 - The water heater is not properly secured, and needs to be strapped in accordance with local standards. Properly strapping the water heater to meet current building standards is advised.

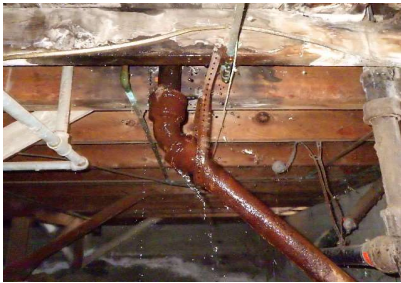
4.27 - There is a leak at the hall bathroom sink drain pipe in the crawl space, which should be further evaluated and repaired by a licensed plumber.

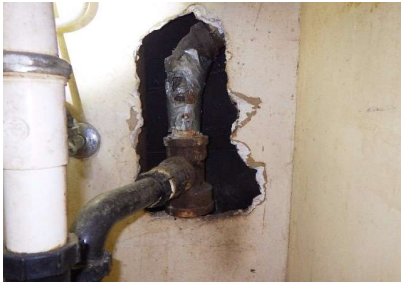
There is a hole and or damage noted in the vent pipe in the wall under the kitchen sink - *Continued*

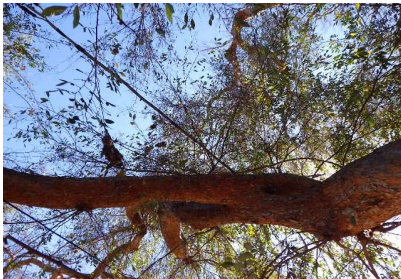
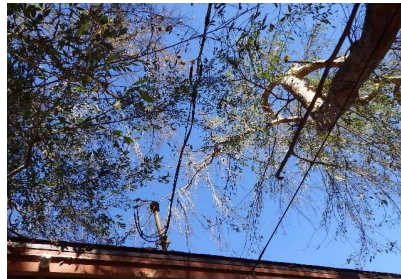
5.3 - The utility company's overhead conductor lines are running through tree limbs that should be trimmed.

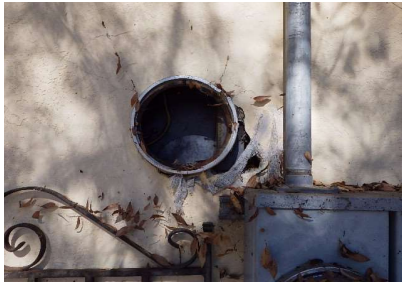
- 5.10 - Sharp tipped screws are used to secure the panel cover. For safety reasons, blunt tipped screws should be installed.
- 5.11 - The old meter socket opening is missing a waterproof cover, which should be installed by a licensed electrician.

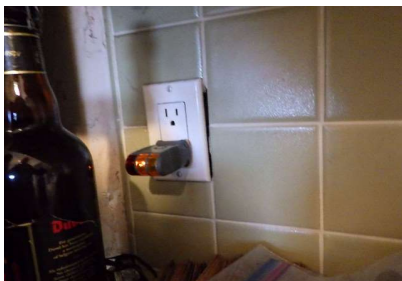
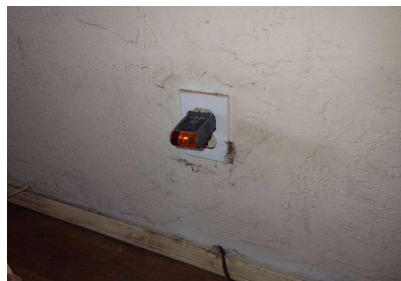
- 5.15 - The home was originally wired with a two wire non-grounded electrical system. Many of the outlets throughout the home have been changed to three prong grounded style, however, remain ungrounded. Further evaluation and repair by a licensed electrician is advised.

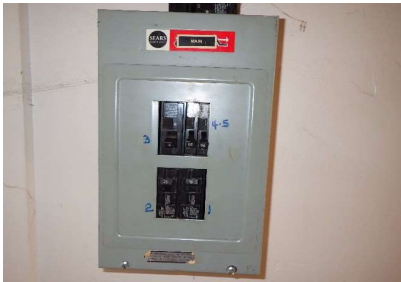
5.23 - The sub-panel is unconventionally located inside a closet, which would not be permitted by current standards, but may have been permitted at original construction. Therefore, you may wish to verify its installation permit or have a licensed electrician further evaluate it.

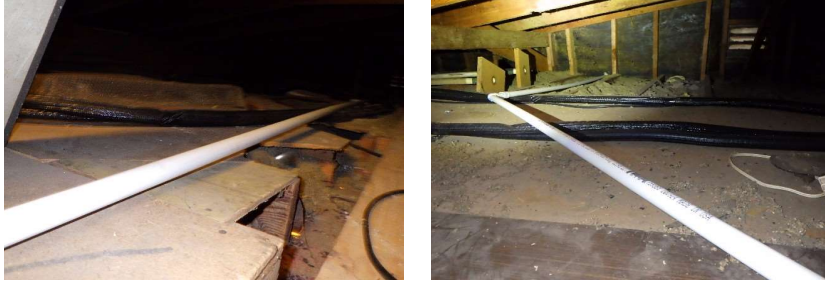
7.7 - The condensate discharge pipe is not plumbed to drain efficiently (Visible in the attic). It should be level or slope at one-quarter inch per foot to drain effectively, and should be serviced by a licensed HVAC contractor.

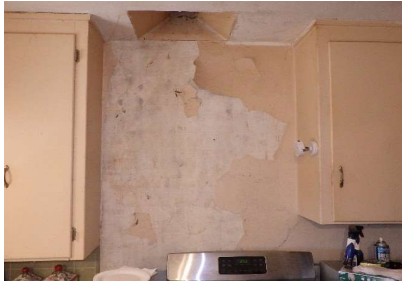
9.3 - Paint was seen chipping, flaking, and peeling at various throughout the interior and or exterior of the home, which may contain lead. Further evaluation by a licensed contractor specializing in environmental abatement is

advised.

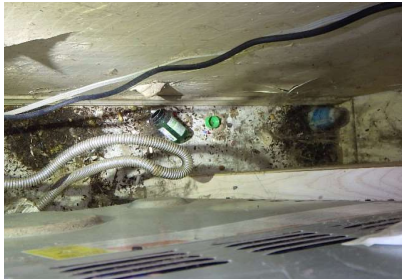
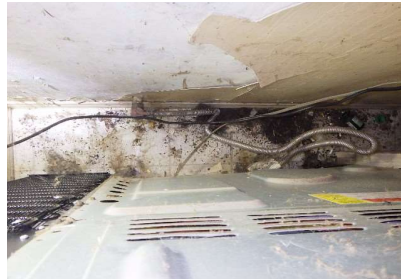
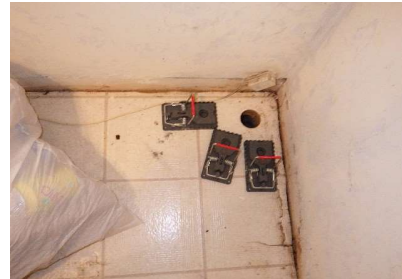
9.4 - There is evidence of rodent activity throughout the home, which can be a significant health hazard, and should be evaluated by a licensed exterminator. Rodents can compromise not only the attic and its various components, such as ducts and insulation, but can eventually compromise the living space as well. Consequently, we disclaim any further responsibility for evaluating the attic and its components.

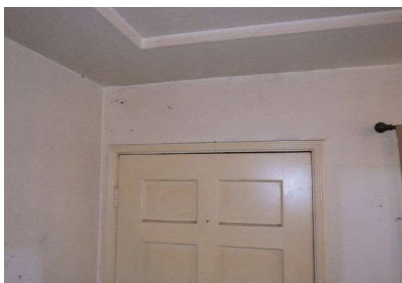
9.7 - The door and or jamb are out of square, which may indicate movement has occurred. Further evaluation and repair by licensed engineer or foundation contractor is advised during the contingency period of the escrow.

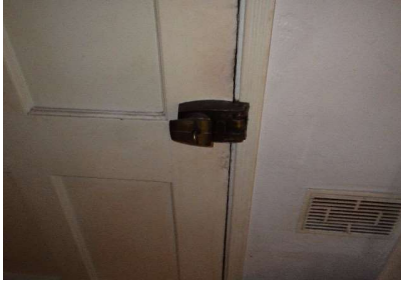
The double cylinder keyed deadbolt on the exterior door could prevent or impede an emergency exit - *Continued*

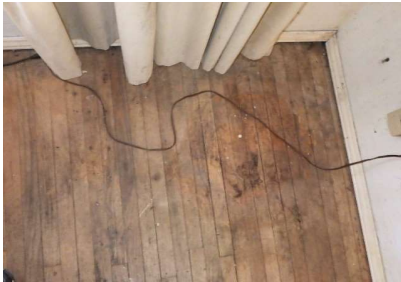
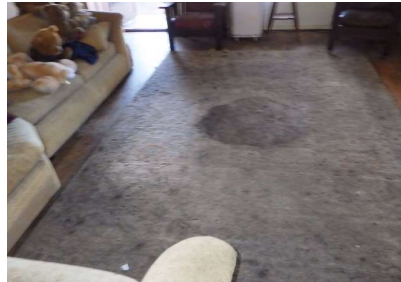
9.10 - The hardwood floor is cupped, or moisture damaged, and should be evaluated by a specialist. Cupping occurs when the hardwood absorbs excessive moisture on the underside, which causes expansion that results in cupping.

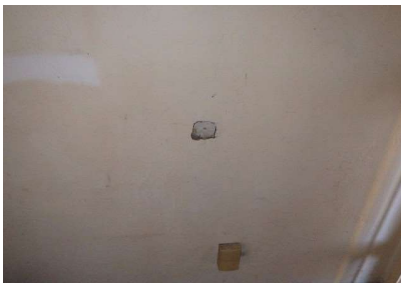
9.12 - There is a hole and or damage in the wall, which should be properly repaired by a licensed contractor.

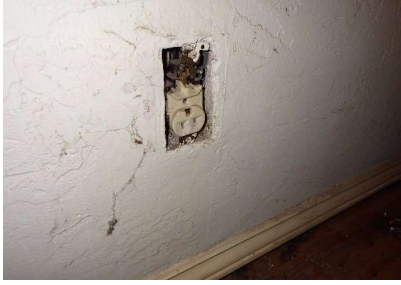
9.16 - There are one or more damaged outlets in the living room, which should be replaced by a licensed electrician.

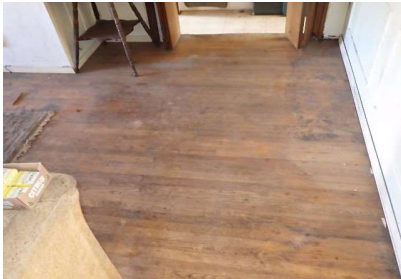
9.20 - The hardwood floor is cupped, or moisture damaged, and should be evaluated by a specialist. Cupping occurs when the hardwood absorbs excessive moisture on the underside, which causes expansion that results in cupping.

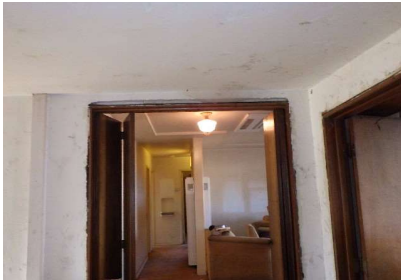
9.27 - The trim is missing around the doors, which should be installed.

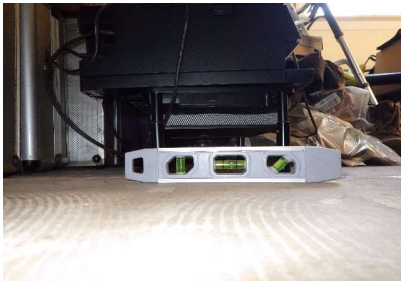
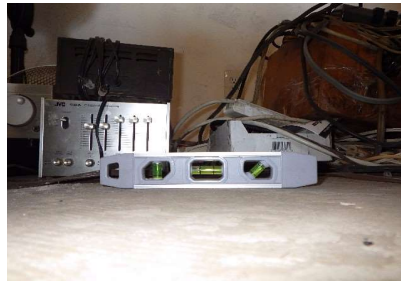
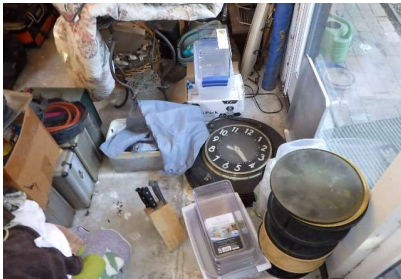
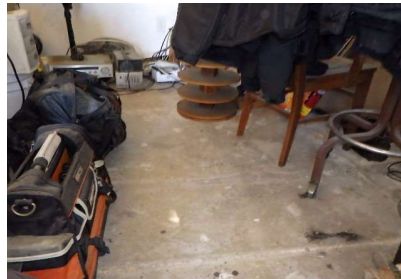
9.28 - The floor appears to be out of level and or uneven. We can elaborate, but this condition should be further evaluated and repaired by a licensed engineer or a foundation contractor during the contingency period of the escrow.

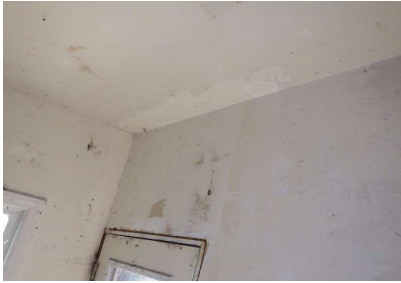
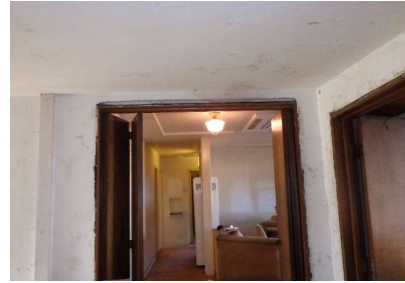
9.30 - There are patched areas in the walls and or ceiling, which you should question the seller about or have further evaluated by a licensed contractor.

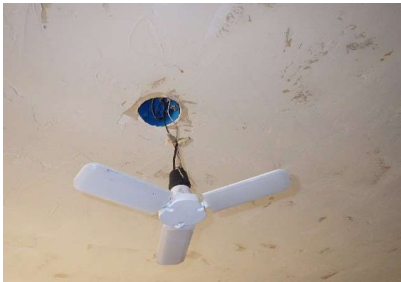
9.32 - One or more ceiling lights did not respond and is improperly hanging by its wiring, which should be properly repaired by a licensed electrician.

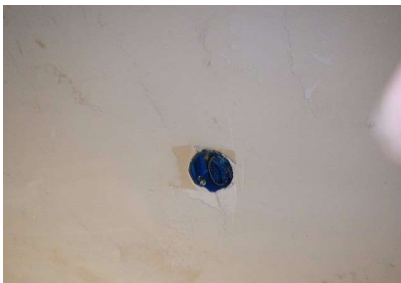
9.33 - There are open electrical junction boxes, which are incomplete.

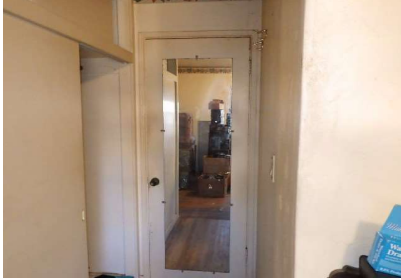
10.2 - The door rubs in the jamb, and needs to be serviced to work smoothly.

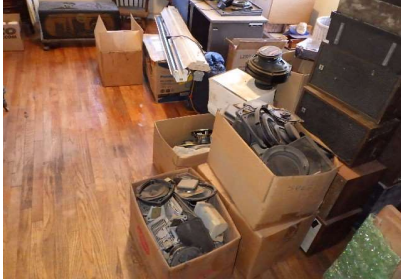
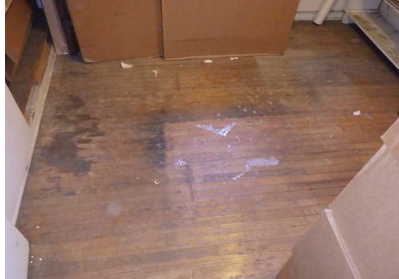
10.5 - The hardwood floor is cupped, or moisture damaged, and should be evaluated by a specialist. Cupping occurs when the hardwood absorbs excessive moisture on the underside, which causes expansion that results in cupping.

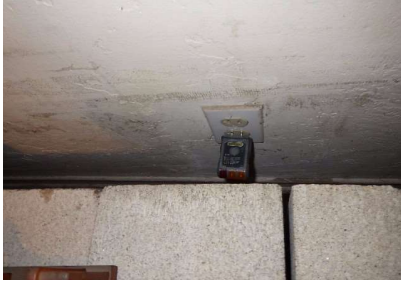
10.11 - There is one or more outlets that are not functional, which should be further evaluated and repaired by a licensed electrician.

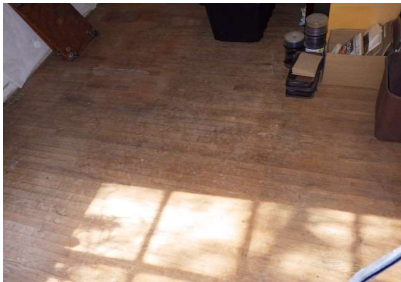
10.18 - The hardwood floor is cupped, or moisture damaged, and should be evaluated by a specialist. Cupping occurs when the hardwood absorbs excessive moisture on the underside, which causes expansion that results in cupping.

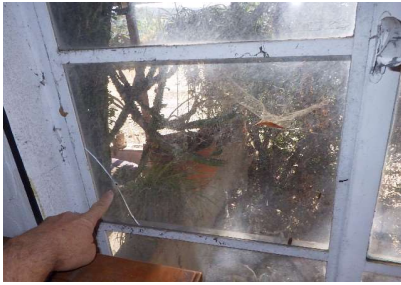
One or more window panes are cracked - *Continued*

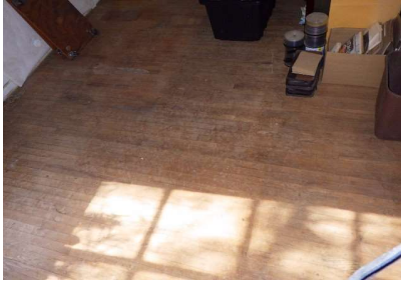
10.30 - The hardwood floor is cupped, or moisture damaged, and should be evaluated by a specialist. Cupping occurs when the hardwood absorbs excessive moisture on the underside, which causes expansion that results in cupping.

The hardwood floor is cupped and should be evaluated by a specialist - *Continued*

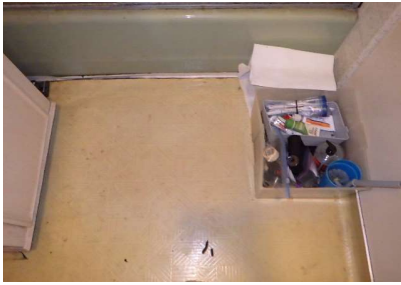
There is moisture damaged in the flooring and or sub floor adjacent to the bathtub - *Continued*

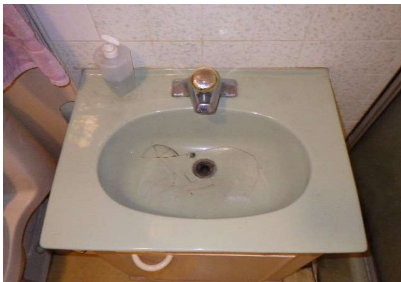
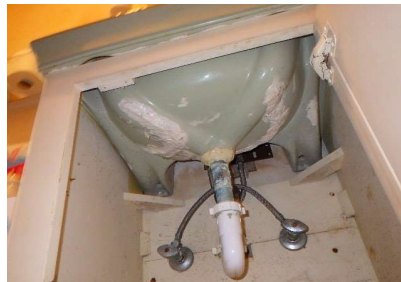
11.8 - The sink is badly cracked and needs to be replaced. Further evaluation and repair by a licensed plumber is advised.

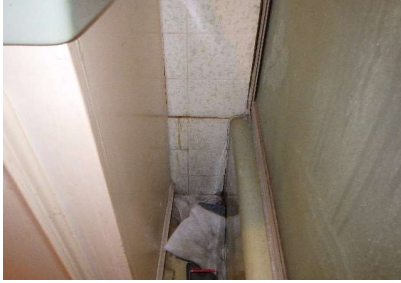
11.9 - There are cracked, loose, and or damaged tiles in the tub-shower area. Further evaluation and repair by a licensed Pest Control Operator and or contractor is advised.

There are cracked loose and or damaged tiles in the tub-shower area - *Continued*

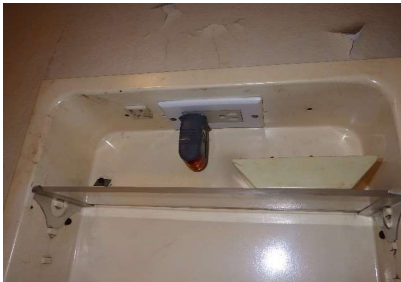
- 11.18 - The sink outlet has an open-ground (Poorly located inside the medicine cabinet), which should be serviced to have ground-fault protection by a licensed electrician.

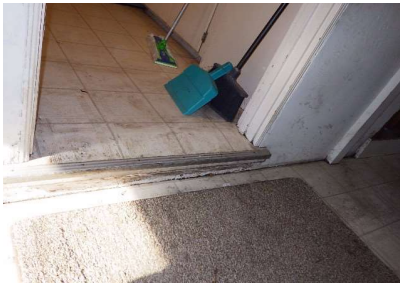
12.4 - The floor appears to be out of level and or uneven. We can elaborate, but this condition should be further evaluated and repaired by a licensed foundation contractor during the contingency period of the escrow.

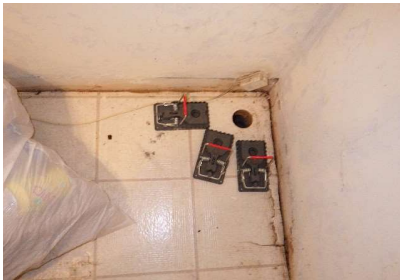
12.5 - A hole has been drilled into the floor, which should be properly repaired.

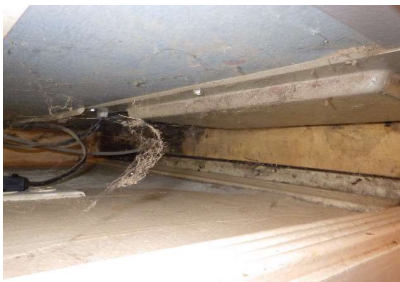
12.6 - There are patched and or damaged areas in the floor under the refrigerator, which you should question the seller about, or have further evaluated by a licensed contractor.

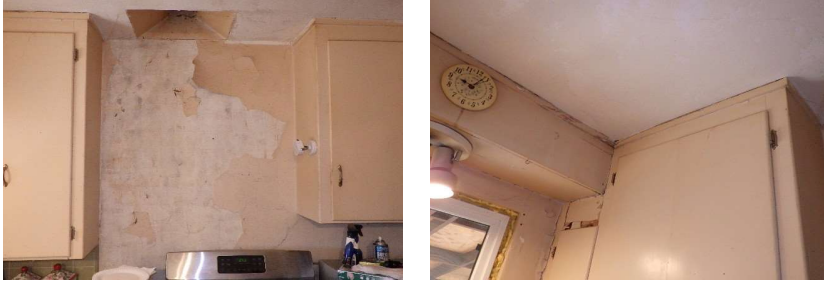
12.8 - There are moisture stains and or damage on the walls and or ceiling, which you should ask the sellers to explain or have explored further by a licensed roofer.

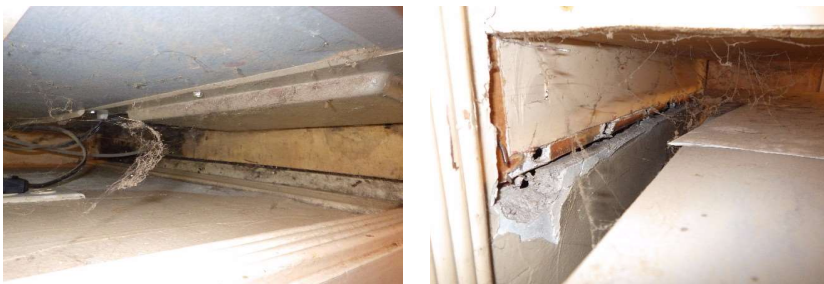
12.9 - There are patched and or damaged areas in the walls and or ceiling, which you should question the seller about, or have further evaluated by a licensed contractor.

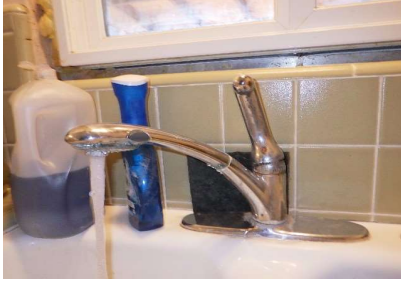
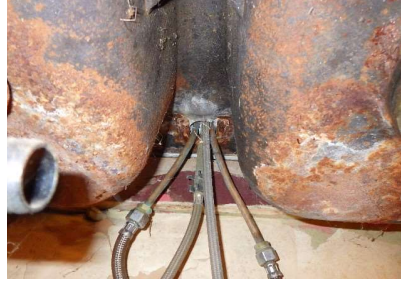
12.19 - The faucet leaks while in use, which should be repaired or replaced by a licensed plumber.

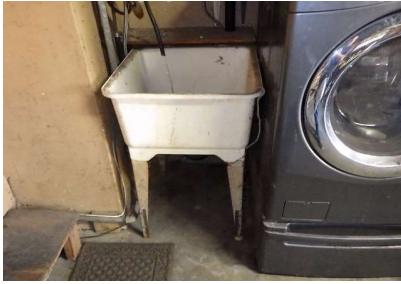
16.5 - The laundry sink is functional, however, it is loose and should be properly secured to the wall.

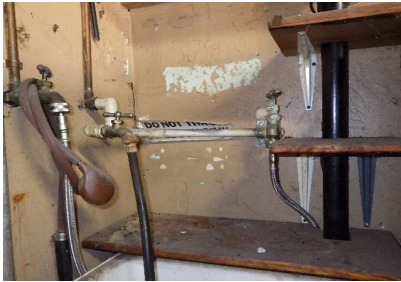
16.9 - Rust and or corrosion was noted on the hose faucet hook-ups for the washer, which should be serviced.

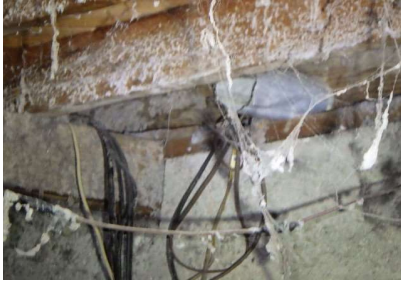
16.15 - The dryer vent terminates improperly within the foundation crawl space. Further evaluation and repair by a licensed contractor advised.

The dryer vent terminates improperly within the foundation crawl space - *Continued*

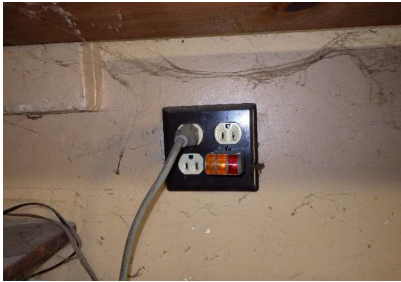
16.16 - One or more outlets have reversed polarity, and should be serviced by a licensed electrician.

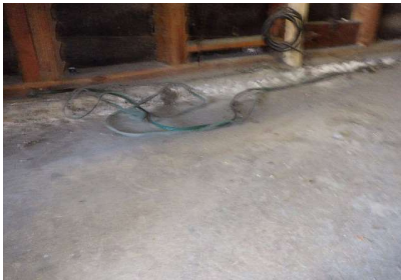
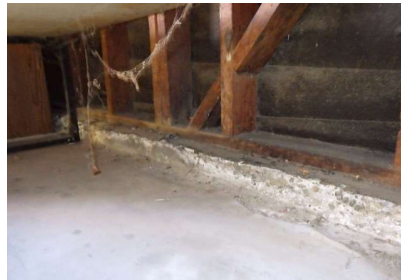
17.2 - Efflorescence on the slab floor or foundation walls confirms that moisture has penetrated. Further evaluation and repair by a licensed foundation contractor is advised.

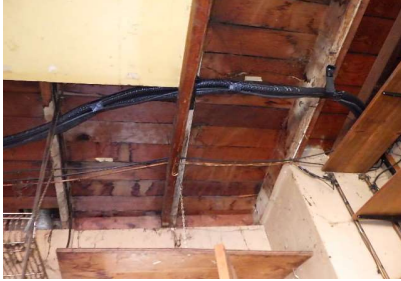
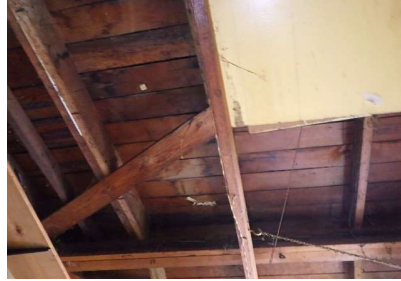
17.3 - There are moisture stains on the walls and or ceiling, the cause of which should be explained or explored further by a licensed contractor.

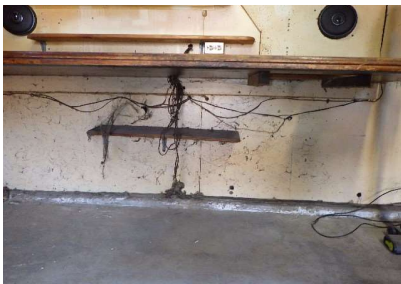
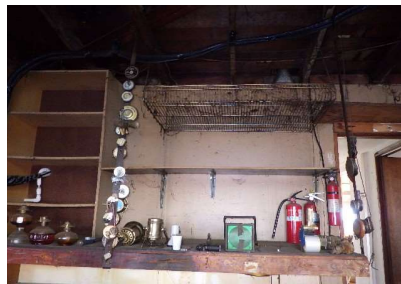
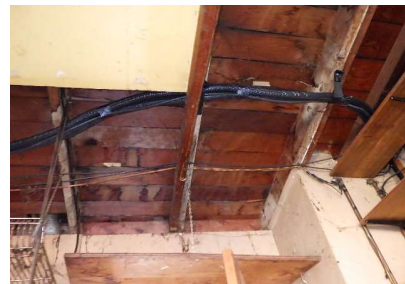
17.7 - There is no firewall separation between the garage and the residence (At the family room addition), which is required by building standards. Further evaluation and repair by a licensed contractor is advised.

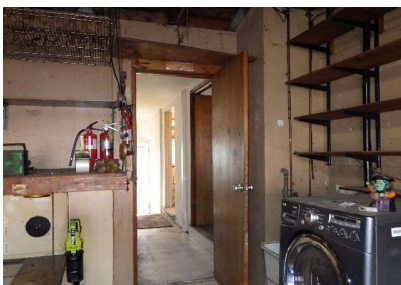
17.8 - The house entry door is not self-closing and is required to be, to maintain the necessary firewall separation between a garage and living quarters, and will need to be serviced.

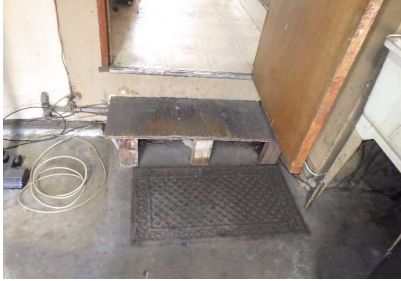
17.9 - The house entry door opens incorrectly over a step, and should open over a platform the width of the door, which should be repaired.

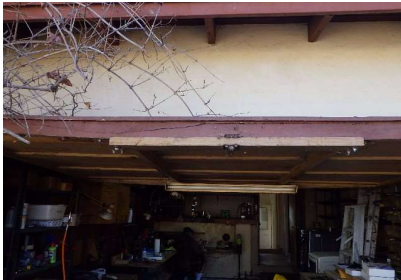
17.12 - The lower rail on the garage door is cracked and or damaged and has an improper repair. Proper repairs are recommended by a licensed contractor.

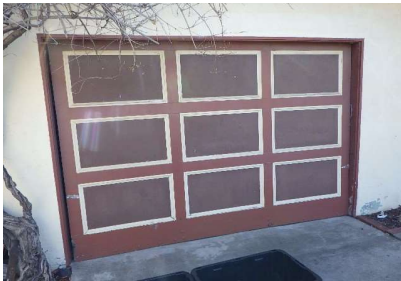
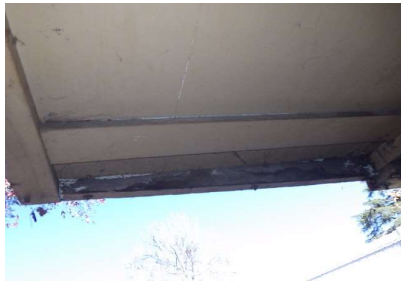
17.13 - There is moisture and or termite damage in the overhead garage door and or jamb. Further evaluation and repair by a licensed Pest Control Operator is advised.

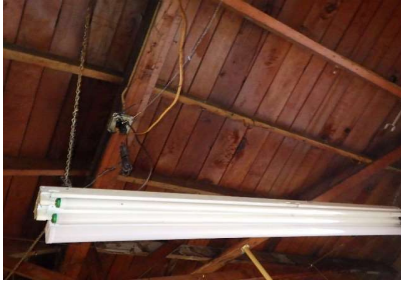
17.14 - Shop lights were added that are not permanently wired. Further evaluation and repair by a licensed electrician is advised.

Shop lights were added that are not permanently wired - *Continued*

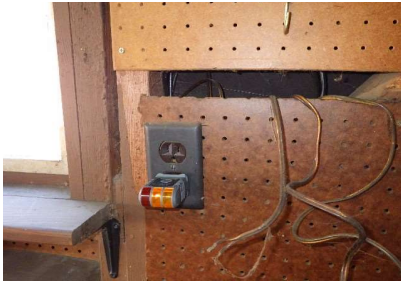
17.15 - One or more outlets have an open ground, and should be serviced by a licensed electrician.

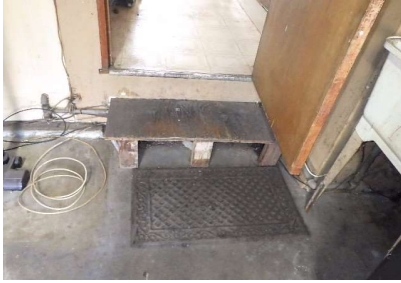
17.19 - The step from the garage to the interior of the home is improperly installed and is loose, which may pose as a trip hazard. Proper repair by a licensed contractor is advised.

The step from the garage to the interior of the home is improperly installed and is loose - *Continued*

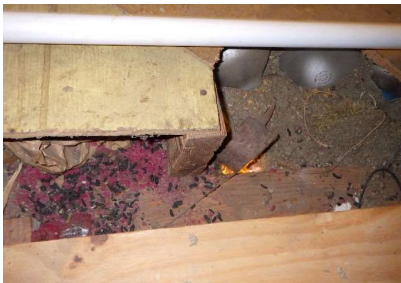
18.3 - There is evidence possible rodent activity in the attic, which can be a significant health hazard, and should be evaluated by a licensed exterminator. Rodents can compromise not only the attic and its various components, such as ducts and insulation, but can eventually compromise the living space as well. Consequently, we disclaim any further responsibility for evaluating the attic and its components.

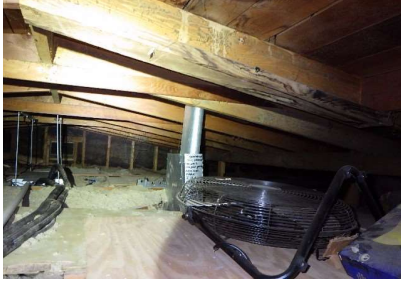
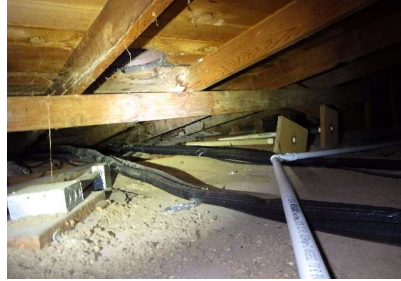
18.7 - There is evidence that the roof has leaked in several locations, which should be reasonably explained, or the roof should be further evaluated by a licensed roofer.
