# Inspection Report

J Bixler Inspections

25657 Long Barn Sugar Pine Rd  
Miwuk Village, CA

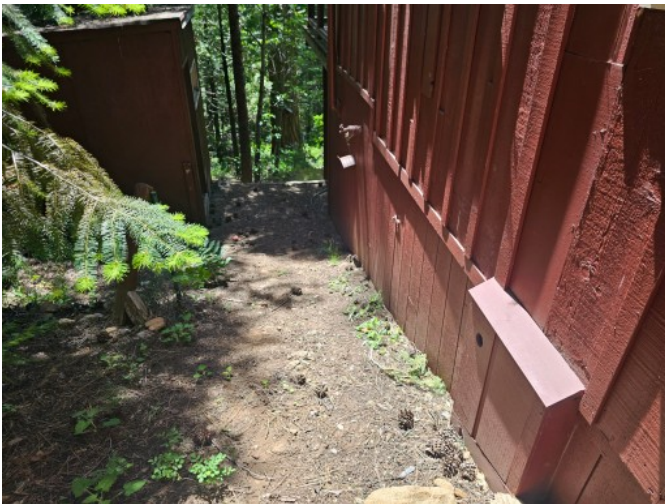
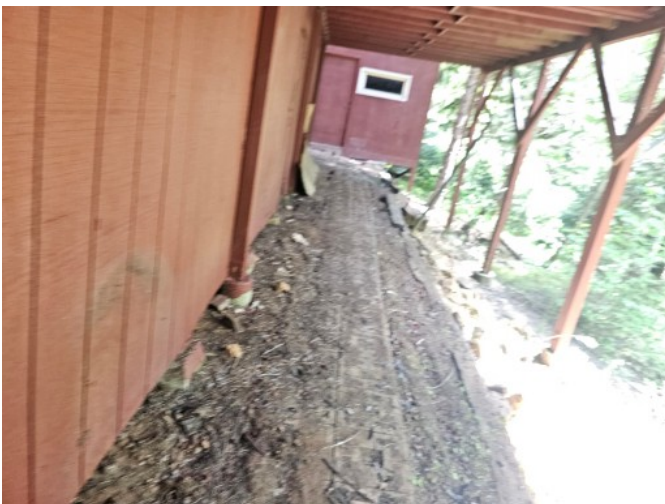
Minor re-grading near the foundation was observed. We recommend re-grading to assure all water drains away from the home's foundation. Failure to re-grade low-lying areas at the foundation can cause water seepage under slabs, into the basement / crawlspace, and / or cracks or movement in the foundation.

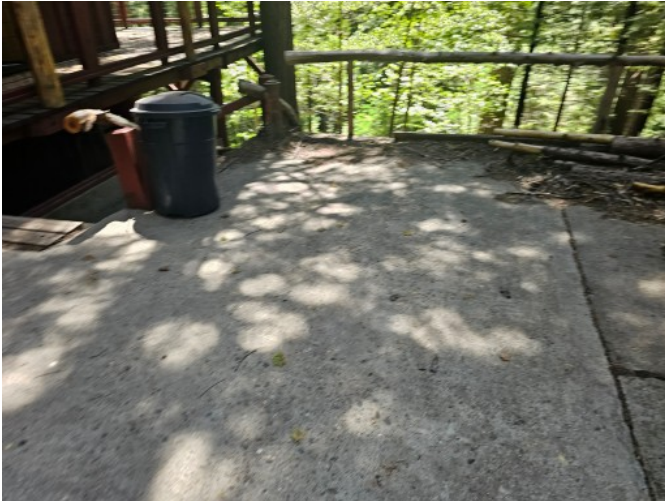
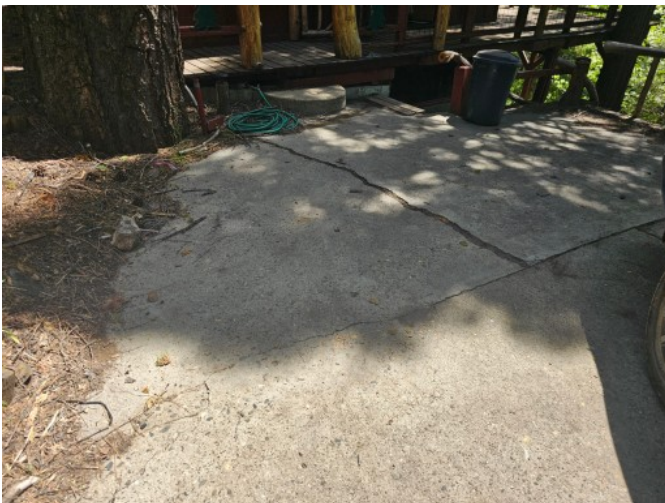
The driveway surface was raised or settled.

Common cracks were observed in the driveway.

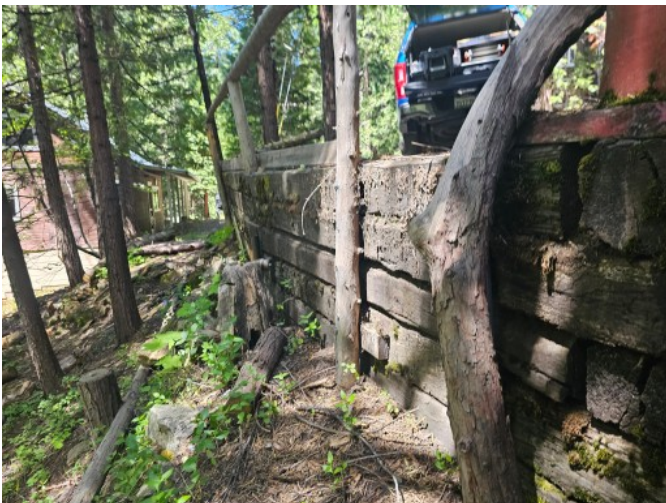
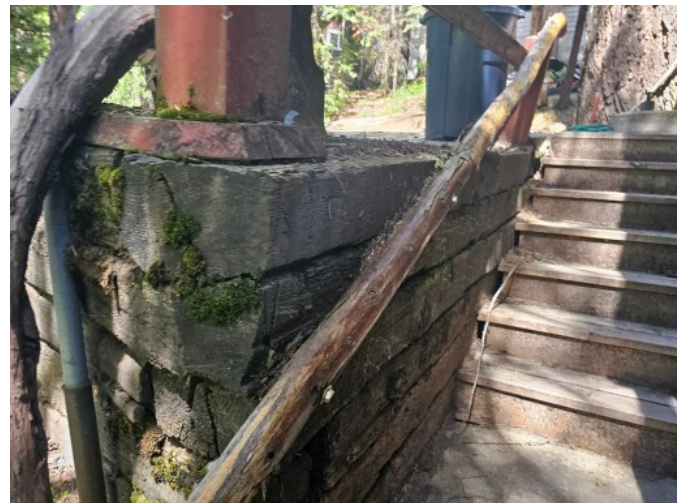
The visible and accessible portions of the retaining walls appeared to be in serviceable condition at the time of the inspection.

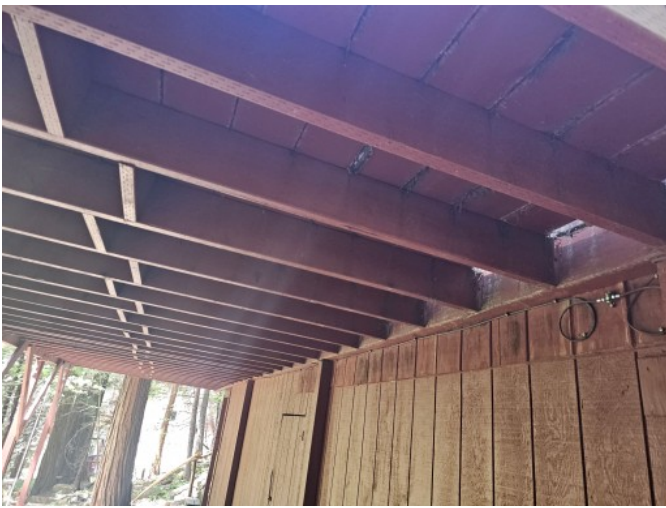
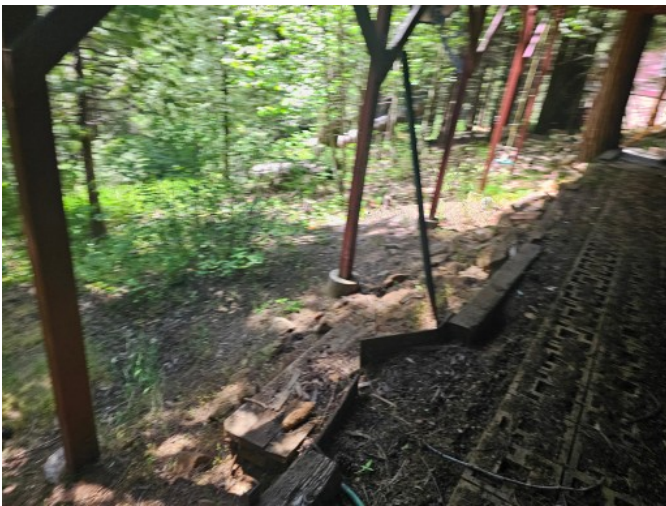
The deck showed signs of rot. See termite report for further break down and cost estimates.

The surface appeared weathered. Recommend cleaning and maintenance as needed.

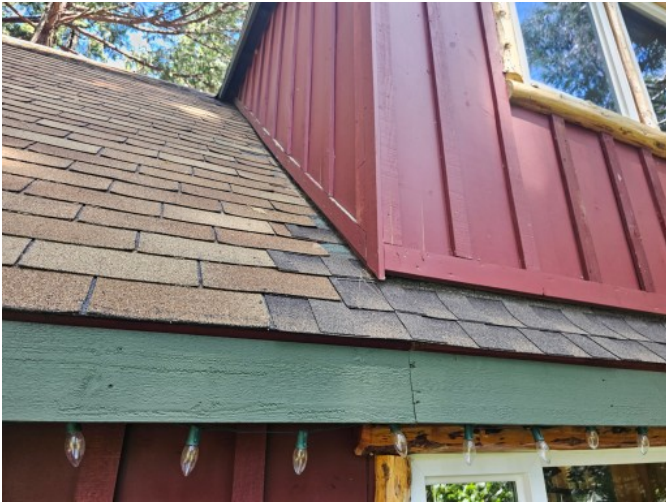
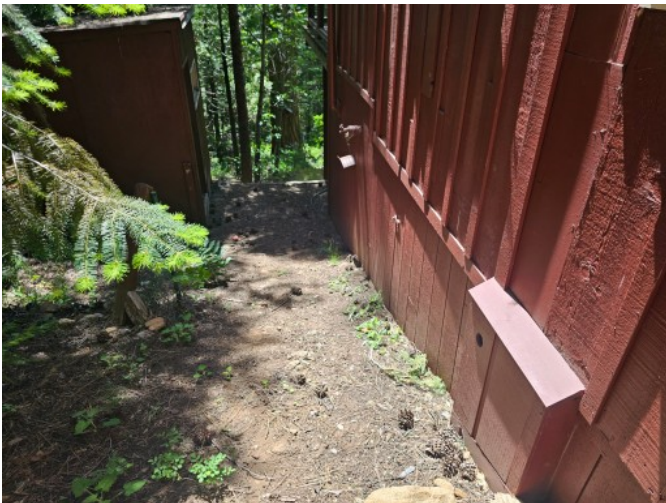
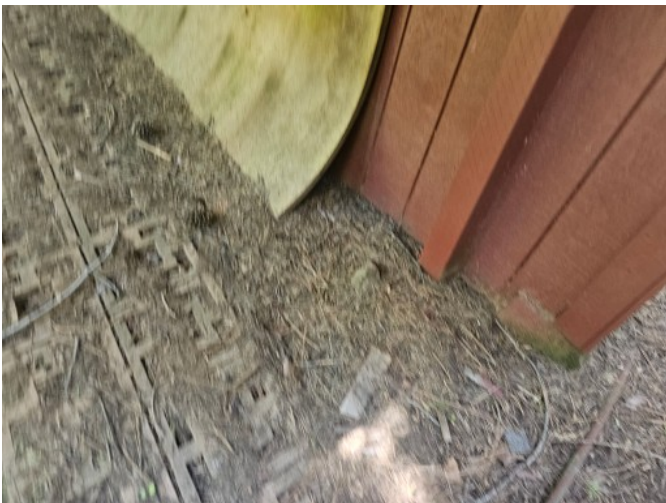
Some earth to wood contact was noted around home. Recommend regrading or raking away soil to break contact as needed.

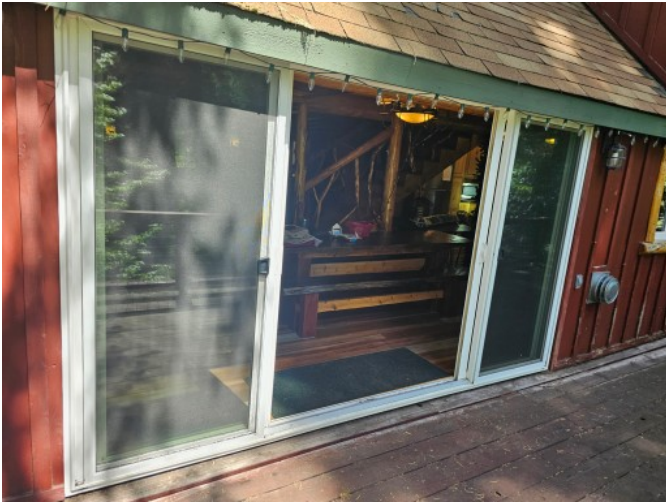
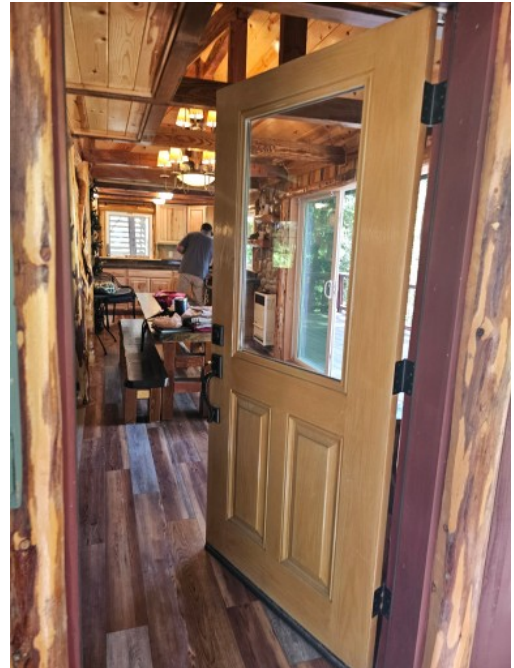
**2.4) Exterior Door Conditions**

The door(s) appeared to be in serviceable condition at the time of the inspection.

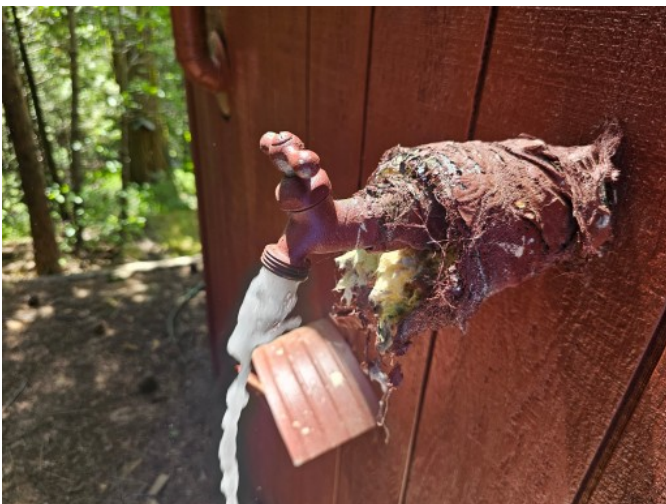
### 2.5) Faucet Conditions

The hose faucets appeared to be in serviceable condition at the time of the inspection. These should be drained prior to freezing temperatures.

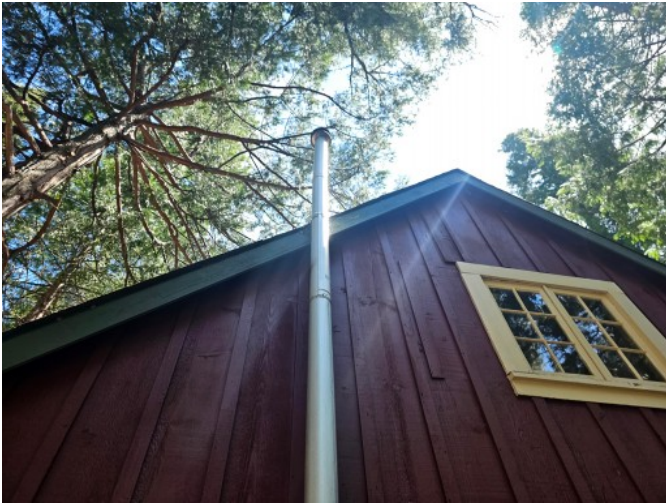
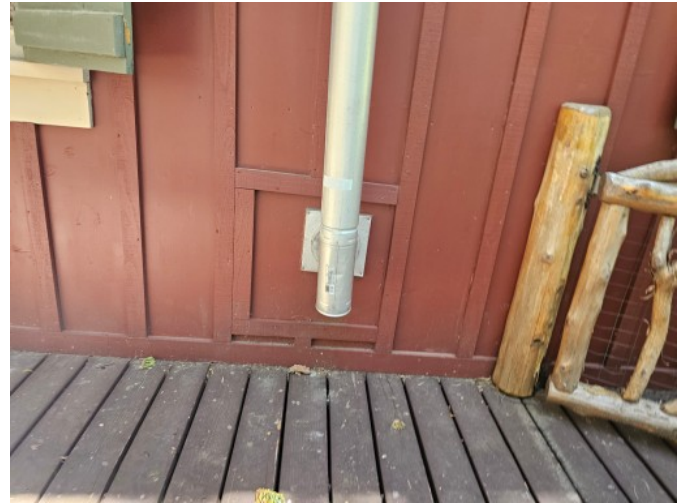
### 2.6) Chimney Conditions

The visible and accessible portions of the chimney(s) appeared to be in serviceable condition at the time of the inspection.

It is recommended that clients have a third party inspection of their fireplaces and chimneys. J Bixler Inspections does not clean the flu nor comment on codes for fireplaces

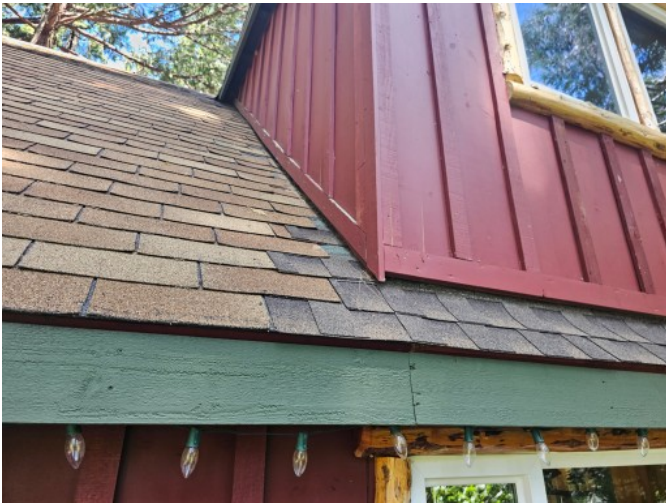
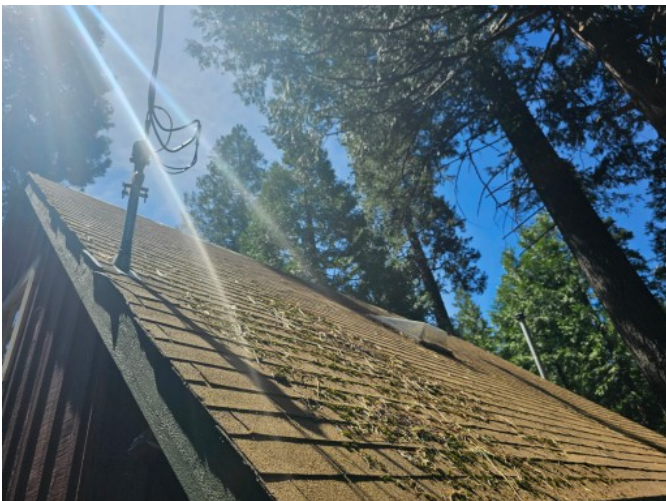
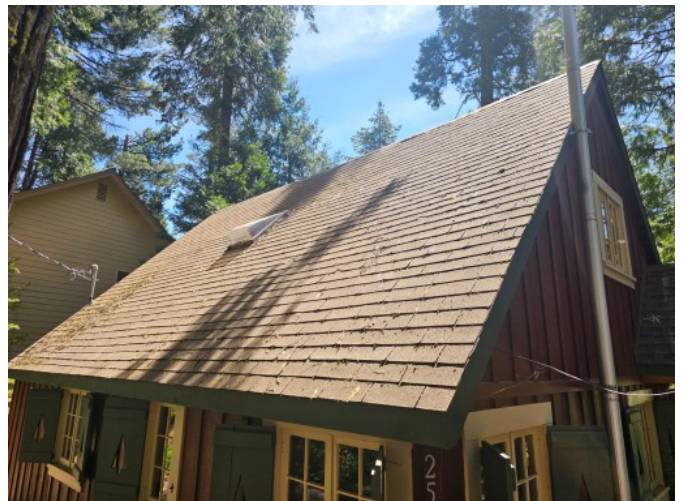
### 3.1) Roof Covering Condition

Maintenance and some repairs are recommended. This usually consists of repair or replacement of any damaged, raised, or missing shingles. This maintenance should help to ensure the water tightness of the building and should be performed on a regular basis.

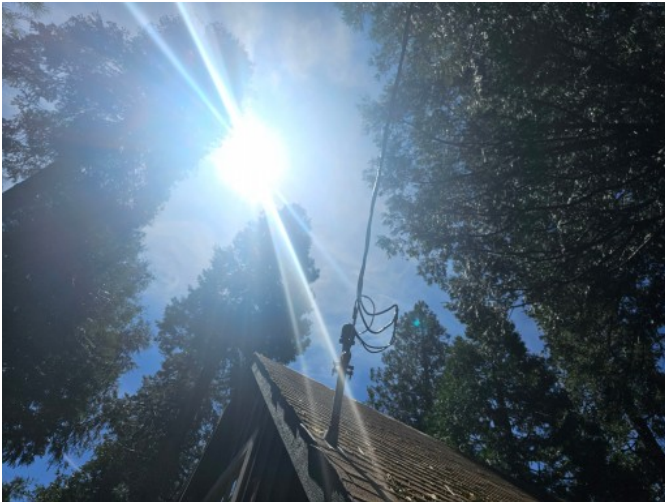
**4.1) Electrical Service Conditions** AS

The main service entry appeared to be in serviceable condition at the time of inspection.

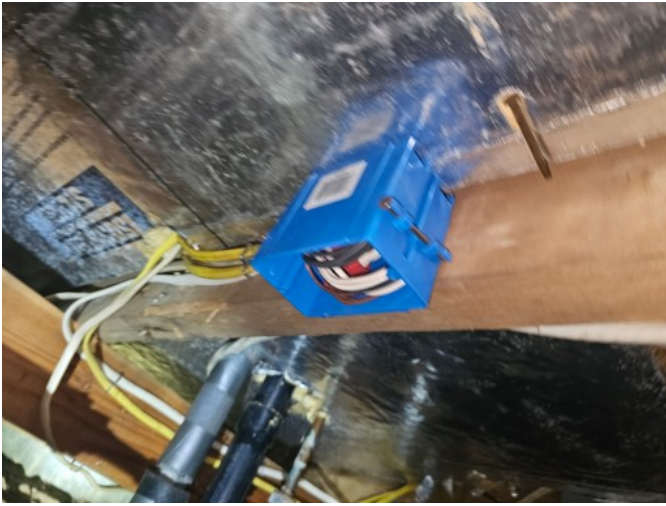
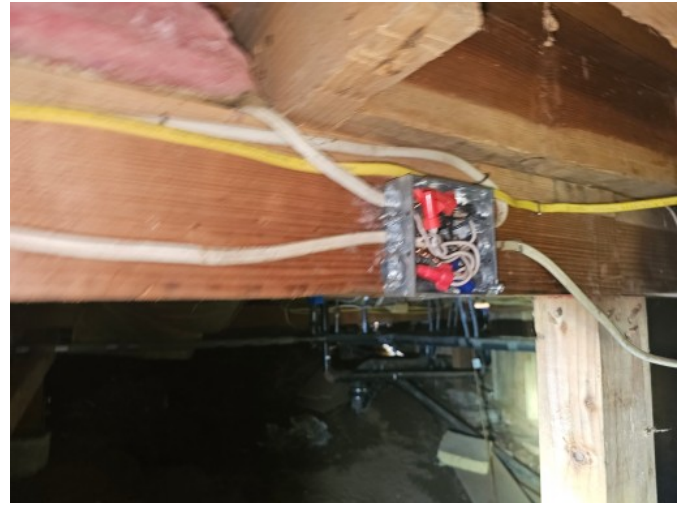
In the crawl space, there were quite a few open junction boxes with electrical splicing. It's recommended that these have proper covers.

The main power cable is aluminum. The branch cables are copper. Plastic insulated (Romex) type wire is present.

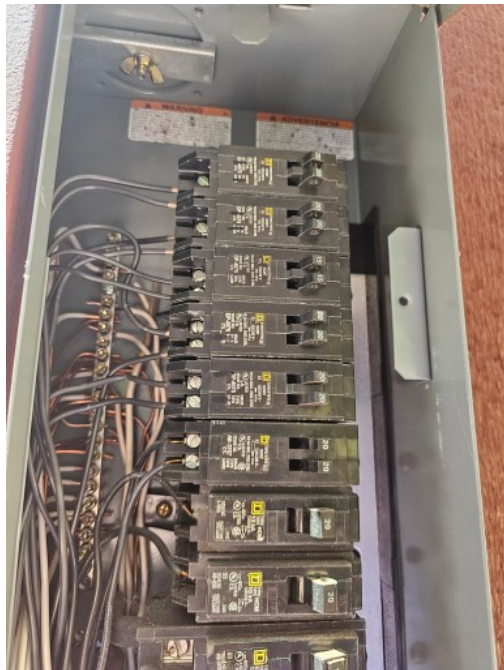
#### 4.3) Electrical Panel Conditions

The main panel appeared to be in serviceable condition at the time of the inspection.

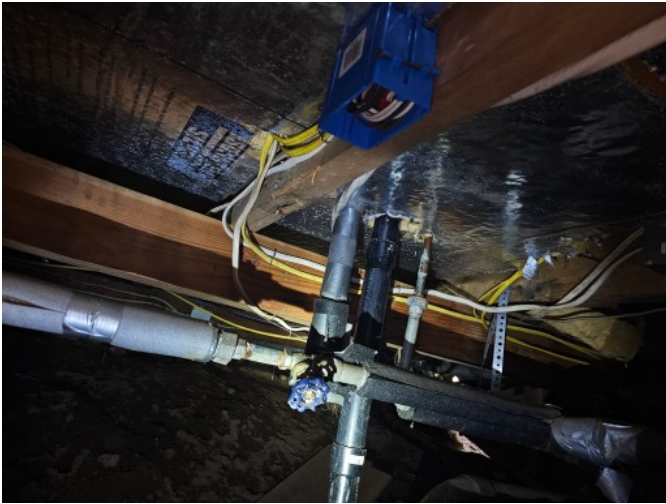
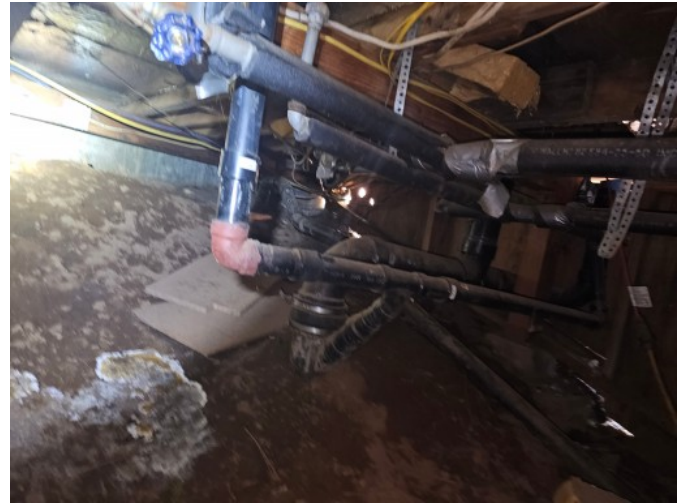
#### 5.2) Drain Line Conditions

The visible portions of the waste lines appeared to be in serviceable condition at the time of

inspection. All of the waste lines were not fully visible or accessible at the time of the inspection.

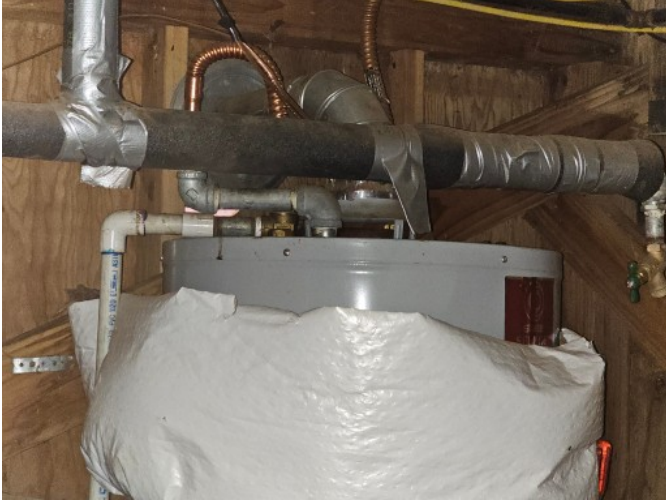
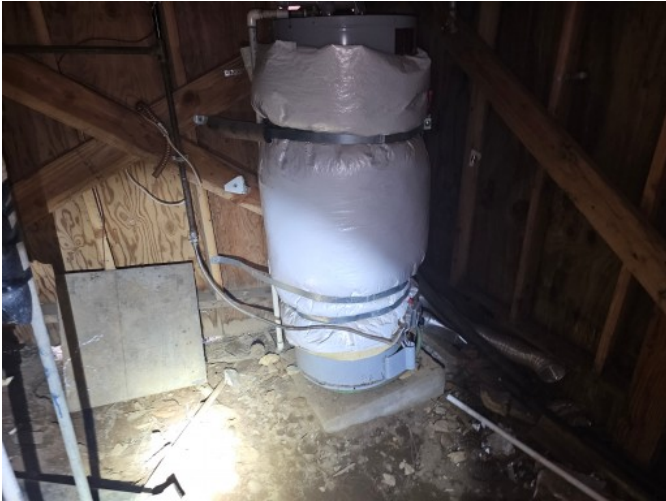
**5.3) Water Heater Conditions** NI

The water heater was off at the time of inspection. Recommend unit be powered a few days prior to close and tested for operation.

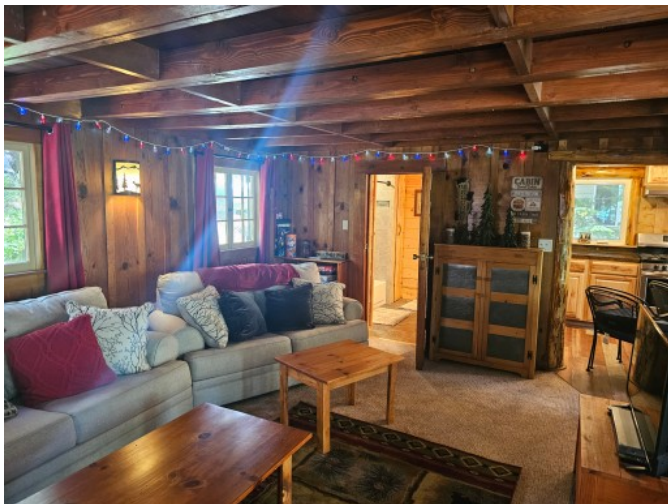
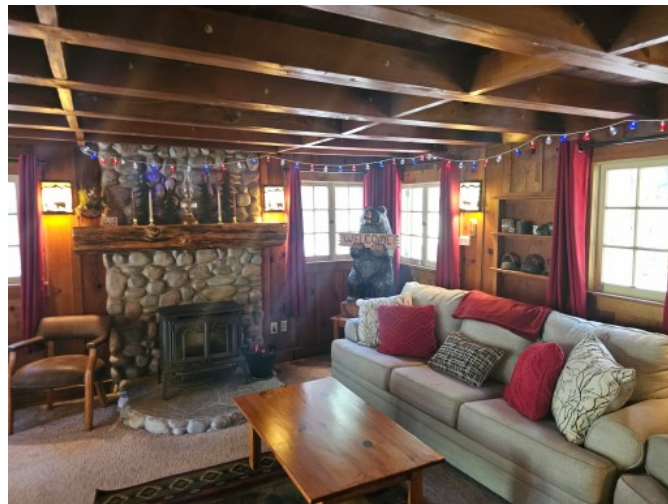
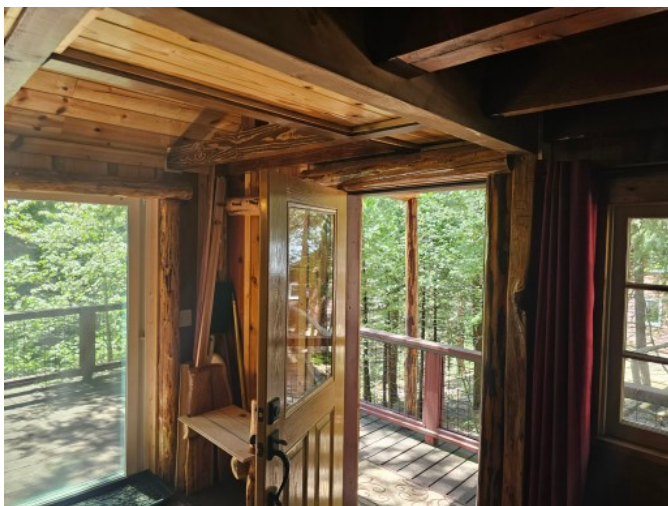
#### 6.1) Wall Conditions

The general condition of the walls appeared to be in serviceable condition at the time of the inspection.

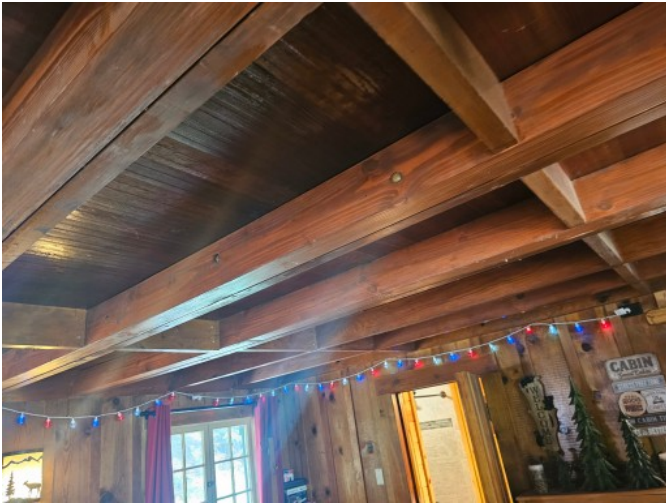
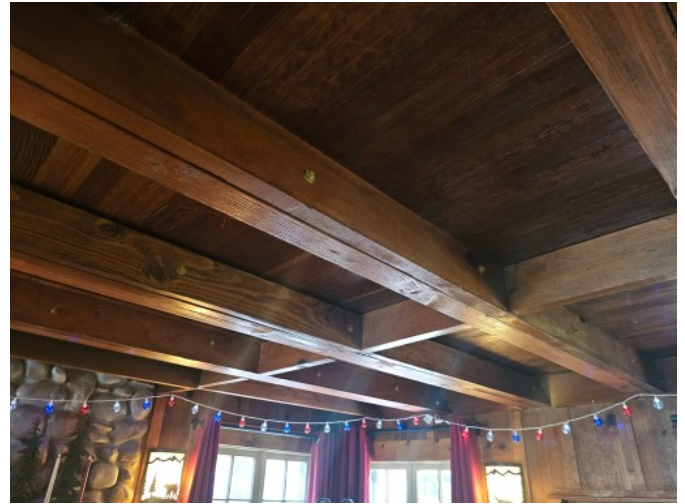
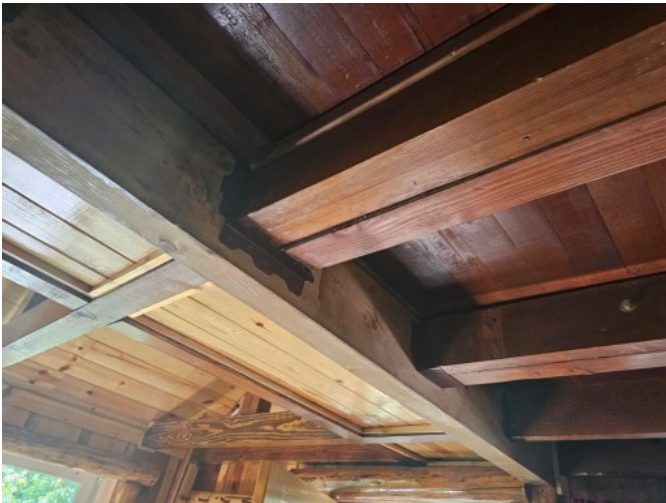
#### 6.2) Ceiling Conditions

The general condition of the ceilings appeared to be in serviceable condition at the time of the inspection.

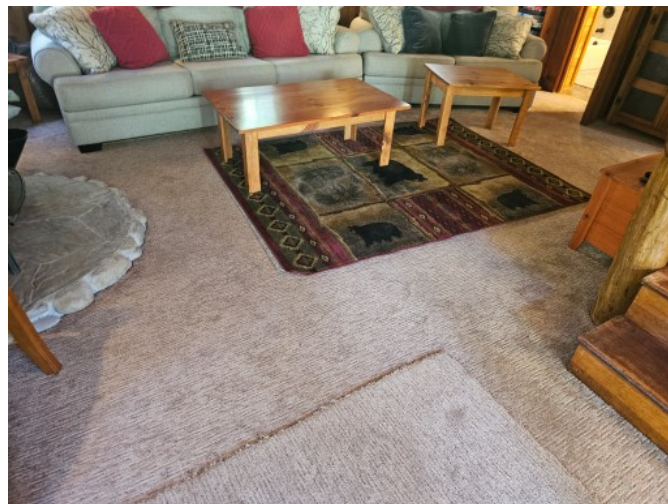
### 6.3) Floor Conditions

The carpets appear to be worn.

Minor floor sloping was observed at the time of inspection. From the visible and accessible areas, no immediate concern was observed. This may not, however, be an indication of future conditions.

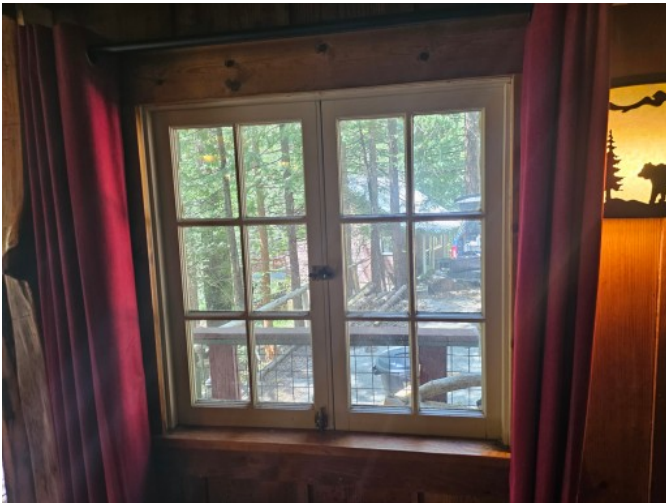
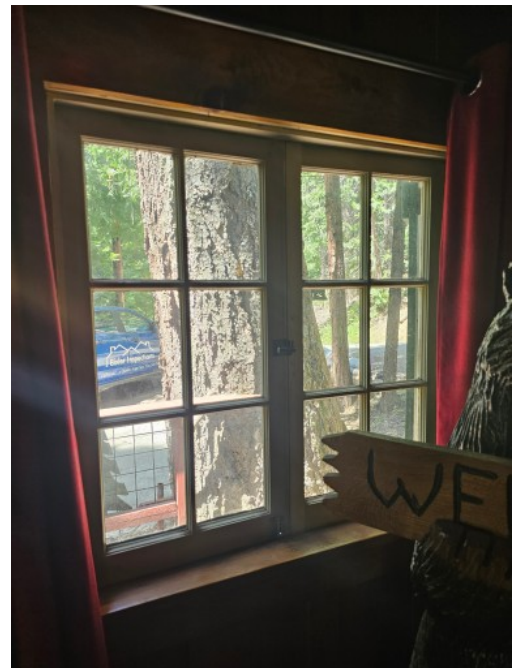
### 6.6) Interior Window Conditions

The sample of windows tested were operational at the time of the inspection.

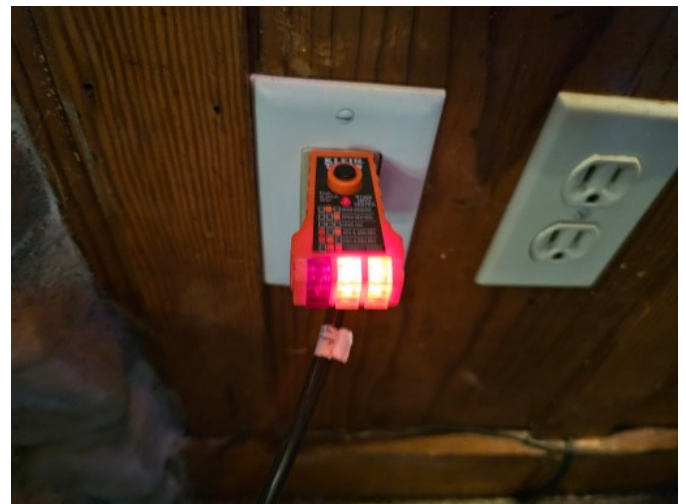
#### 6.8) Electrical Conditions

An outlet was not functional on the right side of fireplace. Recommend further evaluation and repairs by a licensed electrician prior to close.

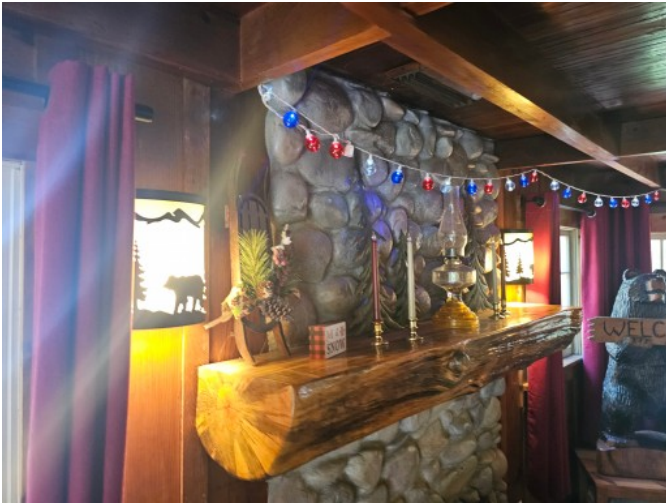
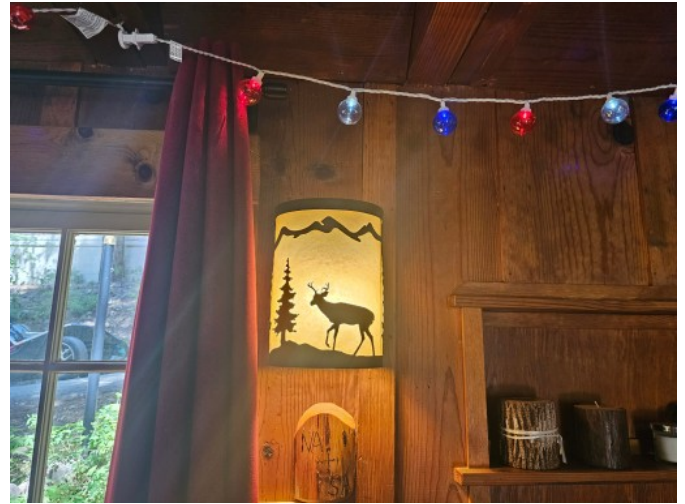
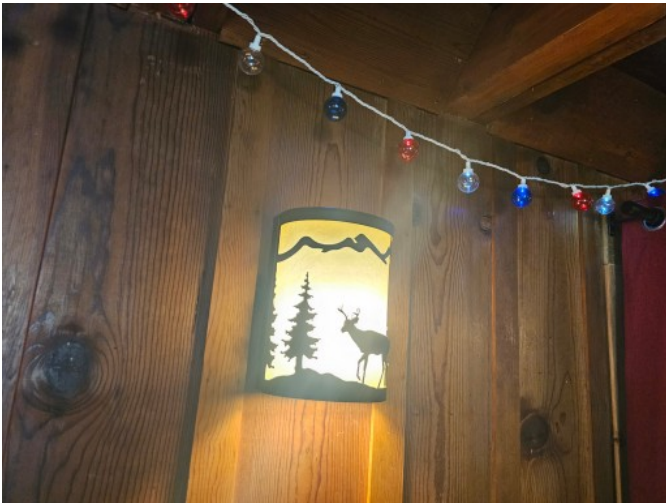
#### 6.9) Lighting Conditions

Appears Serviceable.

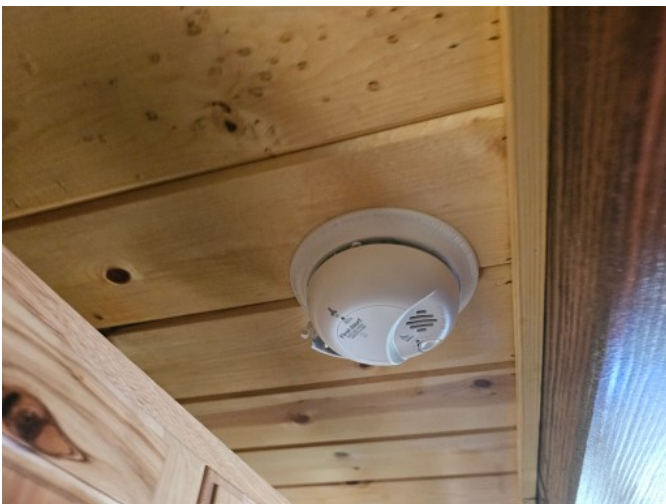
6.10) Smoke Detector Conditions

Appears Serviceable.

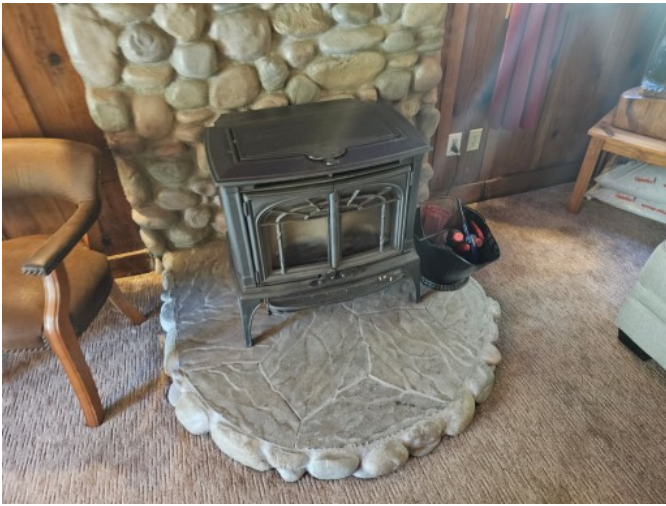
**6.11) Fireplace Conditions**

Recommend the pellet stove be serviced and cleaned prior to use.

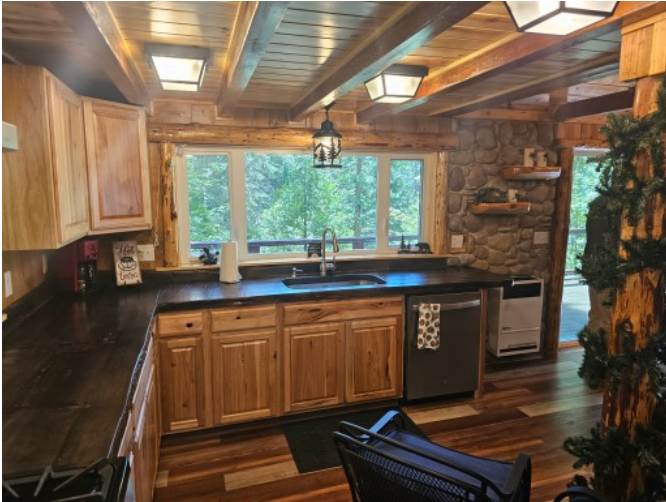
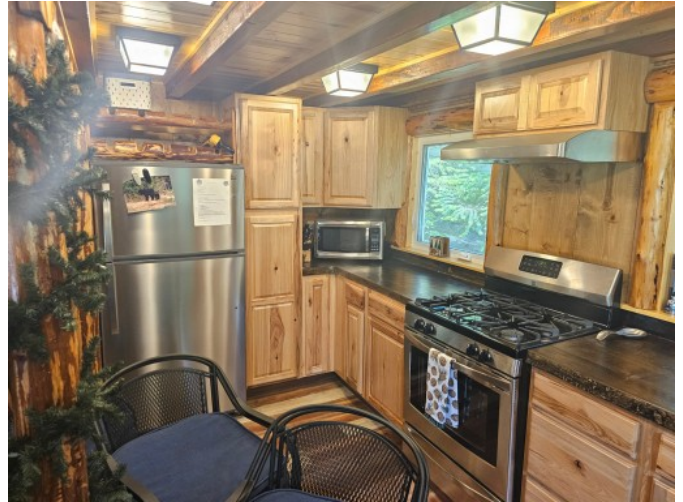
#### 7.1) Wall Conditions

The general condition of the walls appeared to be in serviceable condition at the time of the inspection.

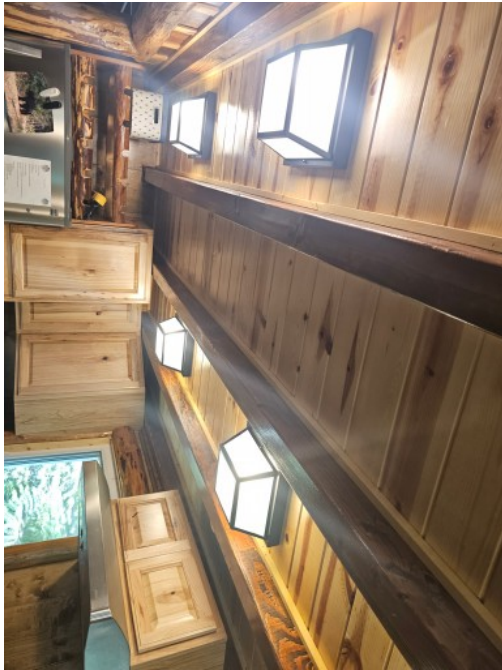
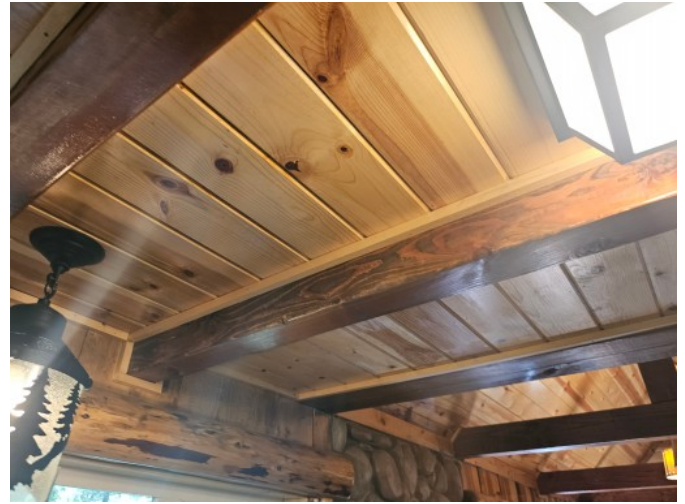
#### 7.2) Ceiling Conditions

The general condition of the ceilings appeared to be in serviceable condition at the time of the inspection.

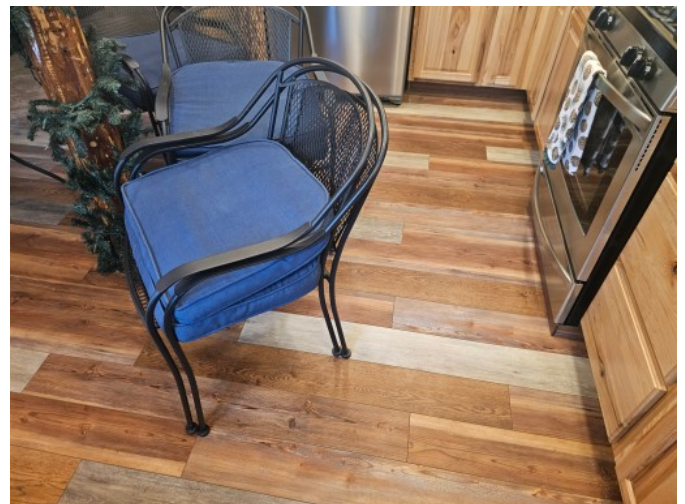
### 7.3) Floor Conditions

The general condition of the visible and accessible portions of the floors appeared to be in serviceable condition at the time of the inspection.

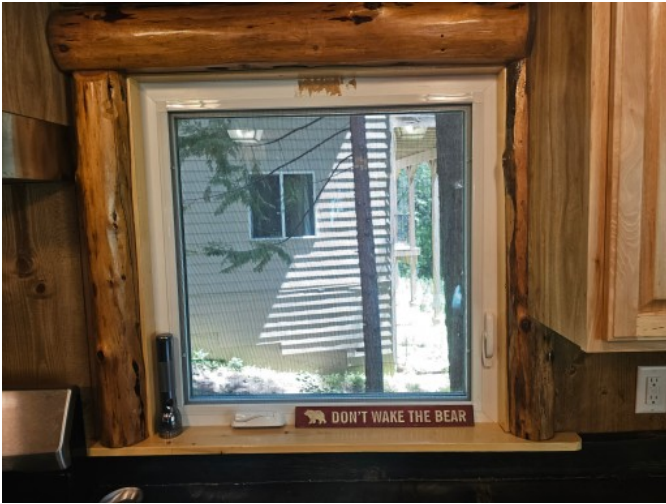
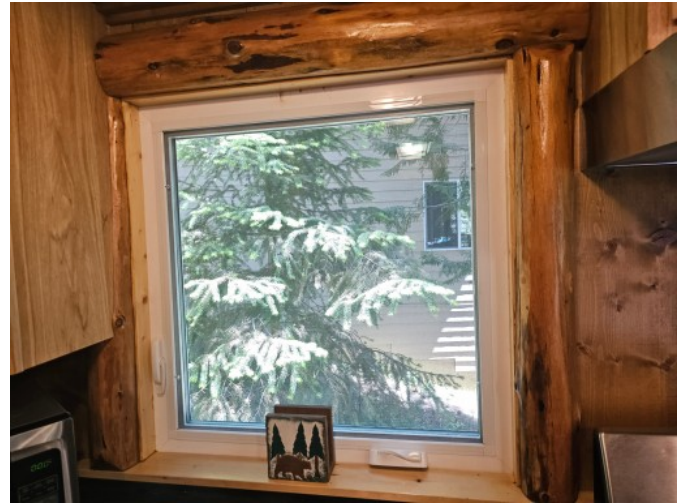
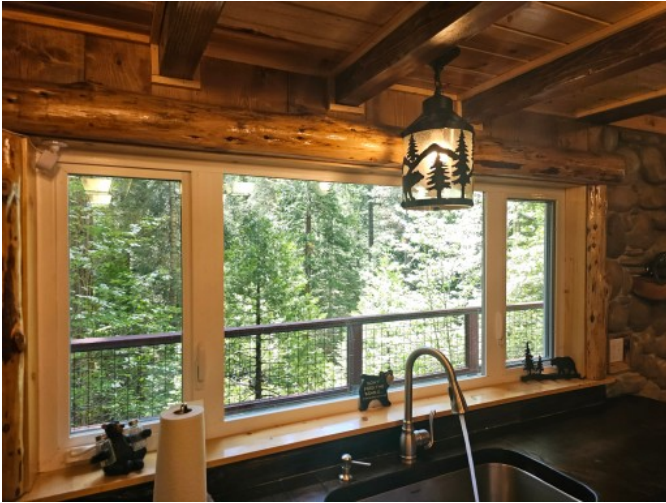
### 7.4) Kitchen Window Conditions

The sample of windows tested were operational at the time of the inspection.

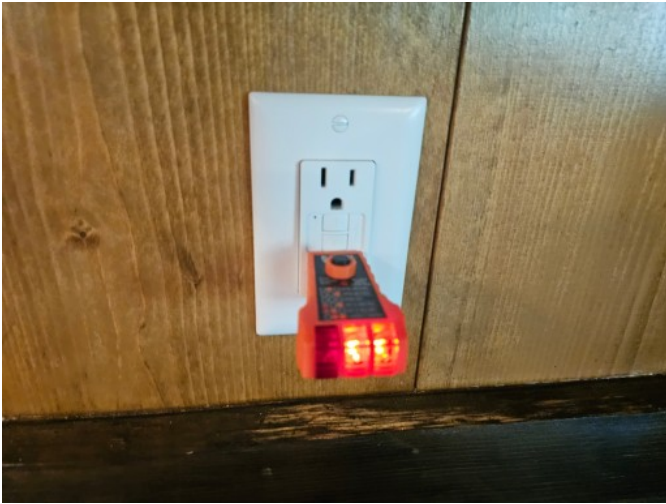
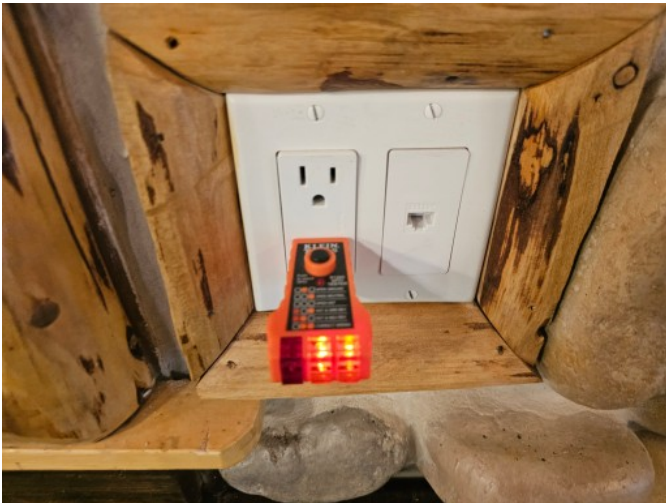
7.5) Electrical Conditions

Appears Serviceable.

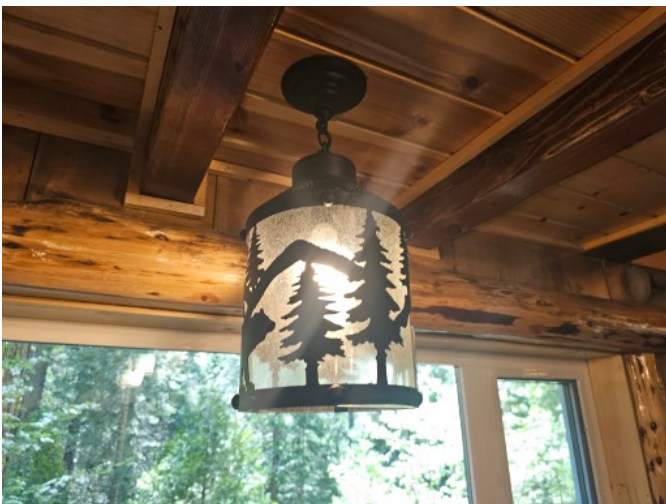
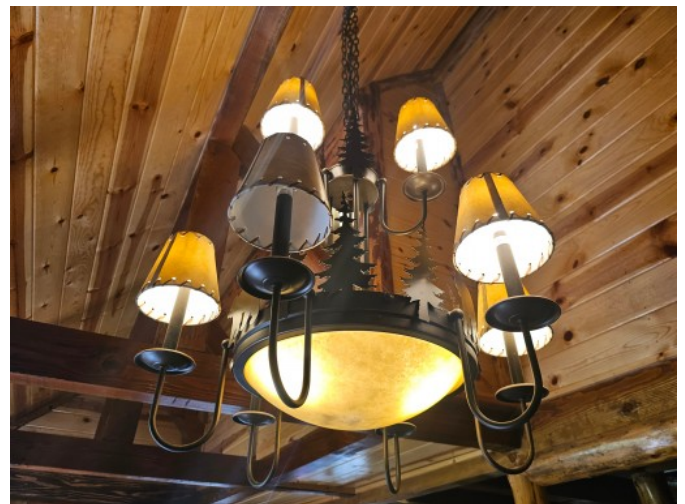
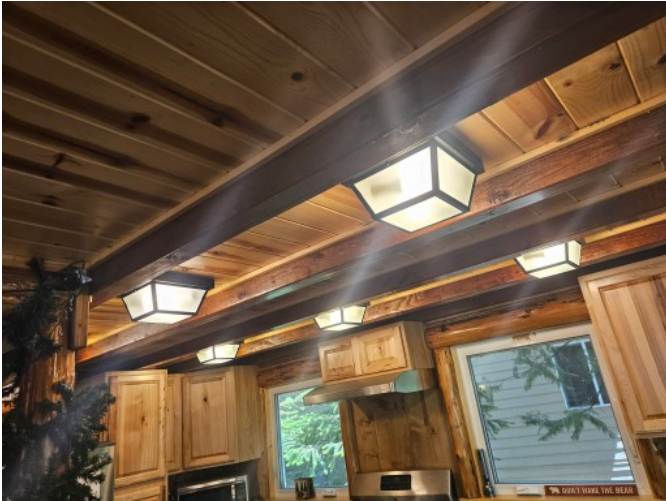
7.6) Lighting Conditions

Appears Serviceable.

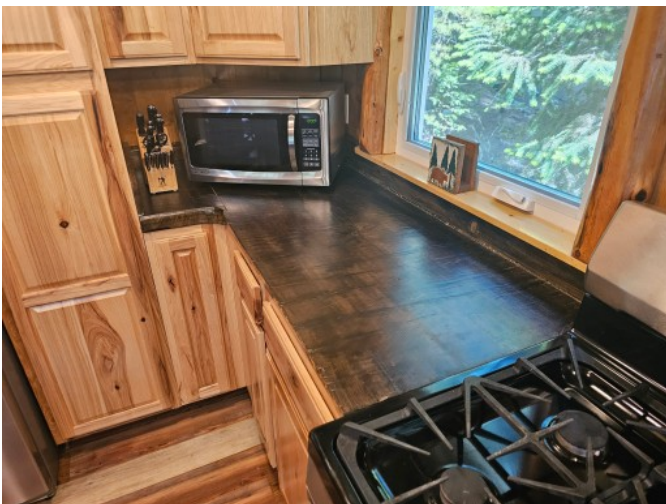
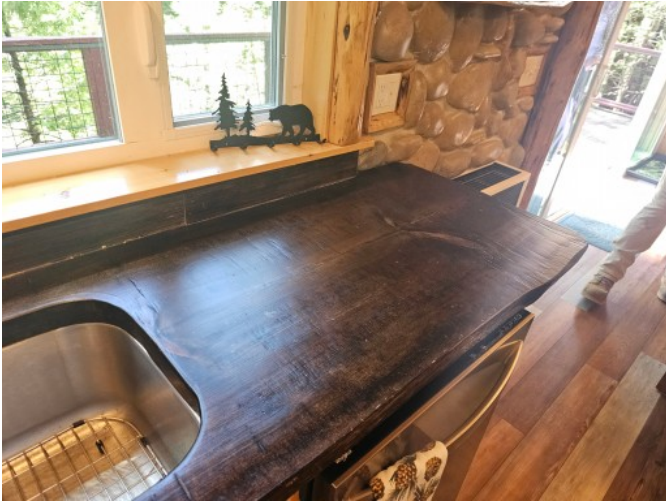
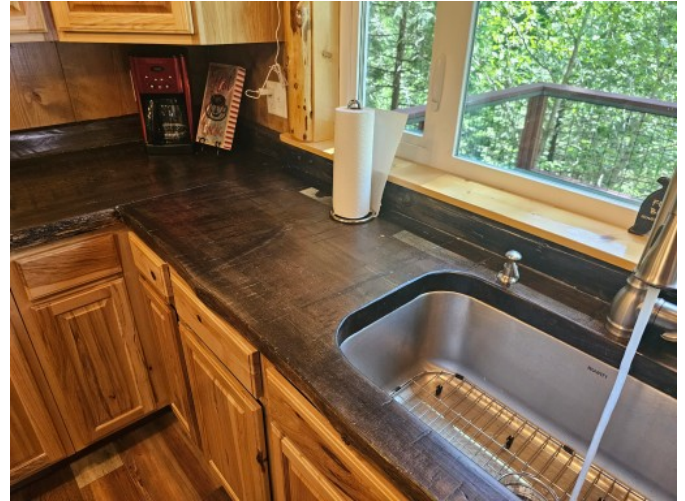
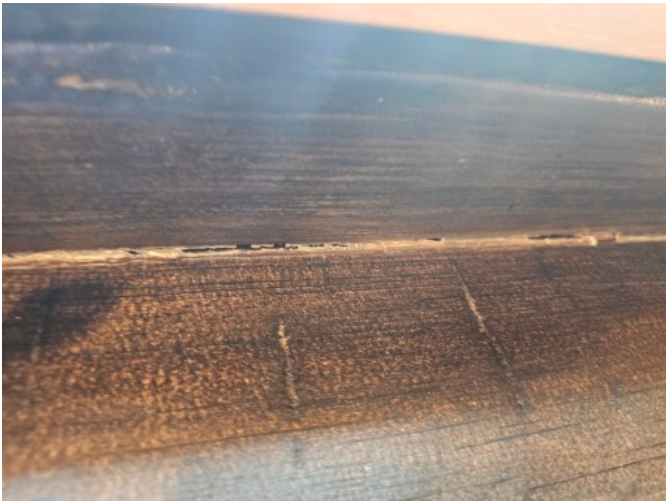
7.7) Counter Conditions

Minor caulking and/or sealing is needed around the backsplash and counter.

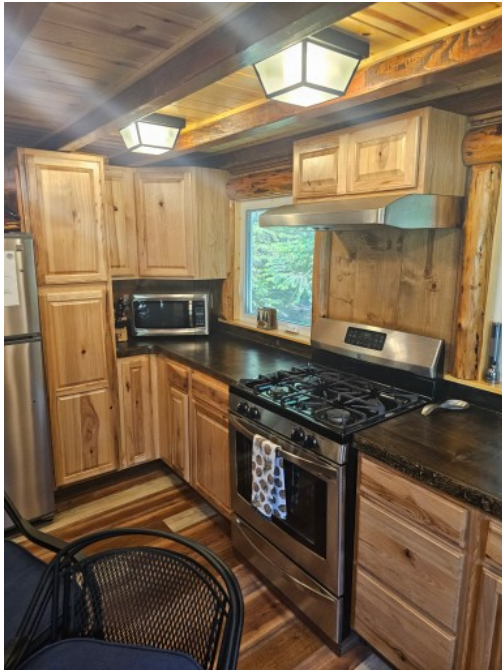
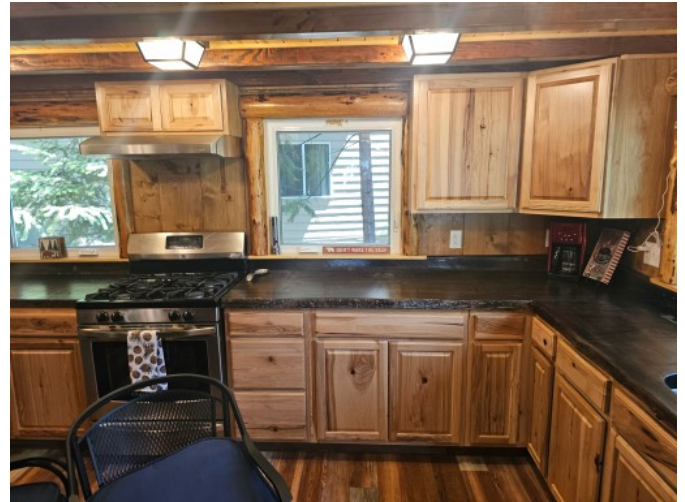
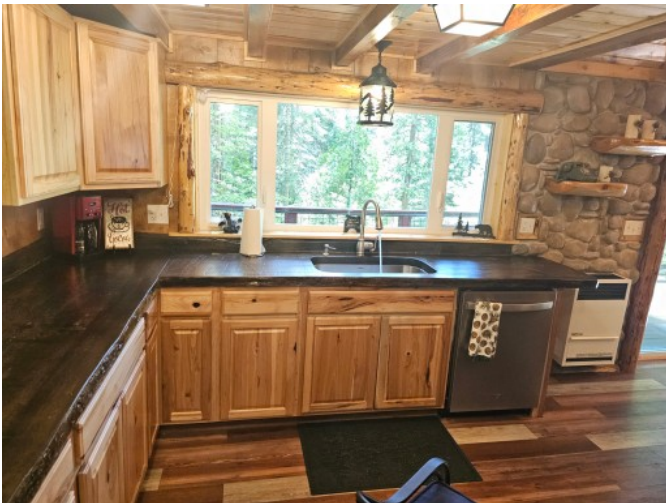
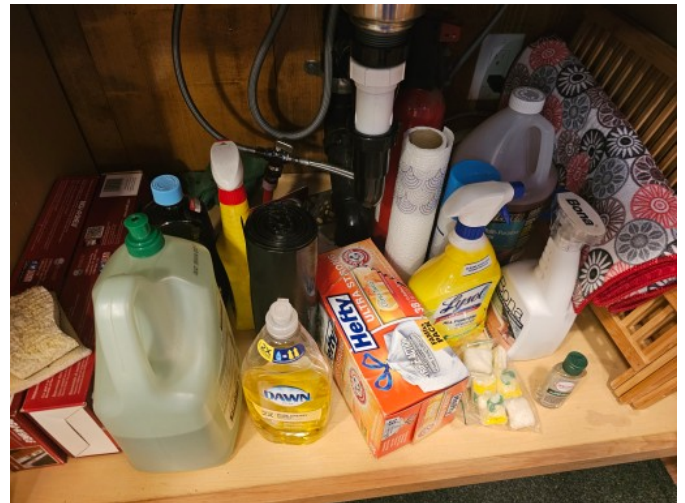
**7.8) Cabinet Conditions**

The kitchen cabinets appeared to be in serviceable condition at the time of inspection.
