# Inspection Report

J Bixler Inspections

25657 Long Barn Sugar Pine Rd  
Miwuk Village, CA

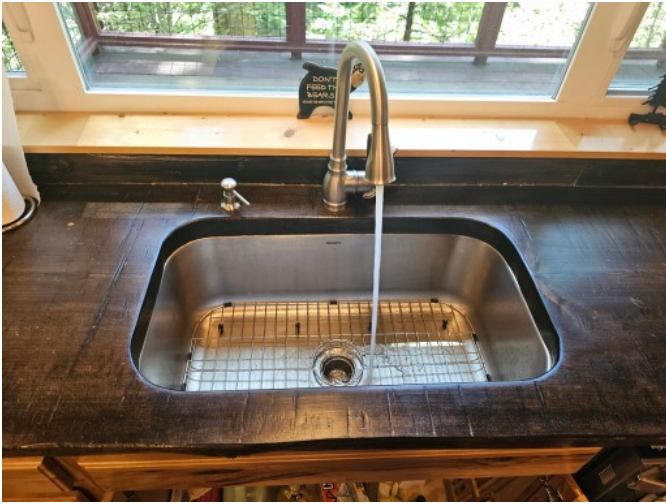
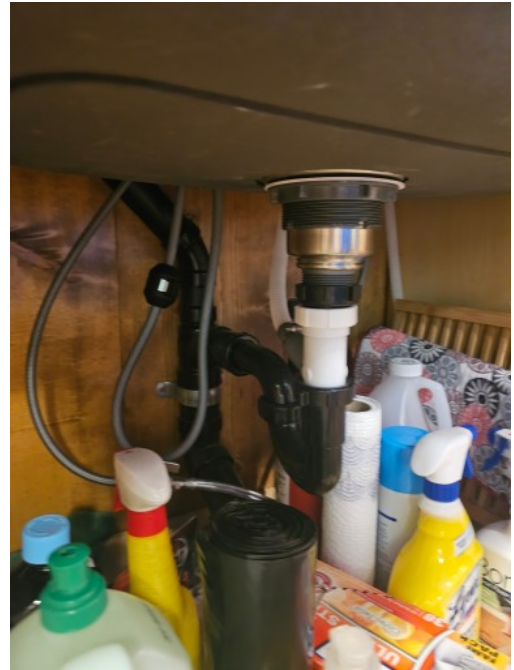
**7.9) Sink Plumbing Conditions**

The kitchen sink appeared to be in serviceable condition at the time of the inspection. The faucet appeared to be in serviceable condition at the time of the inspection. The visible areas of the plumbing under the kitchen sink appeared to be in serviceable condition at the time of the inspection.

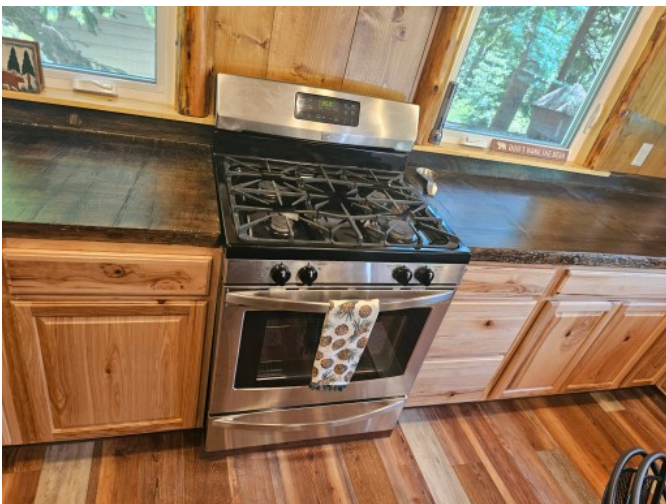
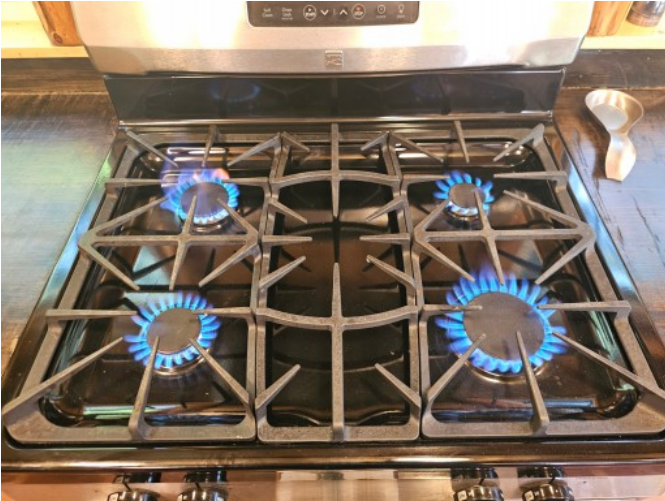
**7.10) Stove - Range Condition**

The stove did not have an anti-tip device. An anti-tip device should be installed for increased safety.

The oven was in operational condition at the time of the inspection. This does not however guarantee future conditions after the time of inspection.

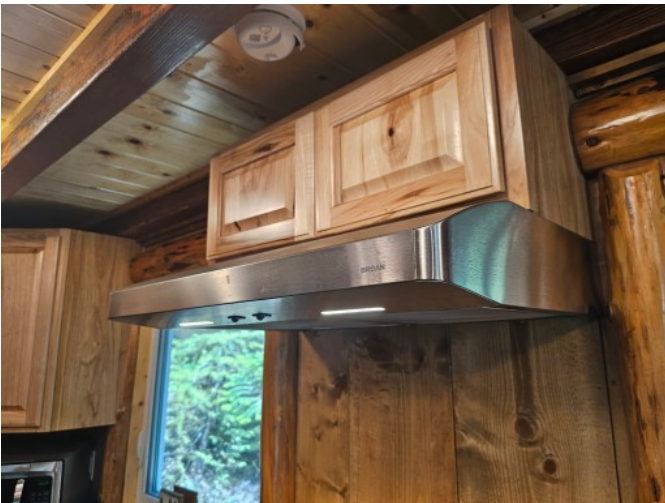
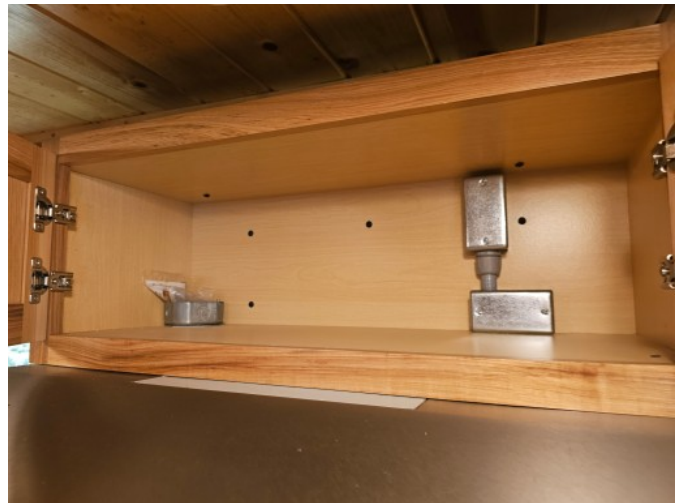
### 7.11) Hood Fan Conditions

The fan / hood and light were in operational condition at the time of the inspection.

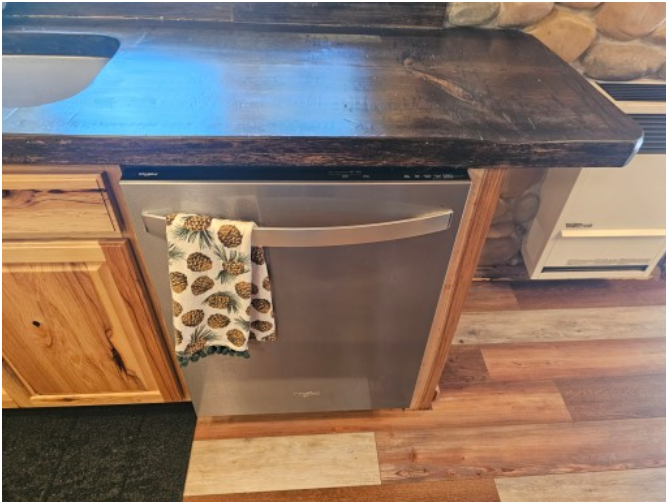
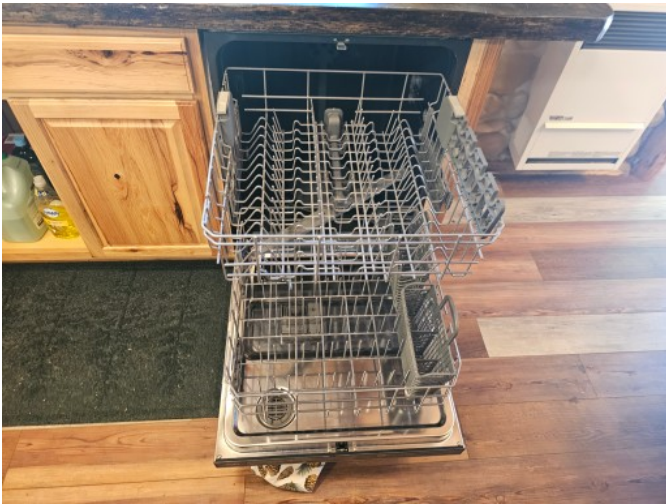
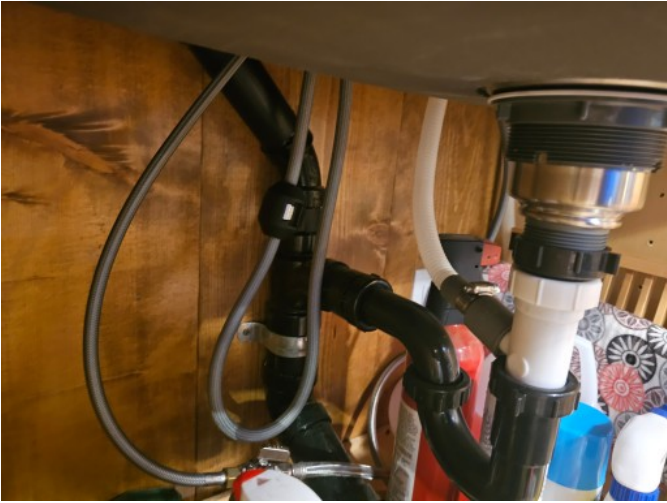
### 7.12) Dishwasher Conditions

There was no high loop or air gap for the dishwasher. Recommend having a high loop or air gap installed to prevent back-flow into the dishwasher.

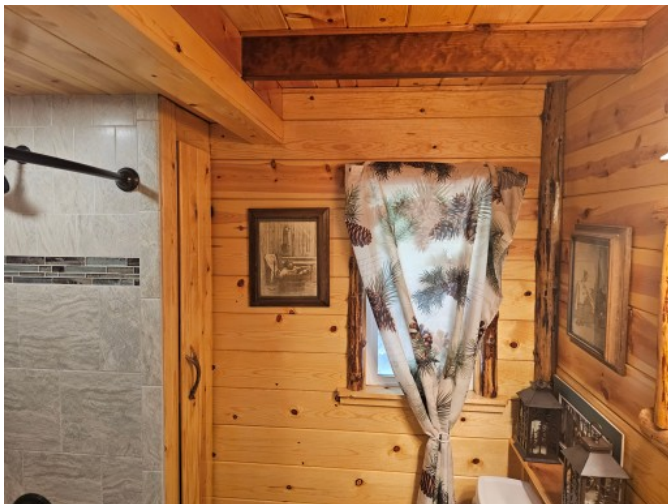
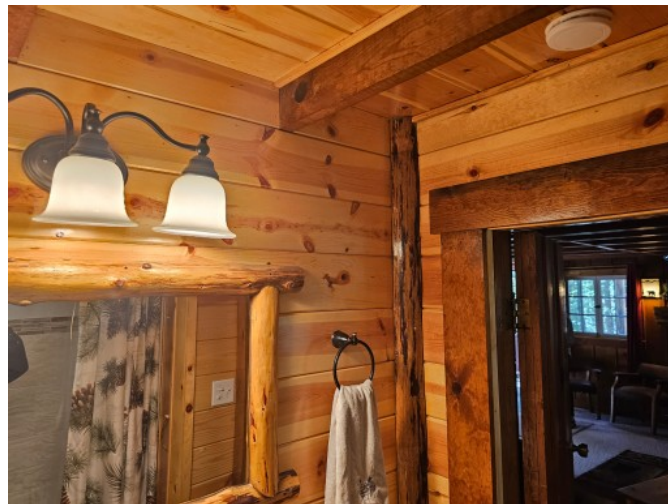
**8 Bath 1****Walls - Ceilings - Floors****8.1) Wall Conditions**

The general condition of the walls appeared to be in serviceable condition at the time of the inspection.

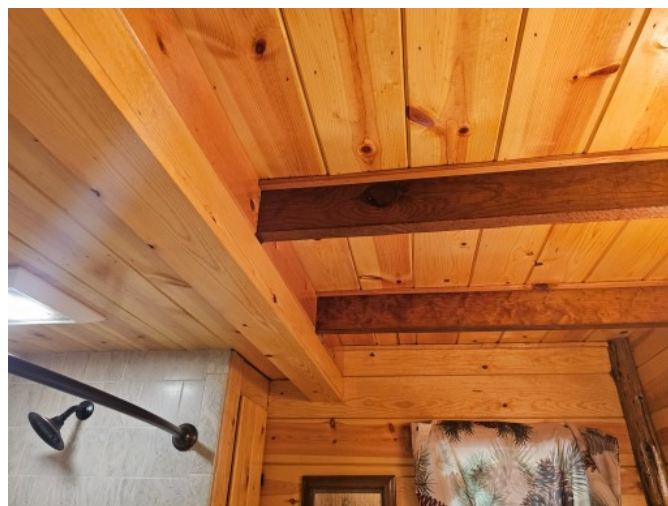
**8.2) Ceiling Conditions**

The general condition of the ceilings appeared to be in serviceable condition at the time of the inspection.

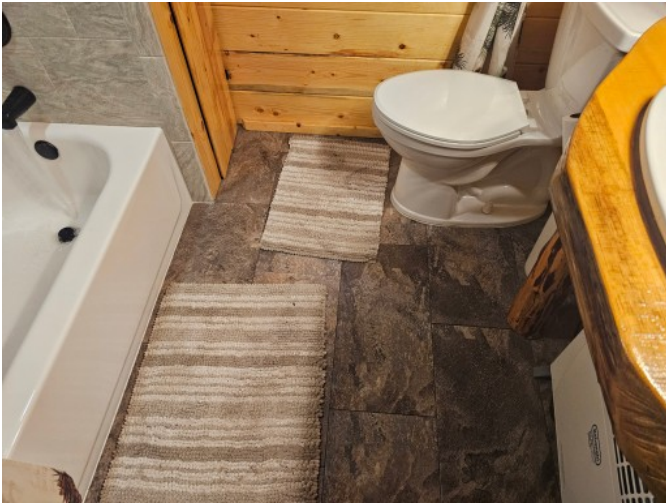
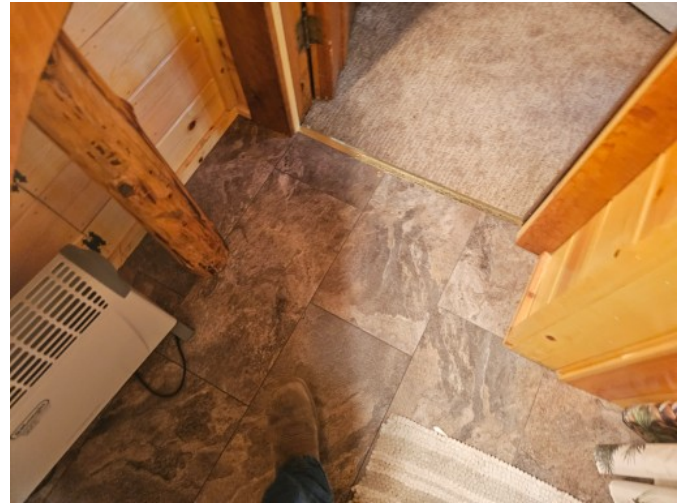
**8.3) Floor Conditions**

Minor floor sloping was observed at the time of inspection. From the visible and accessible areas,

no immediate concern was observed. This may not, however, be an indication of future conditions.

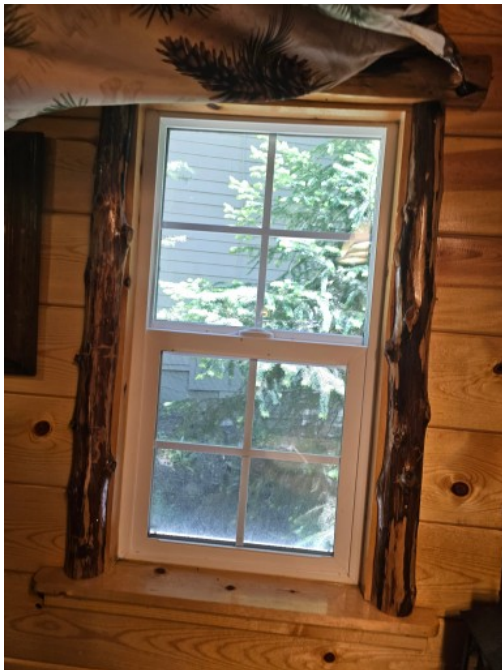
### 8.4) Bathroom Window Conditions

The sample of windows tested were operational at the time of the inspection.

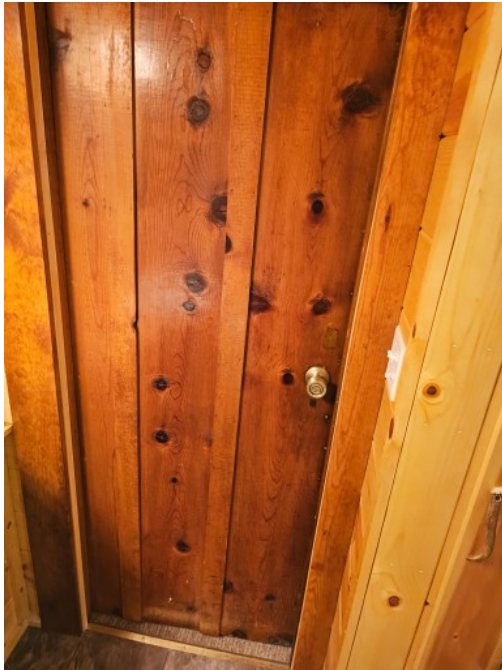
### 8.5) Bathroom Door Conditions

The door sticks at the doorframe. Repair and/or adjustments are recommended.

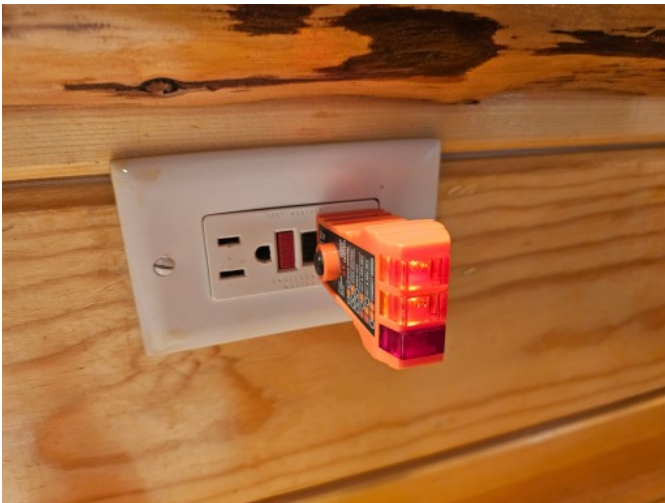
8.6) Electrical Conditions

Appears Serviceable.

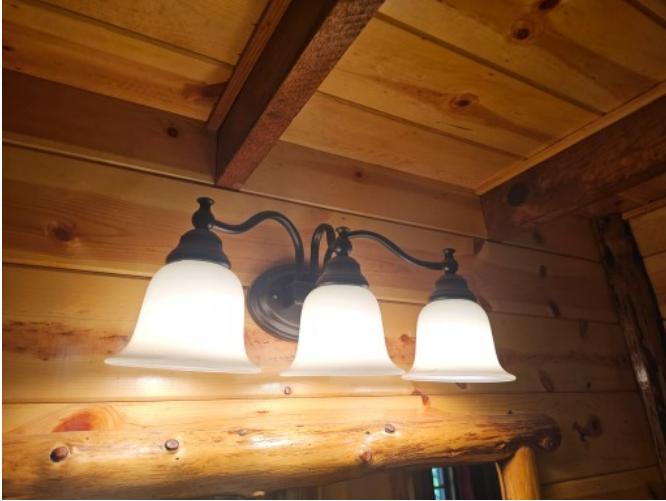
8.7) Lighting Conditions

Appears Serviceable.

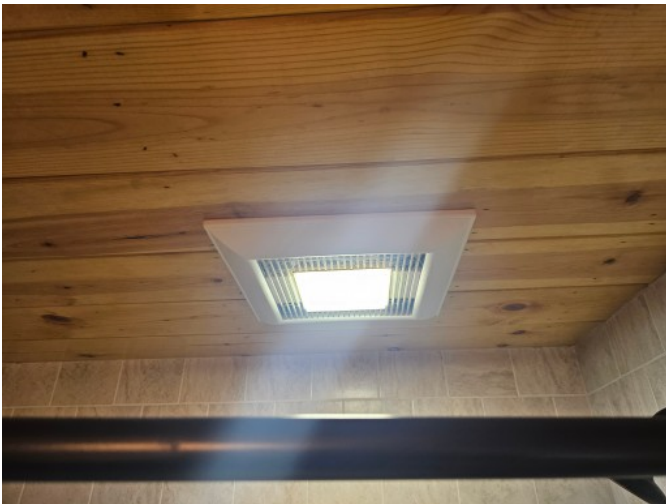
**8.8) Vent Fan Conditions**

Appears Serviceable.

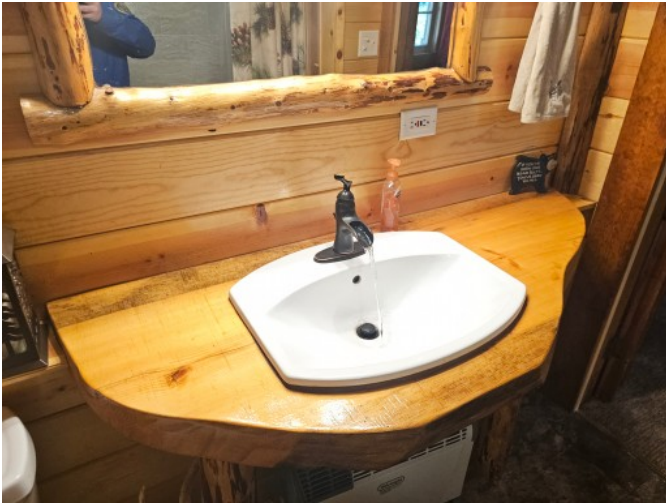
**8.9) Counter - Cabinet Conditions**

Appears Serviceable.

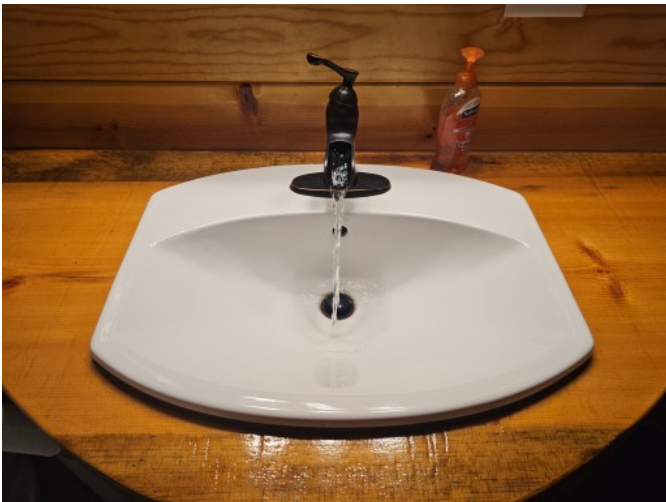
### 8.10) Sink Conditions

The sink drain line was a flex material. This type of material has a higher risk of being clogged or leaking. Recommend replacing with a different type of drain line.

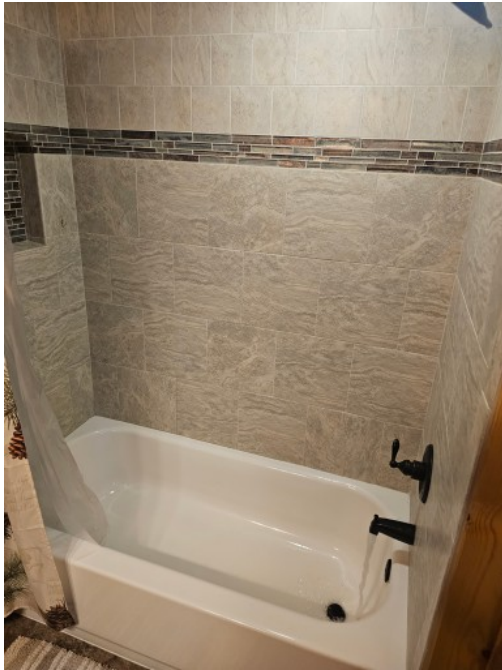
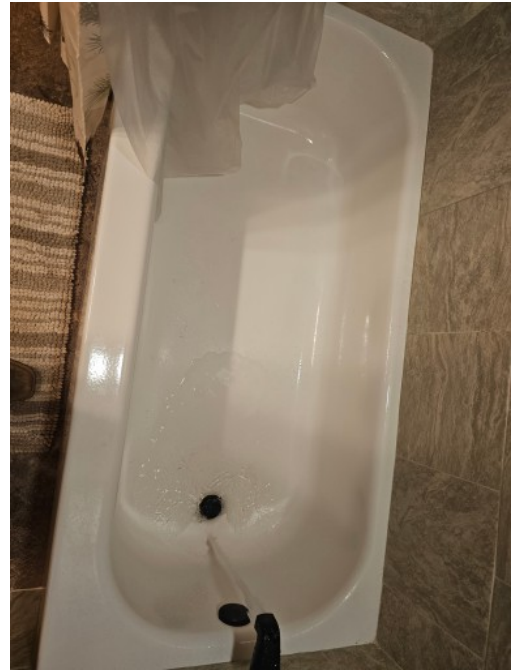
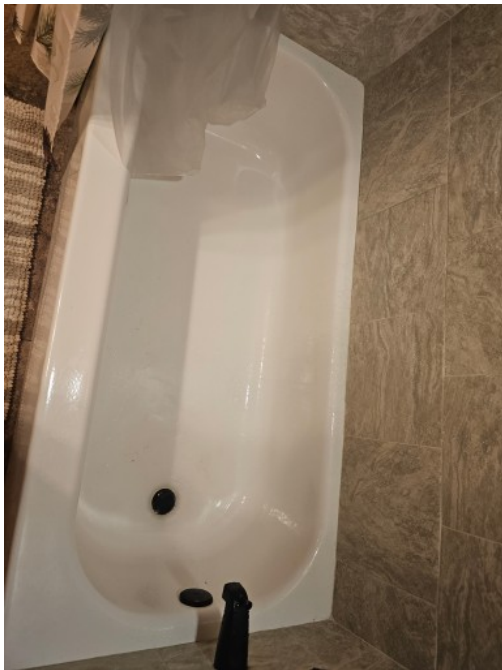
### 8.11) Shower - Tub Conditions

The bathtub, faucet, and drains appeared to be in serviceable condition.

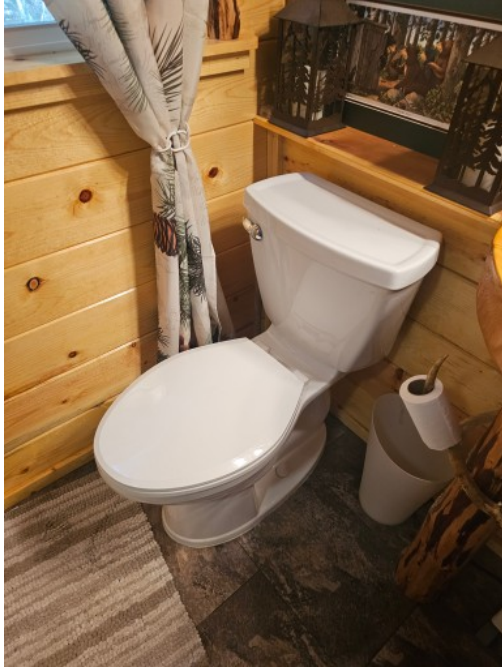
**8.12) Toilet Conditions**

The toilet appeared to be in serviceable condition at the time of inspection in bath.

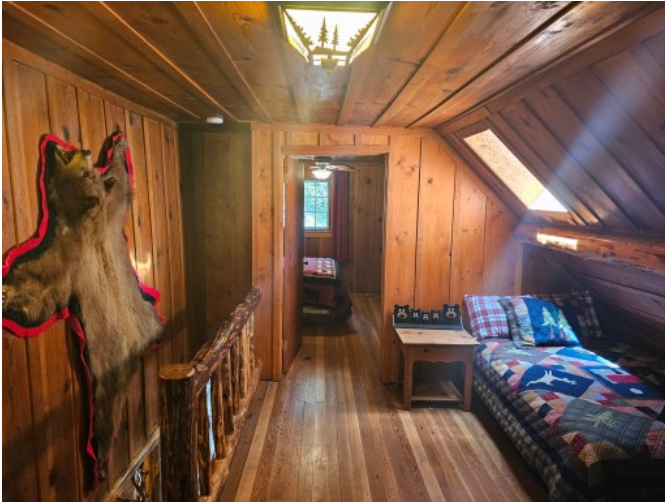
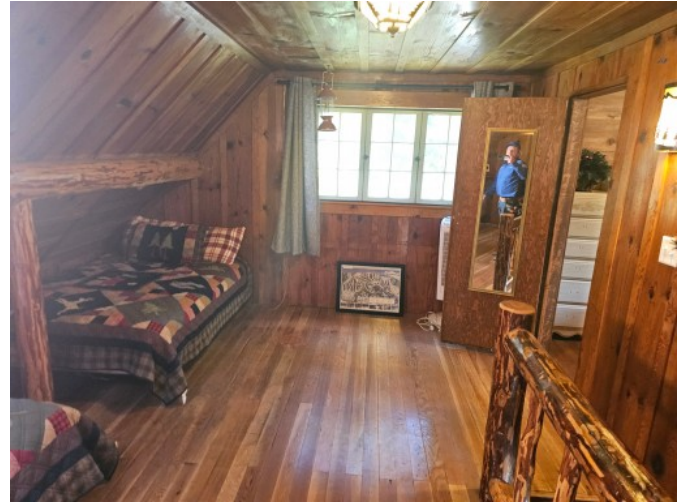
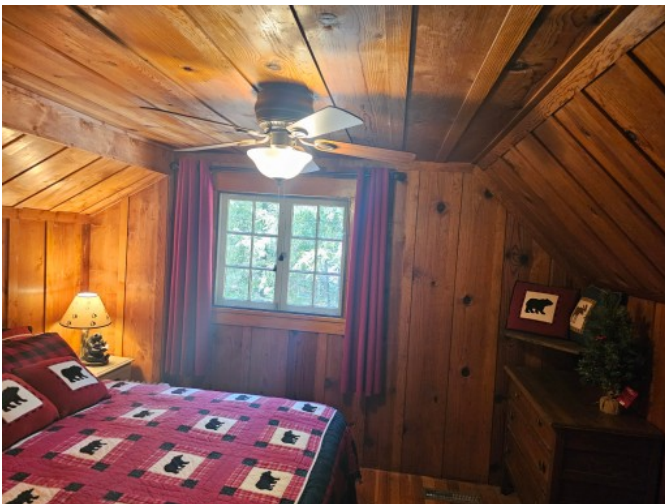
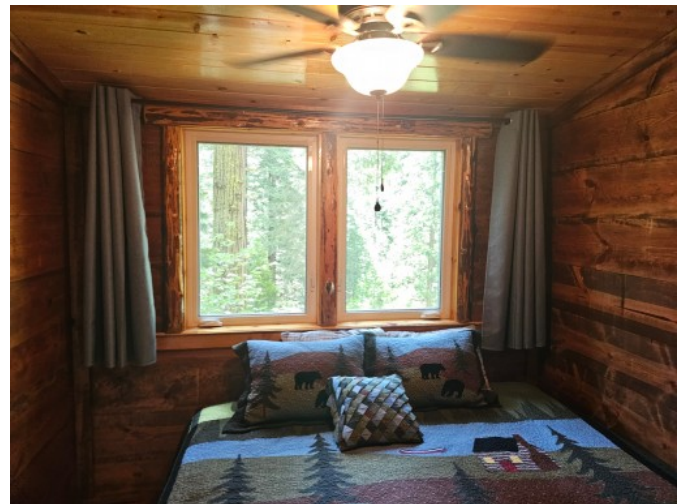
## 9.1) Wall Conditions

The general condition of the walls appeared to be in serviceable condition at the time of the inspection.

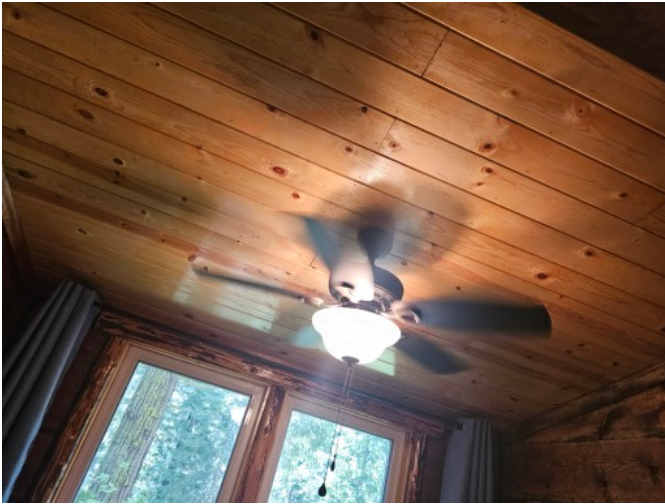
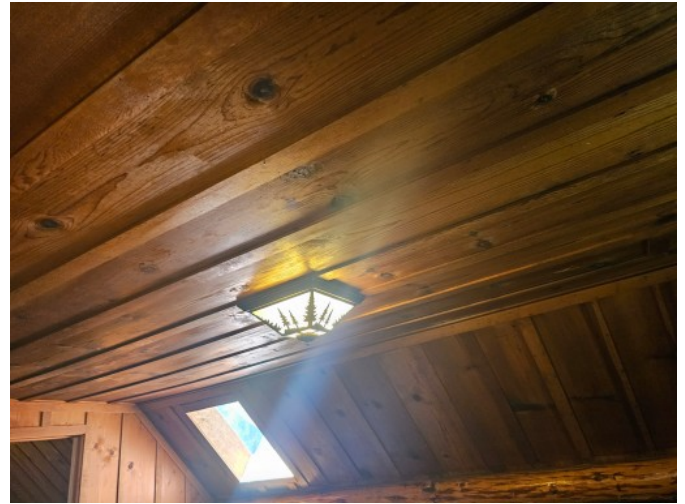
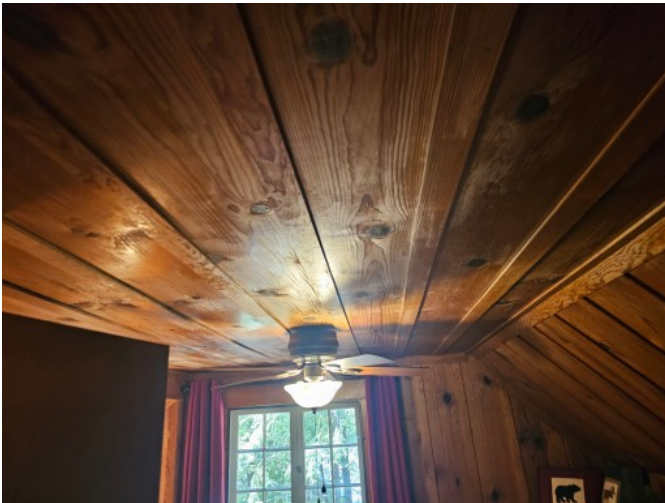
## 9.2) Ceiling Conditions

The general condition of the ceilings appeared to be in serviceable condition at the time of the inspection.

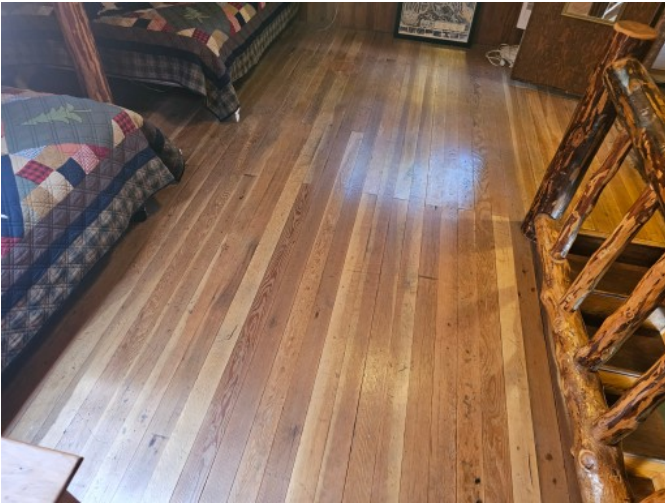
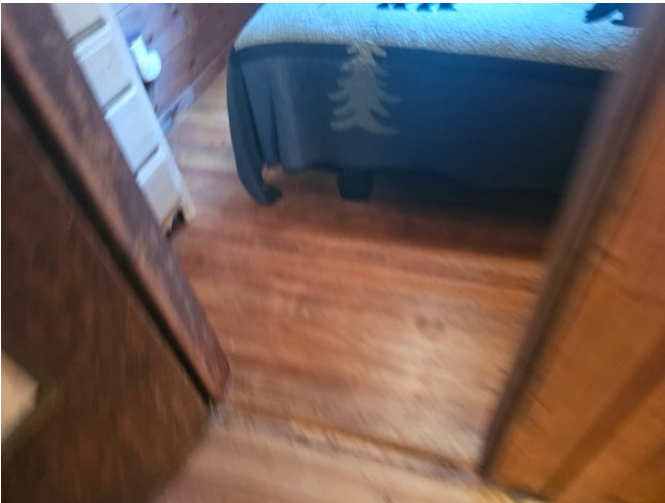
### 9.3) Floor Conditions

The floors squeaked at the time of inspection. Recommend securing floorboards and/or repair as needed.

Minor floor sloping was observed at the time of inspection. From the visible and accessible areas, no immediate concern was observed. This may not, however, be an indication of future conditions.

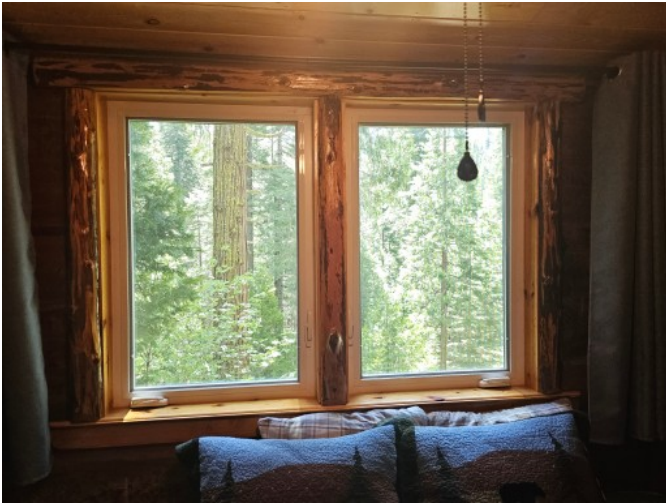
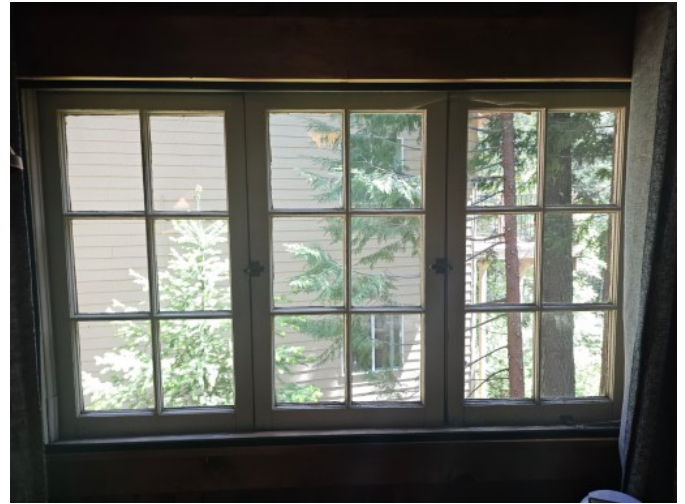
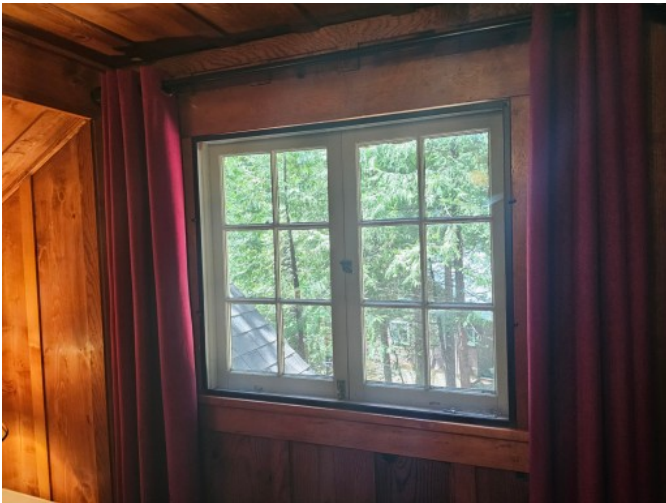
### 9.4) Interior Window Conditions

The sample of windows tested were operational at the time of the inspection.

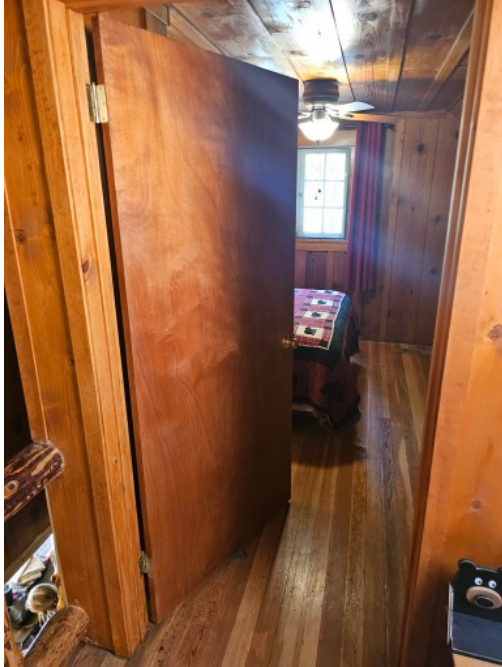
**9.5) Interior Door Conditions**

The interior doors appeared to be in serviceable condition at the time of the inspection.

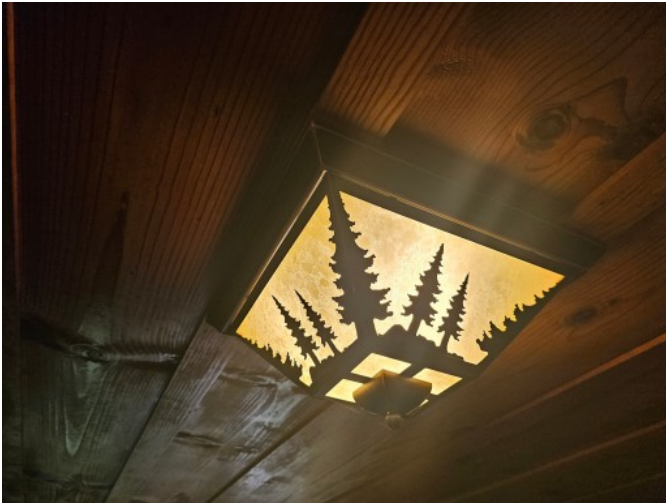
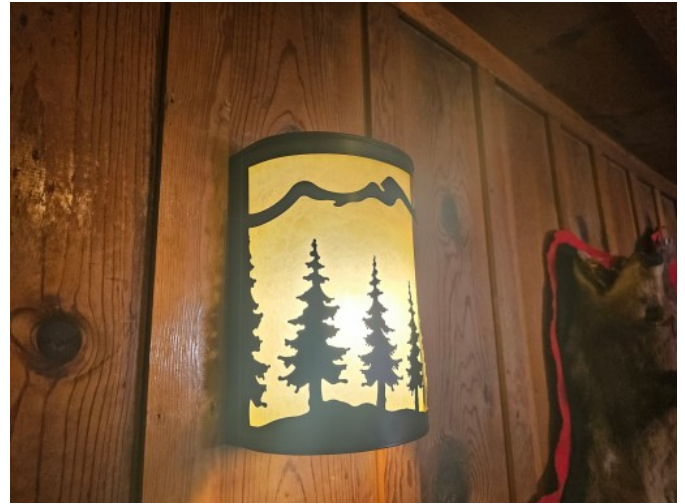
9.7) Lighting Conditions

Appears Serviceable.

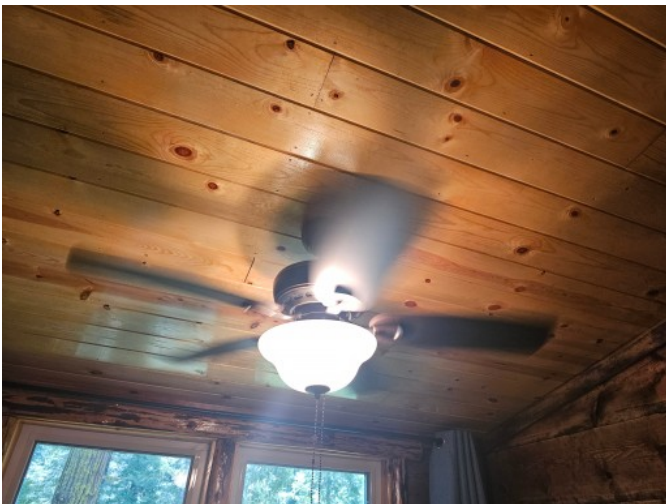
**9.8) Ceiling Fan Conditions**

The ceiling fan(s) wobbled, vibrated or made some noise when operated. Mounting hardware of this or any other fan was not visible or readily accessible at the time of inspection. Recommend repair as needed.

One of the ceiling fans fans did not operate.

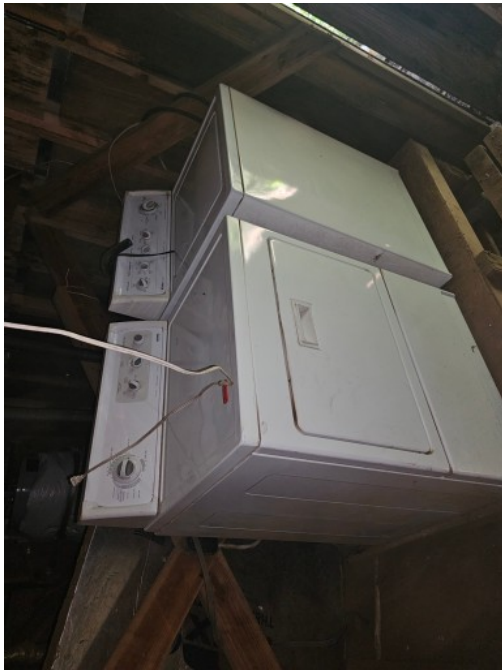
10.1) Laundry Room Conditions

Recommend reconnecting dry vent and running to the exterior of home.

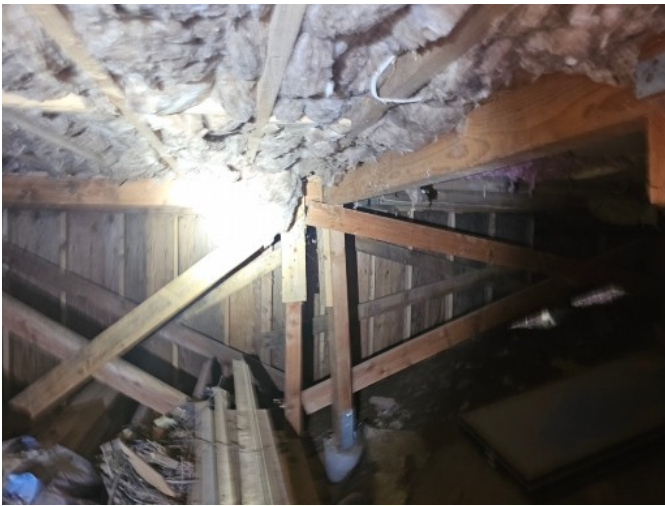
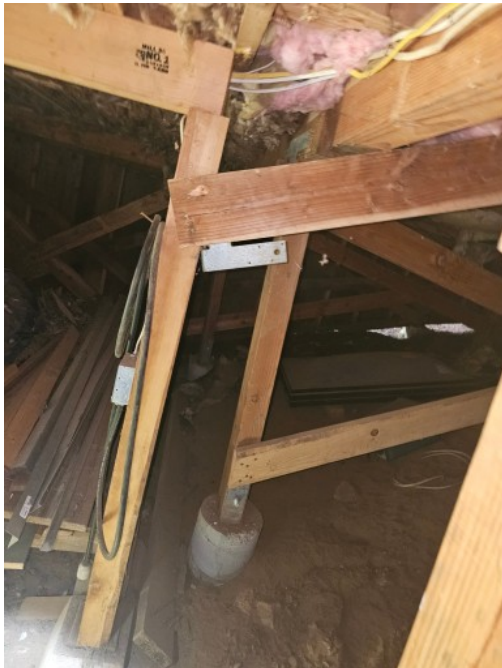
#### 11.1) Foundation Conditions

Repair work was noted at the foundation.

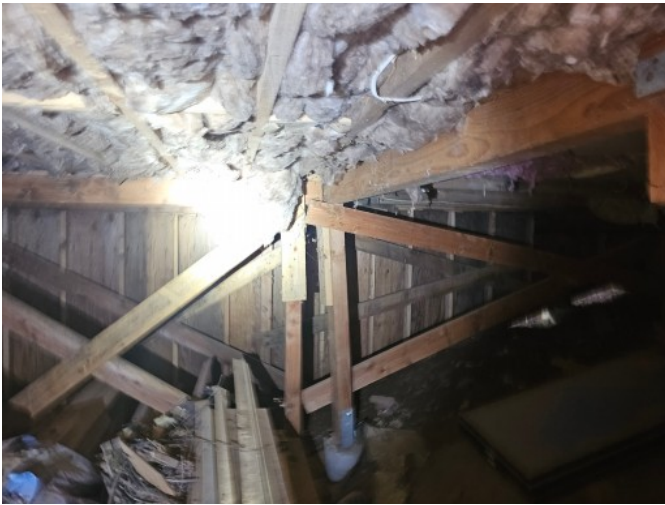
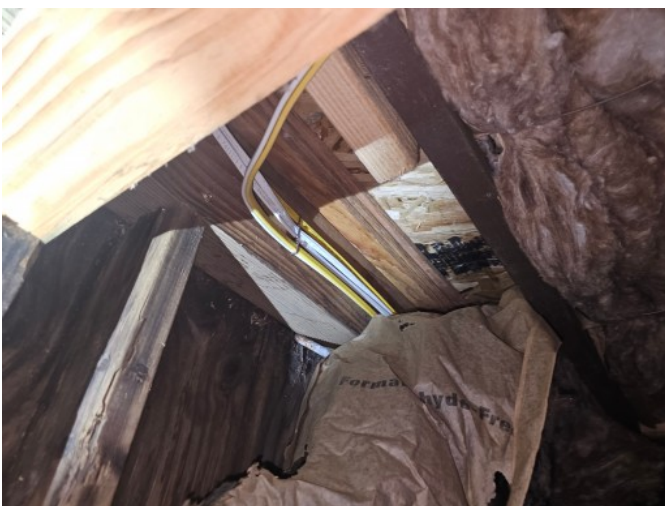
11.2) Flooring Support Conditions

Some of the flooring structure had been resupported and repaired.
