**Inspection Report**  
John Miraglia

**Schultz Property  
Inspection**

**Address:** 6025 Arroyo Road, #8, Palm  
Springs, CA 92264

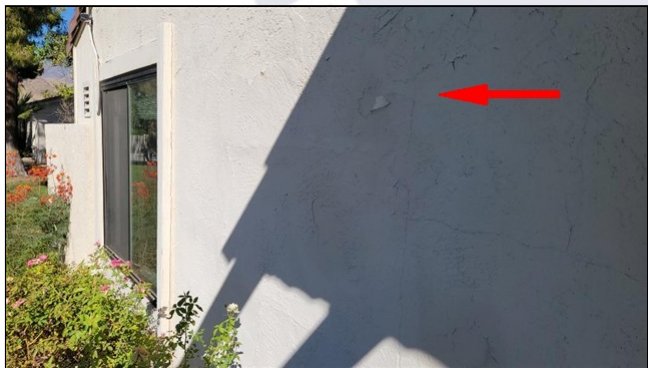
1.0 Item 1(Picture)

🔧 (1) The Stucco coating and wood trim at the exterior in areas is peeling paint or failing. This is a maintenance issue. A qualified person should repair or replace as needed.

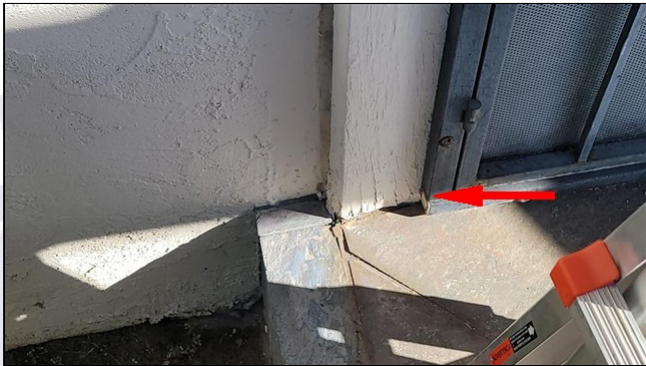
1.0 Item 5(Picture)

🔧 (2) The Wood trim at the exterior in areas is in contact with ground. Ground clearances are recommended to prevent deterioration and for a pest control company to monitor for wood eating insects. Recommend further evaluation by licensed structural termite company.

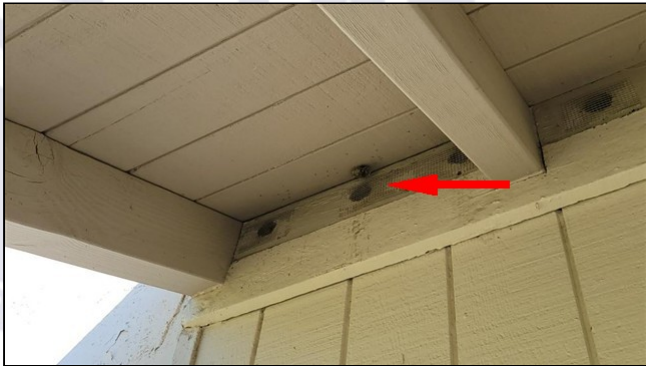
1.0 Item 6(Picture)

🔧 (3) Insect nests noted at various areas of exterior. Recommend proper specialist evaluate further.

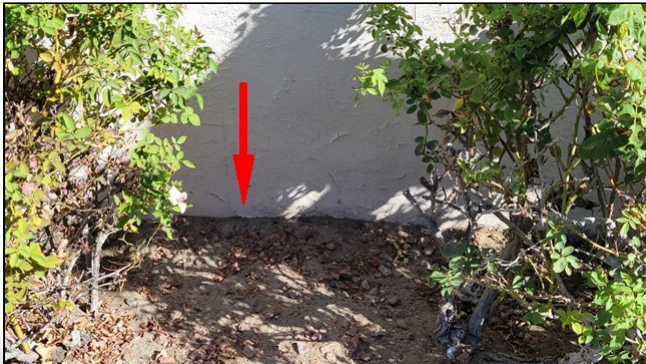
1.0 Item 9(Picture)

🔧 (5) Stucco coating at "All" of exterior does not have a "weep screed" installed and does not allow drainage for the wall cavity. This may not have been required at time of construction. We are unable to determine if moisture intrusion did or still may occur. If no corrections are made, it is recommended to remove any irrigation near exterior walls and provide drainage away from structure to help avoid moisture intrusion into walls. This is no guarantee that you will or do not presently have moisture intrusion problems. If this is a concern for the buyer, we recommend further evaluation by proper licensed specialist.

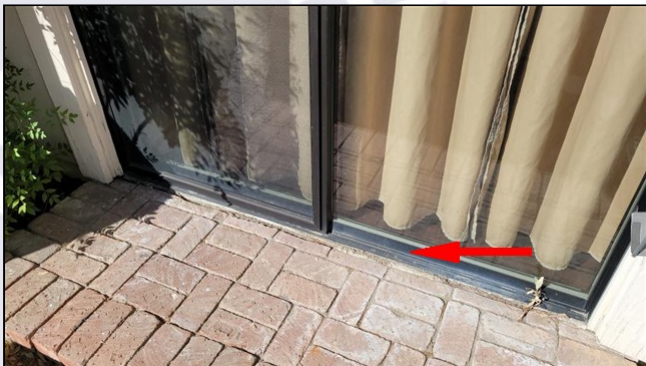
1.1 Item 1(Picture)

🔧 (1) Sliding glass door(s) at right side (facing front) are not installed above grade. This may allow moisture intrusion and debris entry. I recommend correct as necessary.

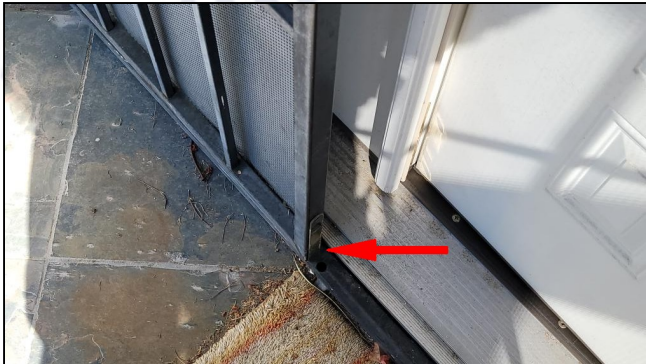
1.1 Item 2(Picture)

🔧 (2) The security door at the main entry door does not lock at bottom. An adjustment/repair is needed. I recommend correct as necessary.

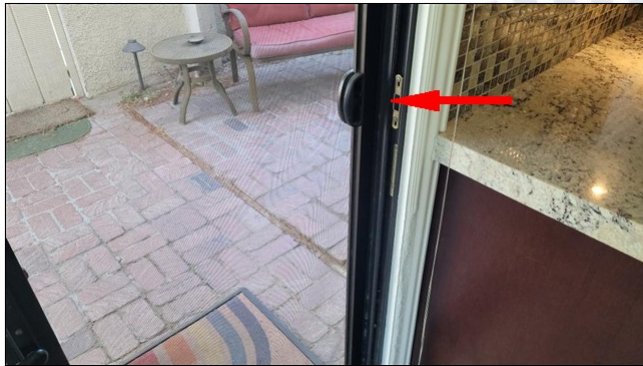
1.1 Item 4(Picture)

🔧 (4) Sliding screen for glass door unit (s) at all locations have loose hardware and do not latch properly. This is a maintenance issue and is for your information. I recommend correct as necessary.

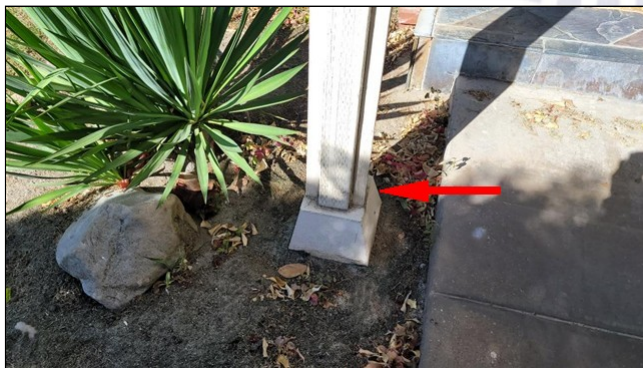
1.3 Item 1(Picture)

🔧 (1) Earth to wood post contact noted at front and side of home. Recommend structural termite company evaluate further for deterioration.

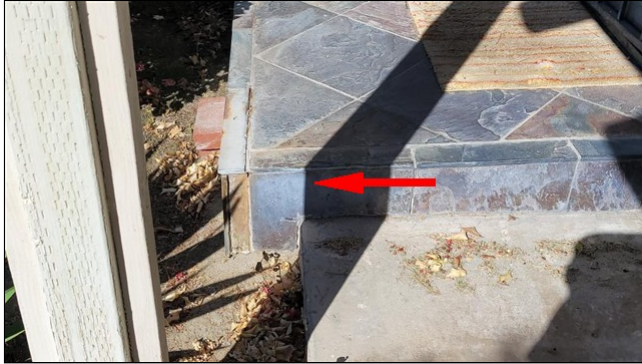
1.3 Item 3(Picture)

🔧 (2) The tile patio at the front of home has a number of loose (hollow) and damaged tiles. A repair or replacement is needed. A qualified contractor should inspect further and correct as needed.

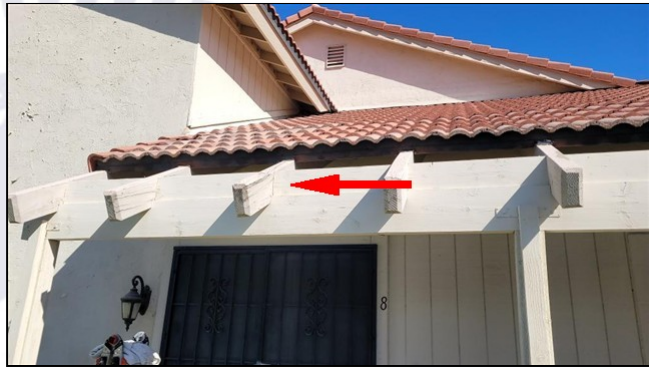
1.3 Item 5(Picture)

🔧 (3) The patio rafters on the front entry at the front of home shows paint failing or peeling and are deteriorated. Further deterioration may occur if not repaired. A qualified person should repair or replace as needed.

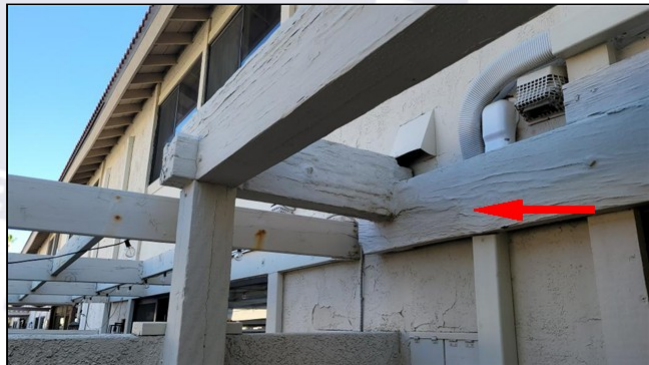
1.3 Item 6(Picture)

🔧 (4) The patio boards on the covered patio at the left side (facing front) are weathered and deteriorated. Repairs are needed. A qualified contractor should inspect further and correct as needed.

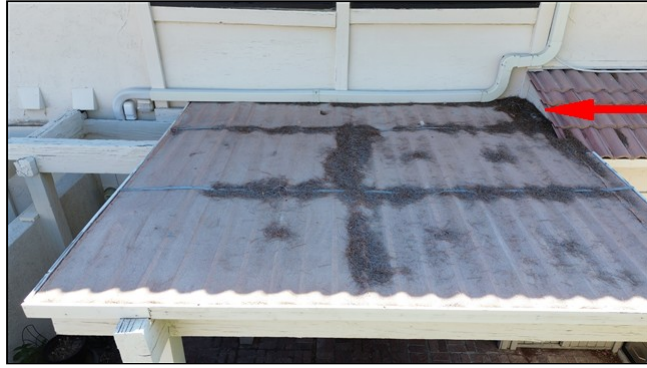
1.3 Item 7(Picture)

🔧 (5) The Patio roof cover has excessive debris at the left side (facing front). These areas will need periodical maintenance and repair. I recommend correct as necessary.

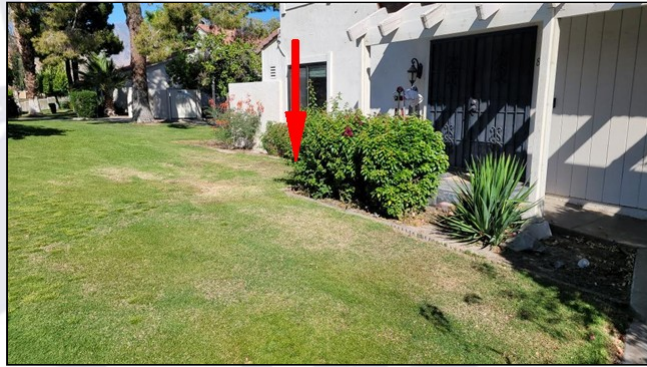
1.4 Item 1(Picture)

🔧 The landscape at the front of home may require a trench or drain if water stands or puddles after heavy rain. I am unable to determine due to no rain during inspection period. Recommend correct as necessary.

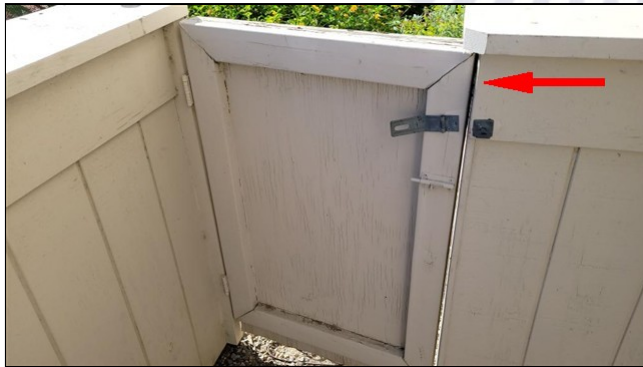
1.6 Item 1(Picture)

🔧 Gate(s) rubs at jamb when closing at right side of home (facing front). I recommend repair as needed.

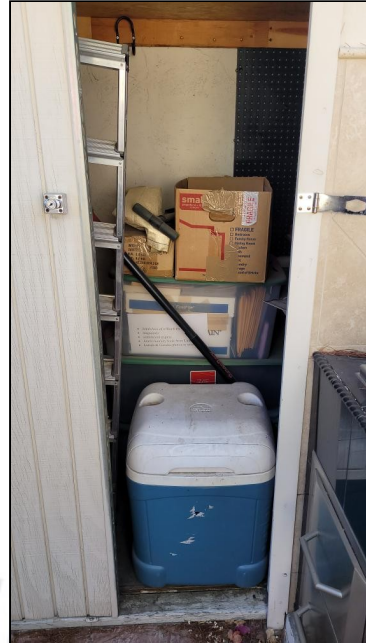
1.7 Item 1(Picture)

🔧 I could not inspect the storage building due to items blocking access. I only inspected the main structure. Deficiencies may exist with these structures or building (s). Our company makes no representation to the condition of these structures or building (s).

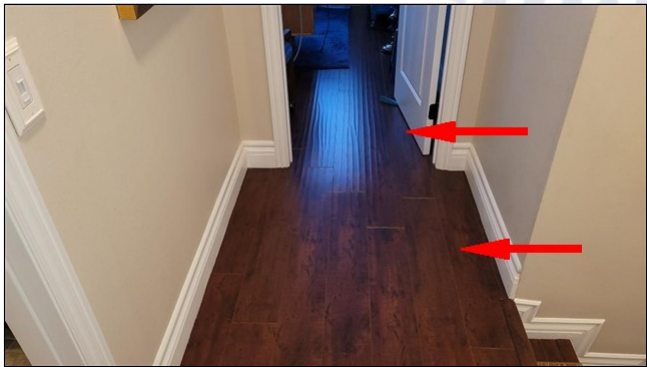
2.3 Item 1(Picture)

Sub-flooring has a number of low/weak spots under the upstairs hallway and Bedrooms. Repairs are needed. A qualified licensed contractor should inspect further and repair as needed.

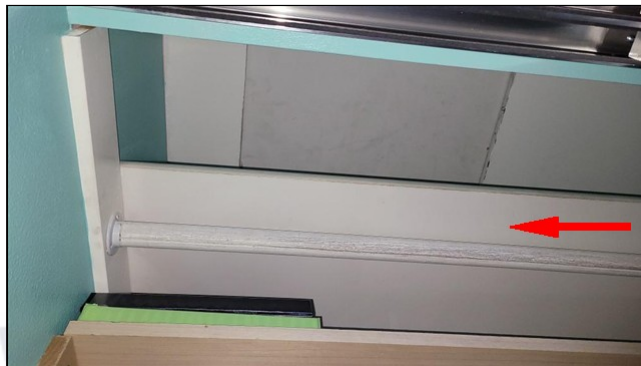
2.5 Item 1(Picture)

🔧 The attic access in Guest bedroom closet is obstructed and was not readily accessible. Attic access should not be obstructed. A qualified contractor should inspect further and correct as needed.

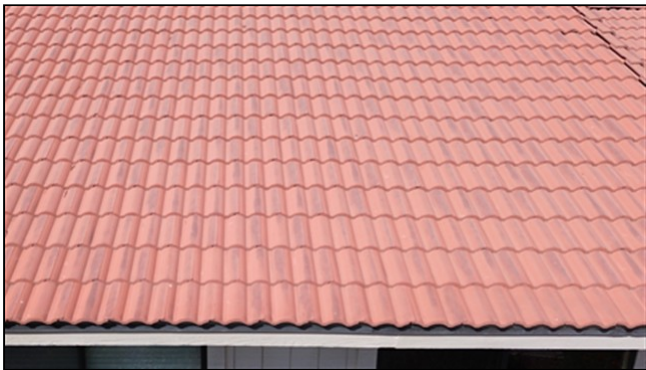
3.0 Item 1(Picture)

🔧 (1) Tile roof covering appears older and shows normal wear for it's age. Tile roofing has an underlayment system which can deteriorate over time and may need to be replaced. Underlayment is not visible and could not be evaluated. We are unable to determine remaining useful life expectancy of the underlayment. Recommend a licensed roofing contractor evaluate further.

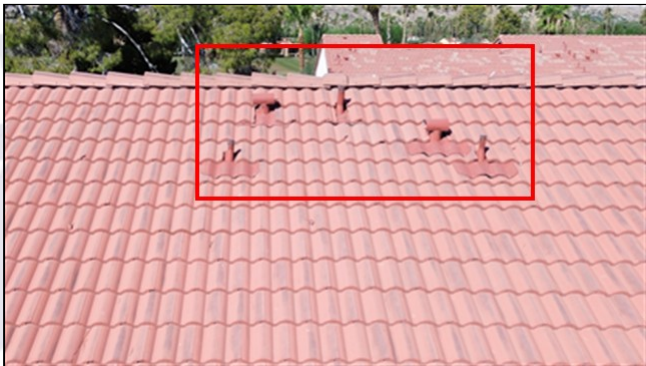
3.0 Item 2(Picture)

🔧 (2) Rodent proofing material noted on roof penetrations. We are unable to determine if a rodent or vermin problem exists. Recommend proper licensed specialist inspect further and correct if necessary.

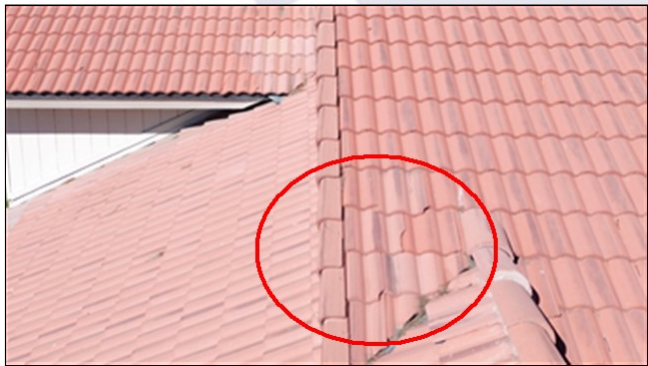
3.0 Item 3(Picture)

🔧 (3) The tile roof has a number of cracked/damaged tiles at various areas. Cracked or damaged tiles need replacement. A qualified contractor should inspect further and correct as needed.

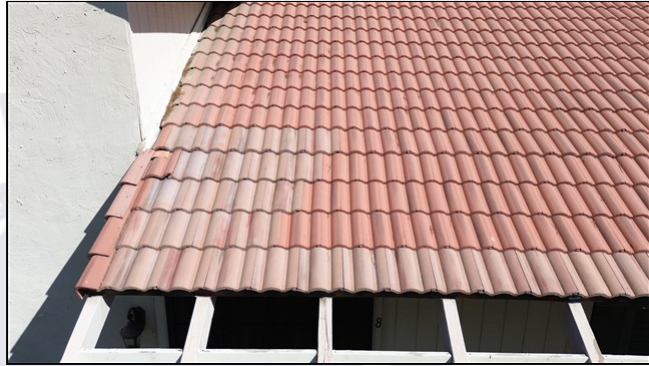
3.0 Item 7(Picture)

🔧 (4) The tile roof has a number of mismatched tile at various areas. The color difference is only cosmetic, and does not effect the integrity of roof covering. I recommend correct as necessary.

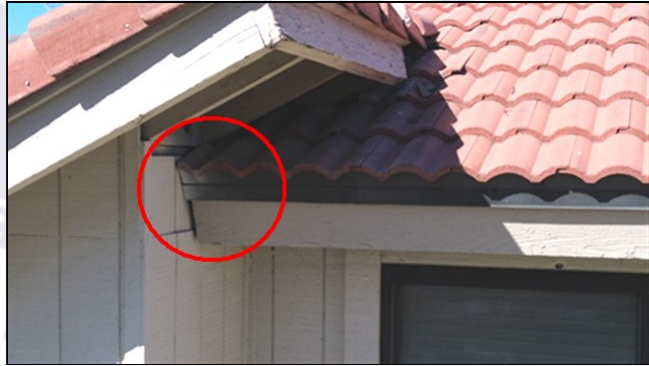
3.1 Item 1(Picture)

🔧 (1) Kickout flashing is missing along rake/eave at right side (facing front). This does not appear adequate. It should be properly repaired or replaced. A qualified roofing contractor should inspect further and correct as needed.

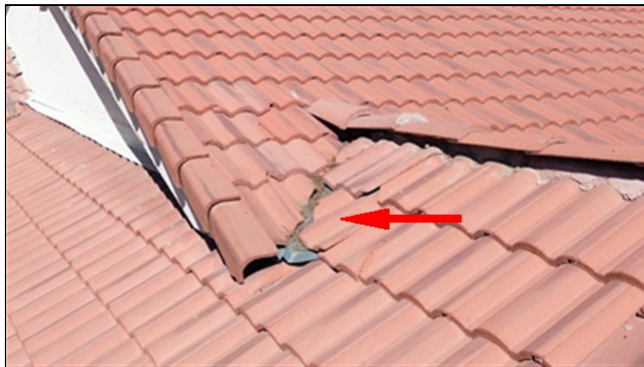
3.1 Item 2(Picture)

🔧 (2) Pan and valley flashings have debris built up and need correcting. These areas require regular maintenance and cleaning. Recommend correct as necessary

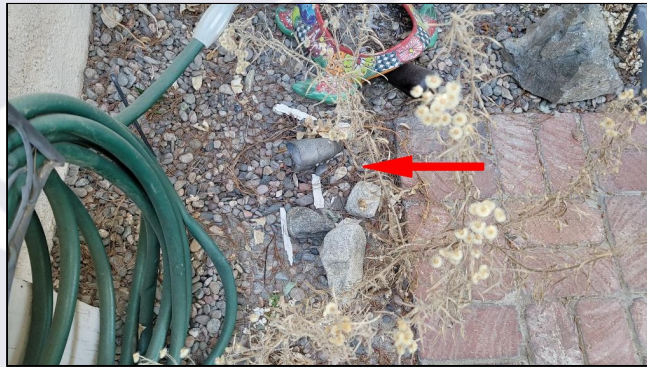
4.3 Item 2(Picture)

🔧 (2) It should be noted that the outdoor lighting system has damaged or inoperable fixtures. Recommend proper specialist evaluate further and correct as necessary.

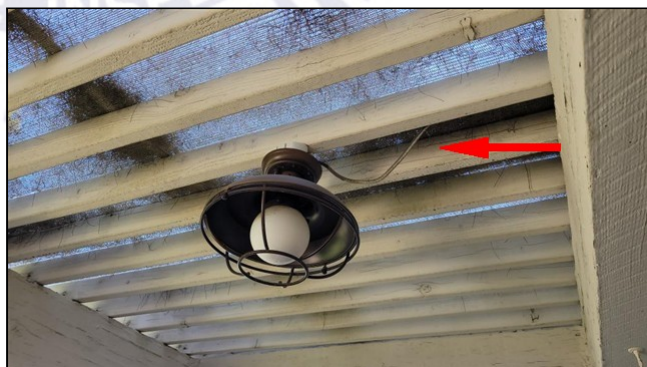
4.3 Item 3(Picture)

🔧 + (3) Improper wiring at light fixture overhead at the patio. This is a safety issue that needs to be corrected. A qualified licensed electrician should inspect further and correct as needed.

The light fixture does not work (try bulb first) at the patio. This is for your information. I recommend repair or replace as necessary.

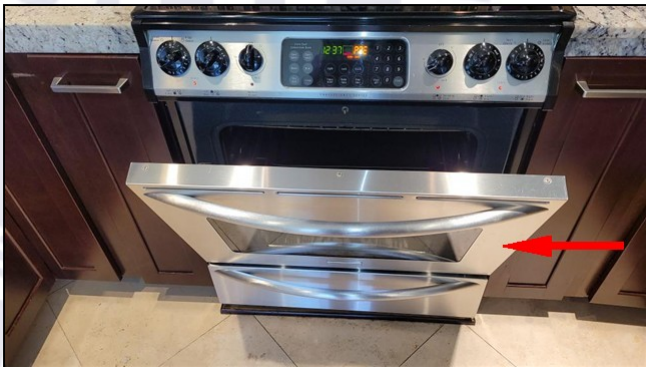
6.1 Item 2(Picture)

🔧🇨🇦 (1) No "anti tip" bracket installed on the stove/range to prevent unit from tipping over if oven door were to be used for a step. This is a safety issue. Recommend installation of "anti tip" bracket for safety.

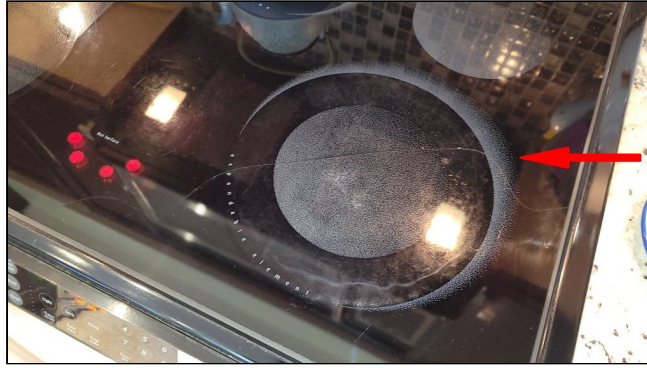
6.1 Item 3(Picture)

🔧 (2) The cooktop for range is damaged. I recommend repair or replace as needed.

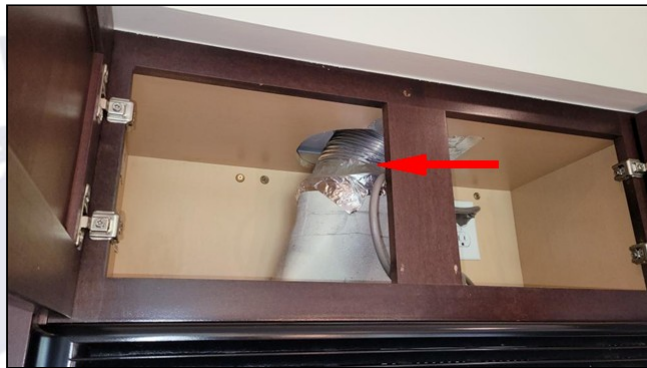
6.2 Item 1(Picture)

🔧 Ductwork for fan is vented using a corrugated vent pipe. Vent pipe should be a smooth walled vent pipe to prevent grease build up. Recommend correct as necessary.. A qualified contractor should inspect and repair as needed.

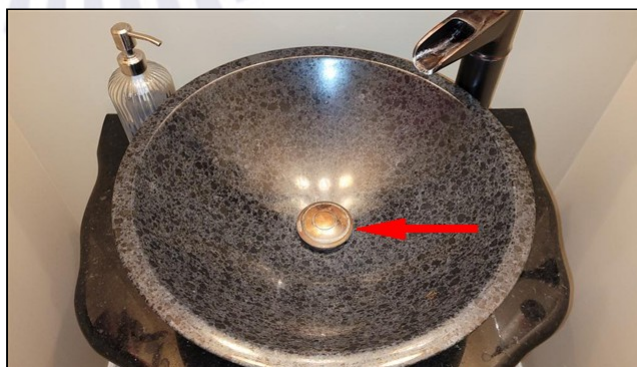
7.0 Item 1(Picture)

🔧 (1) The stop-valve does not work properly at the Powder room sink. Repairs are needed. I recommend repair or replace as needed.

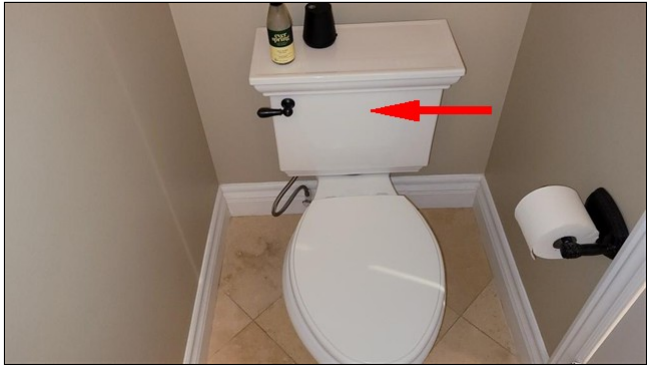
7.0 Item 2(Picture)

primary bath. Repairs are needed. I recommend a licensed plumber inspect further and repair as necessary.

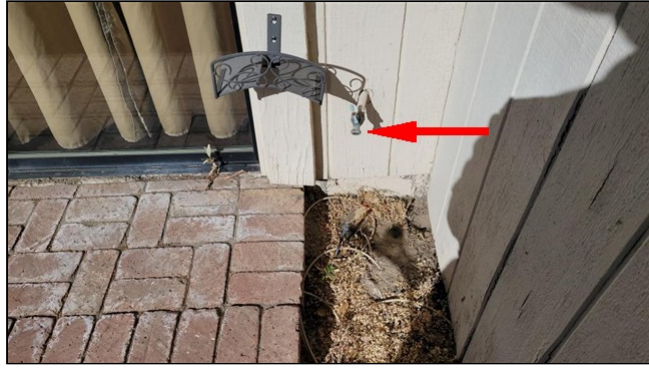
7.1 Item 3(Picture)

🔧 (3) The hose bib drips when off at the right side (facing front). Repairs are needed. I recommend repair or replace as needed.

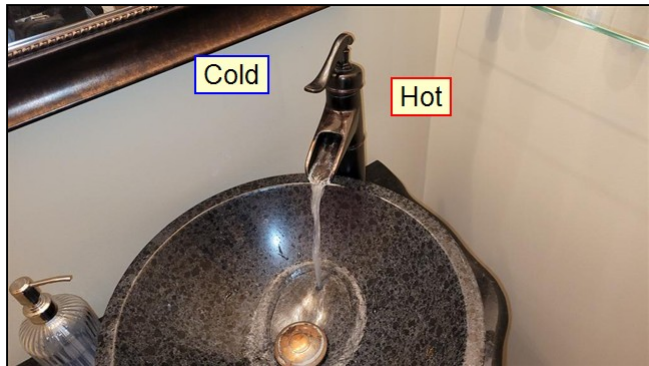
7.1 Item 6(Picture)

🔧 (6) The sink faucets hot control and cold control is reversed (hot is cold, cold is hot) at the powder room. This is not considered up to today's standard. I recommend correct as necessary for safety.

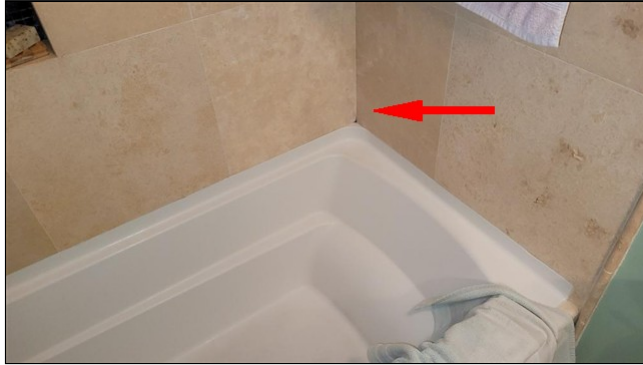
7.1 Item 7(Picture)

🔧 (7) The fiberglass tub enclosure needs re-sealing at the hall bath. This is a maintenance issue. I recommend repair or replace as needed.

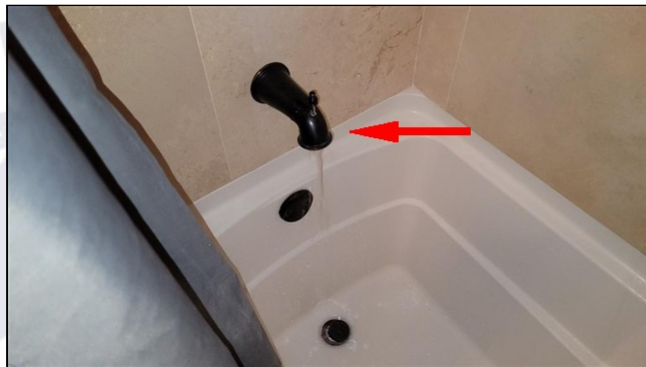
7.1 Item 9(Picture)

🔧 (8) The tub spout diverter leaks a stream through tub spout when shower is on at the hall bath. When a diverter leaks it can sometimes squirt water back against the cut-out on wall and possibly cause water to go behind wall or simply wastes water. A qualified licensed plumber should repair or correct as needed.

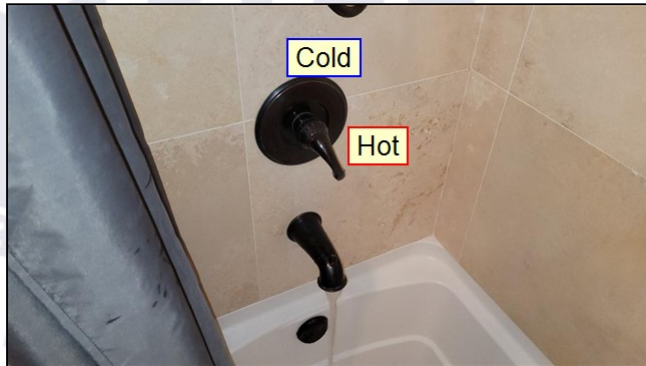
7.1 Item 10(Picture)

🔧 (9) The tub faucets hot control and cold control is reversed (hot is cold, cold is hot) at the hall bath. This is not considered up to today's standard. I recommend correct as necessary for safety.

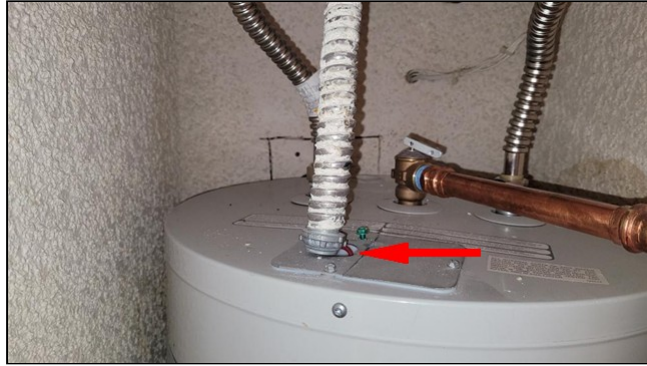
7.2 Item 1(Picture)

🔧 (1) The wiring for the water heater has a loose connector and is missing a lockable disconnect. This is a safety issue that needs to be corrected. I recommend a licensed electrician correct as necessary.

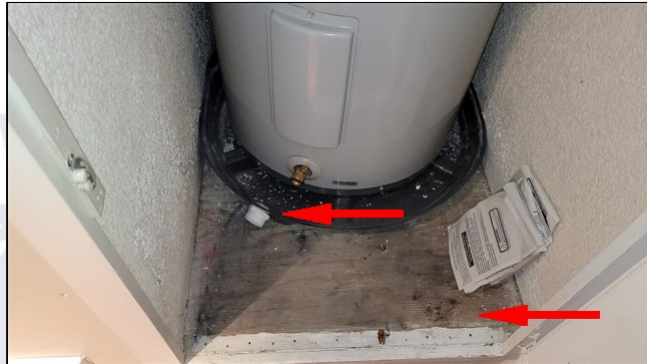
7.2 Item 2(Picture)

The water heater platform shows signs of damage from a leak. We are unable to determine the extent of damage. We recommend further evaluation by proper licensed specialist.

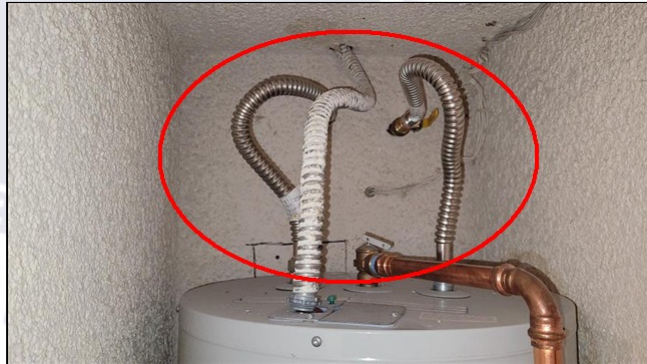
7.2 Item 3(Picture)

🔧 (3) The water heater plumbing is missing insulation on piping. A replacement is needed. I recommend repair or replace as needed.

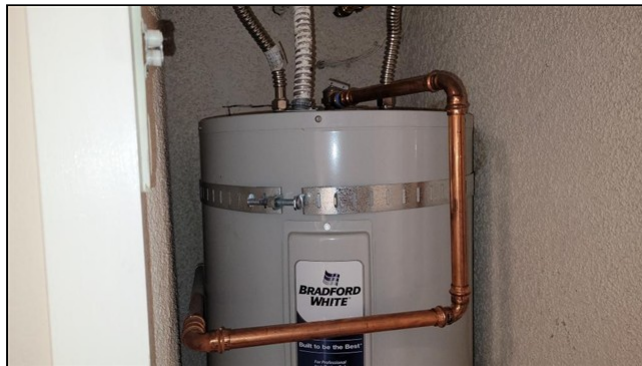
7.2 Item 4(Picture)

🔧 (4) Your water heater does not have a "Thermal Expansion tank" installed to prevent a possible leak at the T&P or "pop-off" valve. Recent changes in code require one when a new water heater is installed. This change is not retroactive on older previously installed water heaters. There were no leaks or drips at the T&P valve during inspection. If your water heater does begin to drip or leak, then a thermal expansion tank may be needed.

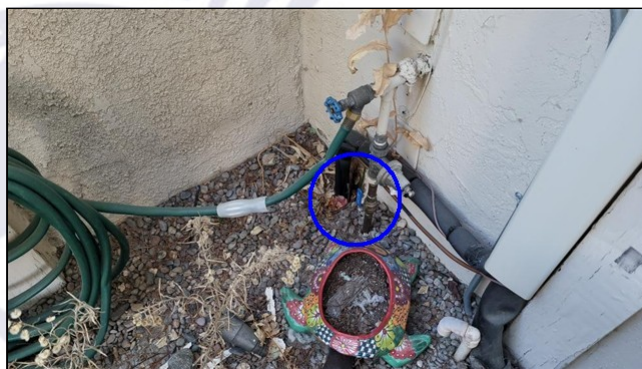
7.3 Item 1(Picture)

The main shut off is the blue lever located outside on South wall. This is for your information.

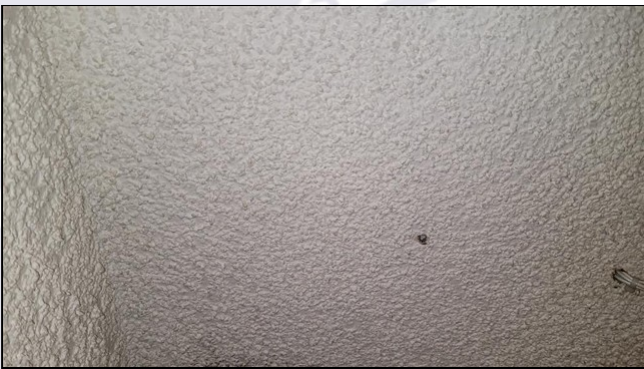
8.0 Item 1(Picture)

🔧 (1) It should be noted that acoustic material on ceilings in subject house may contain asbestos material. Homes constructed in this time frame commonly used asbestos in ceiling coverings. We recommend testing of material to verify.

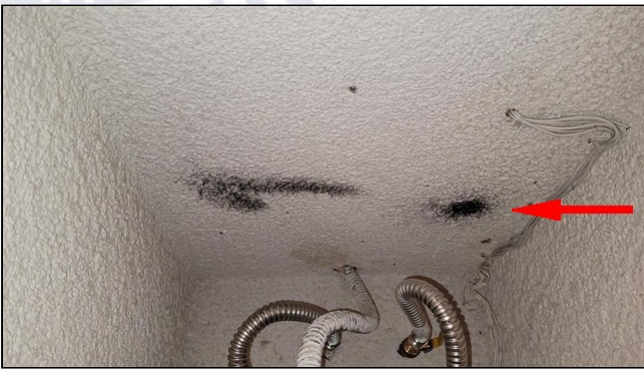
8.0 Item 2(Picture)

🔧 (2) The Sheetrock on the ceiling shows staining from unknown causes at the water heater closet. We are unable to determine the cause for this. A qualified contractor should inspect further and correct as needed.

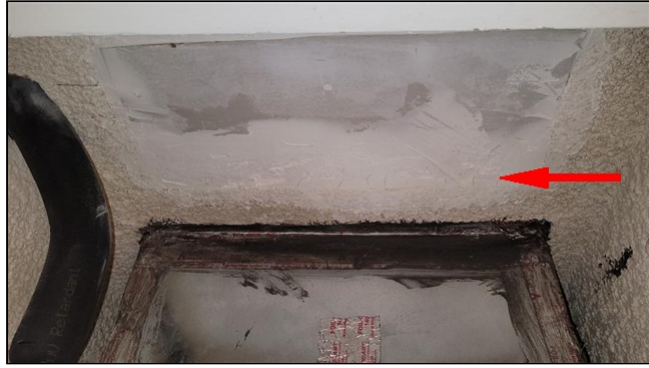
8.0 Item 3(Picture)

🔧 (3) The Sheetrock on the ceiling shows repair signs and is unfinished at the air handler closet. We are unable to determine the cause for this. A qualified contractor should inspect further and correct as needed.

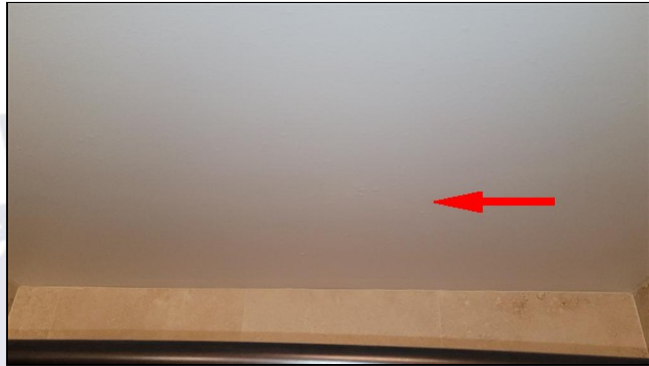
8.0 Item 4(Picture)

🔧 (4) The Sheetrock on the ceiling is peeling as a result from moisture above at the Hall Bath. We are unable to determine the cause or extent of damage. Recommend further evaluation by proper licensed specialist.

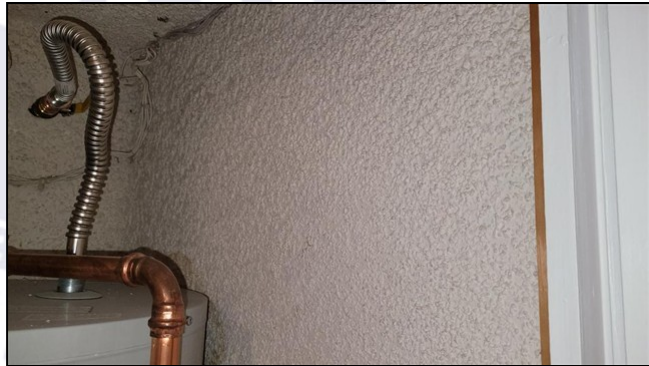
8.1 Item 1(Picture)

🔧 (1) It should be noted that acoustic material on walls in subject house may contain asbestos material. Homes constructed in this time frame commonly used asbestos in wall coverings. We recommend testing of material to verify.

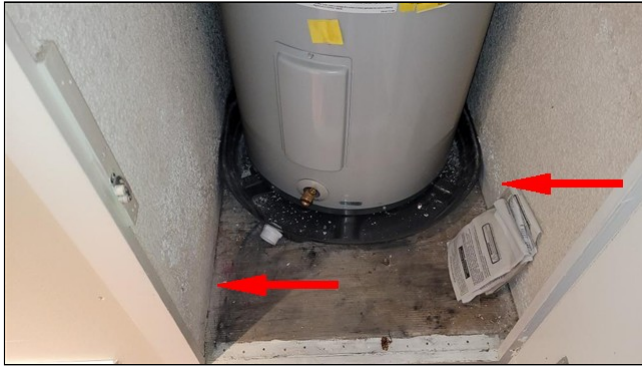
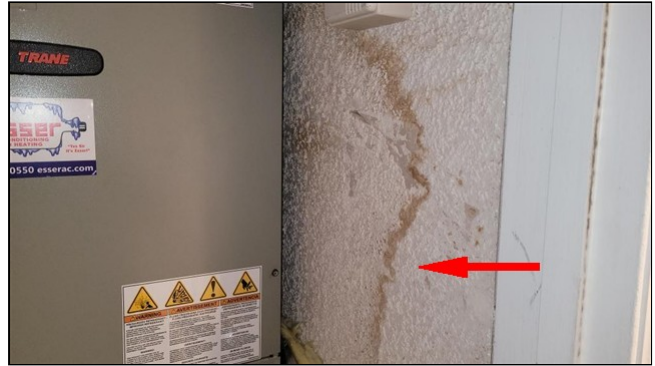
8.1 Item 2(Picture)

🔧 (2) The sheetrock on the wall shows wet stains indicating moisture intrusion did or still may occur and is damaged at the water heater and air handler closets. We are unable to determine the cause or extent of damage. Recommend further evaluation by proper licensed specialist.

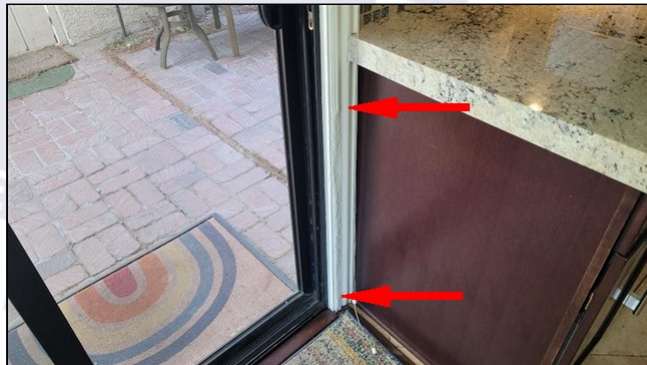
8.1 Item 5(Picture)

🔧 (4) The Moulding on the wall is damaged at the Kitchen. We are unable to determine the cause for this. A qualified contractor should inspect further and correct as needed.

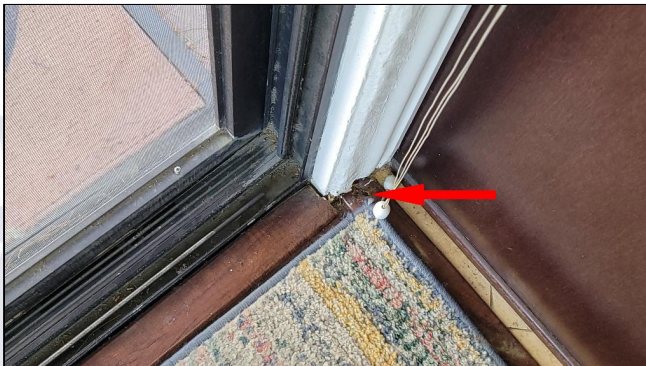
8.2 Item 2(Picture)

🔧 (2) The Wood covering is deteriorated at the Kitchen. We are unable to determine the cause or extent of damage. Recommend further evaluation by proper licensed specialist.

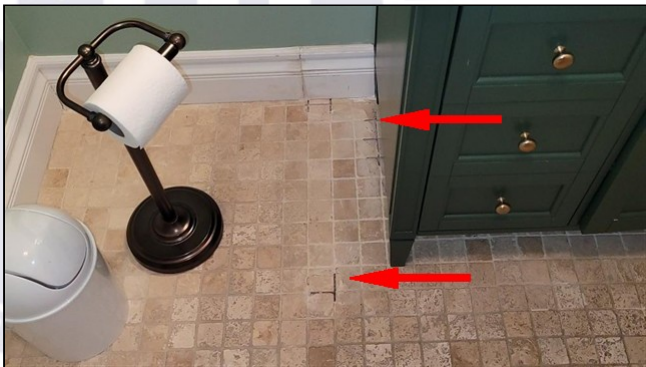
8.2 Item 3(Picture)

🔧 (3) The Tile needs re-grouting at the Hall Bath. Repairs are needed. A qualified person should repair or replace as needed.

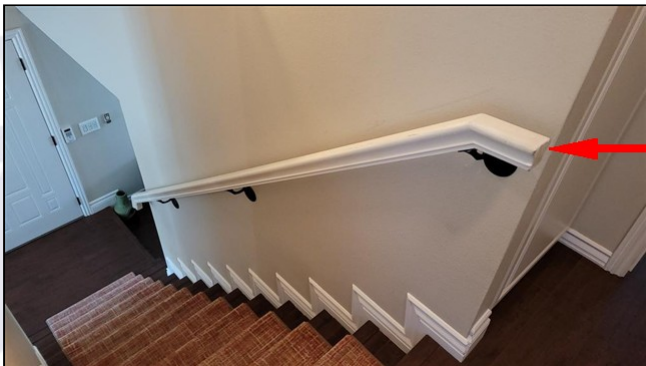
8.3 Item 2(Picture)

🔧 + (2) The hand/guard rail for the second story stairs should return to wall or post to prevent clothing or accessories from getting caught. A fall or injury could occur if not corrected. While this may be a newer requirement, we recommend upgrading for safety.

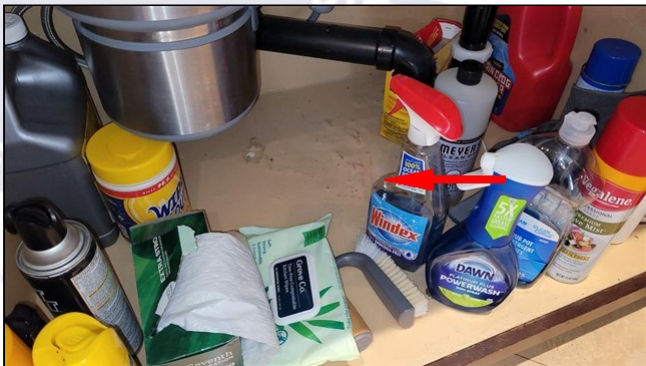
8.4 Item 1(Picture)

🔧 (1) Base cabinetry is damaged from moisture in the kitchen under sink. We are unable to determine the cause or extent of damage. We recommend further evaluation by proper licensed specialist.

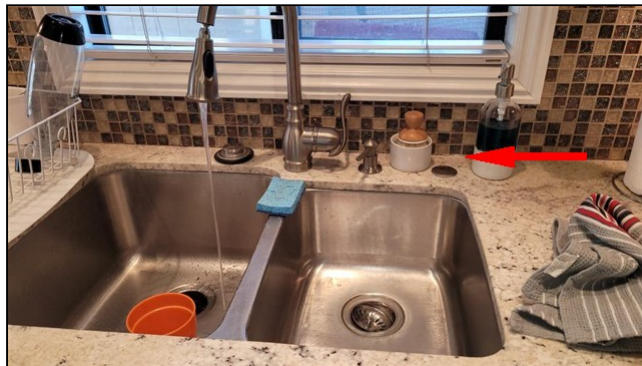
8.4 Item 2(Picture)

🔧 (2) Countertop needs re-sealing along backsplash in kitchen. This is a maintenance issue. I recommend repair or replace as needed.

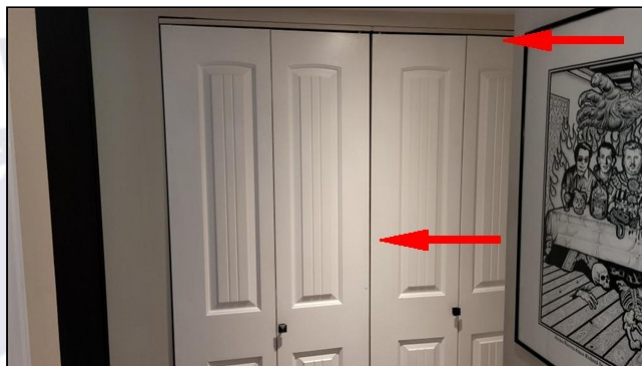
8.5 Item 1(Picture)

🔧 The bifold door (s) have loose tracks and does not fit opening properly (out of square) at the laundry room. An adjustment/repair is needed. A qualified person should repair or replace as needed.

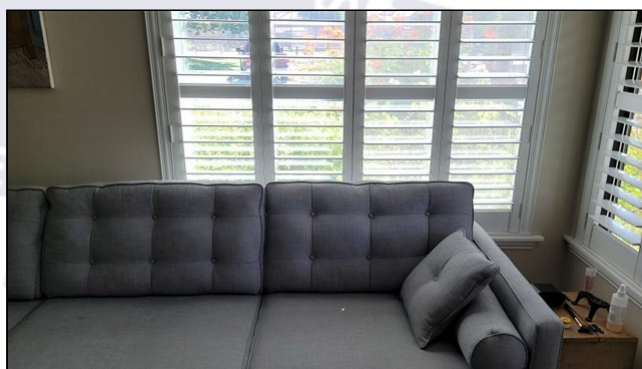
8.6 Item 1(Picture)

🔧 Some windows were blocked by occupants belongings and could not be tested for proper operation.

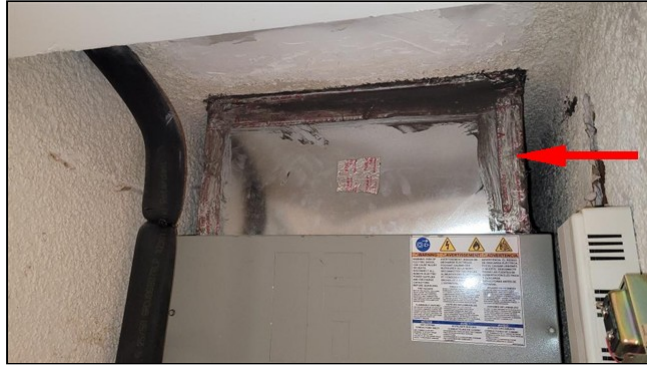
9.3 Item 1(Picture)

🔧 (1) The return plenum is missing insulation at the air handler. Energy loss is occurring. A qualified HVAC person should inspect further and repair or replace as needed.

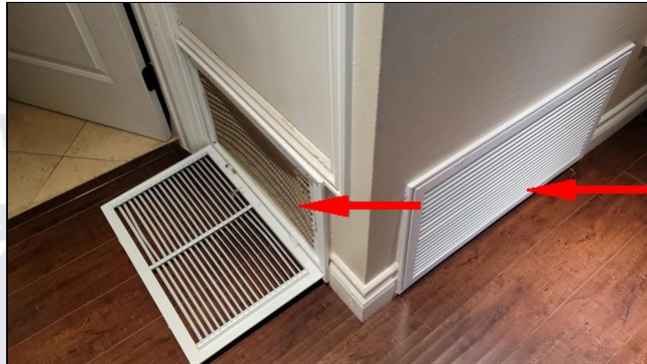
9.3 Item 2(Picture)

Filter location (see photo)

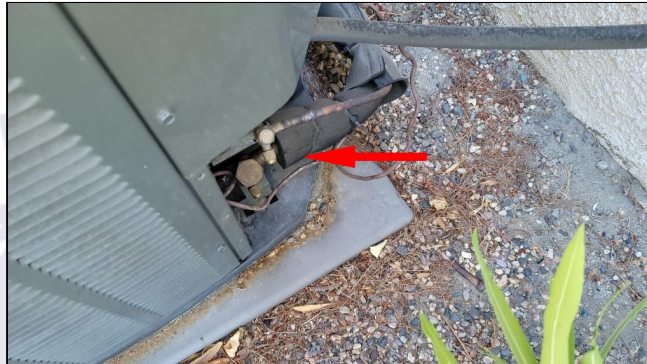
9.8 Item 2(Picture)

🔧 (2) The freon return line (s) are missing tamper resistant caps to cover connections. While this may not have been required at time of construction, we recommend upgrading. I recommend service or repair as needed.

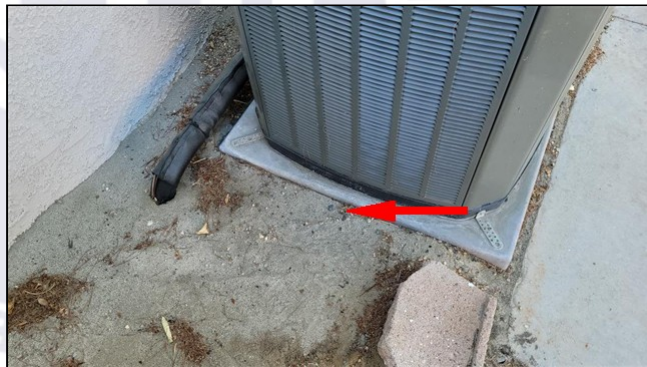
9.8 Item 3(Picture)

🔧 (3) The platform for condenser(s) should be above grade. Correction is needed. This is for your information.
