PACIFIC CREST HOME INSPECTIONS

INSPECTION REPORT BY PACIFIC CREST INSPECTIONS

5036 Litchfield Rd
San Diego, CA 92116

07/07/2025

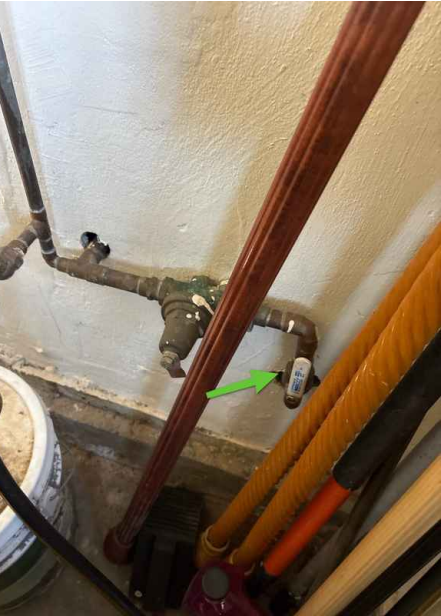
Main Water Shut-Off Device (Describe Location): Main Water Shut off Location
In the Garage

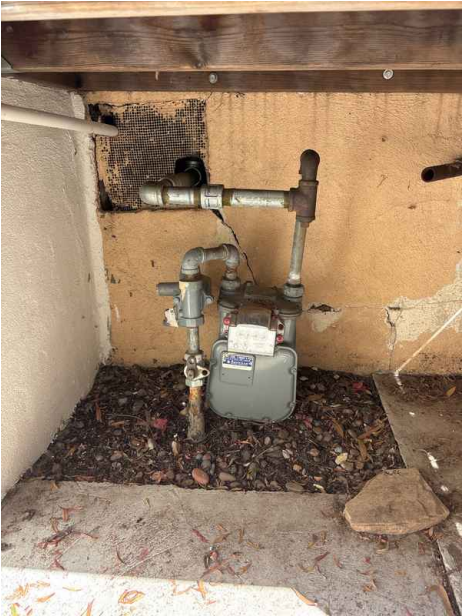
Main Gas Shut Off Valve (Describe Location): Main Gas Shut Off Valve Location
Right side of the Building

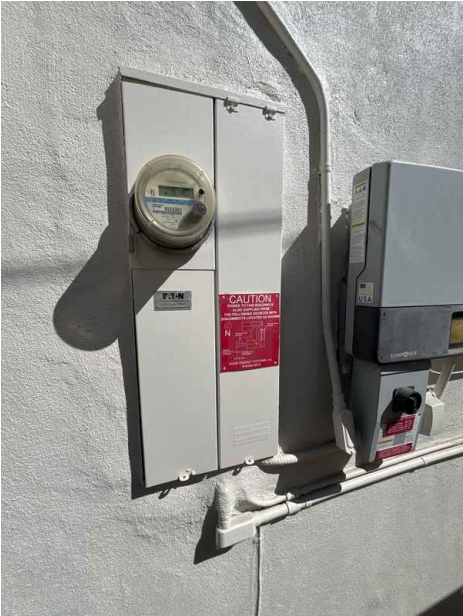
Main and Distribution Panels (Describe Location): Main Panel Location
Right Exterior

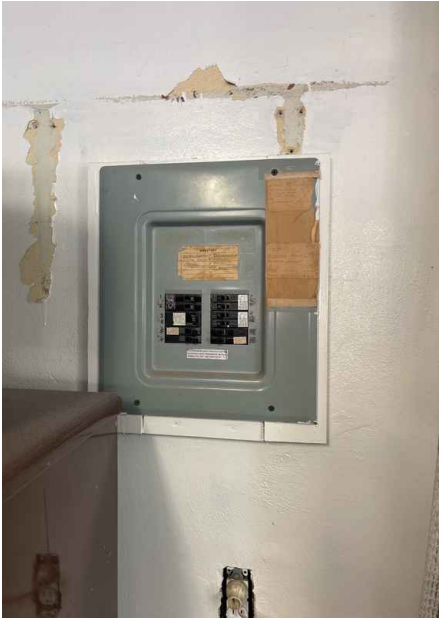
Garage

Main and Distribution Panels (Describe Location): Distribution Panel Location

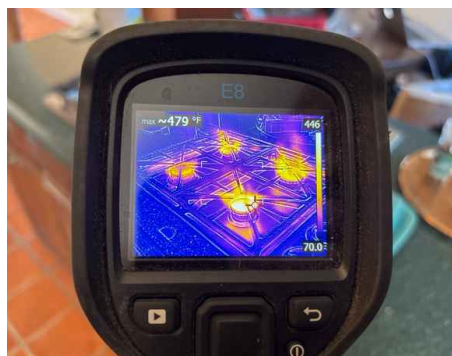
Ranges and Cooktops: Thermal Image Showing Operation

Infrared picture of range/cooktop in operation. This image shows function of the operable range burners.

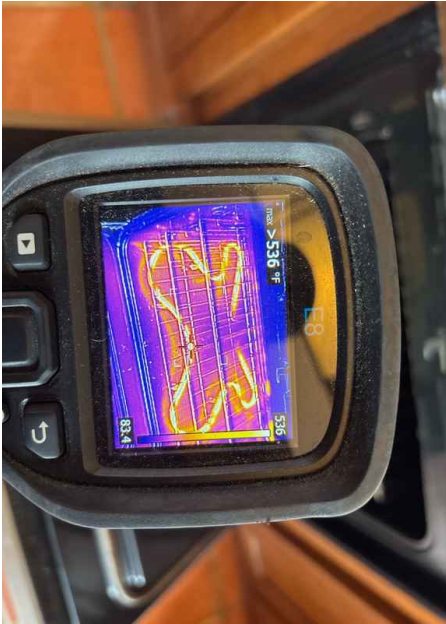
Wall Oven: Thermal Image Showing Operation

Infrared picture of oven in operation. This image shows function of the operable oven heat source.

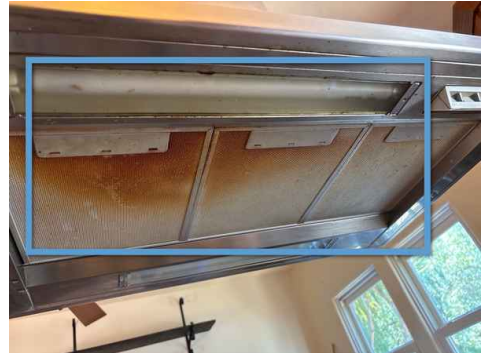
Observation Item

The vent hood appeared operational at the time of the inspection. However, the unit was noted in need of general cleaning and maintenance. Recommend professional cleaning/maintenance by a licensed appliance contractor as necessary.

Recommendation

Contact a qualified appliance repair professional.

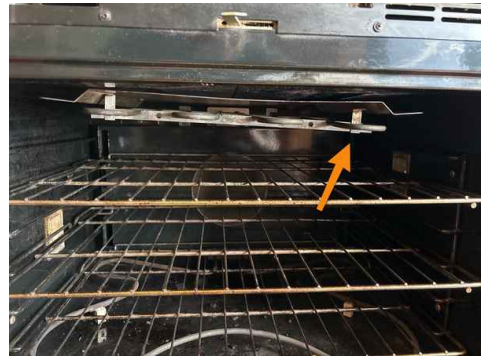
Attention Item

The heating element was loose. This condition may promote damage. Recommend repair by a licensed appliance contractor.

Recommendation

Contact a qualified appliance repair professional.

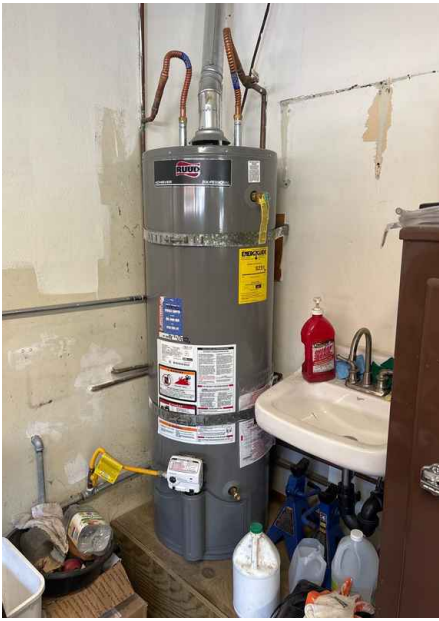
Water Heaters, Controls, Flues and Vents: Picture of Water Heater

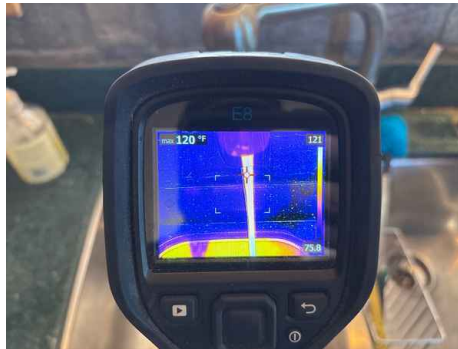
Water Heaters, Controls, Flues and Vents: Thermal Image Showing Operation

Thermal image showing production of hot water at the sink location.

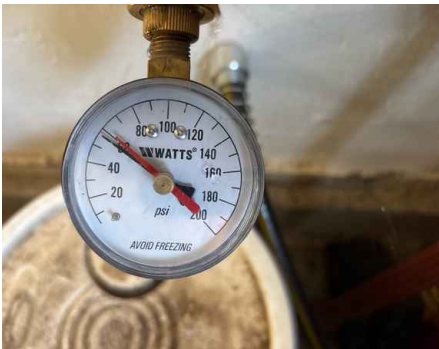
Water Pressure: Water Pressure Normal

Water pressure was noted within normal operation parameters.

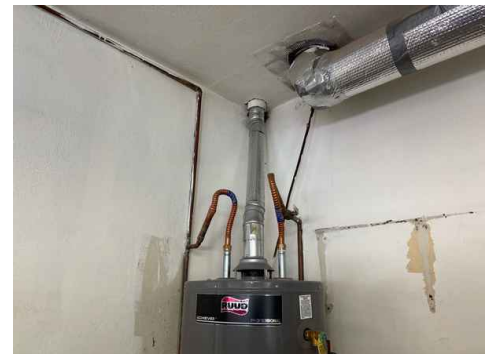
4.6.3 Water Heaters, Controls, Flues and Vents

EXPANSION TANK

Contact a qualified plumbing contractor.

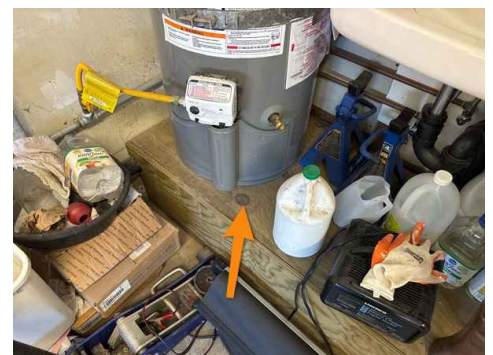
4.6.4 Water Heaters, Controls, Flues and Vents

MISSING PAN

Contact a qualified plumbing contractor.

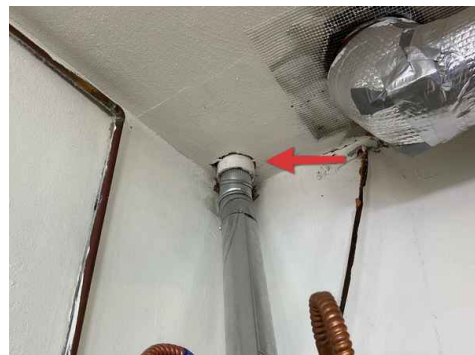
4.6.5 Water Heaters, Controls, Flues and Vents

FLUE-TRANSITE

Contact a qualified environmental contractor

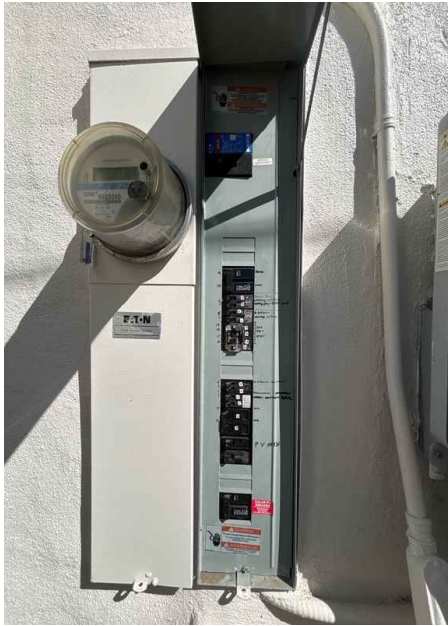
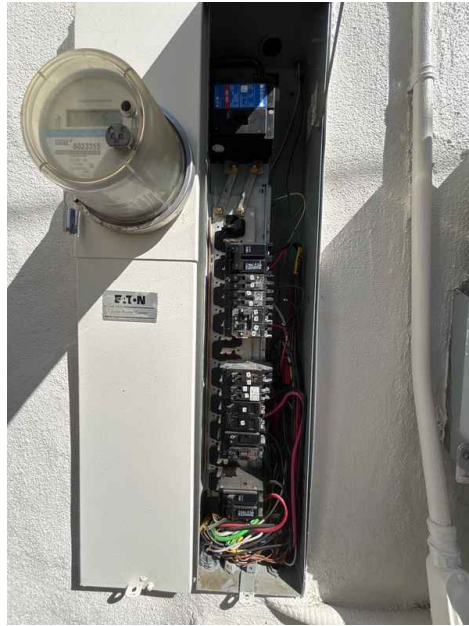
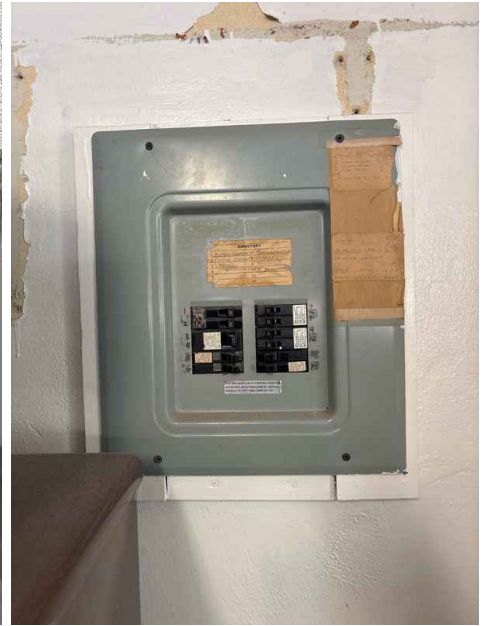
Main and Distribution Panels: Picture of Panels

Pictures of electrical panel(s).

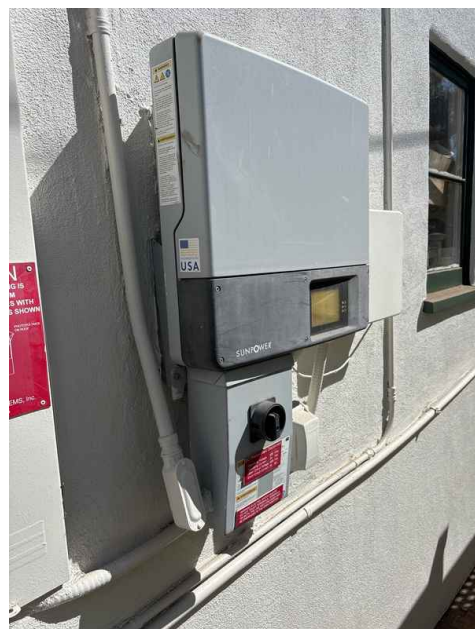
SOLAR

This home is equipped with solar panels. We advise inquiry with sellers about this system: leased/owned, manufacture/installer warranties, etc. Please note: Solar equipment is known to promote moisture intrusion issues when mounted on the roof structure. I was unable to verify the condition of the solar mounts or the roofing below the solar panel areas. You may wish to have this portion of the roof further evaluated by a licensed roofing contractor to determine if latent defects exist.

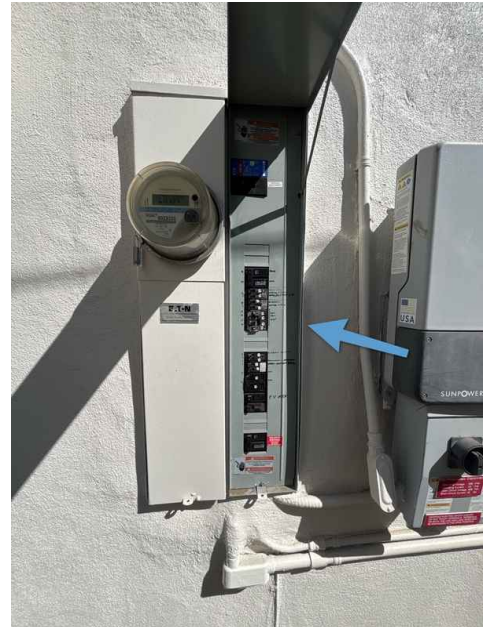
5.1.5 Main and Distribution Panels

NEW PANEL

Contact a qualified electrical contractor.

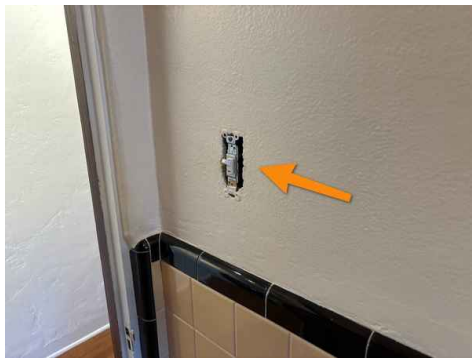
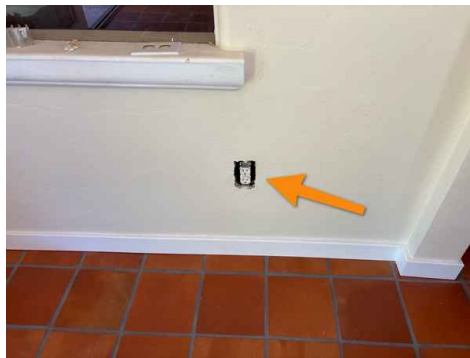
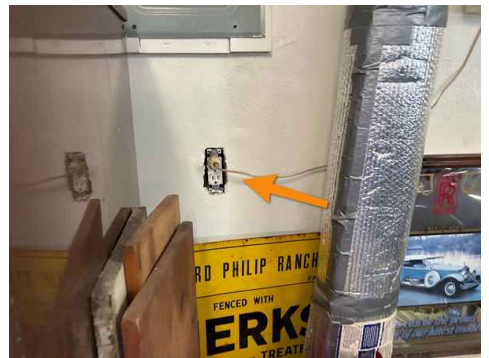
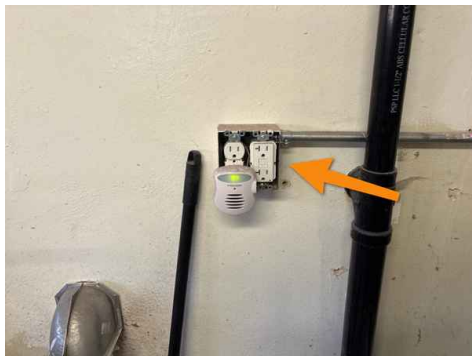
MISSING FACEPLATE

Missing faceplates noted at one or more outlet and/or wall switch. Advise repair.

Contact a qualified electrical contractor.

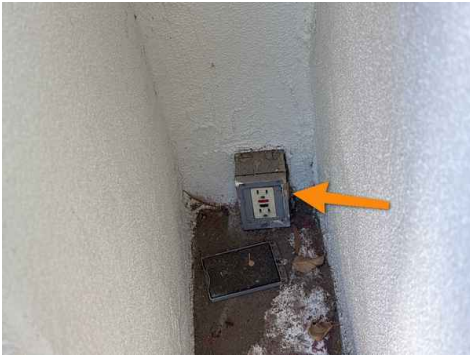
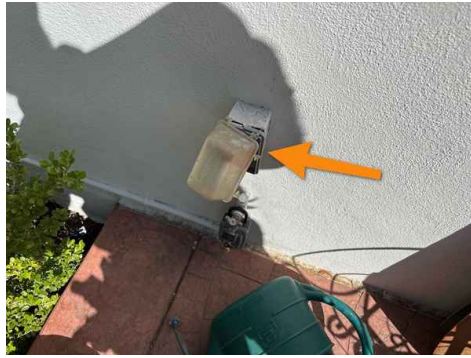
WEATHERPROOF COVER MISSING/DAMAGED

One or more exterior outlet/light switch was noted having a missing or damaged weather cover. Advise correction by a licensed electrical contractor.

Contact a qualified electrical contractor.

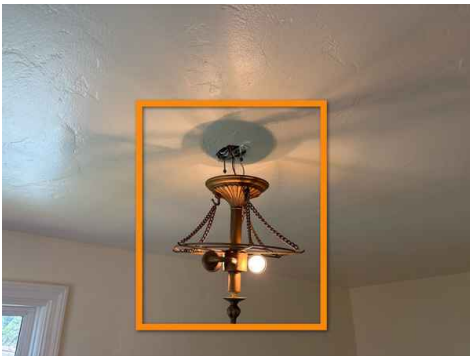
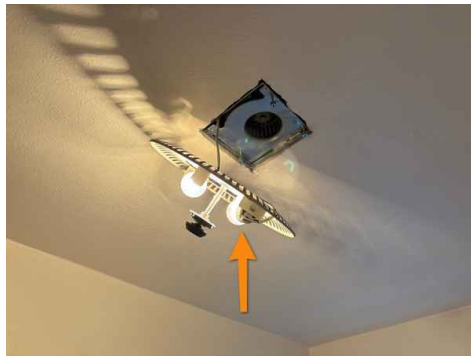
LOOSE LIGHT FIXTURE/TRIM

One or more interior light fixture was noted loose to the wall/ceiling. Advise correcting and repair by a qualified/licensed professional.

Contact a qualified professional.

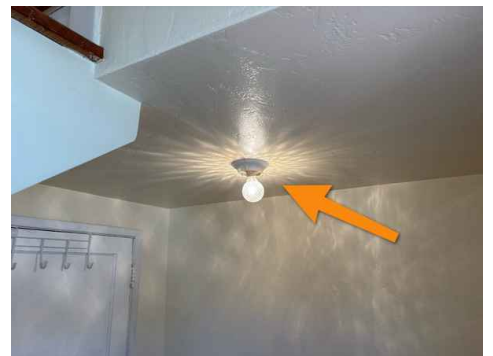
Laundry

MISSING COVER

Missing fixture cover noted at the light. Advise replacement as needed.

Contact a qualified electrical contractor.

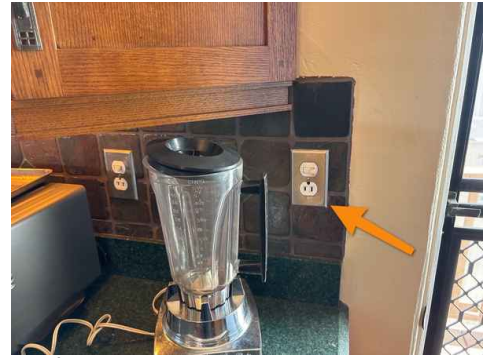
Kitchen

RECEP - LOOSE

Junction box for receptacle in the is loose in the wall. This puts stress on the circuit wires which should not be moved. Recommend securing the junction box properly in the the wall by a qualified person.

Contact a qualified electrical contractor.

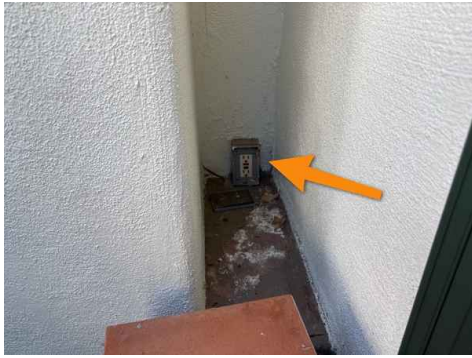
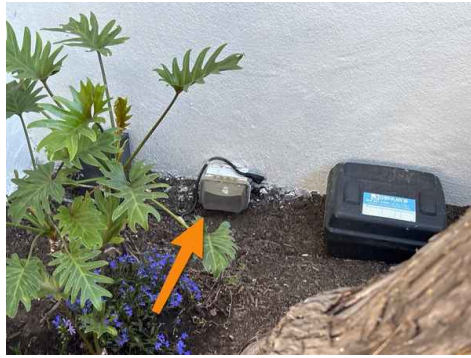
One or more electrical receptacle was noted installed too low or at grade. This condition may promote deterioration, water intrusion, and potential shock hazard. Recommend correction by a licensed electrical contractor as necessary.

Contact a qualified electrical contractor.

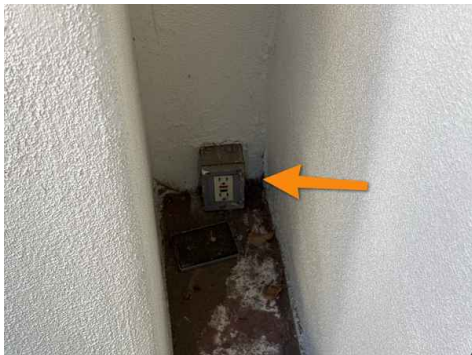
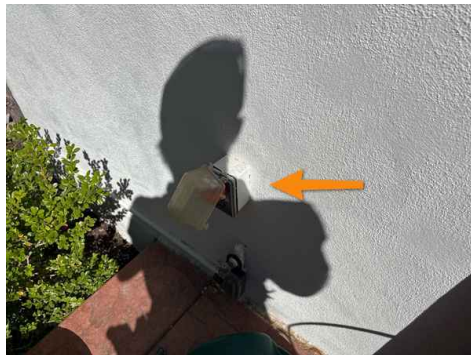
GFCI - FAILED

The GFCI receptacle is not operating properly, or has failed. Recommend replacement by a licensed electrician.

Contact a qualified electrical contractor.

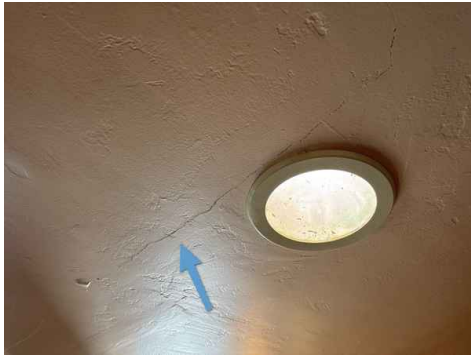
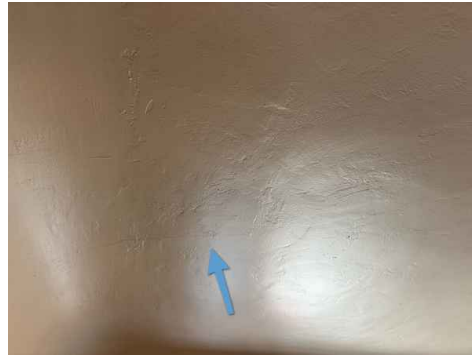
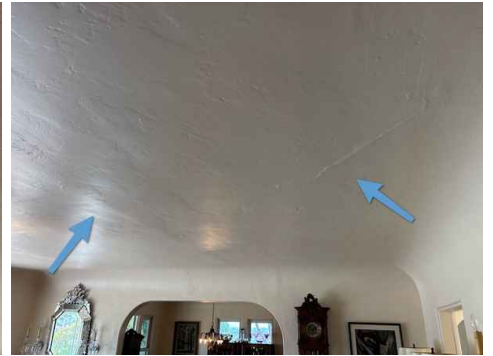
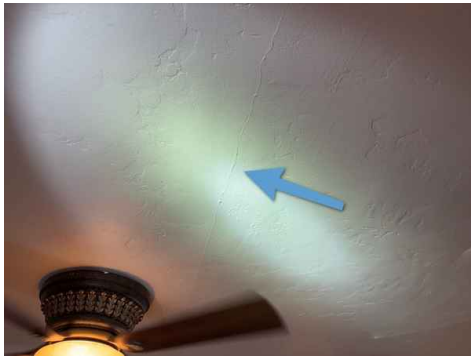
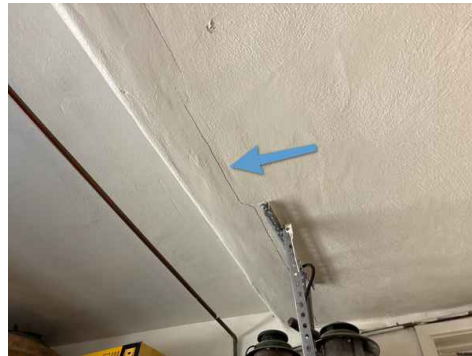
STRESS FRACTURES

The ceiling appears to have stress fractures. You may wish to have this further evaluated by a qualified expert and repair as needed.

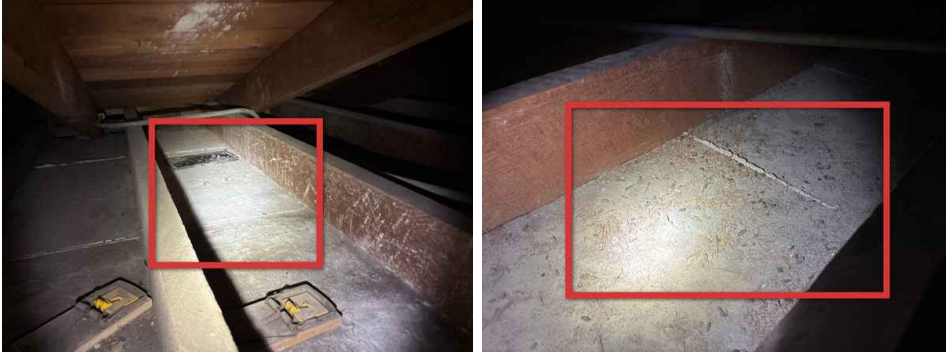
RODENTS DROPPINGS IN THE ATTIC

Contact a qualified pest control specialist.

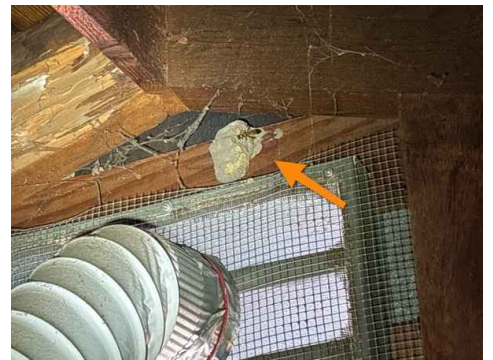
WASP NEST

Contact a qualified pest control specialist.

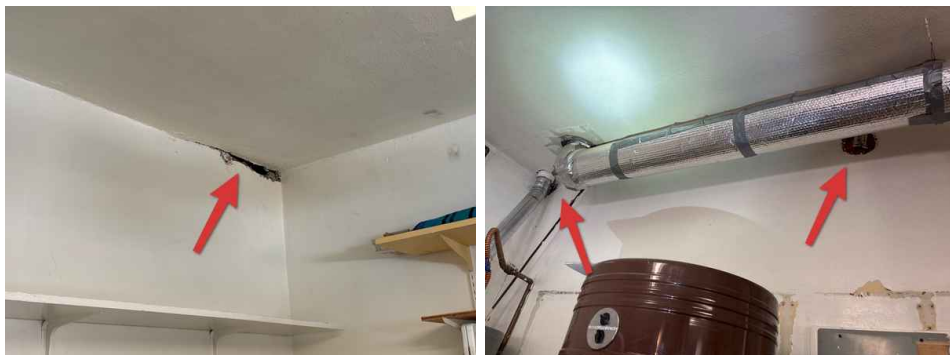
Holes in the fire wall were observed in the garage. Wherever the garage shares a wall with adjacent living space, a fire-rated sheetrock must be installed and intact for fire resistant performance. I recommend having the holes patched by a qualified person.

Recommendation
Contact a qualified drywall contractor.

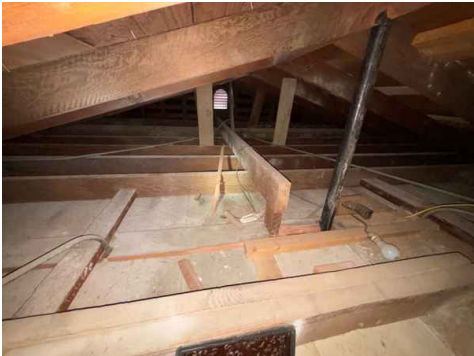
8.2.1 Insulation Under Floor System

The floor system is not fully insulated. This condition will negatively impact the thermal efficiency of the home. Recommend consulting a licensed insulation contractor to determine a complete list of necessary repairs.

Recommendation

Contact a qualified professional.

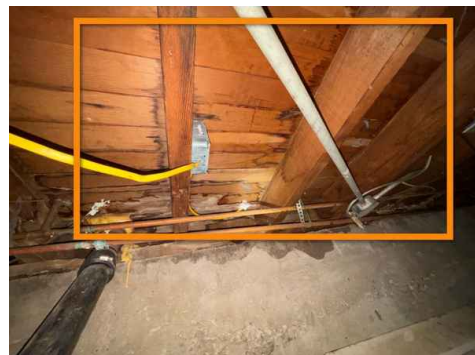
8.3.1 Vapor Retarders (On Ground, In Crawlspace or Basement)

The crawlspace is not equipped with a vapor barrier. This condition can lead to moisture-related issues. Recommend consulting a licensed foundation contractor to determine if corrections are needed at this time.

Recommendation

Contact a foundation contractor.

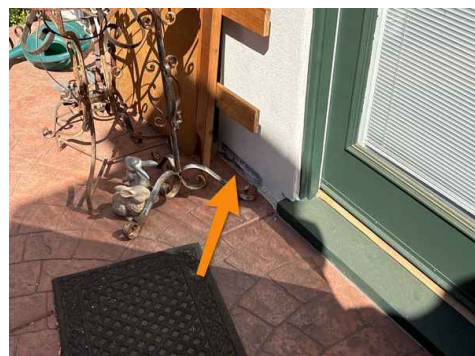
Front Exterior

The foundation vent(s) are installed at or near ground level. Adding mulch or landscape to this area could result in water intrusion, if vent becomes lower than the ground. Should you decide to landscape, or if water intrusion was to occur through vent, I would recommend a half-round window well be installed.

Recommendation

Contact a qualified professional.

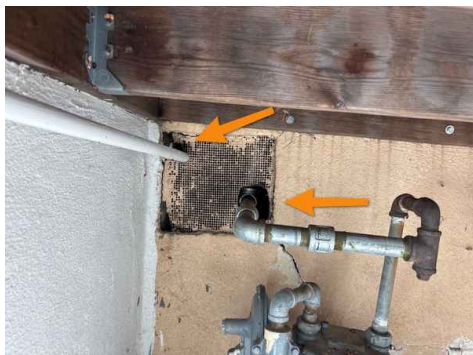
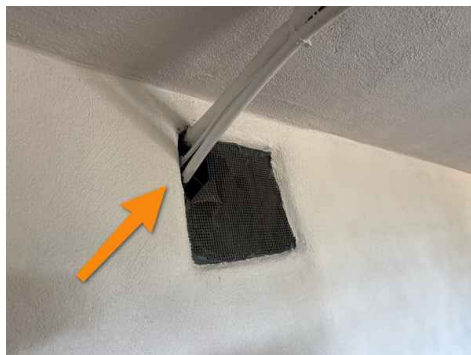
DAMAGED SCREENS-CRAWLSPACE

Damage screens were noted at the crawlspace ventilation. This condition can allow for pest intrusion. Advise correction by a licensed pest control company.

Recommendation

Contact a qualified pest control specialist.

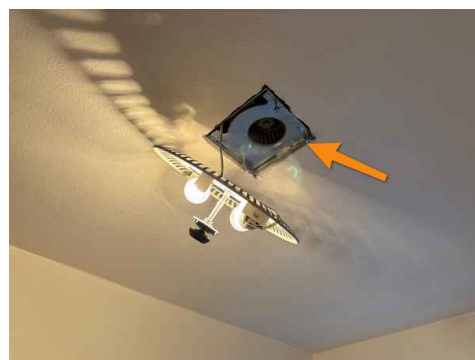
Hall Bathroom

The vent fan did not appear to function properly at the time of the inspection. Unable to determine the exact cause. Advise consulting a licensed electrical contractor for further evaluation and repair.

Recommendation

Contact a qualified electrical contractor.

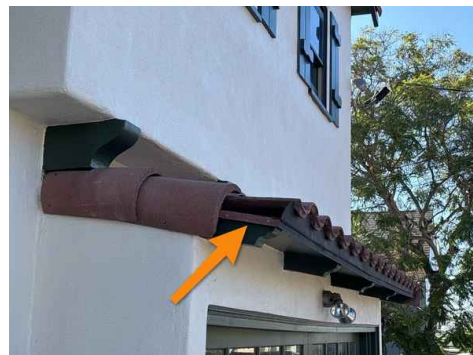
Front Exterior

SLIPPED/CRACKED TILE (TILE)

Slipped/cracked tiles noted. The roof covering was inspected from the ground and attic to avoid damaging the roof covering, and possibly voiding the warranty. This is in accordance with the NACHI standards of practice. The entire roof was not visible, and there may be additional defects. Advise maintenance review of the entire roof and necessary corrections by a licensed roofer.

Recommendation

Contact a qualified roofing professional.

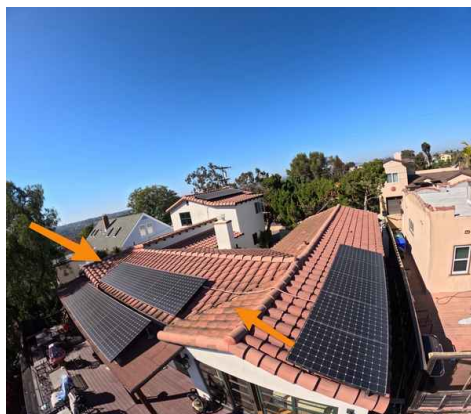
Rear Exterior

Tiles were installed too close together at the valleys. This is called a closed valley. Debris can become logged in the valleys and create a damming effect causing leaks. Recommend having the tiles cut away from the valleys to allow water to flow properly off of the roof. A licensed roof contractor should evaluate the roof to provide a quotation prior to the end of your contingency period.

Recommendation

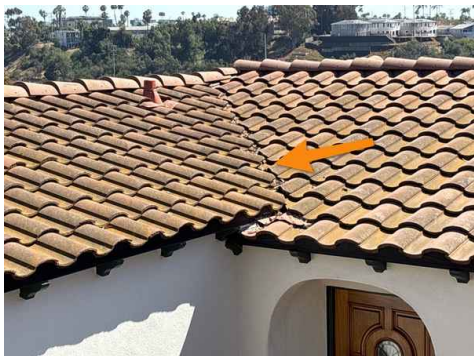
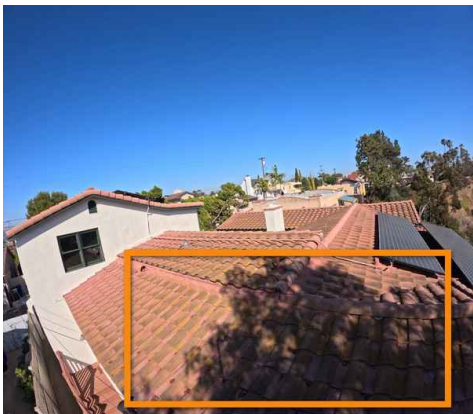
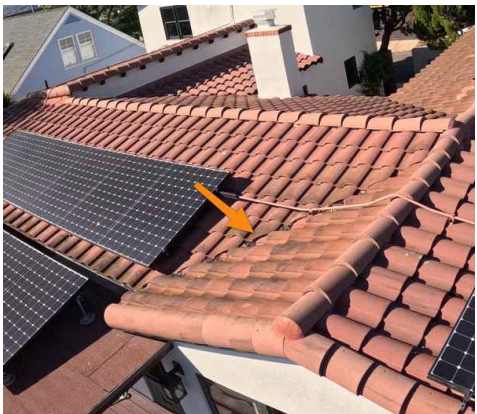
Wear and deterioration noted at roof covering due to age and sun exposure. This appears to be normal deterioration. However, we advise obtaining documentation on the age of the roof, and consulting with a licensed roofing contractor to review and give estimates of life remaining and any necessary repairs to prevent leaks. This is also important because a home inspection is not a guarantee against roof leaks.

Recommendation

Contact a qualified professional.

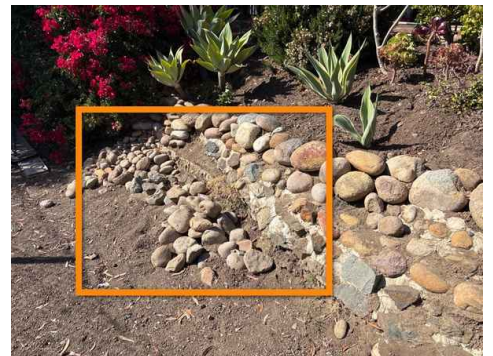
Rear Exterior

REAR EXTERIOR

Evidence of erosion was noted at the exterior landscape in areas. Silt travel is occurring and some form of ground cover, drainage improvements or general landscaping appears necessary. Recommend further evaluation by a licensed grading contractor to determine corrections needed at this time.

Recommendation

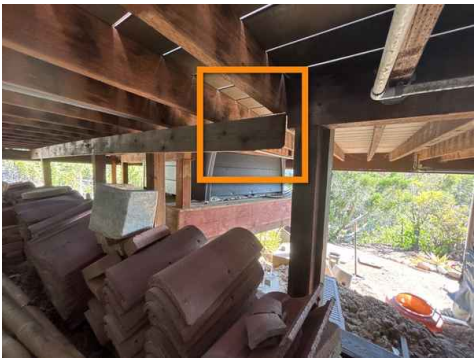
Rear Exterior

A lack of support was noted at the deck girder. Recommend further evaluation by licensed decking contractor to determine if corrections are needed at this time.

Contact a qualified deck contractor.

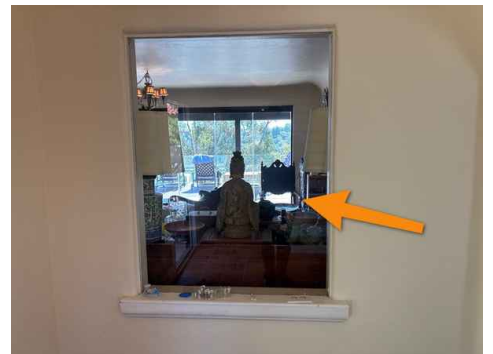
Front Entry

A lack of tempered glass was noted present at one or more required location. Recommend consulting a licensed window contractor or qualified professional to determine the scope of necessary repairs.

Contact a qualified professional.

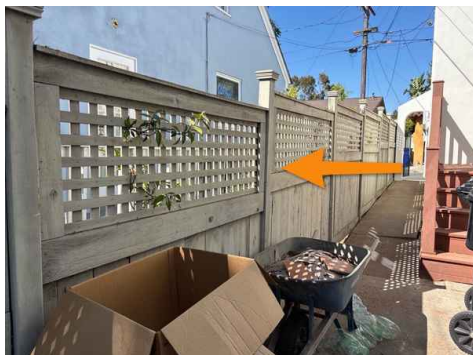
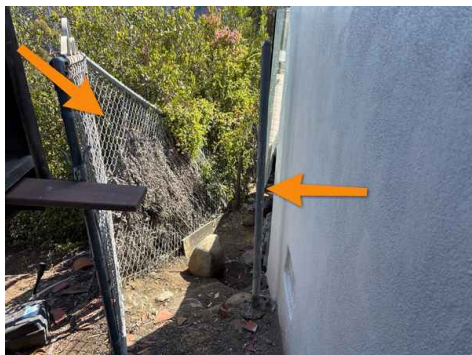
LEANING/DAMAGED FENCING

Portions of the fencing were noted leaning or unstable. The fencing is likely in need of major repair or possible replacement. Advise consulting a licensed fencing contractor for necessary repairs.

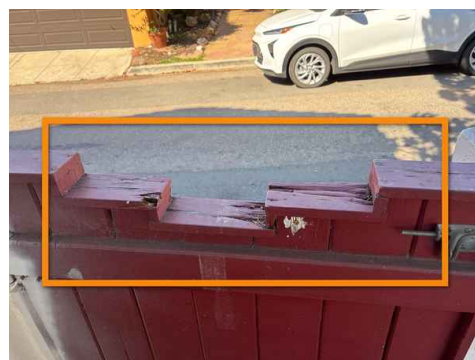
Front Exterior

WOOD DAMAGE

Evidence of wood damage/wood destroying organisms was noted at the fencing in multiple locations. Recommend consulting a licensed fencing contractor to determine the scope of necessary repairs.

Contact a qualified professional.

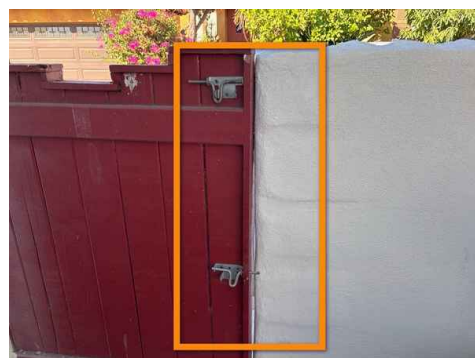
Front Exterior

GATE HARDWARE - MISSING

The gate hardware was noted missing/damaged. Advise correction to allow for proper operation.

Contact a qualified fencing contractor

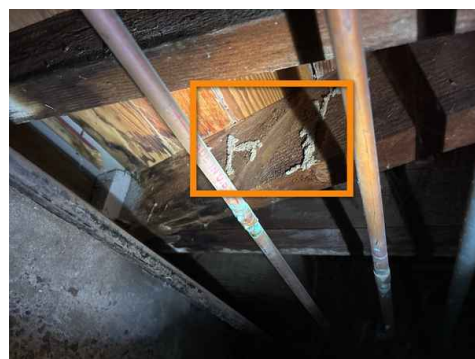
Crawlspace

Evidence of possible wood destroying organisms were noted in the crawlspace in areas. Recommend further evaluation by a licensed termite inspection company to determine the scope of necessary corrections.

Contact a qualified pest control specialist.

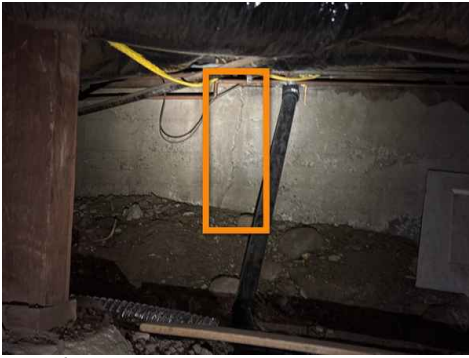
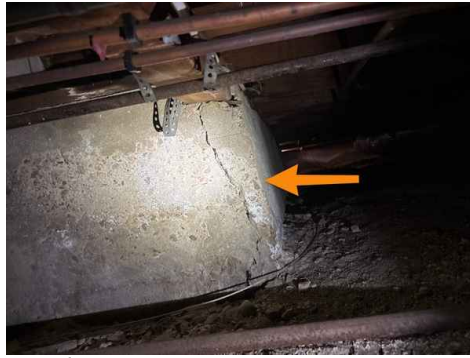
Crawlspace

VERTICAL CRACKING

Vertical cracking noted at the foundations walls in a number of areas. This may be indicative of structural movement. Recommend further evaluation by a licensed foundation contractor to determine a complete list of corrections needed at this time.

Contact a foundation contractor.

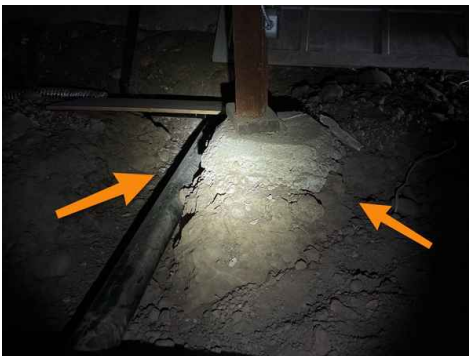
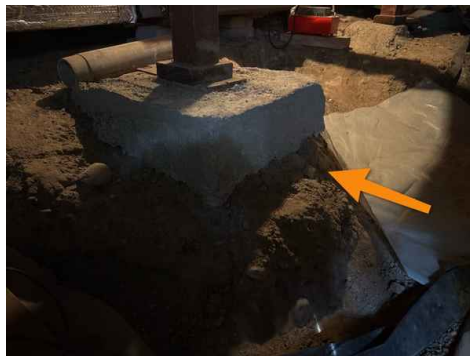
IMPROPER EXCAVATION

Improper excavation was noted around various post/pier locations. This condition may compromise stability and promote structural movement. Recommend further evaluation by a licensed foundation contractor for further evaluation and correction as necessary.

Contact a foundation contractor.

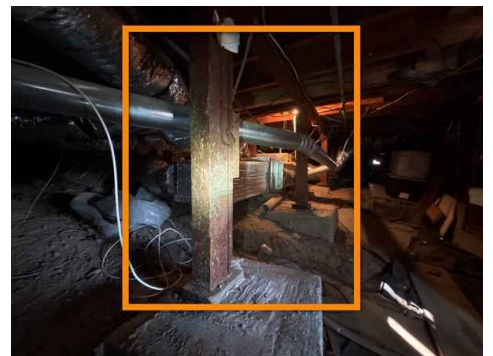
SEISMIC RETROFITTING INCOMPLETE

Portions of the foundation system have not undergone seismic retrofitting. Recommend consulting a licensed foundation contractor for further evaluation and correction as necessary.

Contact a foundation contractor.

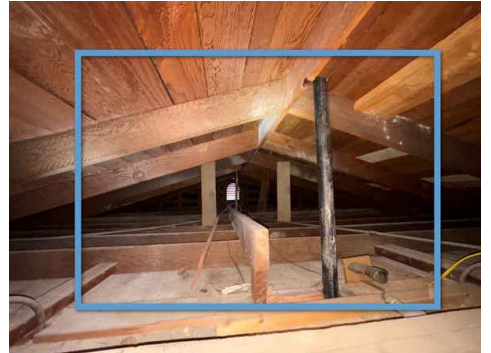
The roof structure was noted framed in an antiquated manner. The framing is under-dimensioned and over-spanned by today's building standards. You may wish to consult a licensed general contractor to determine if reinforcement is needed at this time.

Contact a qualified general contractor.

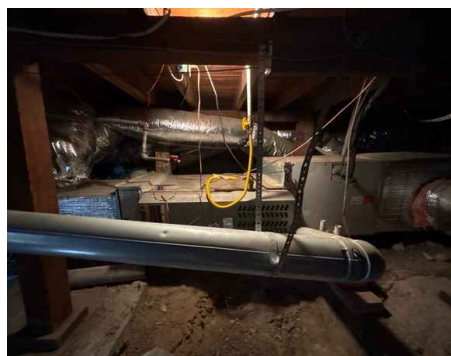
Picture of heating equipment.

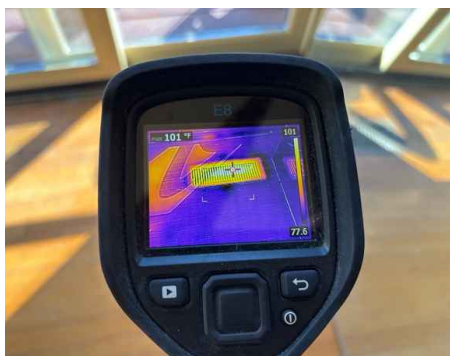
The furnace turned on and produced heat at the time of the inspection.

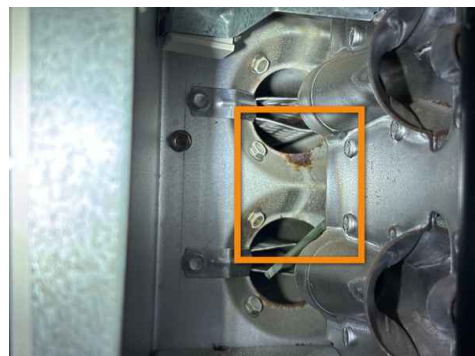
SCORCHING AT BURNER COMPARTMENT

Contact a qualified heating and cooling contractor

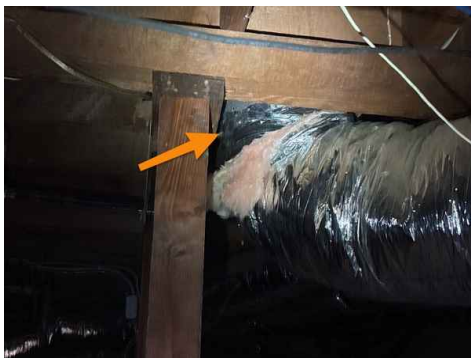
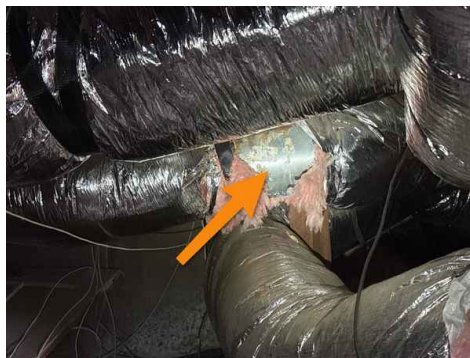
Crawlspace

FLUE-MOISTURE INTRUSION

Contact a qualified HVAC professional.

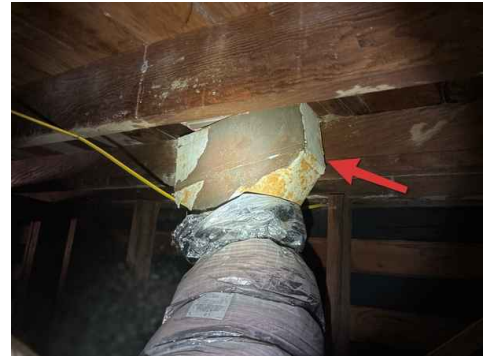
Sections of the duct work appeared to incorporate material that may contain asbestos. Testing for asbestos is beyond the scope of a home inspection. Due to the location and condition of this material, if found to contain asbestos, is typically not a risk to occupants. However, this is best determined by a qualified environmental hygienist, or asbestos abatement company. If you have any concern, further evaluation/testing should be preformed by a qualified professional.

Recommendation

Contact a qualified environmental contractor

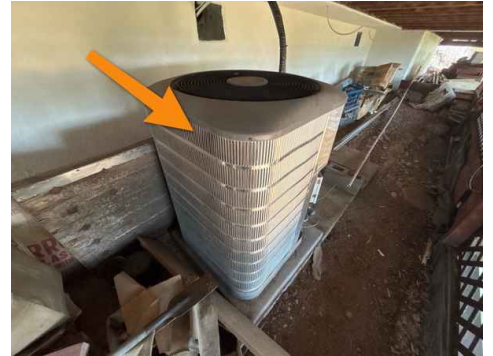
MFD Unknown

A/C AGED

Contact a qualified HVAC professional.

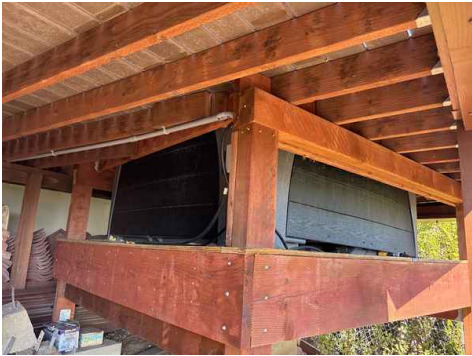
NOT INSPECTED

The spa and all related equipment we're not inspected as part of the home inspection process. You may wish to have these items further evaluated by a licensed spa contractor as necessary.
