WOOD DESTROYING PESTS AND ORGANISMS INSPECTION REPORT

Building No.	Street	City	ZIP	Date of Inspection	Number of Pages
2218	Hutchinson St	Chico	95928	09/23/2026	4

Report # : 43841
Registration # : PR3779
Escrow # :
☐ CORRECTED REPORT

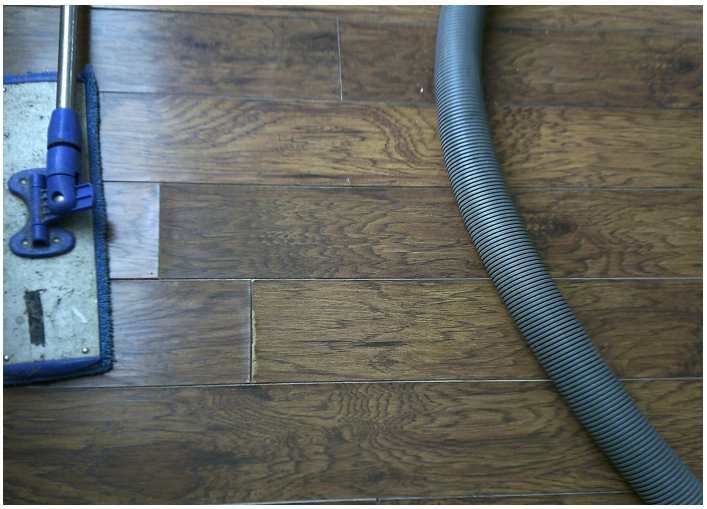
FINDING: Stains and moisture damage noted at the living room flooring. Damage may extend into inaccessible areas.

FINDING: Stains (dry) were noted at the upstairs bathroom sink cabinet bottom.

FINDING: Stains and fungus damage noted at the door jambs. Damage may extend into inaccessible areas. Repaired

RECOMMENDATION: Interested parties should engage the services of a licensed contractor to check for leaks and to perform any corrective work needed. Remove the moisture damaged portions of the flooring. Call for a reinspection of the inaccessible areas. The inaccessible areas will be inspected for a fee if made accessible by the interested parties at his/her expense. A supplemental report will be filed at such time. No opinion is rendered concerning the conditions in the area at this time. Replace with new material.

RECOMMENDATION: Interested parties should engage the services of a licensed plumber to check for leaks and make repairs as needed.

RECOMMENDATION: Interested parties should engage the services of a licensed contractor to check for leaks and to perform any corrective work needed. Remove the fungus damaged portions of the door jambs and replace with new material.
