WOOD DESTROYING PESTS AND ORGANISMS INSPECTION REPORT

BUILDING NO.	STREET, CITY, STATE, ZIP	Date of Inspection	No. of Pages
11360	Providencia, Cypress CA 90630	10/1/2026	4

11360	Providencia, Cypress CA 90630	10/1/2026	26554
BUILDING NO.	STREET, CITY, STATE, ZIP	INSPECTION DATE	REPORT NO.

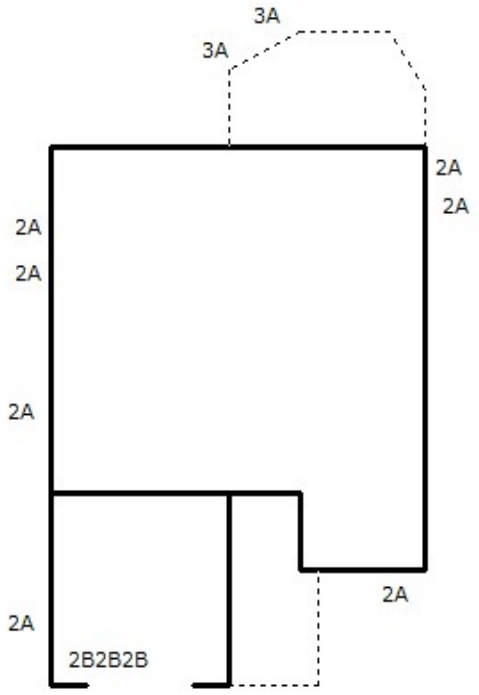
Section I. Evidence of drywood termites noted at fascia board and rafter tails as indicated on the diagram.

Section I. Evidence of drywood termites noted at the framing in garage as indicated on the diagram.

Section I. Fungus/Dry rot damage noted at patio post trims as indicated on the diagram. Condition appears to be due to excessive moisture.

Vacate premises and seal the structure. Fumigate with a lethal gas for 2 nights. Remove seal and air building ready for occupancy.

Repair damaged timbers as necessary. New lumber will be primed only.
