WOOD DESTROYING PESTS AND ORGANISMS INSPECTION REPORT

Building No.	Street	City	ZIP	Date of Inspection	Number of Pages
369	Log Lane	Crestline	92325	07/28/2026	6

Report # : 17894
Registration # : PR6628
Escrow # :
☐ CORRECTED REPORT

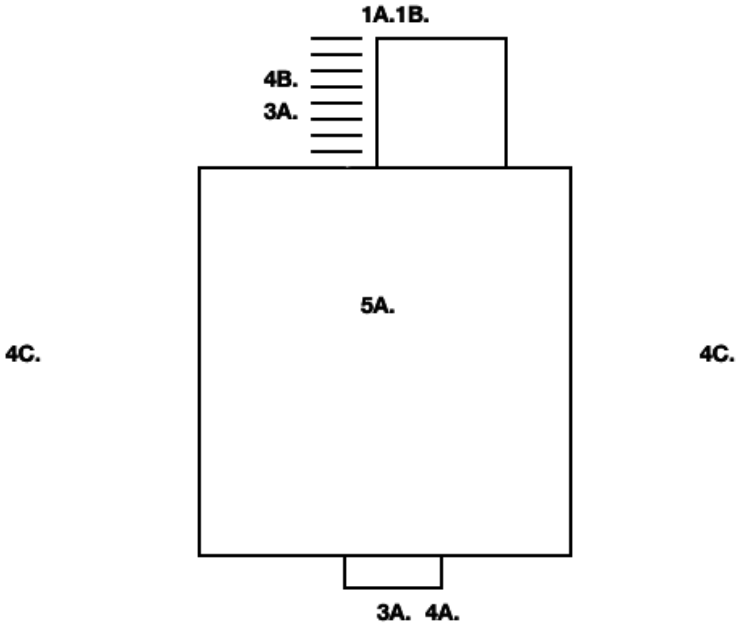
Diagram Not To Scale

FINDING-Evidence of Subterranean Termites noted at landing pad of back stairway.
RECOMMENDATION-Rod and treat area(s) with Talstar (active ingredient: Bifenthrin), a toxic chemical registered with the State of California, Department of Agriculture, in accordance with the label directions for the control of subterranean termites.
SECTION I. $415.00.

FINDING-Subterranean Termite damage noted at landing pad of back stairway.
RECOMMENDATION-Replace damaged wood and further inspect.
(This price does not include paint. If paint is required please call Burkitts Bugs for a bid)
SECTION I. $675.00.

FINDING-Dry rot noted at 2x12 stairway stringer of back stairway and entryway step at front of house.
RECOMMENDATION-Replace damaged wood and further inspect.
(This price does not include paint. If paint is required please call Burkitts Bugs for a bid)
SECTION I. $2,325.00.

FINDING-Evidence of Carpenter Ants noted at exterior of house.
RECOMMENDATION-Treat with Talstar (active ingredient: Bifenthrin), a toxic chemical registered with the State of California, Department of Agriculture, in accordance with the label directions for the control of carpenter ants.
SECTION I. $450.00

FINDING-Earth to wood contact noted at back stairway.
RECOMMENDATION-Break earth to wood contact and further inspect.
SECTION II. $225.00.

FINDING-Faulty grade levels noted at perimeter of house.
RECOMMENDATION-Owner to maintain proper grade levels.
SECTION II. $.00.

FINDING-Inaccessible area noted at subarea due to no access.
RECOMMENDATION-Make areas accessible and further inspect.
THIS IS A FURTHER INSPECTION ITEM. $425.00
