WOOD DESTROYING PESTS AND ORGANISMS INSPECTION REPORT

Building No.	Street	City	ZIP	Date of Inspection	Number of Pages
1012 A	Poppy St	Chico	95928	04/13/2026	6

Report # : 43464
Registration # : PR3779
Escrow # :
☐ CORRECTED REPORT

GENERAL DESCRIPTION:
Single family residence; furnished

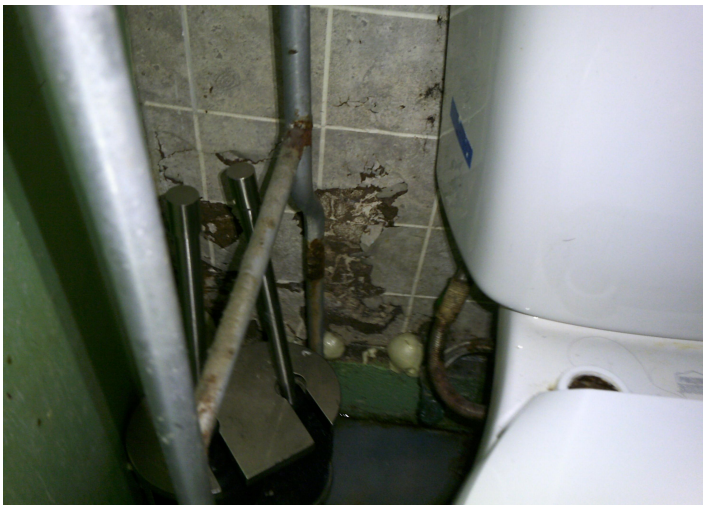
10A - Section I
FINDING: Evidence of subterranean termites were noted at the bedroom and bathroom walls, baseboards, door jambs and trim.

RECOMMENDATION: Remove accessible termite shelter tubes. Chemically treat the soil at all probable entry points with an approved termiticide in the entire structure for the control of subterranean termites. This may included drilling the concrete slab along the perimeter of the garage walls, drilling the concrete patios and/or walkways abutting the foundation.

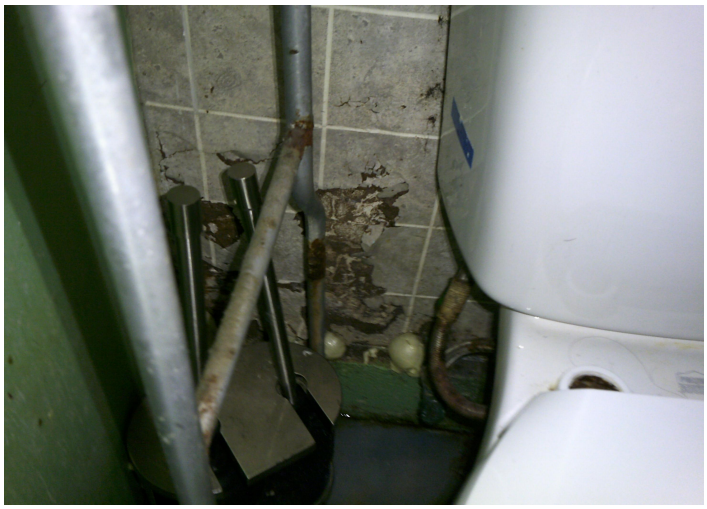
10B - Section I
FINDING: Stains, fungus damage and subterranean termite damage were noted at the bathroom wall paneling. Damage may extend into inaccessible areas.

RECOMMENDATION: Interested parties should engage the services of a licensed contractor to check for leaks and to perform any corrective work needed. Remove the fungus and subterranean termite damaged portions of the wall paneling. Call for a reinspection of the inaccessible areas. The inaccessible areas will be inspected for a fee if made accessible by the interested parties at his/her expense. A supplemental report will be filed at such time. No opinion is rendered concerning the conditions in the area at this time. Replace with new material.

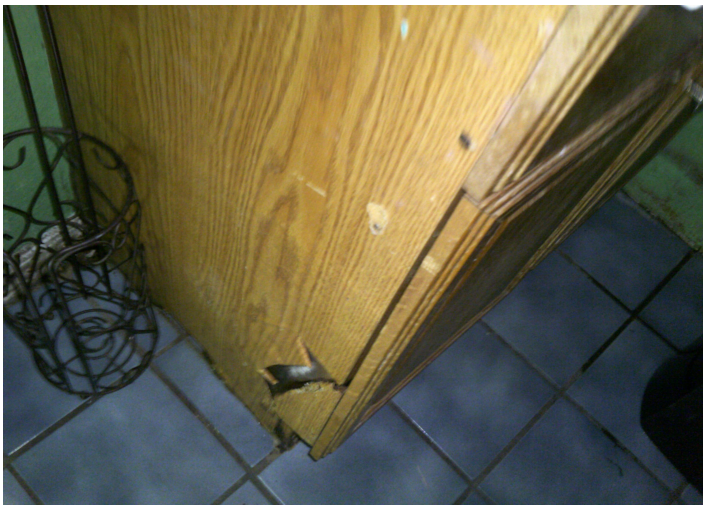
10D - Section I
FINDING: Stains, moisture damage, fungus damage and/or subterranean termite damage were noted at the bathroom sink cabinet. Damage may extend into inaccessible areas.

RECOMMENDATION: Interested parties should engage the services of a licensed plumber to check for leaks and to perform any corrective work needed. Remove the moisture damaged, fungus damage and subterranean termite damaged portions of the bathroom sink cabinet. Call for a reinspection of the inaccessible areas. The inaccessible areas will be inspected for a fee if made accessible by the interested parties at his/her expense. A supplemental report will be filed at such time. No opinion is rendered concerning the conditions in the area at this time. Replace with new material.
