WOOD DESTROYING PESTS AND ORGANISMS INSPECTION REPORT

Building Address:	Date of Inspection	Number of Pages
350 Idyllwild Cir., Chico , CA 95928	09/18/2026	6

Report # W10136
Lic. Registration # PR 8169
Escrow #

General Description:
Single story Single family residence stucco siding with a composition roof and an attached garage OCCUPIED

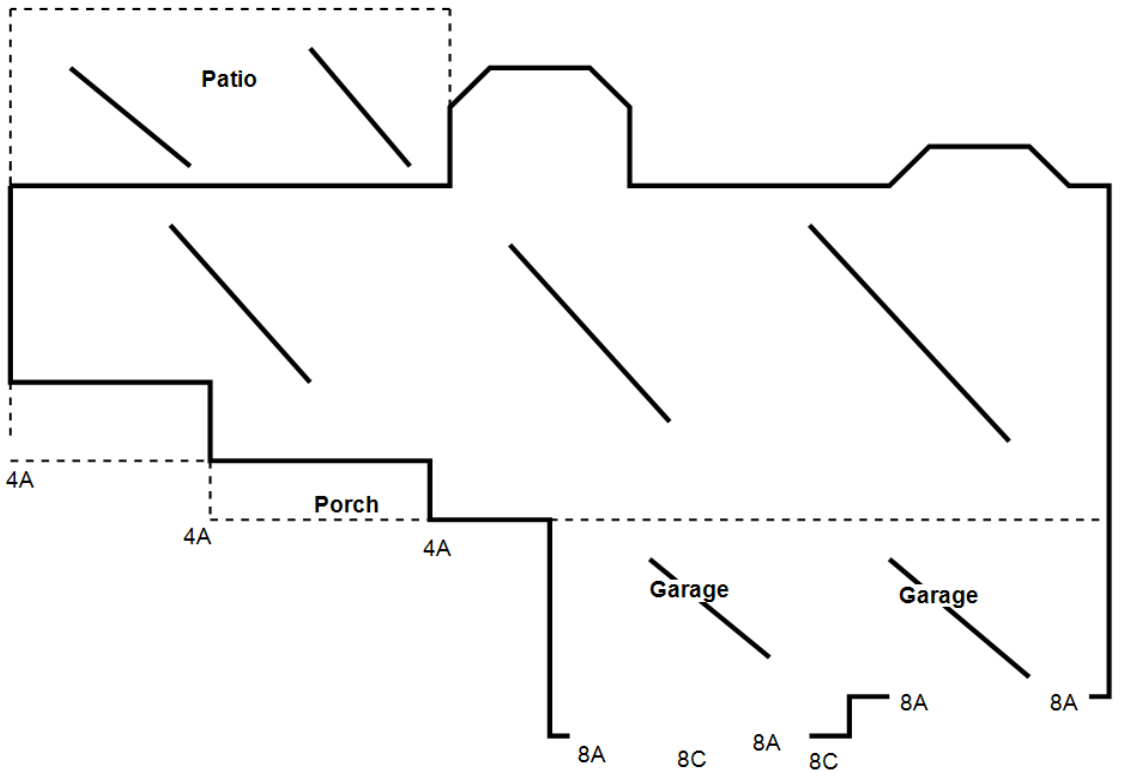
This Diagram is not to scale

4A PRICE: $775.00 (Section I)
FINDINGS: Dry-rot noted on the Column Trim as indicated on the diagram. Due to exposure to Sprinklers.
RECOMMENDATION: Remove and replace dry-rot damaged Column Trim with new material as necessary. No painting is included in this estimate. Redirect Sprinklers.

8A PRICE: $645.00 (Section I)
FINDINGS: Dry-rot noted on the Door jambs as indicated on the diagram. Due to exposure to weather
RECOMMENDATION: Remove and replace dry-rot damaged Door jambs with new material as necessary. No painting is included in this estimate.

8B PRICE: Not Estimated (Section I)
FINDINGS: Inaccessible areas at Inspected due to storage or inadequate clearance making it inaccessible for physical inspection.
RECOMMENDATION: Interested parties should engage the services of an appropriate trades person to remove storage. Call for an inspection of the inaccessible area. The area will be inspected for an additional charge not to exceed the cost of the original inspection and a supplemental report will be issued.

8C PRICE: Not Estimated (Section II)
FINDINGS: Peeling paint noted at time of inspection at barge rafter.
RECOMMENDATION: Contact proper tradesman to inspect and scrape and paint and correct if needed.
