Solar Inspection Report

Sprk Certified Solar Home

26251 Via Oceano, Mission Viejo, CA 92691
Year Built: 1974
Home Size: 1812 sq. feet
Client: Navid Nooryshokry
Inspection Date: September 24, 2026
Inspection Time: 3-4 PM
Weather: Sunny, 80 F

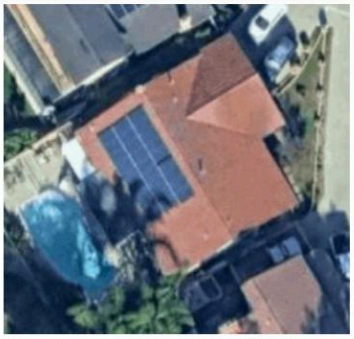
Solar Panel Orientation Optimization

Southern	0	-
Western	27	100%
Eastern	0	-
Northern	0	-
SCORE	100%

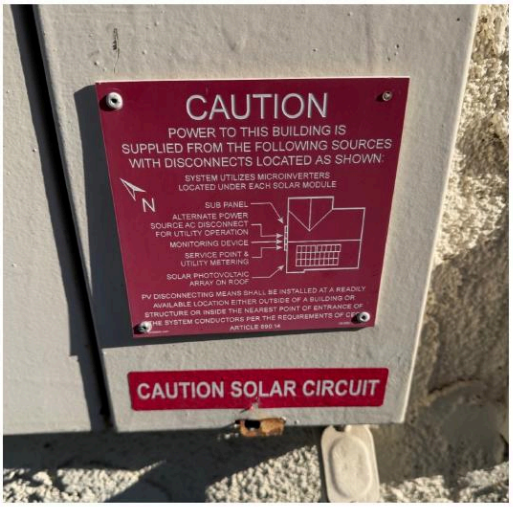
Solar Label on Exterior of Electrical Panel

Electrical panel labeled for solar?	☑ Yes ☐ No
SCORE	100%
