WOOD DESTROYING PESTS AND ORGANISMS INSPECTION REPORT

Building No.	Street	City	ZIP	Date of Inspection	Number of Pages
5050	Awaken Pl	Paso Robles	93446	08/03/2026	4

Report # : 17840
Registration # : PR 9988
Escrow # :
☐ CORRECTED REPORT

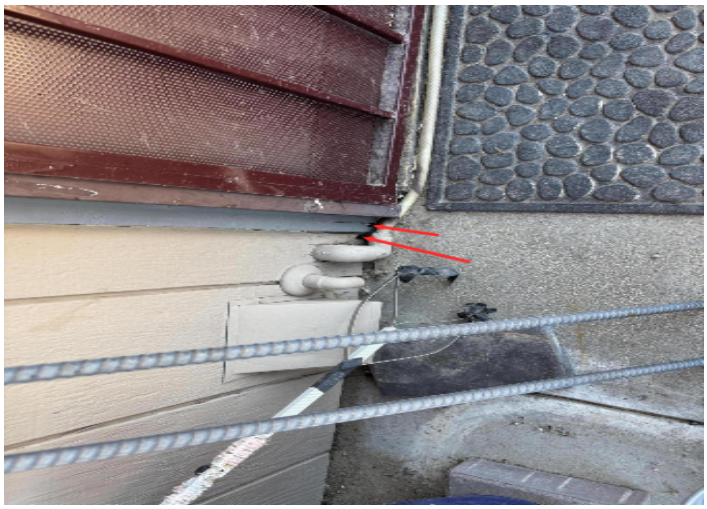
Finding 3B

3B - Fungus / Dryrot
Finding- Fungus infection and damage (dry-rot) noted at the siding and trim boards.

RECOMMENDATION- Remove and replace damaged wood members as necessary. Paint areas to a reasonable match. (Estimate is for the visible damage) (Substitute materials may be used)
