WELCOME HOME INSPECTIONS LLC
7608365500
info@welcomehomeinspections.us
https://welcomehomeinspections.us/

RESIDENTIAL INSPECTION

369 Log Ln
Crestline, CA 92325

Tamara Ortiz
07/29/2026

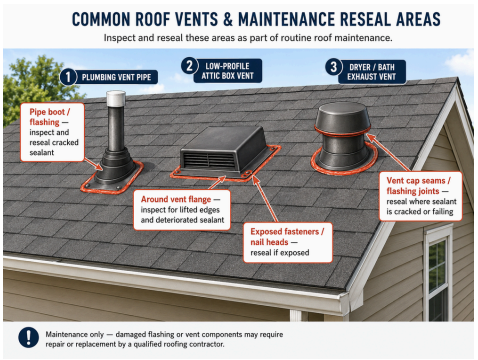
PATCHING/REPAIRS NOTED

Patching/Repairs noted at one or more areas of the roof. Recommend a qualified roofer to evaluate prior to the end of the inspection period.

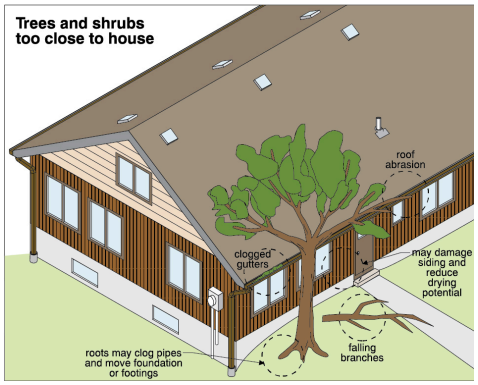
GRADING LIMITATIONS

The performance of the grading and lot drainage is limited to the conditions existing at the time of the inspection only. I cannot guarantee this performance as conditions constantly change. Heavy rain or other weather conditions may reveal issues that were not visible or foreseen at the time of inspection. Furthermore, items such as leakage in downspouts and gutter systems are impossible to detect during dry weather and can add moisture to the soil in the area around the foundation. The inspection of the grading and drainage performance in relation to moisture infiltration through foundation walls or under slabs, therefore, is limited to the visible conditions at the time of inspection, and evidence of past problems. I recommend consulting with the sellers as to any previous moisture intrusion into the home.

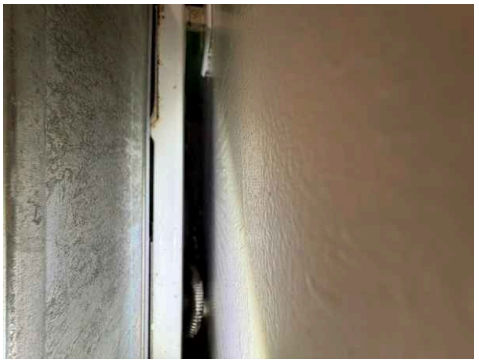
NO DISHWASHER INSTALLED

No dishwasher installed at the time of the inspection. If a concern, recommend a qualified professional install one as necessary.

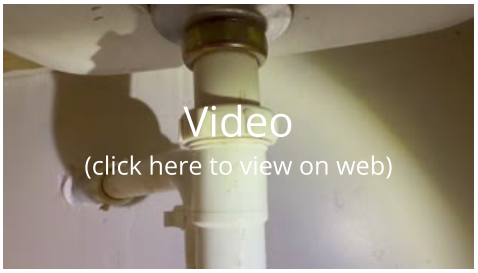
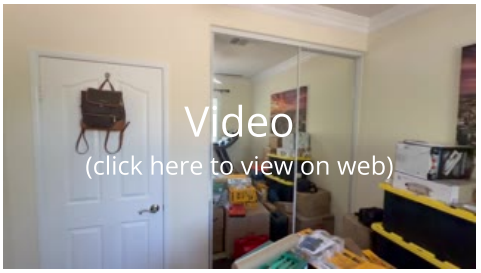
SINK AREA- SEAL FAILING

Sink area has failed or missing sealant. Recommend watertight reseal to avoid water intrusion which can cause mildew.

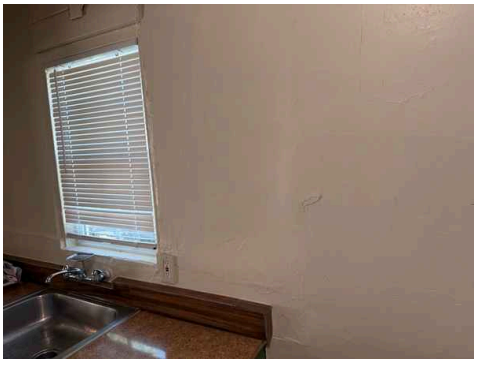
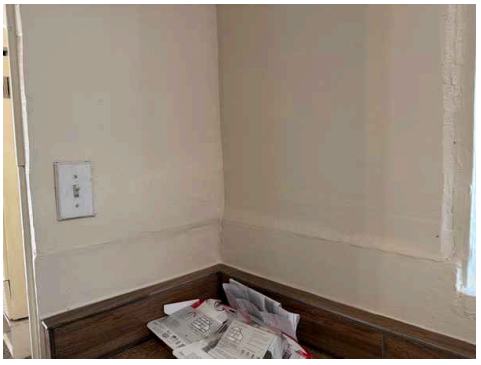
MISSING SCREEN

Window missing screen. Recommend replacement.

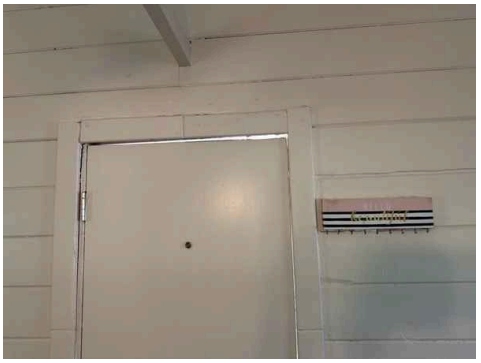
7.2.1 Doors

The door was found to have one or more gaps. This could result in energy loss. Recommend handyman or door contractor evaluate.

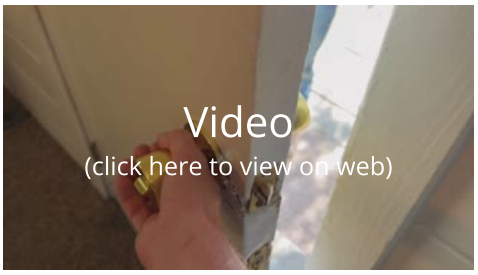
DOOR DOSEN'T LATCH

Door doesn't latch properly. Recommend handyman repair latch and/or strike plate.

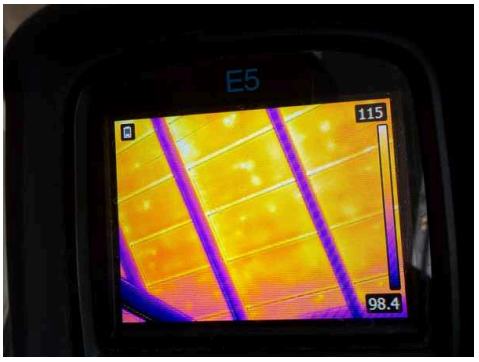
MOISTURE STAIN - MOISTURE NOT DETECTED

Stain(s) on the ceiling visible at the time of the inspection appeared to be the result of moisture intrusion. No moisture was detected at the time of inspection. The source of moisture may have been corrected. I recommend inquiring with the sellers about the stains as they would have firsthand knowledge of why the stain is present, and what repairs were carried out to address it. If they are unsure of the stains, a qualified professional is recommended to evaluate and confirm proper repairs were made.

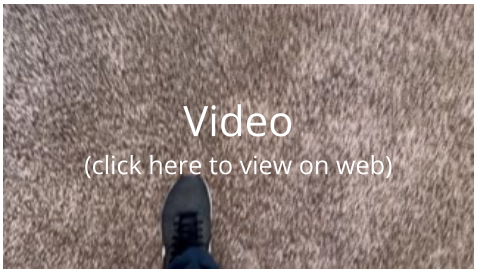
PREVIOUS REPAIRS NOTED

Previous repairs were made and patching noted. No moisture was detected at this location during the inspection. Recommend inquiring with the seller as to what repairs were made. A qualified professional can evaluate to see if satisfactory repairs were completed.

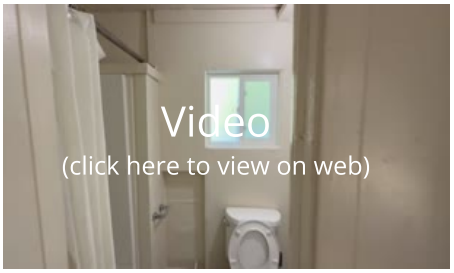
PANELING DAMAGED

There were one or more panels that were damaged at the time of the inspection. If a concern, recommend a qualified professional evaluate and repair as necessary.

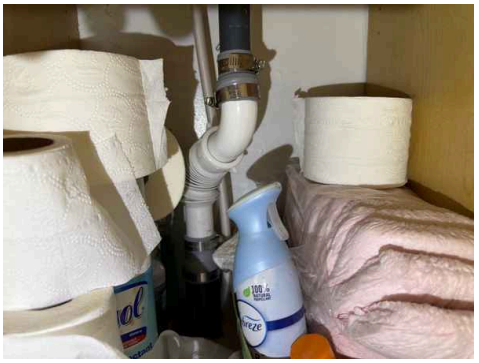
FLEX LINE NOTED

A flex drain line was located under insert location these lines are more prone to clogging and should be replaced with a smooth wall drain pipe by a qualified contractor.

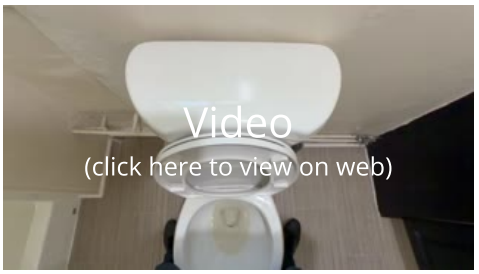
TOILET IS LOOSE

The toilet was found to be loose upon inspection. Recommend tightening, also recommend monitoring for leaks around the base seal. No leak was noted at the time of inspection.

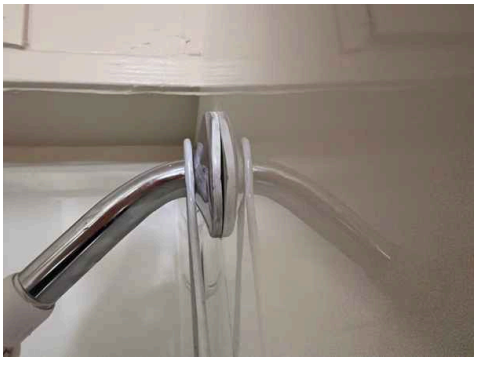
SEALANT MISSING

Bath and shower fixtures, where the tub meets the wall, as well as where the tub meets the floor should be sealed and watertight to avoid water intrusion. This is considered a maintenance item. Recommend resealing.

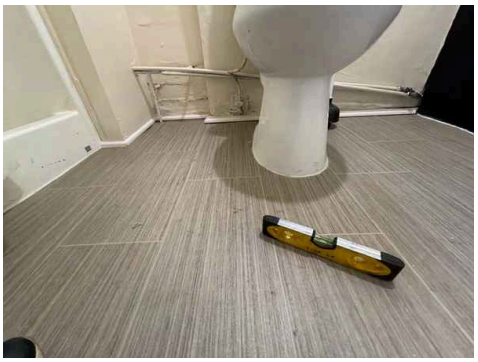
UNEVEN/SAGGING FLOORING

Flooring in this room is uneven/sagging in one or more areas. This is fairly common among older homes. Floor structure appears to be stable. If a concern recommend a qualified contractor to evaluate and correct.

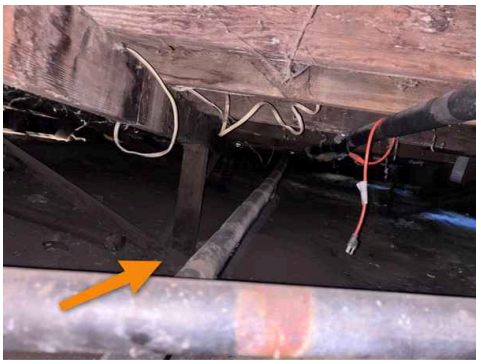
15.2.1 Basements & Crawlspaces

WOOD TO EARTH
