WOOD DESTROYING PESTS AND ORGANISMS INSPECTION REPORT

Building Address:	Date of Inspection	Number of Pages
4821 Lori Ann Ln, Irvine, CA 92604	04/10/2026	5

Report # W8700
Lic. Registration # PR 6411
Escrow #

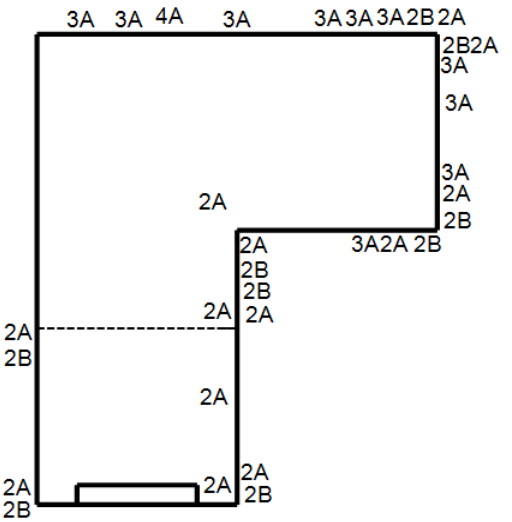
This Diagram is not to scale

2A PRICE: $2,995.00 (Section I)
FINDINGS: NOTED ON THE DIAGRAM AS 2A THERE IS EVIDENCE OF DRYWOOD TERMITES
RECOMMENDATION: CHEMICALLY TREAT INFESTED TIMBERS AT ATTIC, RAFTERTAILS, GARAGE, FASCIA BOARDS WITH A STATE OF APPROVED CHEMICAL FOR THE CONTROL OF DRYWOOD TERMITES. REMOVE OR COVER ALL ACCESSIBLE PELLETS AND FRASS. NOTE IT IS C OMMON FOR ADDITIONAL PELLETS TO SIFT DOWN OVER A PERIOD OF TIME DUE TO NORMAL HOUSEHOLD VIBRATIONS. THIS ESTIMATE IS TO COVER THE PELLETS ONE TIME ONLY. A ONE (1) YEAR WARRANTY ON TREATMENT WILL BE PROVIDED, STARTING FROM THE DATE OF COMPLETION CERTIFICATE.

2B PRICE: See 2A (Section I)
FINDINGS: NOTED ON THE DIAGRAM AS 2B THERE IS A EVIDENCE OF DRYWOOD TERMITE DAMAGE
RECOMMENDATION: REMOVE, REPLACE, AND/OR REPAIR TERMITE DAMAGE AT RAFTERTAILS, FASCIA BOARDS 2X8X8 . IF DAMAGE IS FOUND TO EXTEND INTO AREAS NORMALLY CONSIDERED INACCESSIBLE, AN ADDITIONAL CHANGE MAY BE MADE. A (1) YEAR WARRANTY WILL BE PROVIDED STARTING FROM THE DATE OF COMPLETION CERTIFICATE. PRIMER IS INCLUDED ON ALL WOOD REPAIRS

3A PRICE: See 2A (Section I)
FINDINGS: NOTED ON THE DIAGRAM AS 3A THERE IS EVIDENCE OR DRYROT.
RECOMMENDATION: REMOVE, REPLACE, AND/OR REPAIR ROT AT BACK DOOR WITH WINDOW 30X80X15/8, SHIPLAPS 1X8X8, FASCIA BOARDS 2X8X8 . IF DAMAGE IS FOUND TO EXTEND INTO AREAS NORMALLY CONSIDERED INACCESSIBLE, AN ADDITIONAL CHANGE MAY BE MADE. A (1) YEAR WARRANTY WILL BE PROVIDED STARTING FROM THE DATE OF COMPLETION CERTIFICATE. PRIMER IS INCLUDED ON ALL WOOD REPAIRS

4A PRICE: Not Estimated (Section II)
NOTED ON THE DIAGRAM AS 4A THERE IS EVIDENCE OF WATER DAMAGE.

SECONDARY PRICE: Not Estimated
SECONDARY RECOMMENDATION: REPAIR WATER DAMAGE AT BAY WINDOW AS NECESSARY.
