WOOD DESTROYING PESTS AND ORGANISMS INSPECTION REPORT

Building No.	Street	City	Zip	Date of Inspection	Number of Pages
315	Sunrise Ter	Arroyo Grande	93420-4411	06/04/2026	1 of 5

Report #: 113636

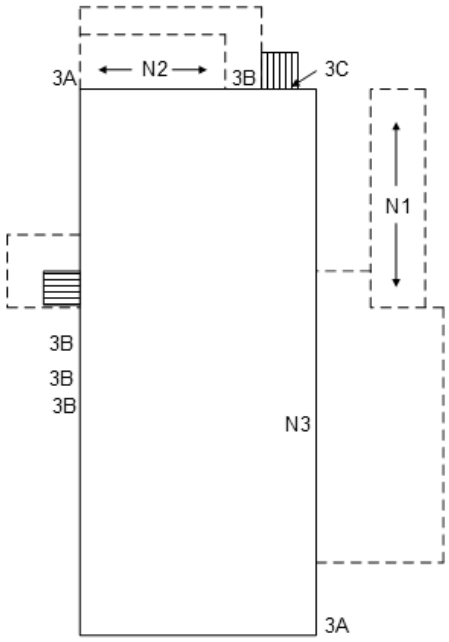
Complete Inspection Report
Diagram not to scale-Finding locations approximate

Finding:	3A	Fungus damage was found at the fascia of the eave area.
Recommendation:		Replace the fungus damaged portions of fascia as needed.
Price:	$510.00	
Finding:	3B	Fungus damage was found at the exterior wood trim.
Recommendation:		Replace the damaged portions of the trim as necessary.
Price:	$496.00	
Finding:	3C	Fungus damage was found at the handrail .
Recommendation:		Remove and replace the damaged portions of the handrail as needed to eliminate the fungus infection and damage.
Price:	$204.00
