SEPTIC SYSTEM EVALUATION REPORT

Owners Name: [redacted] Phone #: [redacted]
Property Address: 9420 Dwyer Court
City, State, Zip: Durham, CA 95938
e-Mailing Address:
Evaluator: Francisco G. Date of inspection: 8/6/2026

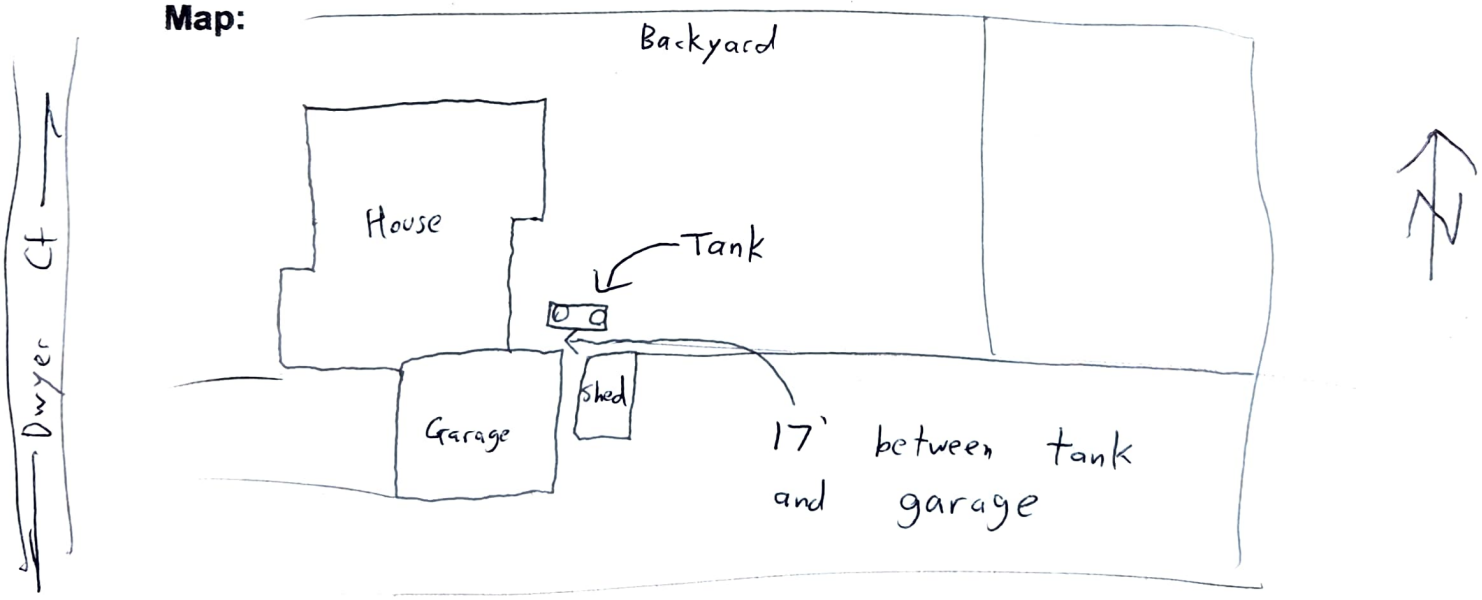
Map:

water level stayed at 7"
after hydro load test

12" of sludge on the
inlet side
2
1

3" abs inlet t

4" sdr inlet t

no sludge

concrete baffel

4" sdr outlet t

water level at 7" before
hydro load test

08/06/2026 10:13:54 AM
-6°
9'11"
dbox looks good
