WOOD DESTROYING PESTS AND ORGANISMS INSPECTION REPORT

Building No.	Street	City	ZIP	Date of Inspection	Number of Pages
10294	Red Eye Rd.	Oroville	95965	09/29/2025	5

Report # : 13420
Registration # : PR 7460
Escrow # :
☐ CORRECTED REPORT

GENERAL DESCRIPTION:
Two-story/multi level residence, raised foundation, wood exterior, metal roofing, ADU with slab foundation, wood exterior, composition roofing

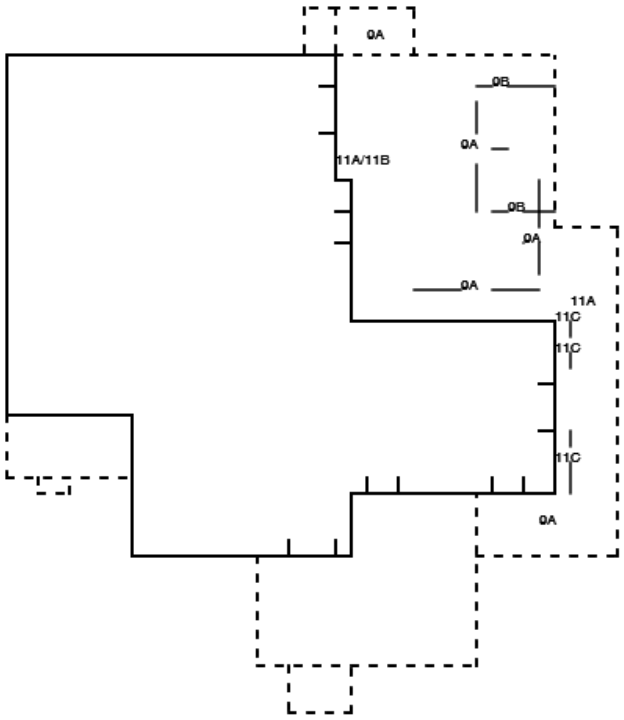
Diagram Not To Scale

9A - Section I
FINDINGS - Surface fungus noted to deck boards and joists at various locations.

9B - Section I
FINDINGS - Excessive moisture damage, fungus/ dry rot noted to deck joists at various locations.

11A - Section I
FINDINGS - Excessive moisture damage, fungus/ dry rot noted to fascia and/or barge rafters at various locations.

11B - Section I
FINDINGS - Excessive moisture damage, fungus/ dry rot noted to rafter tails.

11C - Section I
FINDINGS - Excessive moisture damage, fungus/ dry rot noted to siding at various locations.

11D - Section II
FINDINGS - Excessive moisture conditions, delaminate and/or chipped paint noted to exterior at various locations.

11E - Section I
FINDINGS - Excessive moisture damage, fungus/ dry rot noted to trim.

FINDINGS - Excessive moisture damage, fungus/ dry rot noted to door casing.

RECOMMENDATION - Remove wood destroying fungus and treat areas with an State approved fungicide per State regulations and label instructions.

RECOMMENDATION -Cut out excessive moisture damages to wood members (dry rot and/or fungus), treat with state approved fungicide and repair as needed. (no paint)

RECOMMENDATION - Cut back or cut out infected and or damaged wood members, scrape and treat with timbor as needed. Fill in, replace or repair as needed. Prime paint only upon owners request.

RECOMMENDATION- Remove and replace damaged siding or skirting with matching or harmonizing style material. If further damage is exposed during removal of damaged siding, a supplemental report will be submitted with new findings and recommendations for correction.

RECOMMENDATION - Other trades to repair.

RECOMMENDATION -.Cut out excessive moisture damages to wood members (dry rot and/or fungus), treat with state approved

fungicide and repair as needed. (Prime Paint Only)

RECOMMENDATION -.Cut out excessive moisture damages to wood members (dry rot and/or fungus), treat with state approved fungicide and repair as needed. (Prime Paint Only)
