WOOD DESTROYING PESTS AND ORGANISMS INSPECTION REPORT

Building No.	Street	City	ZIP	Date of Inspection	Number of Pages
1686	GILLIAM CT	RIVERSIDE	92501	08/04/2026	4

Report # : 11010
Registration # : PR9262
Escrow # :
☐ CORRECTED REPORT

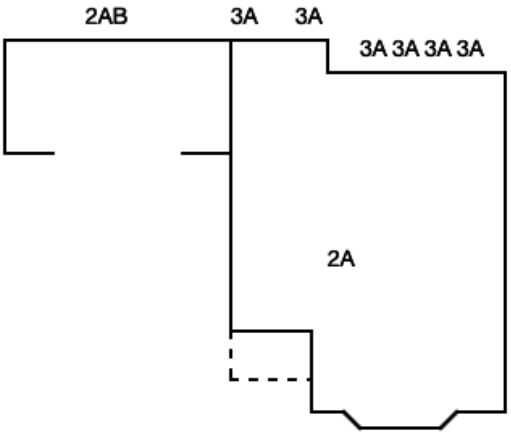
Diagram Not To Scale

FINDING - Evidence of drywood termite activity to the area wood members, as marked on diagram and under kitchen sink.

FINDING - Evidence of drywood termite damage to the 2' door jamb, 7' stucco moulding, as marked on diagram.

FINDING - Fungus/Dryrot damage to the 3' 2x6 fascia, (2) 9' stucco mouldings, (2) 3' door jamb splices as marked on diagram.

RECOMMENDATION - Locally treat for the control of drywood termites. Remove or cover the drywood termite fecal pellets in accessible areas + attic treatment.

RECOMMENDATION - Replace the drywood termite damaged wood member(s) noted in the above.

RECOMMENDATION - Replace the fungus/dryrot damaged wood member(s) noted in the above.
