WOOD DESTROYING PESTS AND ORGANISMS INSPECTION REPORT

Building Address:	Date of Inspection	Number of Pages
24715 San Andres Ln, Mission Viejo, CA 92691	10/05/2026	6

Report # W12848

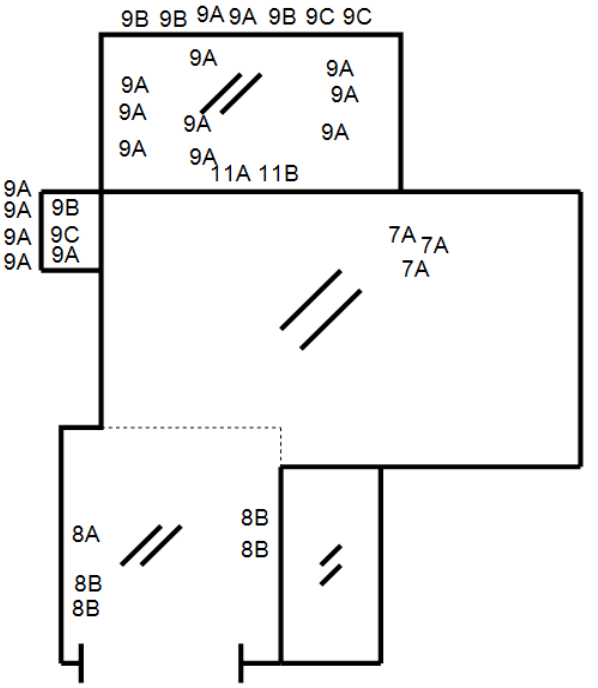
This Diagram is not to scale

7A PRICE: $2,200.00 (Section I)
FINDINGS: Evidence of dry-wood termite infestations at attic as indicated on the diagram.
RECOMMENDATION: Vacate the premises and seal the structure for fumigation with Vikane Gas. Remove or cover accessible evidence of infestation. Fumigation warranteed for two years. Fumigation awareness notice must be signed prior to fumigation. See fumigation notice for terms and liabilities.

8A PRICE: $630.00 (Section I)
FINDINGS: Dry-rot wood members found at time of inspection at side garage door as indicated on the diagram.
RECOMMENDATION: Replace dry-rot damaged wood members as necessary. No painting is included in this estimate.

8B PRICE: See 7A (Section I)
FINDINGS: Evidence of dry-wood termite infestations at garage as indicated on the diagram.
RECOMMENDATION: Vacate the premises and seal the structure for fumigation with Vikane Gas. Remove or cover accessible evidence of infestation. Fumigation warranteed for two years. Fumigation awareness notice must be signed prior to fumigation. See fumigation notice for terms and liabilities.

9A PRICE: $3,790.00 (Section I)
FINDINGS: Dry-rot wood members found at time of inspection at rafter beams and lattice posts as indicated on the diagram.
RECOMMENDATION: Replace dry-rot damaged wood members as necessary. No painting is included in this estimate.

9B PRICE: See 7A (Section I)
FINDINGS: Evidence of dry-wood termite infestations at patio covers as indicated on the diagram.
RECOMMENDATION: Vacate the premises and seal the structure for fumigation with Vikane Gas. Remove or cover accessible evidence of infestation. Fumigation warranteed for two years. Fumigation awareness notice must be signed prior to fumigation. See fumigation notice for terms and liabilities.

9C PRICE: See 9A (Section I)
FINDINGS: Evidence of termite damaged wood members noted at time of inspection at patio rafters beams and post as indicated on the diagram.
RECOMMENDATION: Replace, repair, and/or reinforce termite damaged wood members as necessary. No painting is included in this estimate.

11A PRICE: See 7A (Section I)
FINDINGS: Evidence of dry-wood termite infestations at eaves as indicated on the diagram.
RECOMMENDATION: Vacate the premises and seal the structure for fumigation with Vikane Gas. Remove or cover accessible evidence of infestation. Fumigation warranteed for two years. Fumigation awareness notice must be signed prior to fumigation. See fumigation notice for terms and liabilities.

11B PRICE: See 9A (Section I)
FINDINGS: Evidence of termite damaged wood members noted at time of inspection at eaves as indicated on the diagram.
RECOMMENDATION: Replace, repair, and/or reinforce termite damaged wood members as necessary. No painting is included in this estimate.
