WOOD DESTROYING PESTS AND ORGANISMS INSPECTION REPORT

Building No.	Street	City	ZIP	Date of Inspection	Number of Pages
1464	Kingsport Way	San Marcos	92078	08/03/2026	4

Report # : 22592
Registration # : PR1612
Escrow # :
☐ CORRECTED REPORT

GENERAL DESCRIPTION:
2 story, slab foundation, single family residence, stucco siding, concrete tile roof, and attached garage.

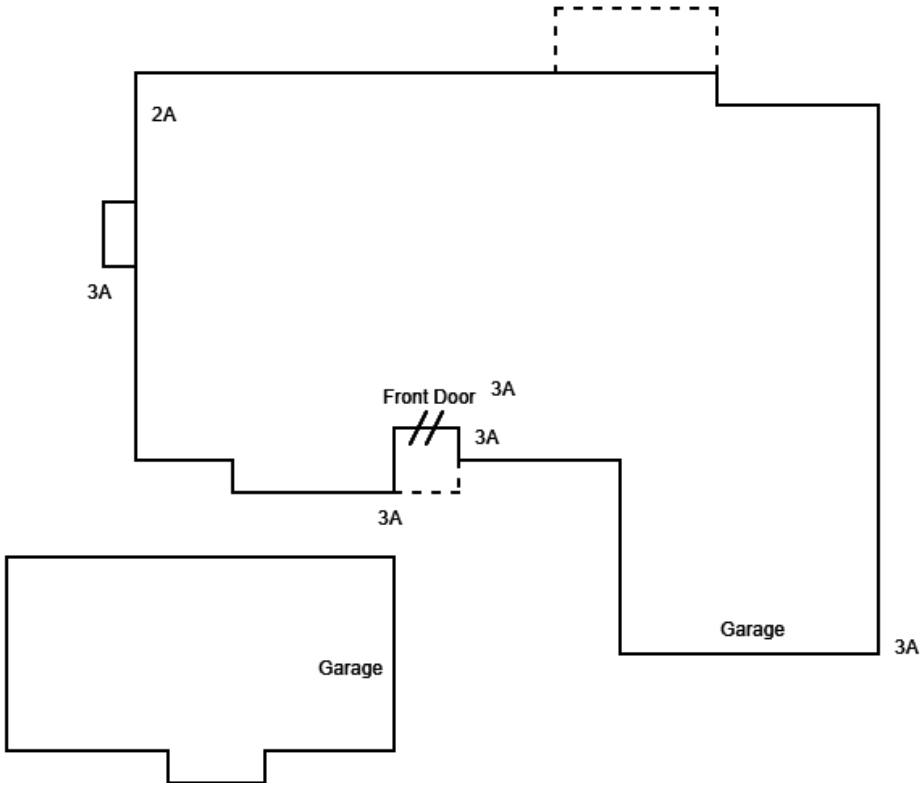
Diagram Not To Scale

2A - Section I
FINDING - Evidence of drywood termite infestations at attic as indicated on the diagram.

3A - Section I
FINDING - Dry-rot wood members found at time of inspection at fascia as indicated on the diagram.

RECOMMENDATION - EcoForce Thermal Treatment.

RECOMMENDATION - Remove and replace and/or repair the damaged wood member(s) as necessary in currently available widths and grades. Minor damage may be filled, or where impractical, reinforcement will be done. If, upon performance of the work, the damage extends into inaccessible areas, a new supplemental report with cost estimate may be issued.
If the paint is provided for us, then painting is included in the price of the bid. If paint is not provided, we will prime the repaired/replaced area only.
