WOOD DESTROYING PESTS AND ORGANISMS INSPECTION REPORT

Building No. / Street	City	Zip	Date of Inspection	Number of Pages
9620 Alto Drive	La Mesa	91941	10/15/2026	1 of 7

Report #: 103654

General Description:
Vacant Single Family One Story
Attached Garage
Raised Foundation with Cedar lite roof Roof

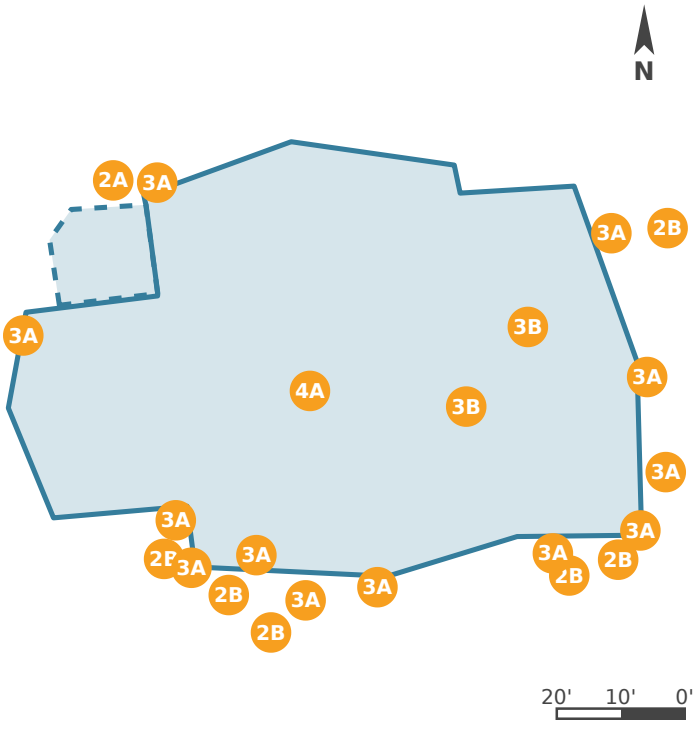
Evidence of drywood termites found in areas marked on Diagram. Attic

Evidence of drywood termites found in areas marked on Diagram. Fascia, beams trim, door jambs

Termite and fungus damaged wood found in area marked on diagram. Beam, fascia, rafters.

Surface infestation of fungus noted at area marked on diagram.

Inaccessible area noted in substructure due to inadequate clearance, marked on diagram. Portions inaccessible

Eliminate infestation with thermal pest eradication treatment. Lloyd Termite Control Company assumes no responsibility for damage to any plant life or roofing caused by this operation.

Locally treat areas marked on diagram with a registered termiticide for the control of drywood termites. Cover or remove accessible termite pellets as needed. Local treatment is not intended to be an entire structure treatment method. If infestations of wood-destroying pests extend or exist beyond the area(s) of local treatment, they may not be exterminated.

Remove and replace termite and fungus damaged wood as needed. Painting is nincluded in this estimate. If damaged wood extends into concealed or inaccessible areas, cost of repair will be in addition to estimate given.

Scrape and treat fungus infected area with fungicide as needed.
