WOOD DESTROYING PESTS AND ORGANISMS INSPECTION REPORT

Building No. / Street	City	Zip	Date of Inspection	Number of Pages
1962 Buckskin Glen	Escondido	92027	07/07/2026	1 of 6

Report #: 98719

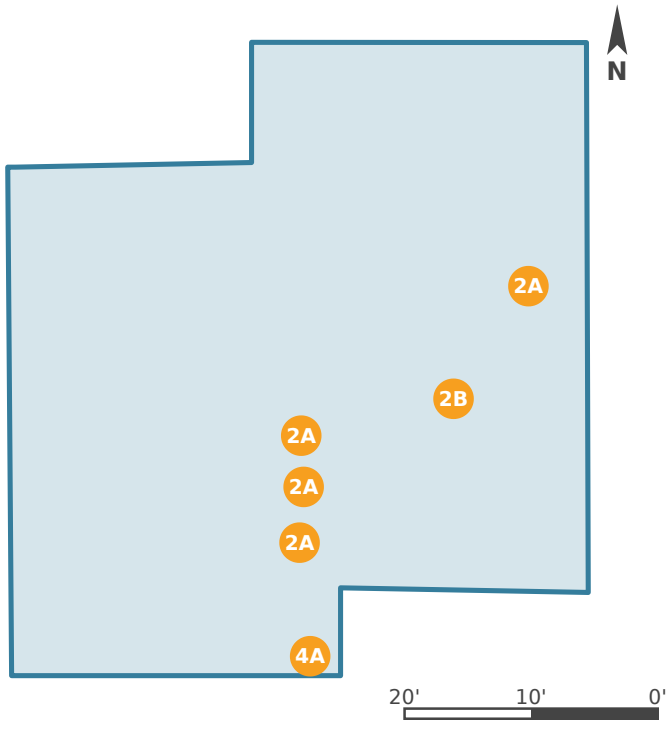
Evidence of drywood termites found in areas marked on Diagram.**4 YEAR WARRANTY ON FUMIGATION SOLAR PANELS ARE WARRANTIED FOR ANY PHYSICAL DAMAGE DURING FUMIGATION**

Water damage found in areas marked on diagram. 2x6 on step

Cover entire structure(s) and fumigate with Sulfuryl Fluoride for the elimination of drywood termites. Chloropicrin will be used as a warning agent. Cover or remove accessible termite pellets. Lloyd Termite Control Company assumes no responsibility for damage to any plant life or roofing caused by fumigation operation.

Repair water damaged areas as needed.
