WOOD DESTROYING PESTS AND ORGANISMS INSPECTION REPORT

Building No.	Street	City	ZIP	Date of Inspection	Number of Pages
518	Pleasant Ave.	Ojai	93023	10/12/2026	6

Report # : 12248
Registration # : PR8825
Escrow # :
☐ CORRECTED REPORT

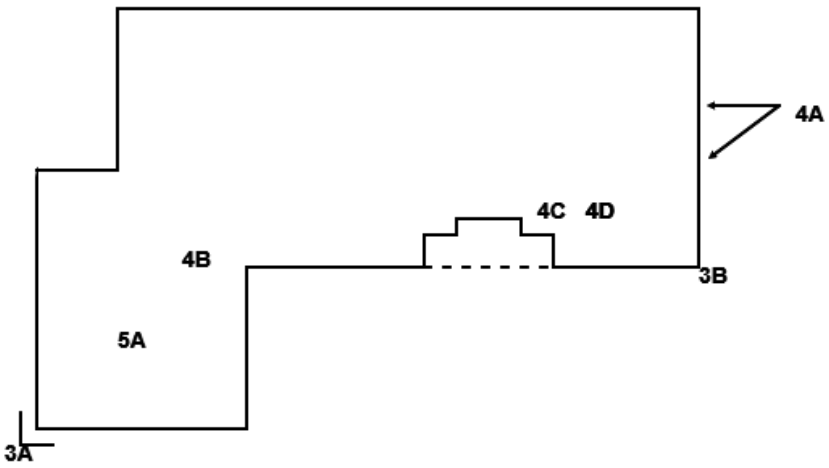
Diagram Not To Scale

GENERAL DESCRIPTION:
Single-story, single-family residence, stucco, and cider block siding, comp roof, slab foundation, occupied/furnished, attached garage,
