WOOD DESTROYING PESTS AND ORGANISMS INSPECTION REPORT

Building No. / Street	City	Zip	Date of Inspection	Number of Pages
4940 Alzeda Drive	La Mesa	91941	09/28/2026	1 of 7

Report #: 102735

General Description:
Vacant Single Family Two Story
Attached Garage
Split Foundation with Composition Roof

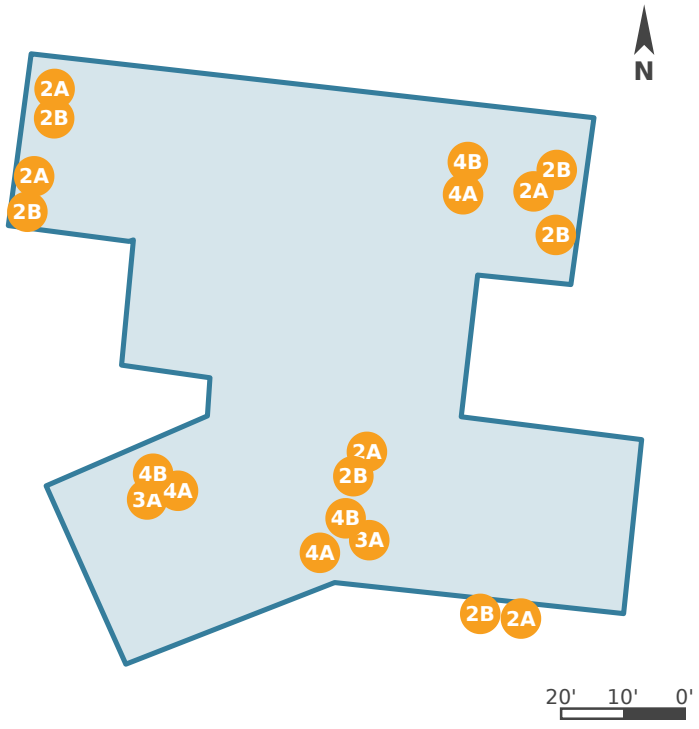
Evidence of drywood termites found in areas marked on Diagram. 4 YEAR WARRANTY ON FUMIGATION

Termite damaged wood found at areas marked on diagram. Cabinets, fascia, decking, beam.

Surface infestation of fungus noted at area marked on diagram.

Water stains found in areas marked on diagram. No visible signs of fungus at this time.

Water damage found in areas marked on diagram.
Ceiling, subarea

Cover entire structure(s) and fumigate with Sulfuryl Fluoride for the elimination of drywood termites. Chloropicrin will be used as a warning agent. Cover or remove accessible termite pellets. Lloyd Termite Control Company assumes no responsibility for damage to any plant life or roofing caused by fumigation operation.

Repair termite damaged wood as needed. Painting is included in this estimate. If damaged wood extends into concealed or inaccessible areas, cost of repair will be in addition to estimate given.

Scrape and treat fungus infected area with fungicide as needed.

Owner to contact a licensed contractor to make necessary repairs.
