WOOD DESTROYING PESTS AND ORGANISMS INSPECTION REPORT

Building No.	Street	City	Zip	Date of Inspection	Number of Pages
1163	Tuscon Ct	El Cajon	92021	04/29/26	1 of 6

Report # 103981

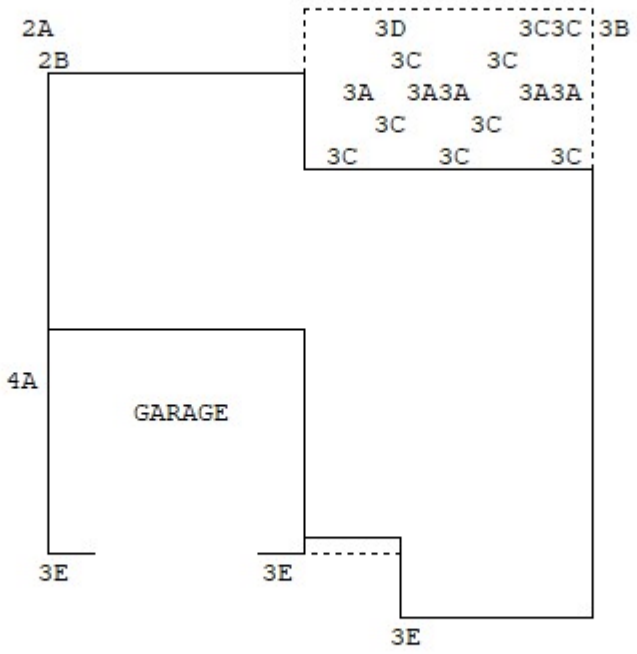
DIAGRAM NOT
TO SCALE

FINDING: Evidence of drywood termites noted in FASCIA marked 2A on diagram.

FINDING: Drywood termite damage noted in FASCIA marked 2B on diagram.

FINDING: Fungus damaged noted in PATIO JOIST marked 3A on diagram.

FINDING: Fungus damaged noted in PATIO BEAM marked 3B on diagram.

FINDING: Fungus damaged noted in PATIO BLOCKING marked 3C on diagram.

FINDING: Fungus damaged noted in PATIO POST marked 3D on diagram.

FINDING: Fungus damaged noted in EXPOSED BEAM marked 3E on diagram.

FINDING: Weathering noted at GARAGE DOOR due to outdoor elements marked 4A on diagram. No fungus noted at time of inspection.

RECOMMENDATION: Locally treat accessible areas with Termidor for the control of drywood termites. Remove or mask all accessible termite evidence. One year guarantee on areas treated only.

RECOMMENDATION: Repair damage as deemed necessary. A wood filler may be used to repair damaged areas. Estimate includes painting (1 coat). There is no paint match guarantee.

RECOMMENDATION: Remove damaged wood members and replace with new material. If damage extends into inaccessible areas, then a supplemental report will be issued with any new findings, recommendations and costs, if any. Painting of new material (1 coat) is included in the estimate. There is no paint match guarantee.

RECOMMENDATION: Remove damaged wood members and replace with new material. Minor damage may be removed and repaired. If damage extends into inaccessible areas, then a supplemental report will be issued with any new findings, recommendations and costs, if any. Painting of new material (1 coat) is included in the estimate. There is no paint match guarantee.

RECOMMENDATION: Repair door as deemed necessary.
