WOOD DESTROYING PESTS AND ORGANISMS INSPECTION REPORT

Building No.	Street	City	ZIP	Date of Inspection	Number of Pages
329	Laurel Court	Oxnard	93035	11/06/2026	6

Report # : 15959
Registration # : PR9970
Escrow # :
☐ CORRECTED REPORT

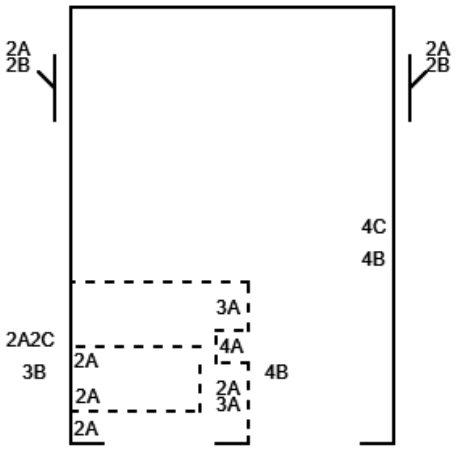
Diagram Not To Scale

FINDING - Evidence of Drywood Termites Noted at Exterior/Garage.

Evidence of termite damage noted at Barge.

Evidence of termite damage noted at Door.

3A - Section I
Fungus and/or dry rot noted at Doors.

3B - Section I
Fungus and/or dry rot noted at Jamb.

4A - Section II
Water stains and/or water damage at Flooring/Threshold.

4B - Section II
Water stains and/or water damage at Wall/Flooring at Kitchen.

4C - Section II
Water stains and/or water damage at Window Sill.

4D - Notes
Unknown staining at Garage Ceiling.

RECOMMENDATION - Fumigate the structure for the control of drywood termites. Owner/agent to prepare for fumigation as per list of instructions to be furnished by this company. Fumigant to be used is sulfuryl fluoride with chloropicrin as a warning agent. The structure must be vacated until released for re-entry by the licensed fumigator.

RECOMMENDATION - Repair the damaged wood member(s) noted in the above. Should Infestation or Infection Extend Into an Inaccessible Area, Work Will Cease, and a Supplemental Report will be Issued with Our Findings, Recommendations and Costs. Replace with New Materials As Necessary. **During the Course of Repairs, Roofing Tiles, Stucco, Drywall, Decking, Flooring, Flashing and/or Gutters May Have Possible Damages Once Repairs Are Completed Due To The Process of Repairs. Inside Out Pest Control, Inc. is Not Responsible for Correcting Any Roofing, Gutters, Drywall or Stucco if Damages Occur and Does Not Guarantee Paint Color/Texture To Any Repairs That Are Made.**

Inaccessible Area, Work Will Cease, and a Supplemental Report will be Issued with Our Findings, Recommendations and Costs. Replace with New Materials As Necessary. **During the Course of Repairs, Roofing Tiles, Stucco, Drywall, Decking, Flooring, Flashing and/or Gutters May Have Possible Damages Once Repairs Are Completed Due To The Process of Repairs. Inside Out Pest Control, Inc. is Not Responsible for Correcting Any Roofing, Gutters, Drywall or Stucco if Damages Occur and Does Not Guarantee Paint Color/Texture To Any Repairs That Are Made.**
REPLACE WITH PREHUNG DOOR.

RECOMMENDATION - Owner/agent should engage the services of a licensed Tradesman to perform any corrective work needed.
Quote Price: $Others

RECOMMENDATION - Owner/agent should engage the services of a licensed contractor to check for leaks and to perform any corrective work needed.
Quote Price: $Others
