WOOD DESTROYING PESTS AND ORGANISMS INSPECTION REPORT

Building No. / Street	City	Zip	Date of Inspection	Number of Pages
5799 Amarillo Avenue	La Mesa	91942	03/09/2026	1 of 6

Report #: 93985

General Description:
Vacant Single Family One Story
Attached Garage
Raised Foundation with Composition Roof

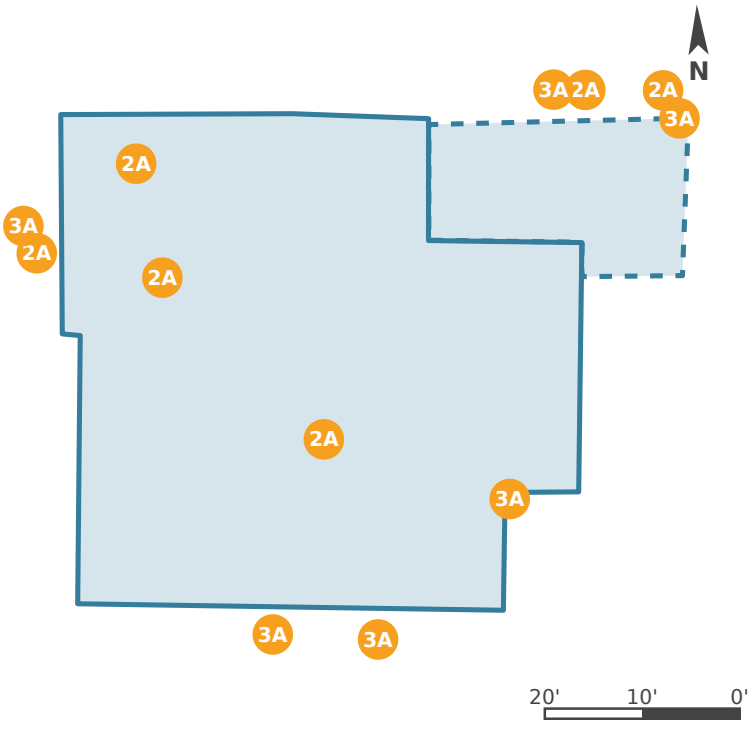
Evidence of drywood termites found in areas marked on Diagram. 4 YEAR WARRANTY ON FUMIGATION

Termite and fungus damaged wood found in area marked on diagram. Beam, fascia,

Cover entire structure(s) and fumigate with Sulfuryl Fluoride for the elimination of drywood termites. Chloropicrin will be used as a warning agent. Cover or remove accessible termite pellets. Lloyd Termite Control Company assumes no responsibility for damage to any plant life or roofing caused by fumigation operation.

Remove and replace termite and fungus damaged wood as needed. Painting is included in this estimate. If damaged wood extends into concealed or inaccessible areas, cost of repair will be in addition to estimate given.
