WOOD DESTROYING PESTS AND ORGANISMS INSPECTION REPORT

Building No. / Street	City	Zip	Date of Inspection	Number of Pages
8960 Capcano Road	San Diego	92126	11/04/2026	1 of 6

General Description:
Vacant Townhouse Two Story
Attached Garage
Slab Foundation with Composition Roof

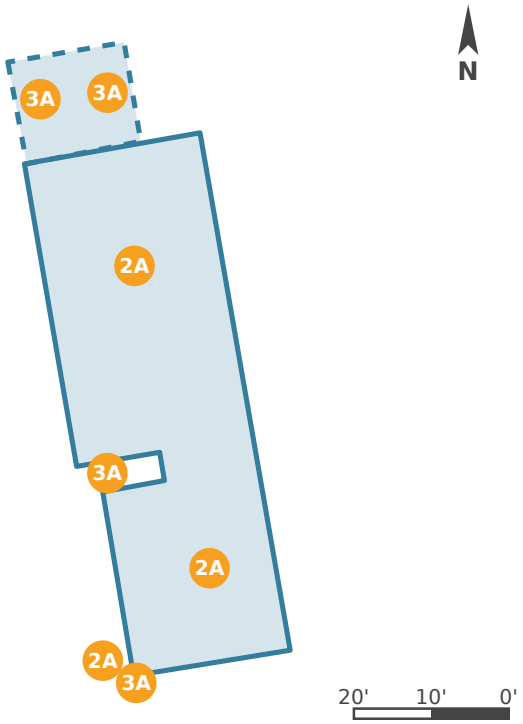
Evidence of drywood termites found in areas marked on Diagram.

Termite and fungus damaged wood found in area marked on diagram. Fascia, patio slats

Locally treat areas marked on diagram with a registered termiticide for the control of drywood termites. Cover or remove accessible termite pellets as needed. Local treatment is not intended to be an entire structure treatment method. If infestations of wood-destroying pests extend or exist beyond the area(s) of local treatment, they may not be exterminated.

Remove and replace termite and fungus damaged wood as needed. Painting is included in this estimate. If damaged wood extends into concealed or inaccessible areas, cost of repair will be in addition to estimate given.
