WOOD DESTROYING PESTS AND ORGANISMS INSPECTION REPORT

Building No.	Street	City	ZIP	Date of Inspection	Number of Pages
450	Avenida De La Vereda	Ojai	93023	11/09/2026	6

JETTY TERMITE & PEST

Report # : 12281
Registration # : PR8825
Escrow # :
☐ CORRECTED REPORT

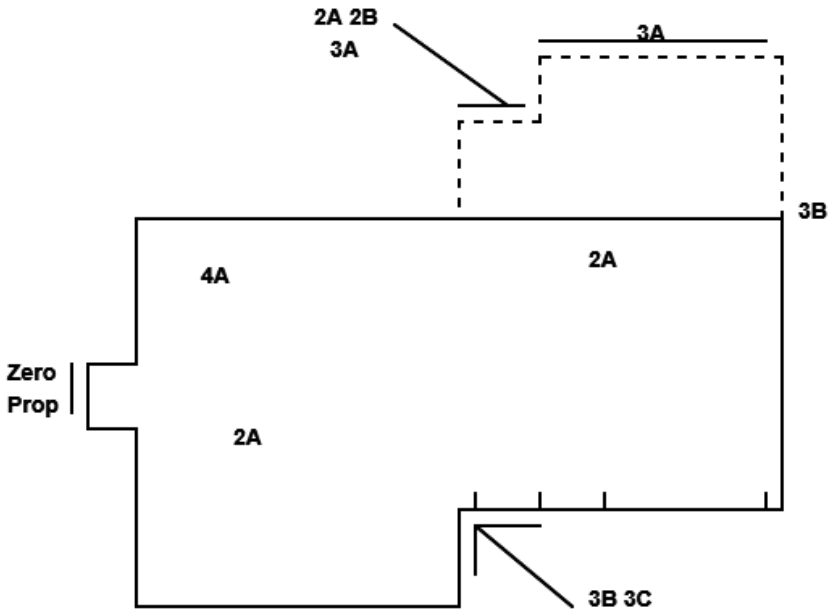
Diagram Not To Scale

FINDING: Evidence of drywood termite infestation noted at attic framing, water heater stand framing, patio fascia. Infestation(s) may extend into inaccessible area(s) of structure.

FINDING: Evidence of drywood termite damage noted at patio fascia.

FINDING: Fungus infection and damage noted at patio fascia, patio header, patio joist, patio roof sheathing.

FINDING: Fungus infection and damage noted at fascia board.

FINDING: Fungus infection and damage noted at rafter tail.

FINDING: Water staining noted at attic framing.

RECOMMENDATION: Vacate, seal, and fumigate the entire structure with registered fumigant **Vikane® (Sulfuryl Fluoride)** for the control of drywood termites. Chloropicrin will be used as a warning agent. Remove the seals and aerate the structure ready for occupancy. Owner/agent responsible for preparation of structure prior to date of scheduled fumigation. **3-year warranty included with fumigation**. Remove or cover all accessible pellets, frass or other evidence from wood destroying pests, for an additional fee of $225.00.

RECOMMENDATION: Remove, replace, reinforce, or repair with wood filler at technician's discretion. If damage extends into inaccessible area(s), a supplemental report will be made outlining new finding(s), recommendation(s), and any additional costs. All repairs will be completed using one coat of primer. Finish paint is not included in report bid unless otherwise noted. **1-year warranty on all repairs performed by this company only.**

RECOMMENDATION: Remove and replace damaged wood members with new wood. If damage extends into inaccessible area(s), a supplemental report will be made outlining new finding(s), recommendation(s), and any additional costs. All repairs will be completed using one coat of primer. Finish paint is not included in report bid unless otherwise noted. **1-year warranty on all repairs performed by this company only.**

RECOMMENDATION: Owner/Agent to consult a licensed contractor for further inspection, recommendation, and repairs.
