**Exclusive Property Inspection Report Prepared For  
Jonathan & Kristin Mead**

Property Address: 2113 Gates Ave. Redondo Beach CA.

Inspection Date: 3/9/2021

Inspector: Ron Schloderer

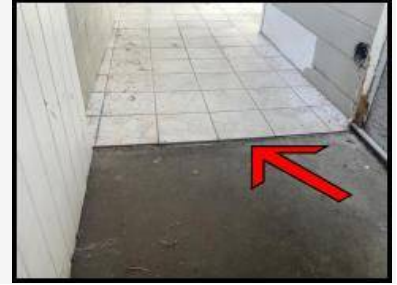
- Uneven surface joints are visible at the left rear walkway transition to the rear patio. The condition poses a trip hazard. We recommend correction using appropriate methods.

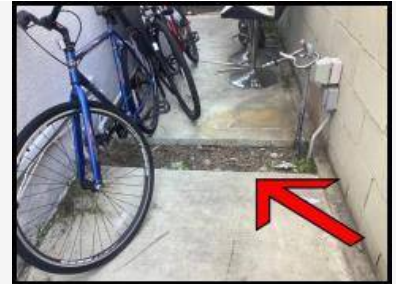
- The surface is cut out at the right side walkway. The condition poses a trip hazard. We recommend correction using appropriate methods.

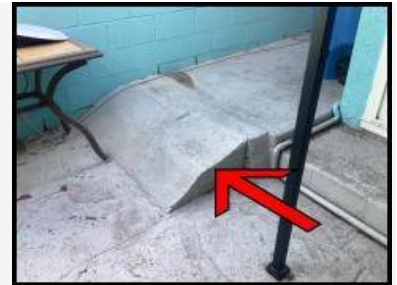
- A ramp is installed in place of steps at the right side walkway. The condition poses a trip hazard. We recommend correction using appropriate methods.

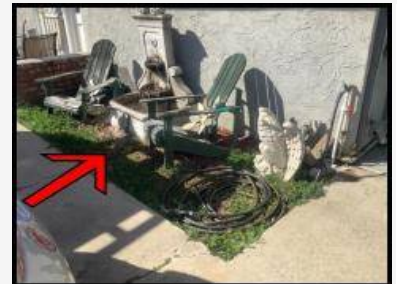
- Insufficient slope for drainage is visible adjacent to the building. Soil should slope away from the building a minimum 1/4" per foot within 6ft. of the building. We recommend correction using appropriate methods.

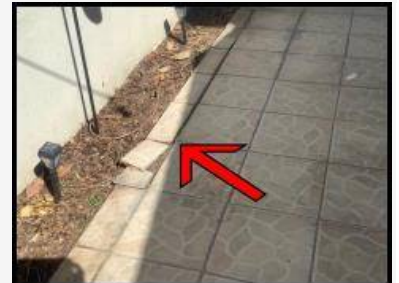
- Loose tiles are visible at the rear edge of the patio. The condition poses a trip hazard. We recommend correction using appropriate methods.

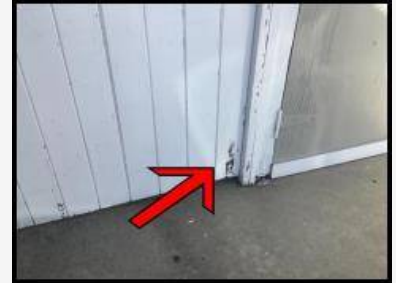
- Damage is visible to the wood at multiple locations. The damage may possibly be pest related. We recommend further evaluation by a qualified state licensed Structural Pest Control Operator.

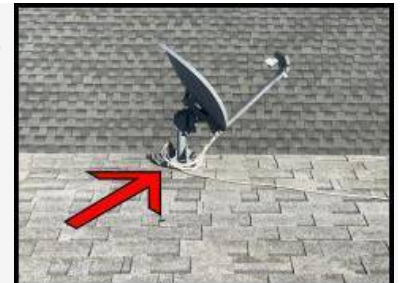
- A satellite dish mount is bolted through the roof material. The condition is conducive to roof leakage and subsequent damage. We recommend correction using appropriate methods.

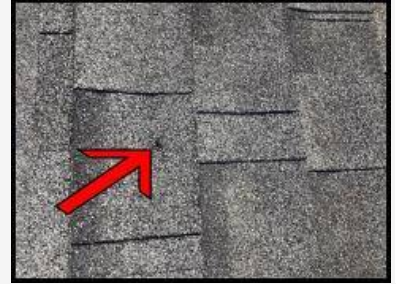
- Fasteners are lifting through shingles at multiple locations. The condition is conducive to moisture intrusion and subsequent damage. We recommend correction using appropriate methods.

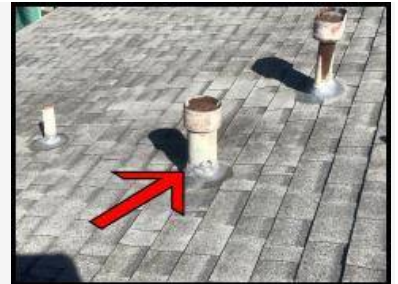
- Storm collars are absent where the furnace and water heater vent pipes transition through their flashings. The condition is conducive to moisture intrusion and subsequent damage. We recommend correction using appropriate methods.

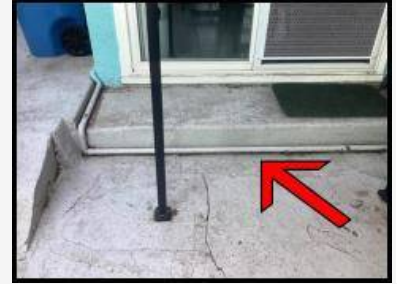
- Exposed piping subject to damage is visible at the front unit rear patio. We recommend correction using appropriate methods.

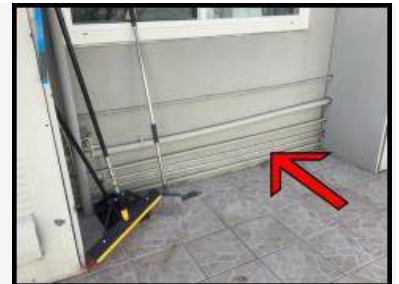
- Exposed piping at the exterior is not insulated for protection against freezing. We recommend correction using appropriate methods.

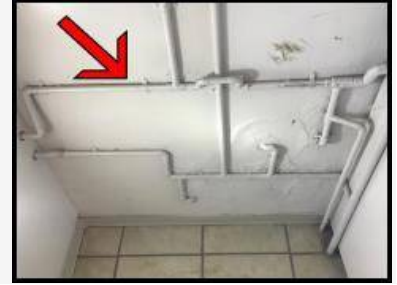
- Exposed piping subject to damage is visible at unit B laundry area. We recommend correction using appropriate methods.

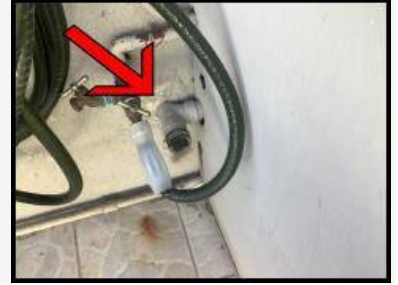
- A sanitary tee fitting is used in place of an appropriate fitting on the rear patio laundry piping. The condition is an improper installation conducive to poor drainage. Replacement with an appropriate installation is recommended.

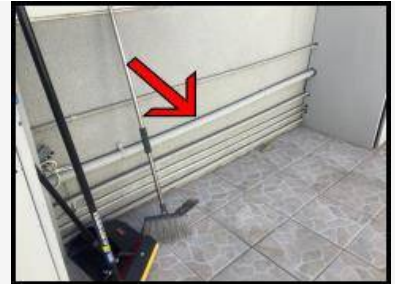
- Exposed piping subject to damage is visible at the rear patio laundry. We recommend correction using appropriate methods.

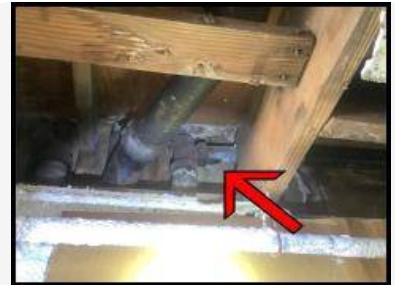
- Significant corrosion damage caused by leakage is visible on portions of the piping at the rear units where exposed in the garages. Replacement of any damaged piping is recommended.

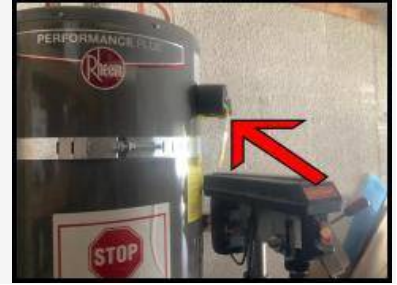
- There is no drain pipe to direct discharge water to an appropriate safe location. The condition poses a scalding hazard and the surrounding area is subject to moisture related damage in the event of water discharge from the valve. We recommend correction using appropriate methods.

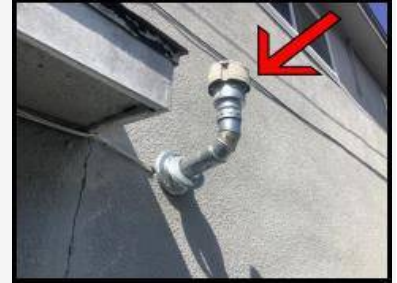
- Single wall vent piping is located outside the enclosure which is an improper installation. The vent pipe may not heat fast enough to establish a draft resulting in spillage of hazardous exhaust gases. A carbon monoxide poisoning hazard exists as a result. Replacement with an appropriate installation is recommended.

- The vent pipe terminates too close to an exterior wall, therefore the vent system may not function as intended. There should be a minimum 8ft. clearance or the pipe should terminate at an appropriate height above the adjacent roof. A vent system that does not function properly can cause spillage of hazardous exhaust gases resulting in a carbon monoxide poisoning hazard. Replacement with an appropriate installation is recommended.

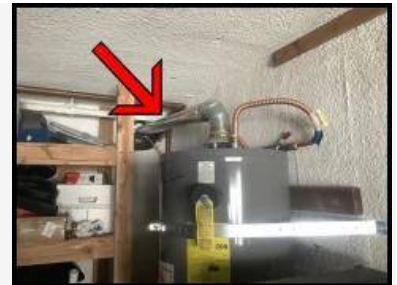
- Insufficient slope is visible on the vent connector pipe. The vent connector should rise a minimum of 1/4" per foot. The length of the vent connector pipe is also greater than the length of the vertical vent pipe which is improper. These conditions could cause spillage of hazardous exhaust gases, therefore a carbon monoxide poisoning hazard exists. We recommend correction using appropriate methods.

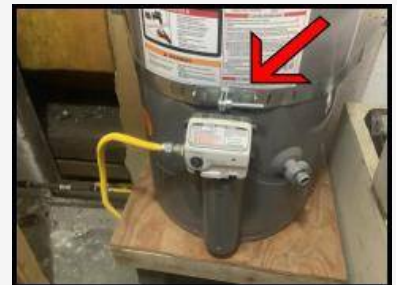
- The lower strap is located too close to the gas control (within 4") which is improper. Potential damage to the control and subsequent gas leakage can occur in the event of an earthquake. We recommend correction using appropriate methods.

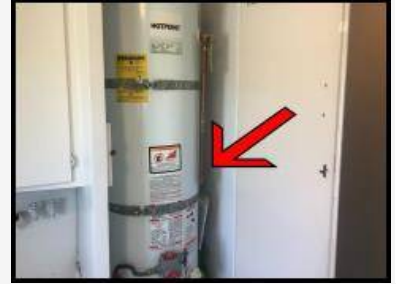
- The drain pipe terminates within the building which is an improper installation. Damage to the surrounding area can occur in the event of water discharge. We recommend terminating the drain pipe to an appropriate exterior location.

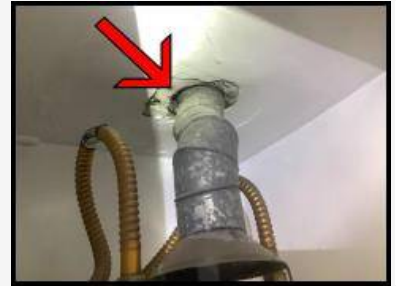
- A transition collar is absent where the vent connector attaches to the vent pipe. Spillage of hazardous exhaust gases can occur as a result, therefore a carbon monoxide poisoning hazard exists. We recommend correction using appropriate methods.

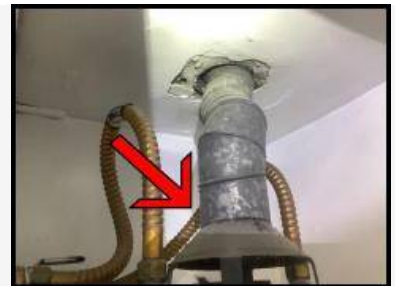
- The vent connector is not effectively joined to the draft hood and other joints with screws to prevent separation. A separated vent connector or pipe joint can cause spillage of hazardous exhaust gases resulting in a carbon monoxide poisoning hazard. We recommend correction using appropriate methods.

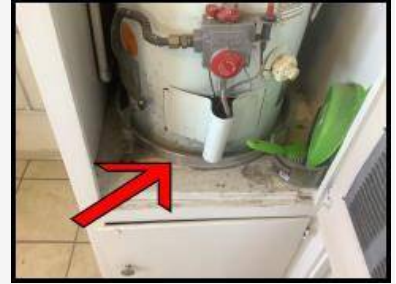
- There is no drain pipe from the catch pan to an appropriate location. Damage to the platform and surrounding area can occur in the event of leakage. We recommend correction using appropriate methods.

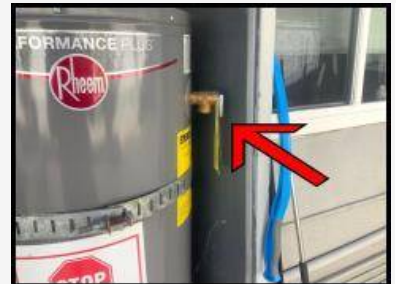
- There is no drain pipe to direct discharge water to an appropriate safe location. The condition poses a scalding hazard and the surrounding area is subject to moisture related damage in the event of water discharge from the valve. We recommend correction using appropriate methods.

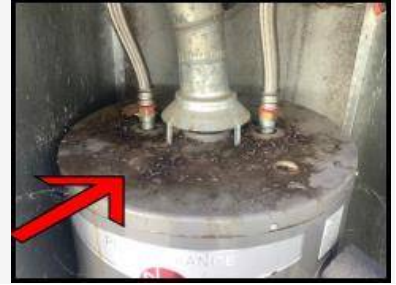
- Vermin droppings are visible on top of the tank. The condition poses an adverse health hazard from contamination. Remediation is recommended. Determining active infestation is beyond the scope of this inspection. We recommend further evaluation by a qualified state licensed Pest Control Operator.

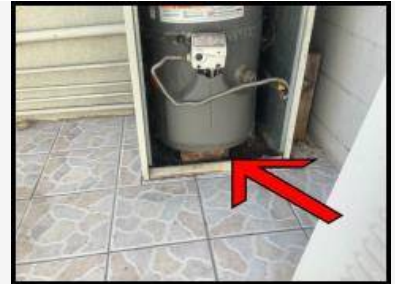
- The base of the tank rests on a loose bricks which is an improper installation. The condition makes the tank support unstable. We recommend correction using appropriate methods.

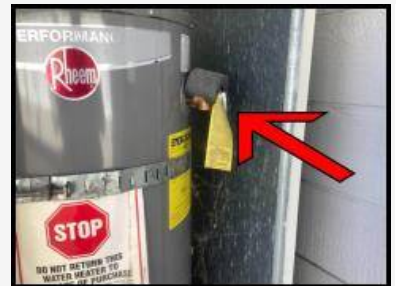
- There is no drain pipe to direct discharge water to an appropriate safe location. The condition poses a scalding hazard and the surrounding area is subject to moisture related damage in the event of water discharge from the valve. We recommend correction using appropriate methods.

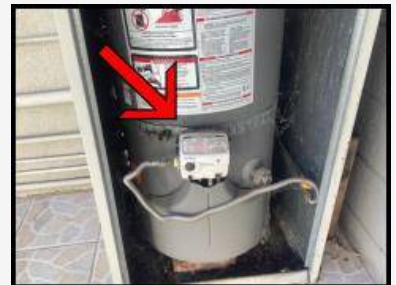
- The lower strap is located too close to the gas control (within 4") which is improper. Potential damage to the control and subsequent gas leakage can occur in the event of an earthquake. We recommend correction using appropriate methods.

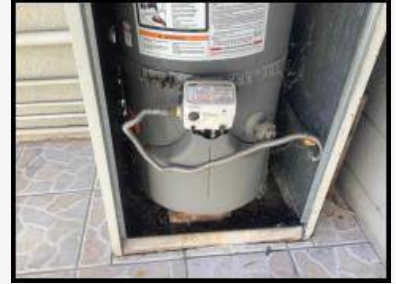
- There is no sediment trap at the gas line supplying the water heater. The purpose of a sediment trap is to catch potential debris that could clog and block an automatic gas valve in the open position, preventing the appliance from shutting off. A gas valve blocked in the open position poses a fire ignition hazard. We recommend correction using appropriate methods. Refer to the water heater manufacturers installation manual for gas piping installation instructions.

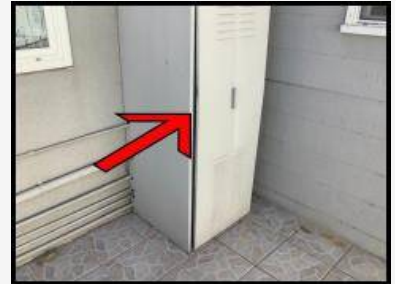
- The door is bent and does not stay attached to the enclosure. We recommend correction using appropriate methods.

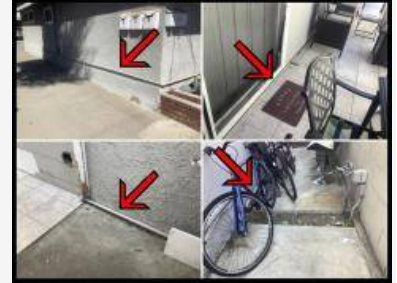
- Exposed piping subject to damage is visible at multiple locations along the front, left side, rear, and right side exterior walls. We recommend correction using appropriate methods.

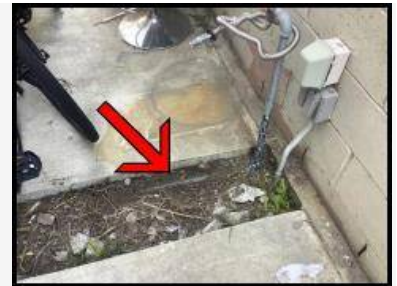
- Piping is installed at grade level, therefore subject to damage at the right side walkway. We recommend correction using appropriate methods.

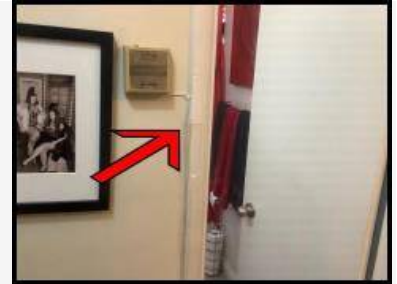
- Exposed thermostat wires subject to damage are visible on the interior wall. We recommend correction using appropriate methods.

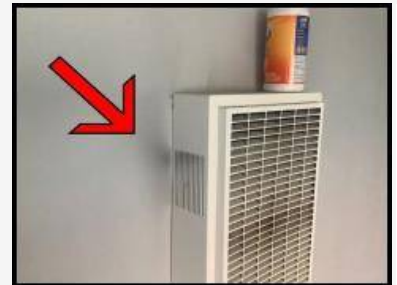
- Soot is visible on the wall cladding adjacent the makeup air vent. The condition may be an indication that spillage of hazardous exhaust gases occurs, therefore a carbon monoxide poisoning hazard exists. Further evaluation by a qualified state licensed Warm-Air Heating, Ventilating and Air-Conditioning contractor is recommended.

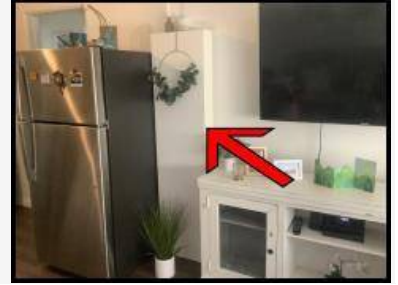
- The heater is covered over with a box, therefore not readily accessible for visual inspection. The condition is not determined. Further evaluation by a qualified state licensed Warm-Air Heating, Ventilating and Air-Conditioning contractor is recommended.

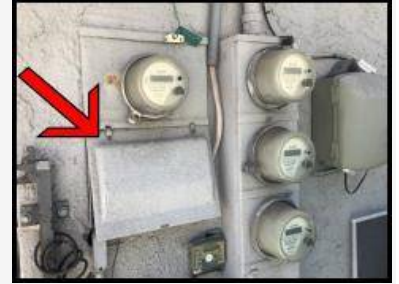
- The panel is manufactured by Zinsco. The clip to bus style of circuit breaker is conducive to failure at the point of contact. Hazards may be present in the electrical panel which could result in overheating, fire, or inability to turn off the electrical power in the home. The inspector does not remove the circuit breakers and does not perform any other disassembly of the electrical panel components, therefore visual inspection may not identify significant damage or other failures that may be present. Also, the panel components may be near / at the end of their service life due to age. Replacement with a panel meeting current construction standards should be considered for safety enhancement. We recommend further evaluation of this system / cost estimate for corrections by a qualified state licensed electrical contractor.

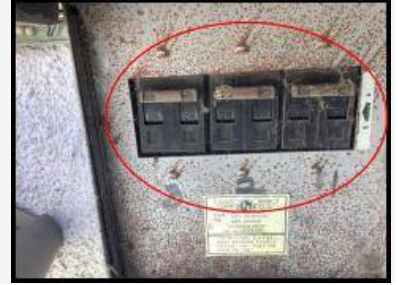
- The amperage of the service disconnects is less than 100 amp which is outdated by today's construction standards. Circuit overload can occur as a result. Upgrading the electrical system to current construction standards should be considered for safety enhancement. We recommend further evaluation of this system / cost estimate for corrections by a qualified state licensed electrical contractor.

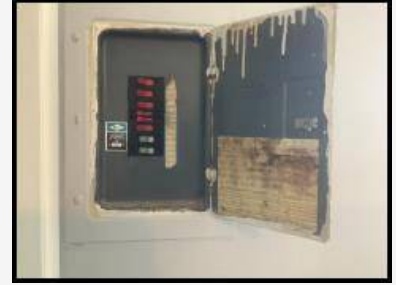
- The panel is manufactured by Zinsco. The clip to bus style of circuit breaker is conducive to failure at the point of contact. Hazards may be present in the electrical panel which could result in overheating, fire, or inability to turn off the electrical power in the home. The inspector does not remove the circuit breakers and does not perform any other disassembly of the electrical panel components, therefore visual inspection may not identify significant damage or other failures that may be present. Also, the panel components may be near / at the end of their service life due to age. Replacement with a panel meeting current construction standards should be considered for safety enhancement. We recommend further evaluation of this system / cost estimate for corrections by a qualified state licensed electrical contractor.

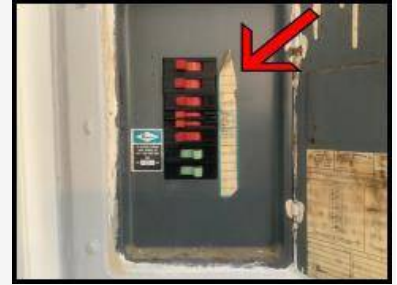
- The circuit breakers lack complete location labeling. We recommend that each breaker be properly labeled to allow persons to identify them for safe operation when and if necessary. We recommend correction using appropriate methods.

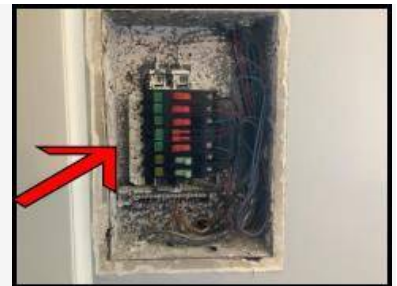
- Wall texture has been sprayed onto the components within the panel. The condition could cause failure of the components from contamination, therefore replacement of the panel may be necessary. We recommend further evaluation of this system / cost estimate for corrections by a qualified state licensed electrical contractor.

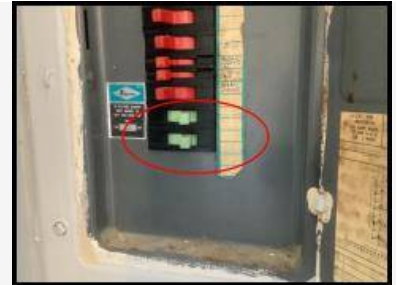
- Handle ties are absent from the 240v. circuit breakers. The function of a handle tie is to ensure that the circuit breakers will simultaneously disconnect all ungrounded conductors on the circuit to prevent electrical shock and fire ignition hazards. We recommend correction using appropriate methods.

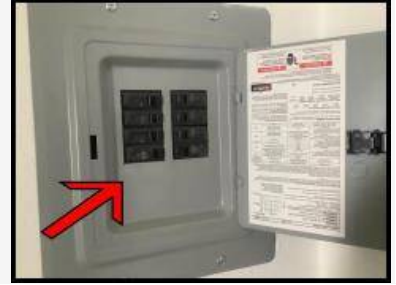
- The circuit breakers lack complete location labeling. We recommend that each breaker be properly labeled to allow persons to identify them for safe operation when and if necessary. We recommend correction using appropriate methods.

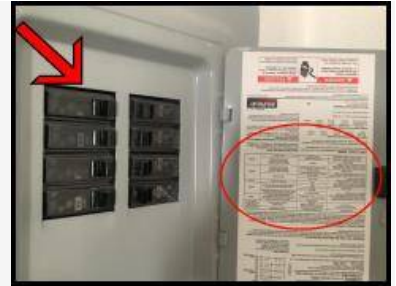
- The circuit breakers are not listed for use in the panel per the listing attached to the panel. Incompatible breakers do not offer safe overcurrent protection, therefore an electrical shock and fire ignition hazard exists. We recommend correction using appropriate methods. Determining the compatibility of the circuit breakers beyond what is listed on the panel is beyond the scope of this inspection. We recommend further evaluation of this system / cost estimate for corrections by a qualified state licensed electrical contractor.

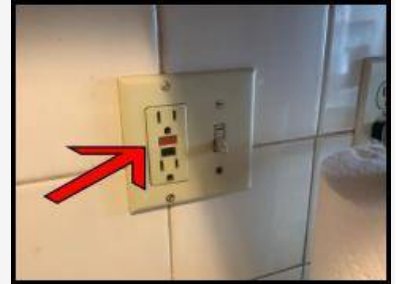
- The Ground Fault Circuit Interrupter (GFCI) protection is not functional on receptacles at the front unit kitchen counter. The condition poses an electrical shock hazard. We recommend correction using appropriate methods.

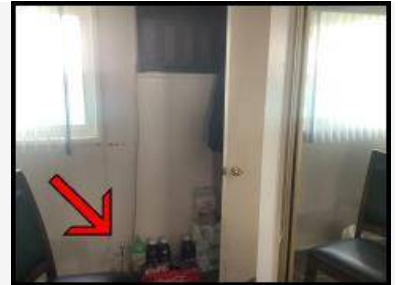
- A dedicated circuit is not installed for the receptacle outlet at the wall mount air conditioner at unit A. Circuit overload can occur as a result. We recommend correction using appropriate methods.

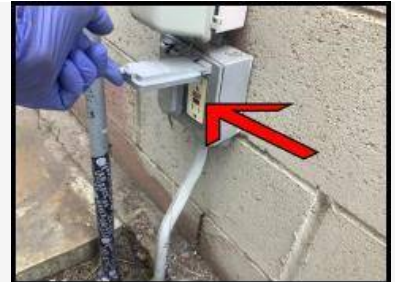
- The reset button was found tripped on a GFCI receptacle at the right side walkway. The button does not reset which may be an indication of a ground fault. We recommend correction using appropriate methods.

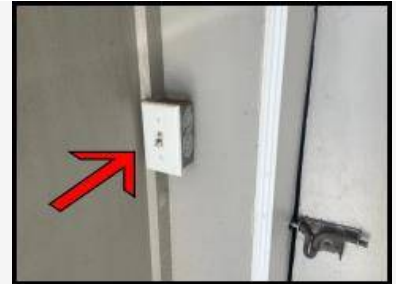
- Switches at the exterior walls are not wet location type. The condition poses an electrical shock hazard. Replacement with appropriate switches is recommended.

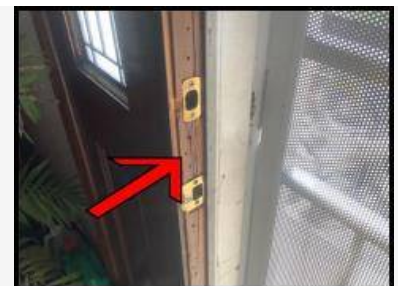
- Crack damage is visible to the jamb. We recommend correction using appropriate methods.

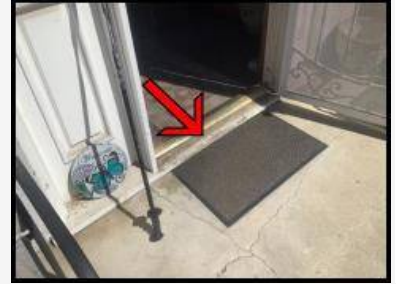
- Insufficient slope for drainage is visible on the wood threshold. We recommend correction using appropriate methods.

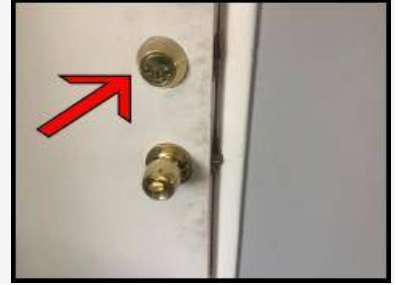
- The existing double keyed deadbolt is an improper installation that could prevent fire egress. Egress door locks should be keyless from the interior. Replacement with an appropriate deadbolt is recommended.

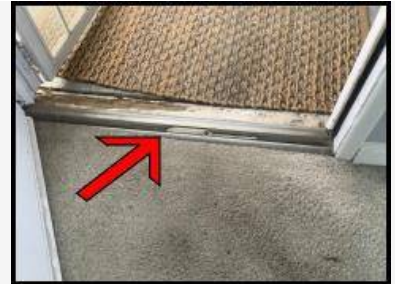
- Damage is visible to the rubber on the threshold. We recommend correction using appropriate methods.

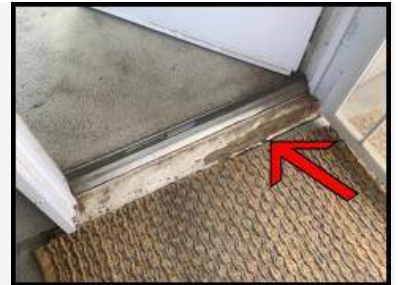
- Damage is visible to the wood threshold. The damage may be pest related. We recommend further evaluation by a qualified state licensed Structural Pest Control Operator to determine if any wood destroying organism conditions exist.

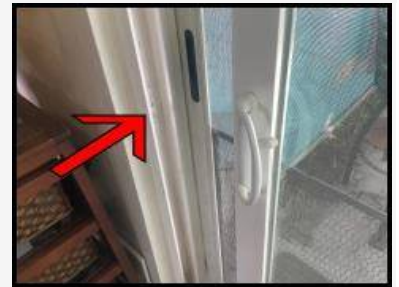
- The latch is not functional as there is no receiver. We recommend correction using appropriate methods.

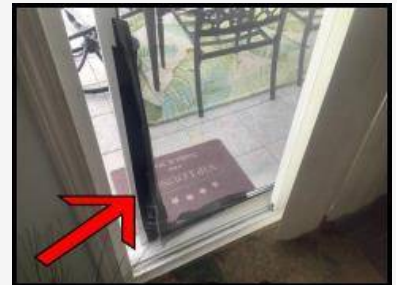
- The screen is torn. Replacement of any torn screens is recommended.

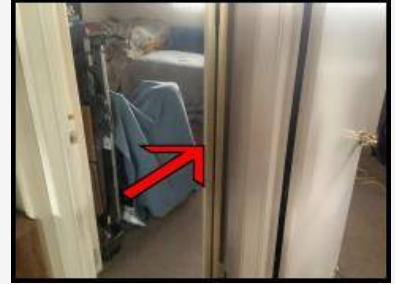
- The frame is separated from the glass at the master bedroom closet door. We recommend correction using appropriate methods.

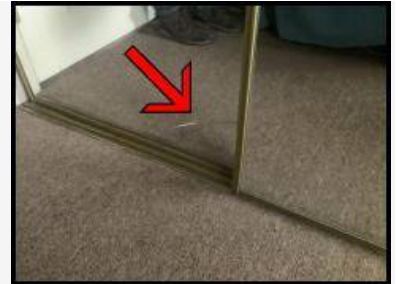
- Cracked glass is visible at the left rear bedroom closet door. Replacement of any cracked glass is recommended.

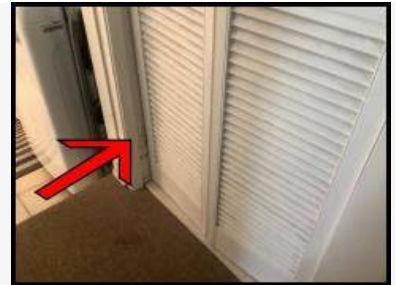
- Hinges are loose at the left rear bedroom closet doors. We recommend correction using appropriate methods.

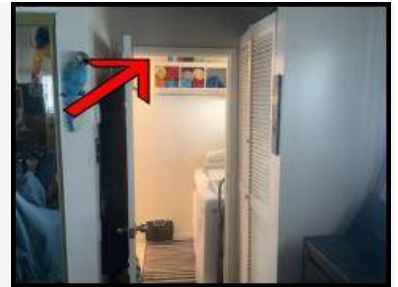
- Low head height (less than 6'-8") is visible at the left rear bedroom / bathroom door. We recommend correction using appropriate methods.

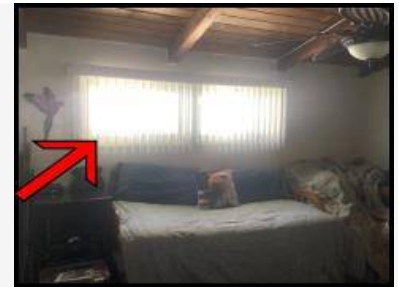
- The bedroom windows do not meet today's construction standards for emergency escape & rescue as the sills are not located within 44" from the floor and the diameter of the openings are too small. Upgrades to current construction standards should be considered for safety enhancement.

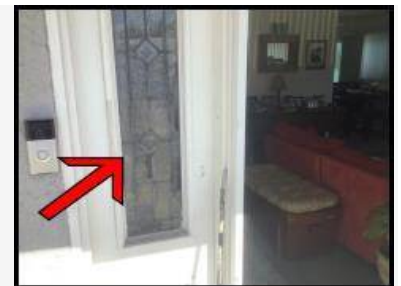
- Cracked glass is visible in the fixed window adjacent the main entry door. Replacement of any cracked glass is recommended.

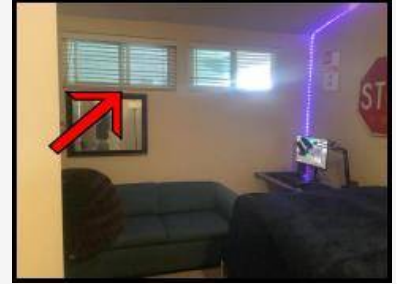
- The bedroom windows do not meet today's construction standards for emergency escape & rescue as the sills are not located within 44" from the floor and the diameter of the openings are too small. Upgrades to current construction standards should be considered for safety enhancement.

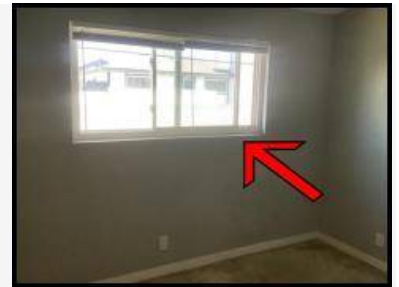
- Windows at the bedrooms do not meet today's construction standards for fire egress as the height of the sills are greater than 44" from the floor. Upgrades to current construction standards should be considered for safety enhancement.

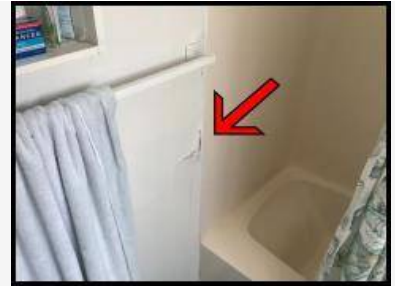
- Moisture related damage is visible to the wall cladding at the master bathroom. We recommend correction using appropriate methods.

- Moisture is conducive to adverse mold / microbial growth. Determining the presence of any type of mold / microbial growth is beyond the scope of this inspection. We recommend further evaluation by a qualified specialist to determine if such conditions exist.

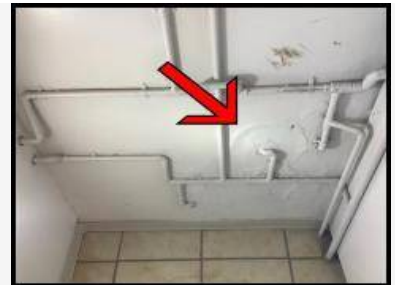
- Moisture related damage is visible to the wall cladding at the laundry area. Determining if any active leakage exists is beyond the scope of this inspection. We recommend correction using appropriate methods.

- Moisture is conducive to adverse mold / microbial growth. Determining the presence of any type of mold / microbial growth is beyond the scope of this inspection. We recommend further evaluation by a qualified specialist to determine if such conditions exist.

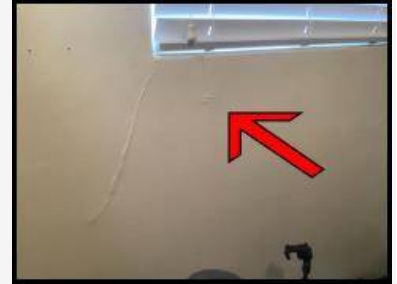
- Moisture related damage is visible to the wall cladding at the living room closet below the window. Determining if any active leakage exists is beyond the scope of this inspection. We recommend consulting with the seller to confirm the history of any moisture intrusion including remediation of such an event.

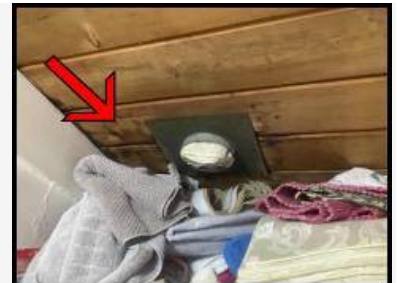
- Moisture related damage is visible to the ceiling cladding at the left rear bedroom closet. Determining if active roof leakage exists is beyond the scope of this inspection. Further evaluation by a qualified state licensed roofing contractor is recommended.

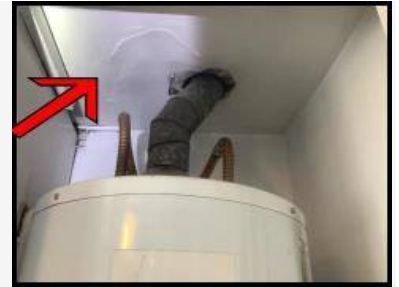
- Moisture related damage is visible to the ceiling cladding within the water heater cabinet. Determining if active roof leakage exists is beyond the scope of this inspection. Further evaluation by a qualified state licensed roofing contractor is recommended.

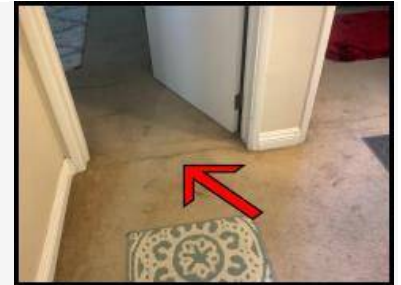
- Loose carpet is visible at multiple locations. The condition poses a trip hazard. We recommend correction using appropriate methods.

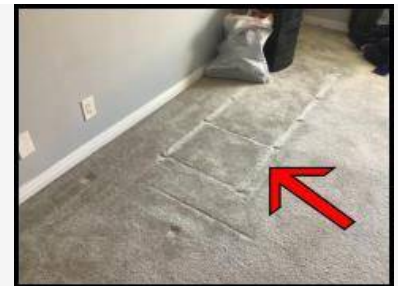
- Crush damage is visible to the carpet. Replacement may be needed.

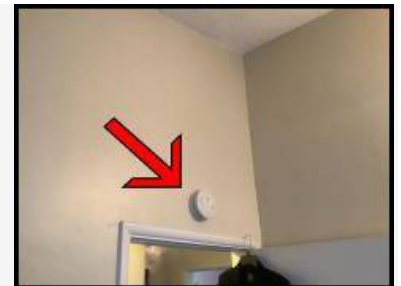
- The bedroom smoke alarms are not installed within 12" of the ceiling, therefore may not function as intended. We recommend correction using appropriate methods. Refer to the smoke alarm manufacturers installation manual for location instructions.

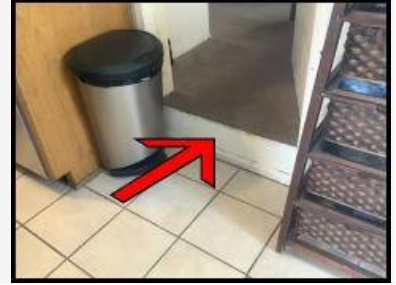
- The height of the step risers is greater than 7-3/4". The condition poses a trip hazard. We recommend correction using appropriate methods.

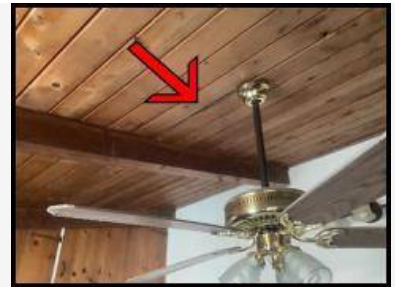
- Lamp cords are used as permanent wiring which is improper. The condition poses a fire ignition hazard from potential overheating of the wiring.

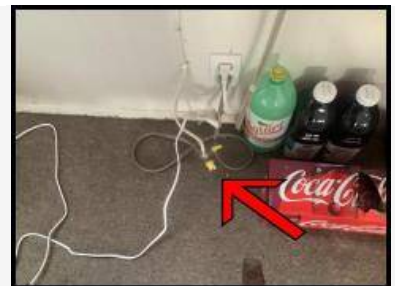
- Non metallic sheathed cable is spliced to lamp cord at the main bedroom fan. The condition is an improper installation that poses an electrical shock and fire ignition hazard. We recommend correction using appropriate methods.

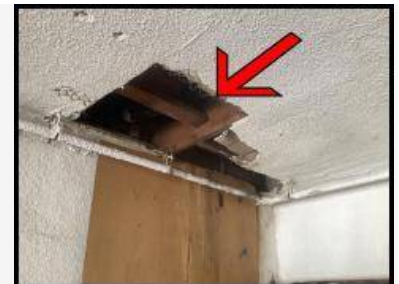
- Holes / openings are visible in the fire separation cladding. We recommend correction using appropriate methods to prevent flame spread in the event of fire.

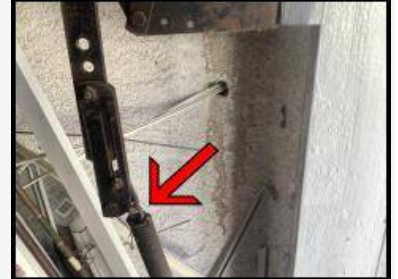
- Retaining clips to keep the springs attached to the hinges are absent. We recommend correction using appropriate methods.

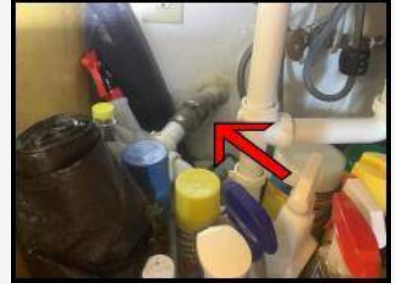
- Drain: The drain pipe slopes upward which is improper. The condition is conducive to poor drainage and sludge accumulation. We recommend correction using appropriate methods.

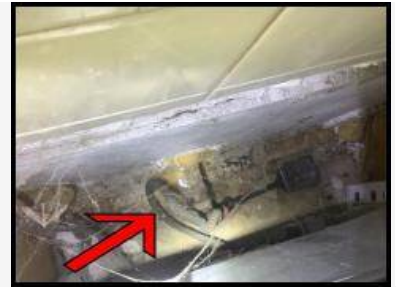
- The existing brass gas connector is an improper material by today's construction standards (photo). Replacement with a new gas connector of appropriate size & material is recommended. According to a Consumer Product Safety Commission safety alert, "these older brass connectors have a serious flaw in how their tubing was joined to their end pieces. Over time, the end pieces can separate from the tubing, and cause a serious gas leak, explosion, or fire. To our knowledge, these dangerous uncoated brass connectors have not been made for more than 30 years, but many of them are still in use. The older these connectors get, the greater the possibility of failure". <https://www.cpsc.gov/s3fs-public/gas.pdf>.

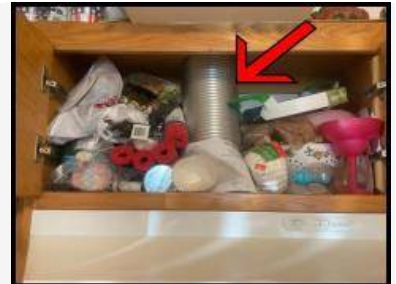
- Exhaust duct: The flex duct is an improper material as it is not a smooth wall type. Grease accumulation resulting in a fire ignition hazard can occur as a result. Replacement with an appropriate duct material is recommended.

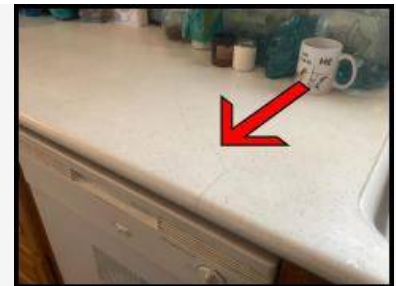
- Crack damage is visible to the counter. We recommend correction using appropriate methods.

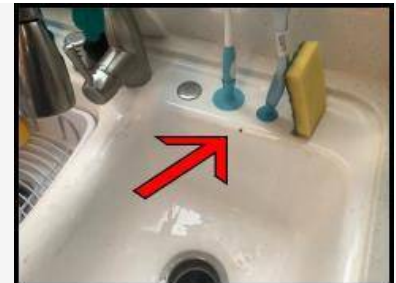
- Basin: Chip damage is visible to the surface of the basin. We recommend correction using appropriate methods.

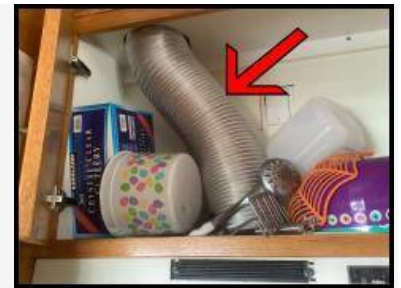
- Exhaust duct: The flex duct is an improper material as it is not a smooth wall type. Grease accumulation resulting in a fire ignition hazard can occur as a result. Replacement with an appropriate duct material is recommended.

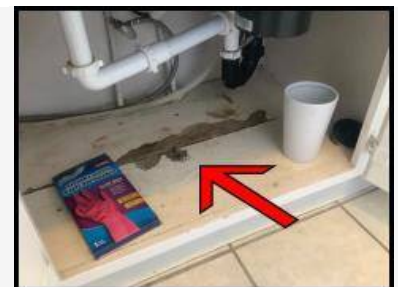
- Moisture related damage is visible to the floor of the sink base cabinet. We recommend correction using appropriate methods.

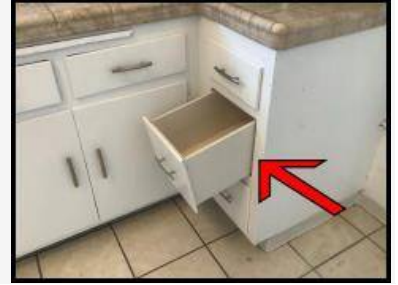
- Multiple drawers are off the tracks. We recommend correction using appropriate methods.

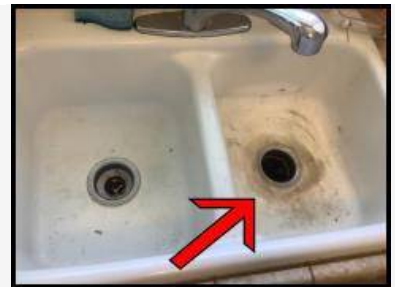
- Basin: Significant wear is visible to the to the basin.

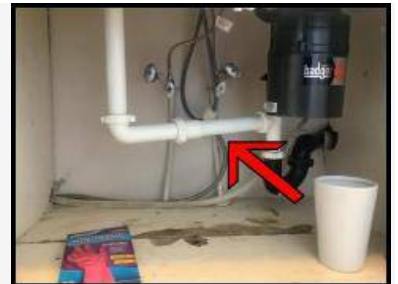
- Drain: The drain pipe slopes upward which is improper. The condition is conducive to poor drainage and sludge accumulation. We recommend correction using appropriate methods.

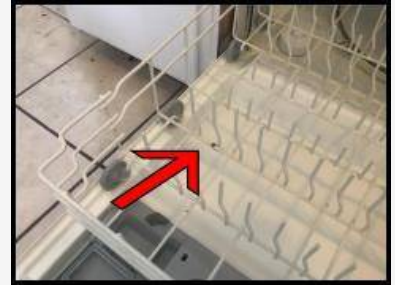
- Rust related damage is visible to the racks. We recommend correction using appropriate methods. Replacement may be needed.

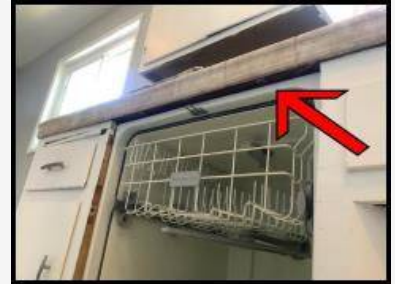
- The appliance is not secured to the cabinet. We recommend correction using appropriate methods.

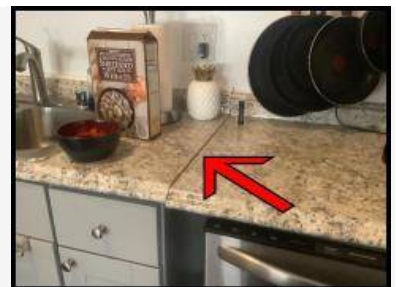
- An uneven joint is visible on the counter. We recommend correction using appropriate methods.

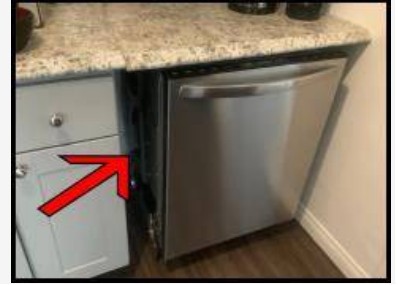
- Large gaps are visible between the base cabinet and dishwasher. We recommend correction using appropriate methods.

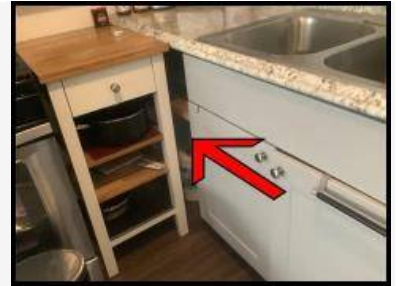
- Cabinet doors / drawers are absent at the base cabinet left of the sink. We recommend correction using appropriate methods.

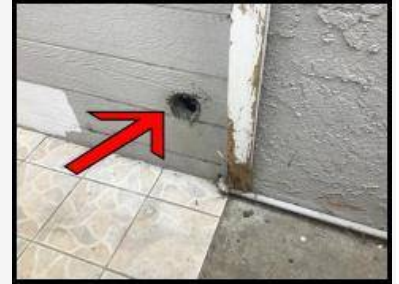
- A termination hood is absent. Replacement with an appropriate hood is recommended.

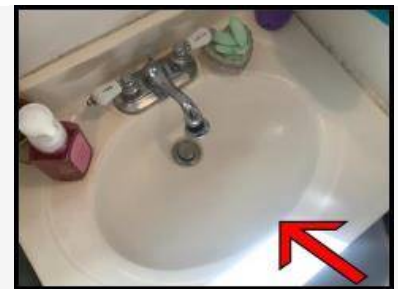
- Caution, an overflow drain is not provided in the basin for the drain stopper. Water can spill over the basin if overfilled.

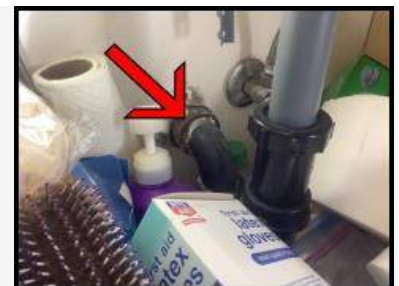
- Drain: Corrosion related damage caused by leakage is visible on the piping. Replacement of any damaged piping is recommended.

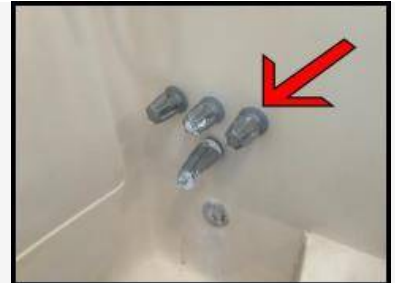
- Faucet fixture: The faucet is a manual mixing type, therefore a scalding hazard exists. The installation of a pressure balance / thermostatic control type faucet should be considered for safety enhancement.

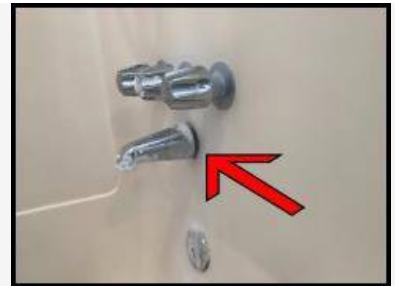
- Spout: The spout is separated from the shower wall. The condition is conducive to moisture intrusion and subsequent damage. We recommend correction using appropriate methods.

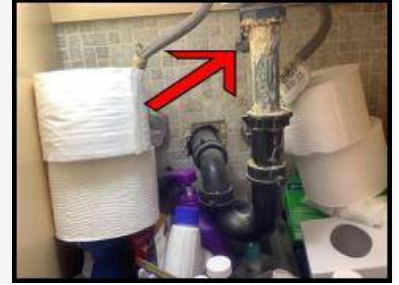
- Drain: Corrosion related damage caused by leakage is visible on the piping. Replacement of any damaged piping is recommended.

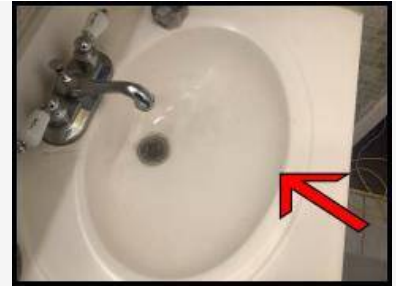
- Caution, an overflow drain is not provided in the basin for the drain stopper. Water can spill over the basin if overfilled.

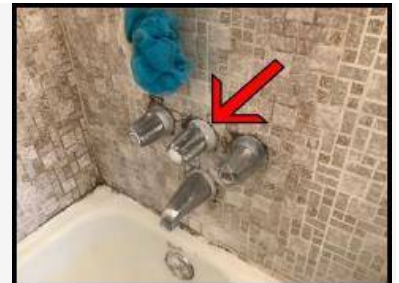
- Shower diverter: The diverter is stuck, therefore not functional. We recommend correction using appropriate methods.

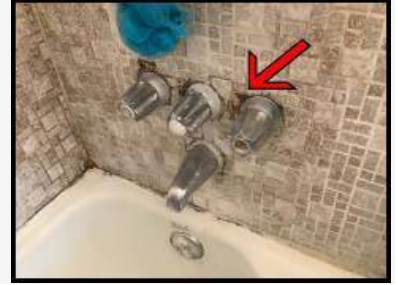
- Shower walls: Damage is visible to tiles around the fixtures. The condition is conducive to moisture intrusion and subsequent damage. We recommend correction using appropriate methods.

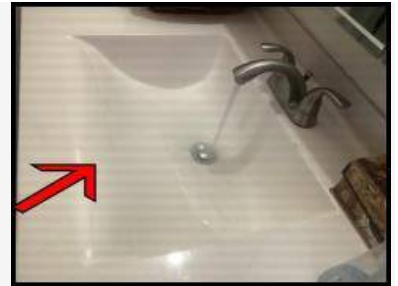
- Caution, an overflow drain is not provided in the basin for the drain stopper. Water can spill over the basin if overfilled.

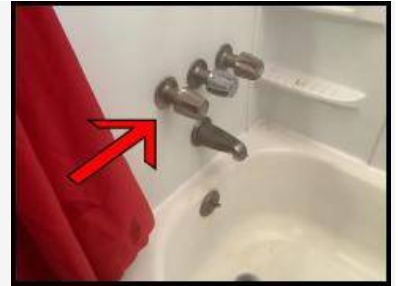
- Faucet fixture: The faucet is a manual mixing type, therefore a scalding hazard exists. The installation of a pressure balance / thermostatic control type faucet should be considered for safety enhancement.

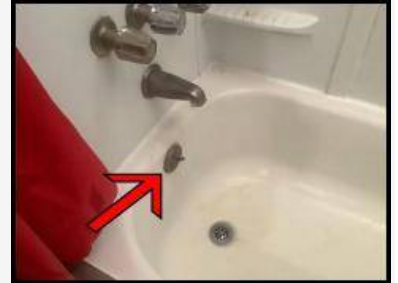
- Drain: The stopper is not functional. We recommend correction using appropriate methods.

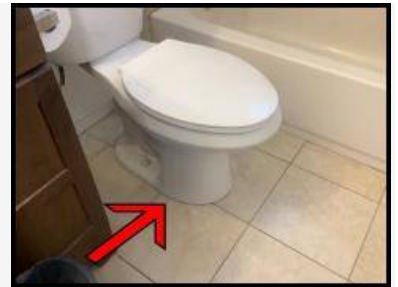
- The toilet mount is loose. The condition is conducive to leakage and subsequent damage. We recommend correction using appropriate methods.

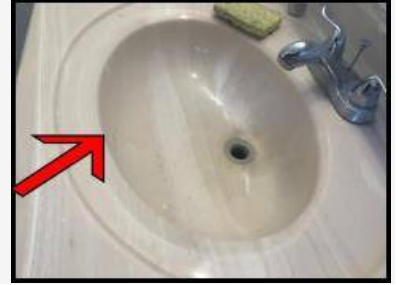
- Caution, an overflow drain is not provided in the basin for the drain stopper. Water can spill over the basin if overfilled.

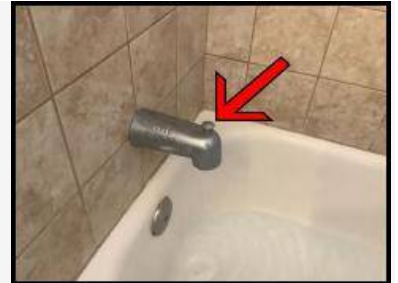
- Shower diverter: The diverter does not function as intended as water flows from the tub spout and shower head at the same time. We recommend correction using appropriate methods.

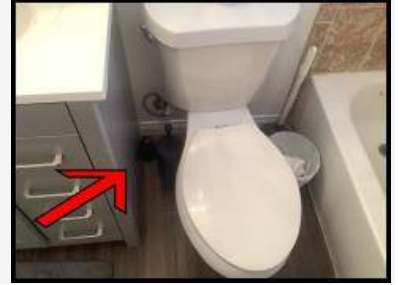
- Side clearance is insufficient between the toilet and cabinet. We recommend correction using appropriate methods.

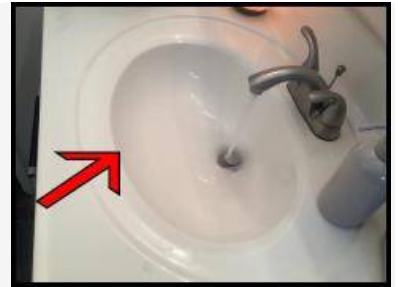
- Caution, an overflow drain is not provided in the basin for the drain stopper. Water can spill over the basin if overfilled.

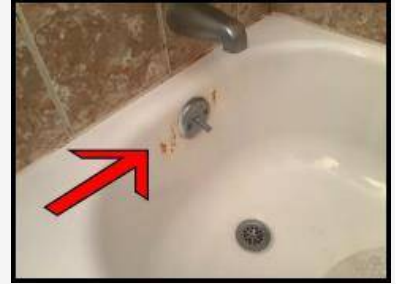
- Basin: Rust related damage is visible to the basin. We recommend correction using appropriate methods.
