Staci's Home Inspections
310-948-9675

Inspection Report

Property Address:
6953 Purple Ridge Dr.
Rancho Palos Verdes CA 90275

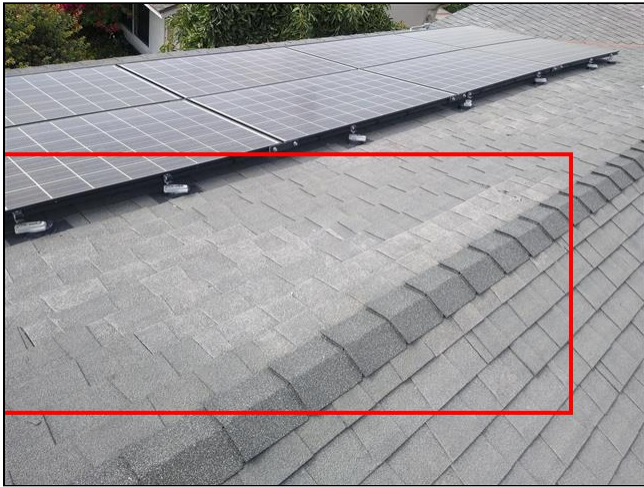
1.0 (1) Asphalt composite shingle roof covering is older and worn. Anticipate replacement, especially as roof cover ages. Consult licensed roofer for full evaluation and cost estimates for repairs/replacement as needed for lasting performance.

1.0 Item 4(Picture) Wear noted

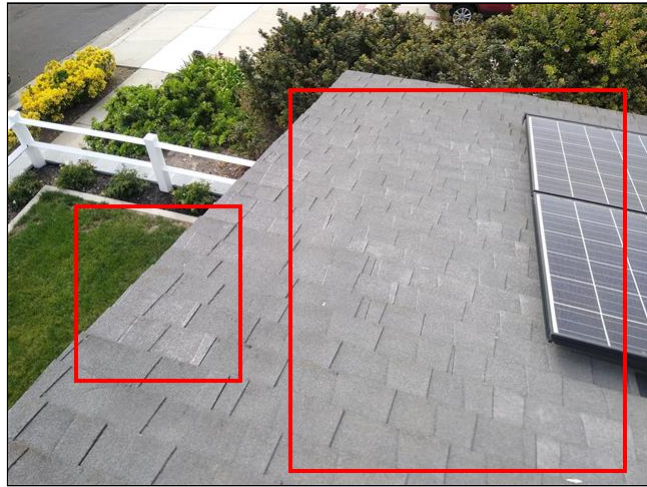
1.0 Item 5(Picture) Wear noted

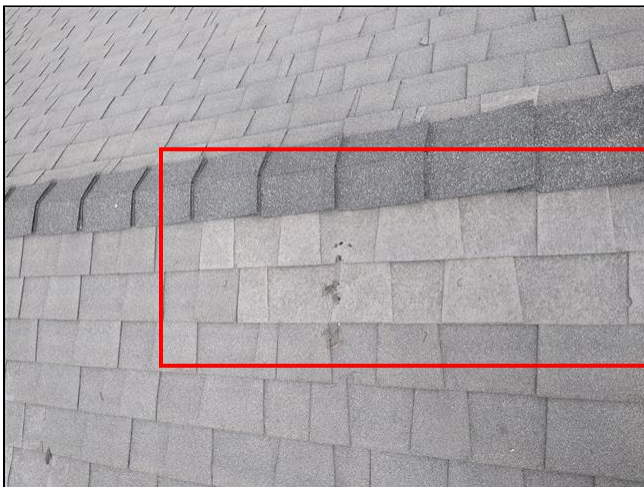
1.0 Item 6(Picture) Wear noted

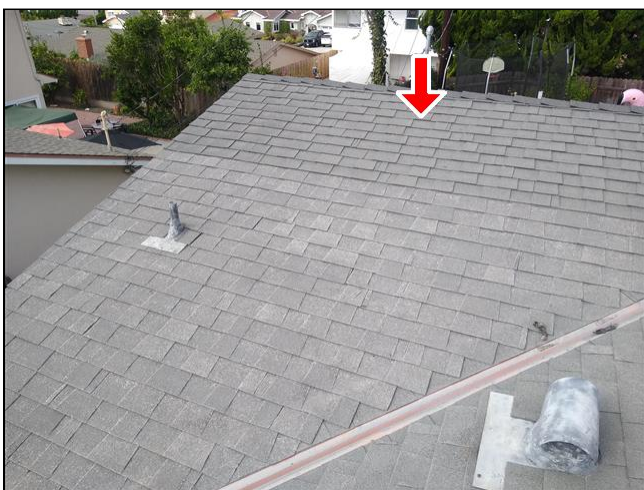
1.0 Item 7(Picture) Repairs noted

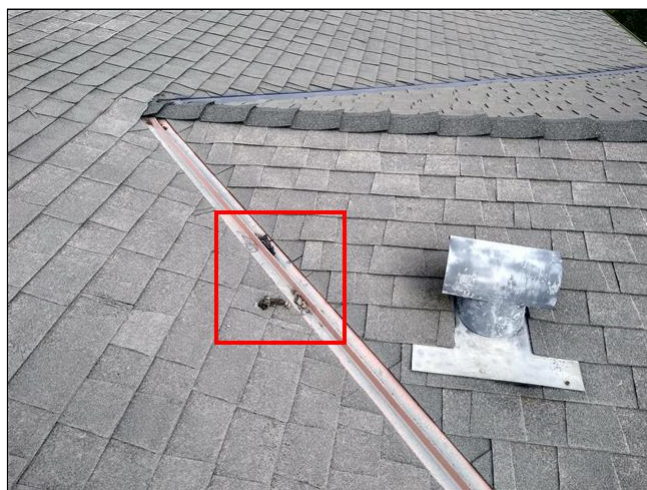
Debris noted on roof covering at various locations (Ex: Item 8). Debris impedes the proper performance of roof drainage and can shorten the useful life of roofing materials. Recommend cleaning/removal of debris on a routine basis.

1.0 Item 8(Picture) Debris noted

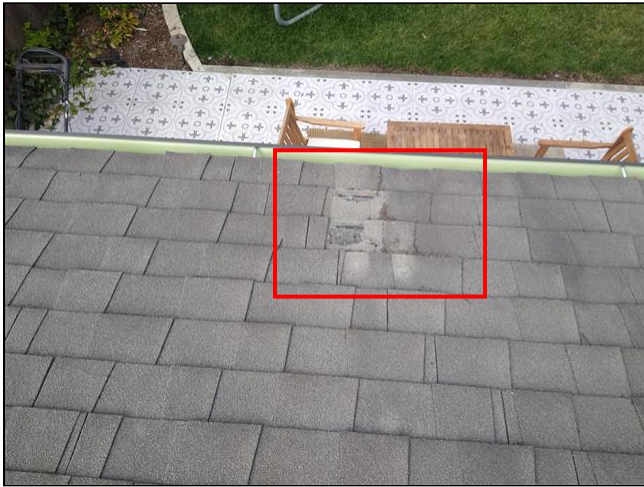
1.0 Item 10(Picture) Wear noted at shingles

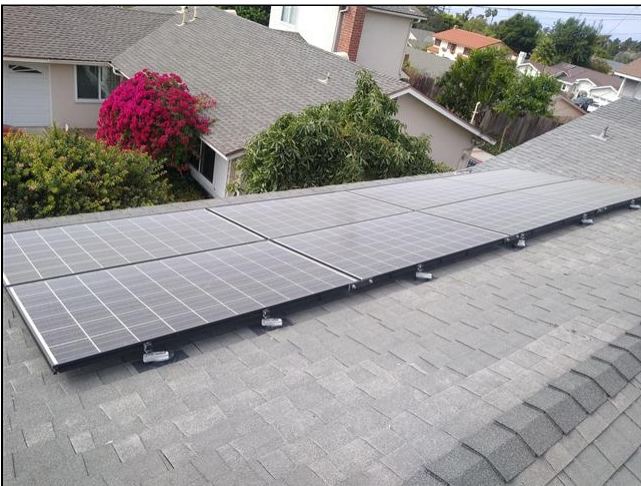
1.0 Item 13(Picture)

(2) Photovoltaic/Solar panels - Solar panels are not part of a general home inspection. Any comments are provided as a courtesy. Recommend annual servicing/maintenance to ensure proper functioning. Recommend seasonal cleaning to surface of photovoltaic cells in order to maintain optimal performance and resealing/maintenance around roof penetrations to prevent water intrusion into underlying structural materials. Periodic solar panel evaluation should include an inspection to attic area sheathing to check for conditions below to ensure watertight sealing.

Consult seller for history and manufacturer/vendor concerning maintenance and operation of photovoltaic/solar panels.

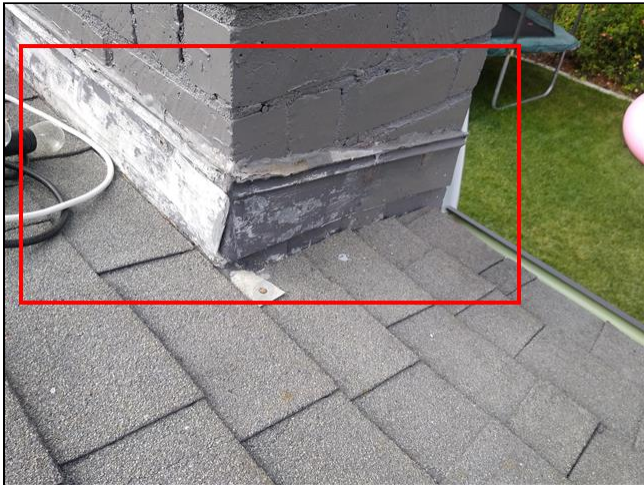
Item 2 - Flashings at base of chimney are old/ worn. Older/worn flashings are more vulnerable to water penetration and require more frequent than normal maintenance/repairs. Contact licensed roofer for further evaluation and repairs/replacement as needed for lasting performance and to prevent leaks.

1.1 Item 2(Picture) Older/worn flashings noted

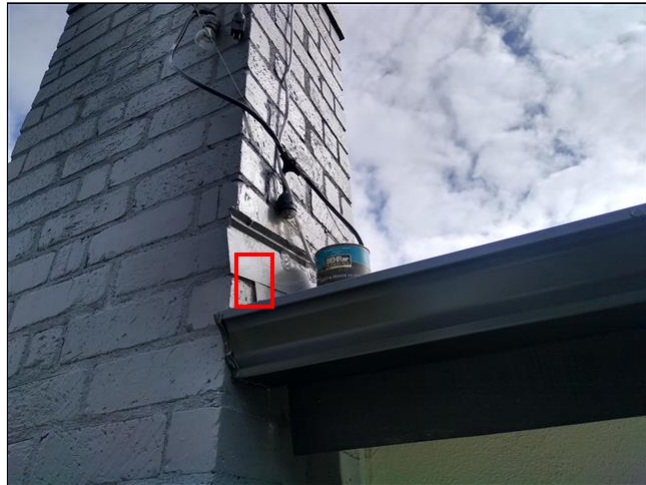
No kick out flashings noted at both sides of chimney (Ex: Item 3). Contact licensed roofer for repairs for proper drainage of roof covering.

1.1 Item 3(Picture) No kick out flashings noted at both sides of chimney (above rain gutters)

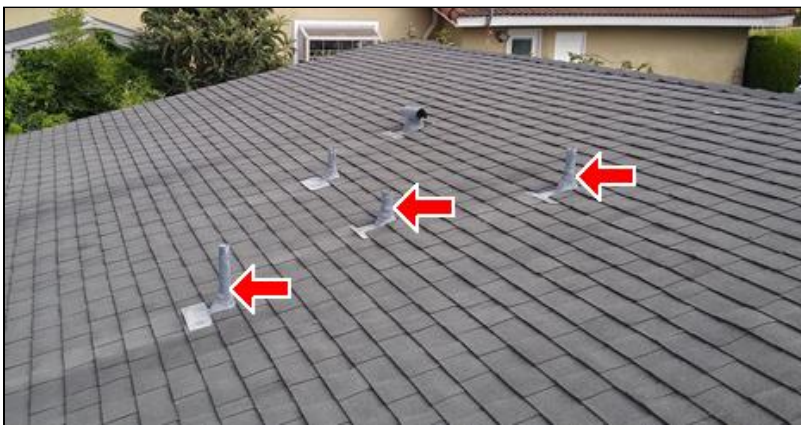
1.4 Item 2(Picture)

1.4 MAINTENANCE TIP: Reseal all roof penetrations on a routine basis to prevent leakage to interior of structure.

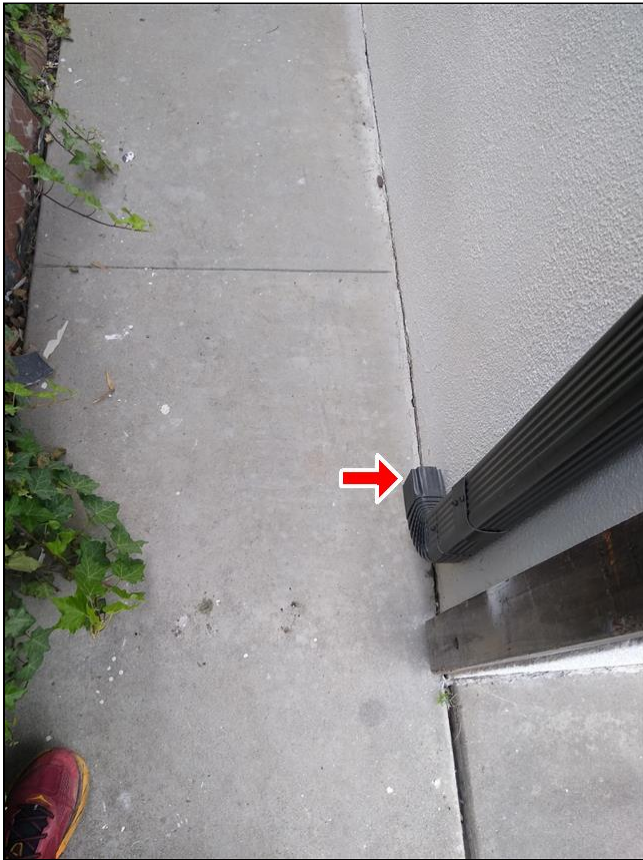
1.5 Item 1(Picture) Downspout terminates by base of structure. Recommend repairs and adding downspout extender/splash block.

1.5 Suggest upgrades to downspouts by adding downspout extenders/splash blocks to direct water away from foundation in order to extend the lifespan of structural materials and reduce/prevent moisture intrusion. OPTION: Add rainbarrels.
OPTION: Built-in drains.

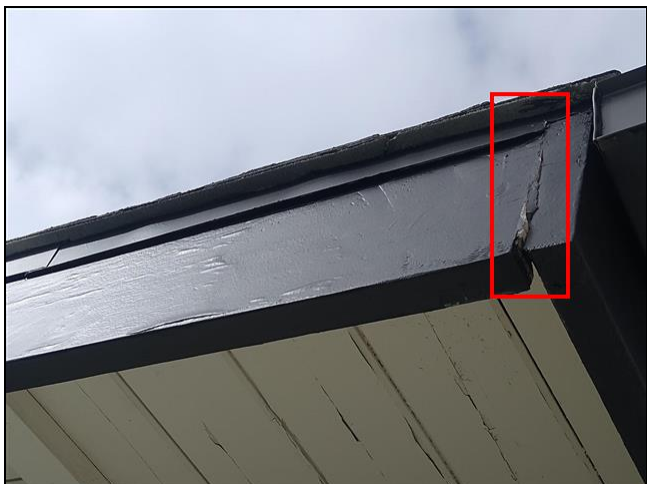
Paint is peeling and/or loose at various locations at fascias / soffits. Older paint layers from before 1979 may contain lead. Suggest repairs and repainting to preserve wood components and protect materials from weathering. Recommend testing paint before working with materials for safety.

1.6 Item 1(Picture) Wear noted

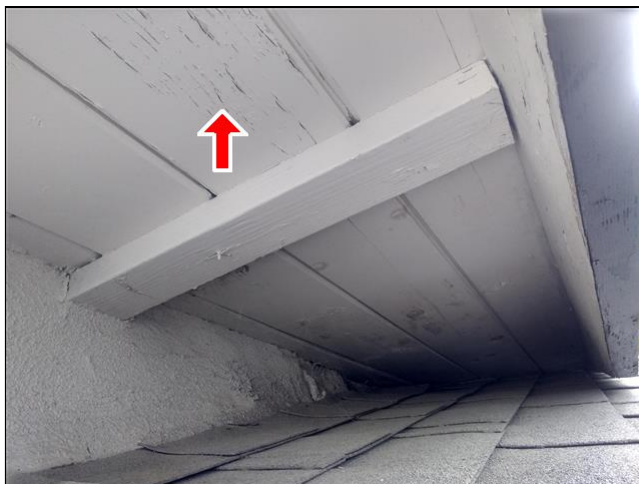
1.6 Item 2(Picture) Wear noted at paint under soffit

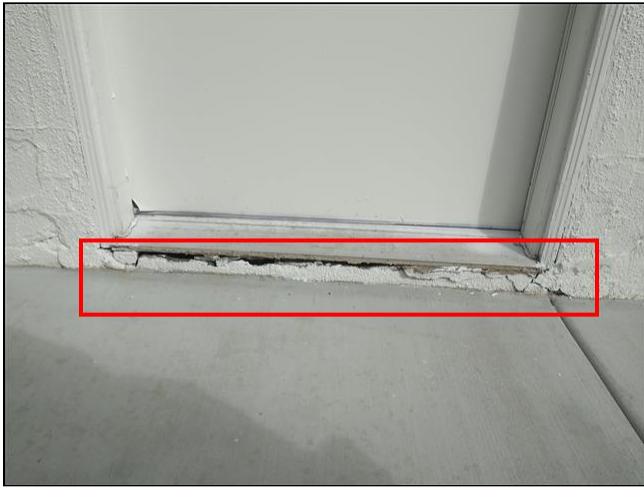
2.0 Item 2(Picture) Wear noted at garage pedestrian door threshold. Recommend repairs to prevent water intrusion.

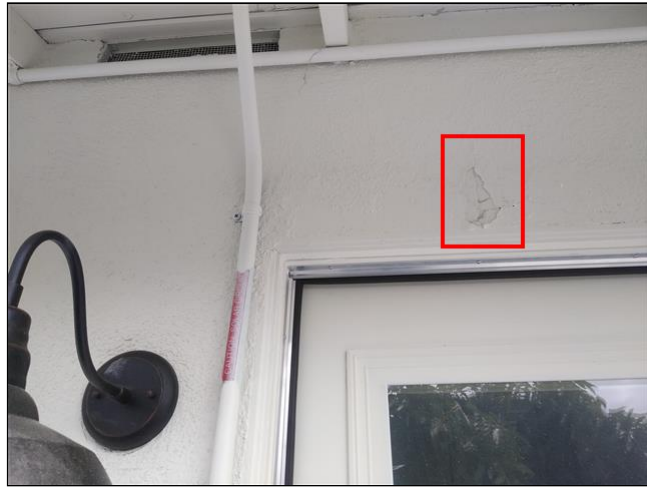
2.0 (1) Stucco exhibits cracking at various locations of structure. Suggest sealing at cracks, any gaps, around light fixtures, windows, doors, trim, penetrations, etc...to aid in preventing water intrusion.

2.0 Item 3(Picture) Wear noted

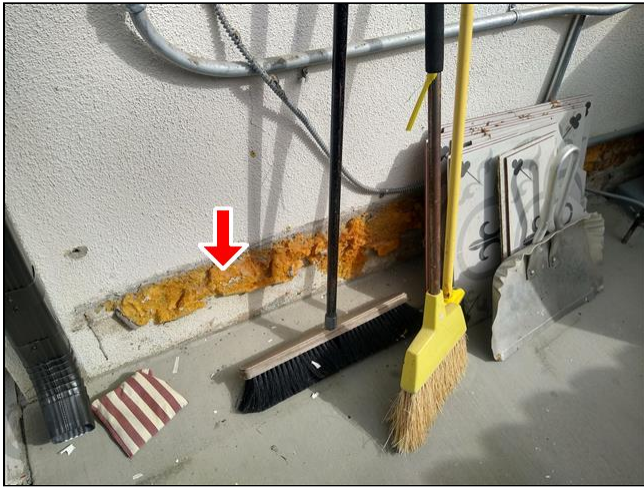
2.0 Item 5(Picture) Unconventional repairs noted (area by electrical panel). Ask seller for history.

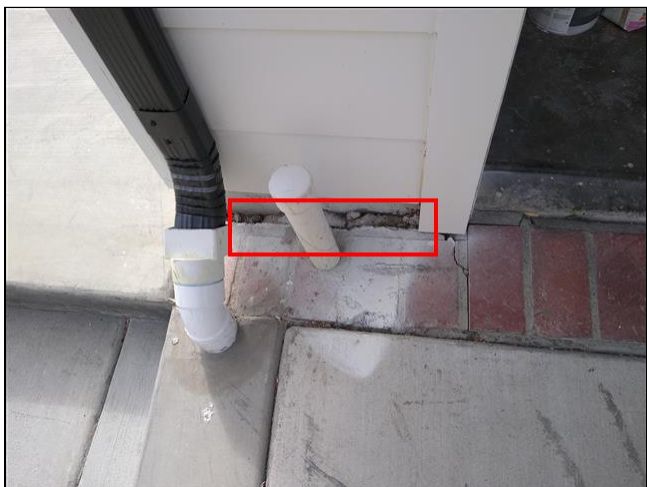
(2) Weep Screed (bottom of the framed wall) is absent from stucco siding, which is common in older structures in southern California. (NOTE: Weep Screeds were not required at time of construction). This condition may permit water to become trapped behind stucco. Recommend sealing at areas where pavement meets siding with elastomeric expansion joint now and on a periodic basis to prevent water seepage at foundation area.

2.0 Item 7(Picture) Suggest repairs at area where pavers meet siding and installation of elastomeric expansion joint

Recommend upgrades to landscape drainage/irrigation (See comments under Exterior: Groundslope) and roof drainage (See comments under Roofing: Downspouts). Consult qualified contractor for further evaluation and repairs to stucco siding as needed. OPTION: Acquire cost estimates from qualified contractor for installation of Weep Screed.

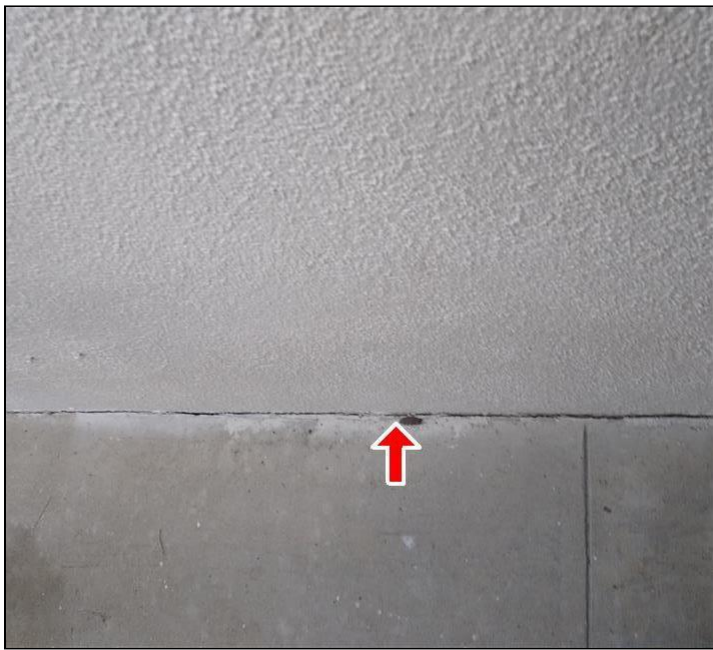
2.0 Item 9(Picture) Recommend sealing where pavement meets siding with elastomeric expansion joint.

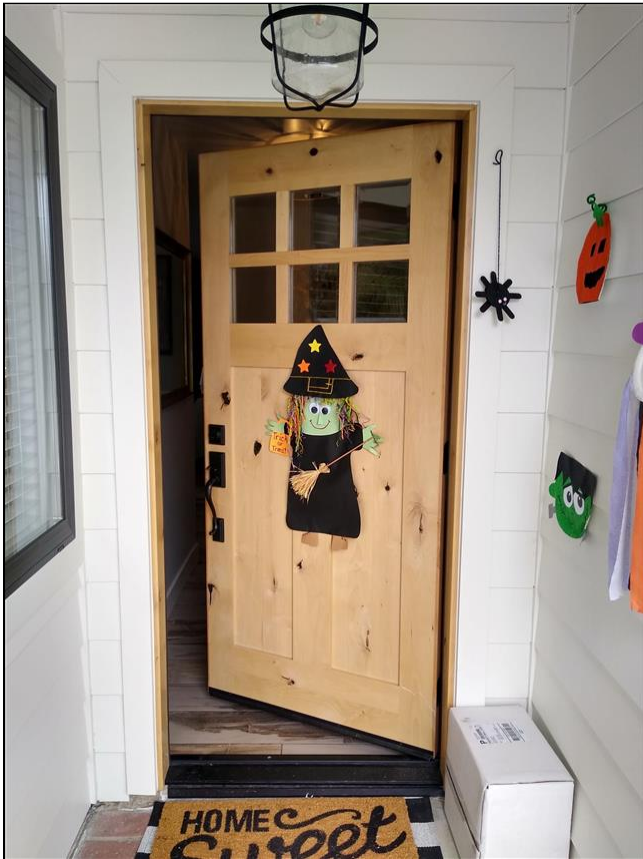
2.1 Item 1(Picture)

2.1 Entry doors - Satisfactory.

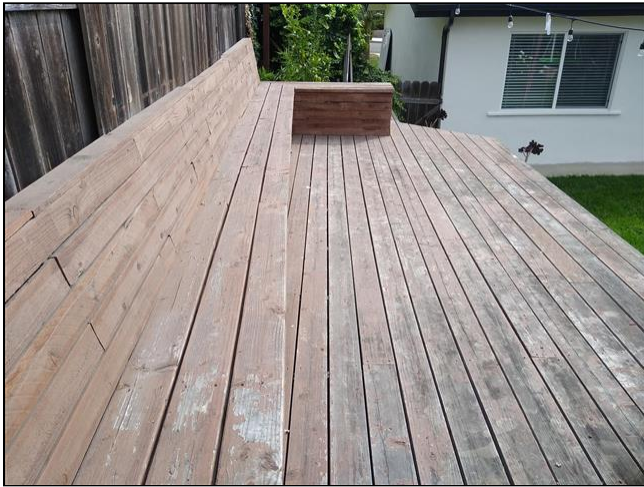
2.2 Item 6(Picture)

2.2 Multiple concerns noted at rear deck area. Suggest full evaluation by qualified deck specialist and repairs as needed for safety and lasting performance.

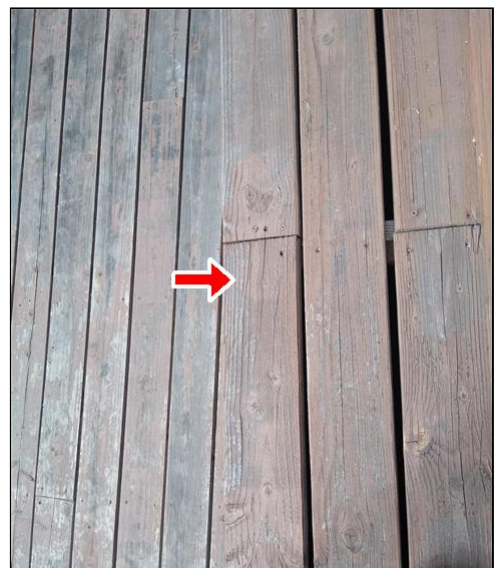
- Item 1 - No guard railing assembly noted at elevated deck, which is more than 30" above grade and presents a safety concern in the presence of children. Contract qualified contractor for further evaluation and cost estimates for proper installation as desired.
- Item 3 - No hand railing noted at steps, which have more than 4 risers. Recommend adding handrailing as needed for safety.
- Wear noted at deck wood components. MAINTENANCE TIP: Recommend periodic repairs/resealing at exterior wood components with weatherproof, UV-protective sealant/stain/paint to protect materials and for lasting performance.
- Checking/splitting/wear noted at planks at various locations. (Ex: Item 7 and Item 10). Warping noted. (Ex: Item 9 at benching).
- Item 8 - Loose plank noted at benching (towards left area).

2.2 Item 8(Picture) Loose plank noted at benching (towards left area of deck)

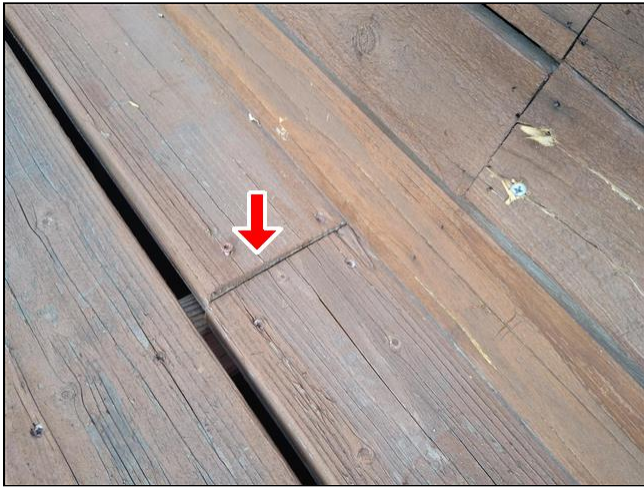
2.2 Item 9(Picture) Warping, loose plank noted with protruding screw, left area of benching

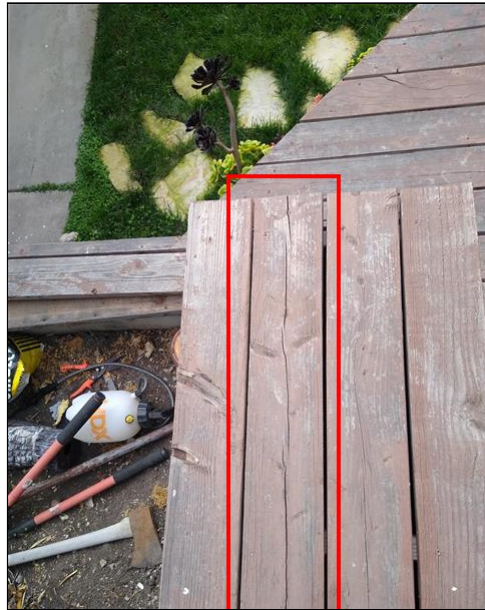
2.2 Item 10(Picture) Checking/splitting noted at deck plank

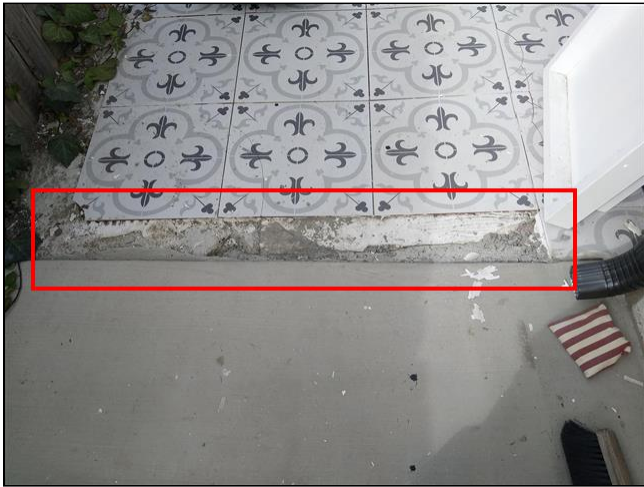
2.3 (1) Tiled area noted at patio. Tiles at various locations are cracked/missing. Suggest repairs/replacement as desired.

2.3 Item 1(Picture) Wear, uneven areas noted

NOTE: Tile does not appear to be outdoor-rated and may become slippery when wet, which is a safety concern. Recommend considering replacing with outdoor-rated tile that has a non-slip surface for safety to prevent falls/accidental injury.

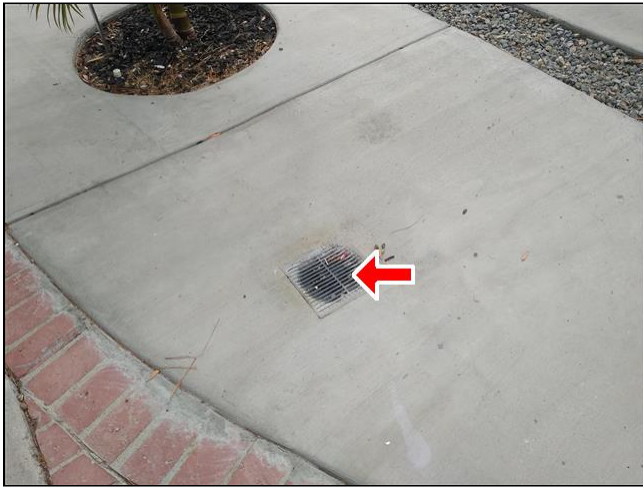
2.4 Subsurface drainage noted (Ex: Item 1). Suggest routine cleaning and maintenance to piping to help drain properly. No interior evaluation of pipes or drainage was performed at the time of the inspection. Suggest checking and cleaning as needed for proper drainage and flow.

2.4 Item 1(Picture) Subsurface drainage noted.

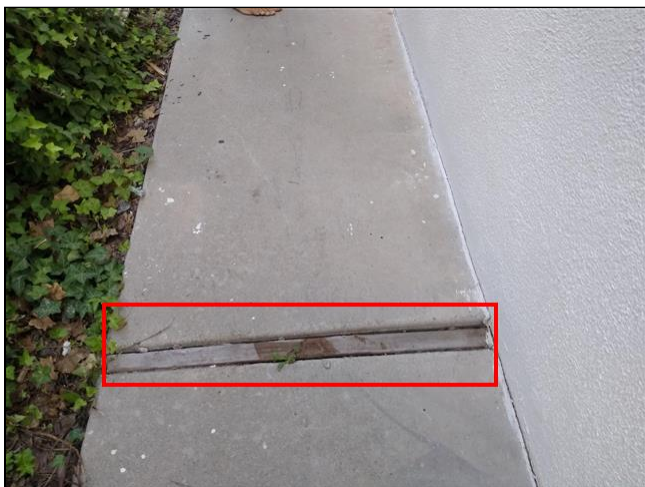
2.5 Out-of-level surfaces noted. Trip concerns noted. Suggest repairs for safety.

2.5 Item 1(Picture) Uneven surfaces noted, E

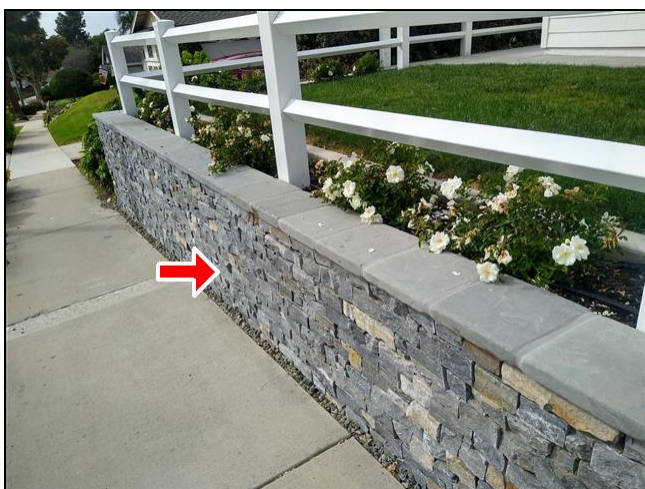
2.6 (1) Weep holes are not visible at retaining wall. Consult seller/ builder/ plans for possible underground drainage system behind wall. If no drain system is installed, consult contractor for further evaluation and repairs to help prevent water pressure buildup behind wall.

2.6 Item 1(Picture) No weep holes noted

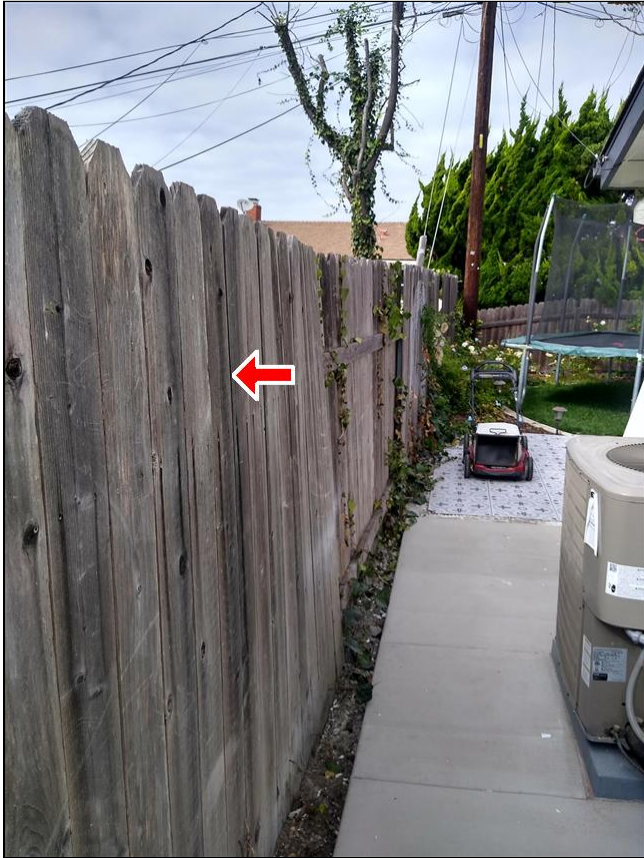
Leaning/loose fencing noted at various locations. Contact qualified contractor for further evaluation and repairs as needed.

2.6 Item 2(Picture) Leaning noted

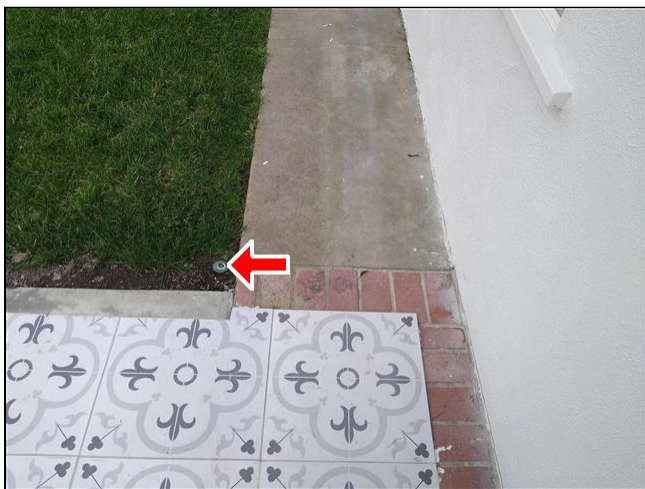
2.7 Item 3(Picture) Sprinkler head noted by pavement

(2) NOTE: Irrigation/sprinkler system falls outside of the scope of a general home inspection. Any comments are provided as a courtesy. Given that property is at a hillside location, recommend checking irrigation system and ensuring that sprinklers do not spray onto siding, pavement, and walls/fencing. Recommend removing lawn and irrigation sprinklers away from structure and any retaining walls and sloping areas. OPTION: Suggest considering upgrades to drip-type irrigation to limit/reduce water penetration and for better control during watering. OPTION: Upgrading lawn/landscaping to [water-wise methods](#). (See <https://socalwatersmart.com/wp-content/uploads/2018/07/CAFriendlyBook.pdf>)

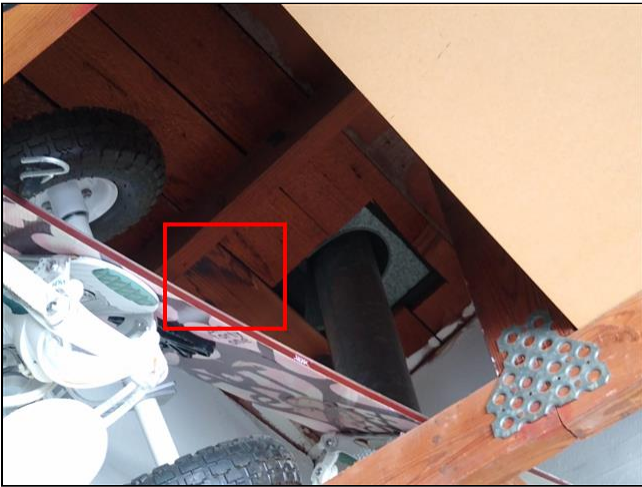
3.0 Stains noted at framing in garage. Unable to determine if active. Monitor and repair as needed to prevent leakage.

3.0 Item 1(Picture) Staining noted

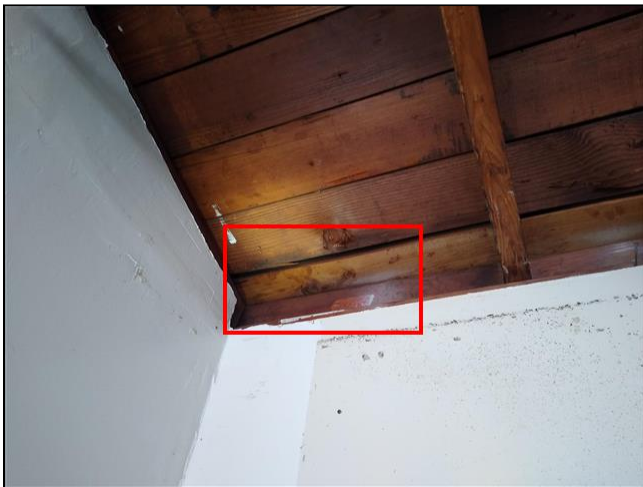
3.0 Item 3(Picture) Staining noted

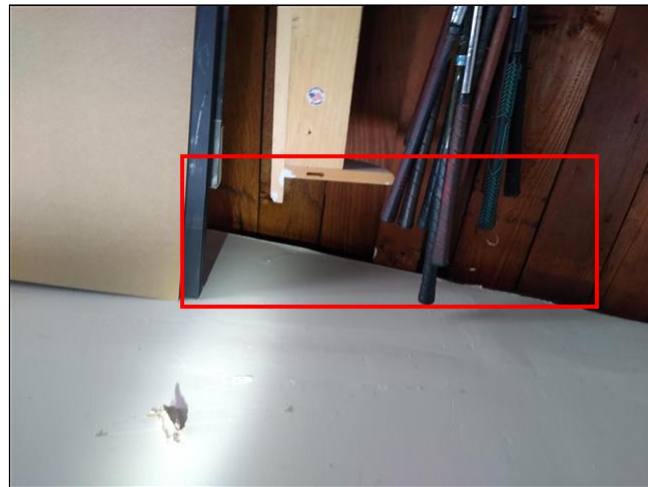
3.0 Item 4(Picture) Staining noted

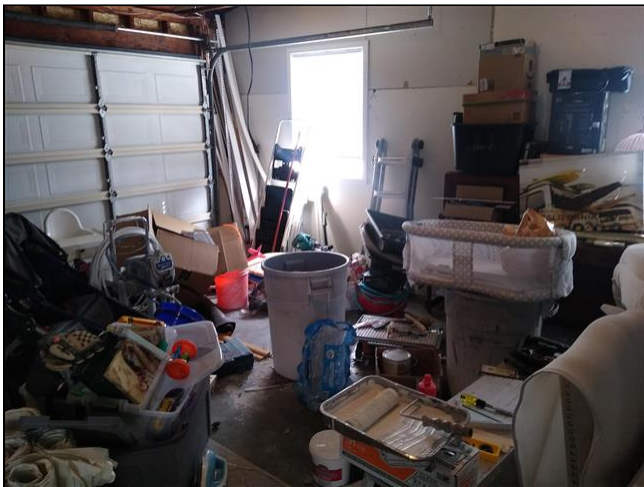
3.1 Item 1(Picture)

3.1 Garage floor slab is not fully visible due to personal items / obstructions and therefore inspection is limited. Suggest careful walkthrough when fully visible.

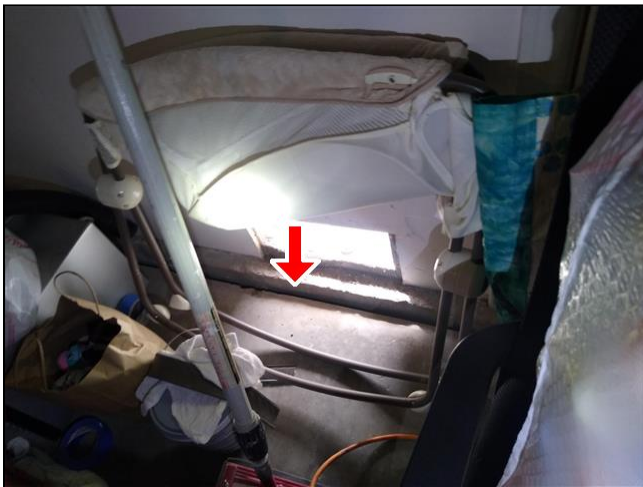
Item 2 - Cracking noted at garage floor slab. **Item 3 and Item 4 - Gap noted where garage floor slab meets curb. Contact qualified contractor for further evaluation and repairs as needed.**

3.1 Item 3(Picture) Gap noted where garage floor slab meets curb

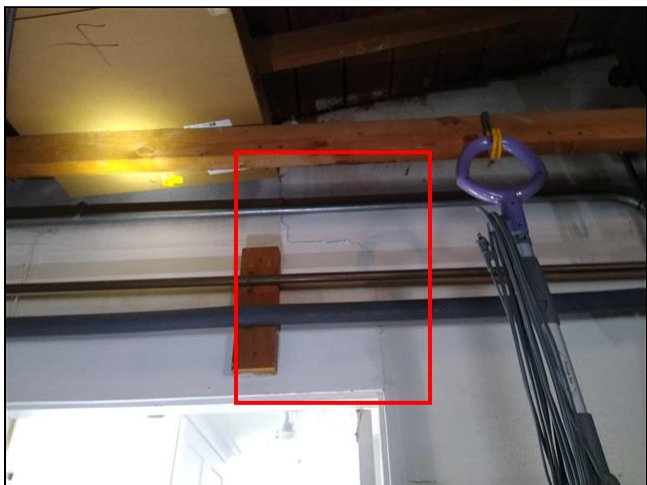
Item 1 - Cracking noted at wall by garage door, possibly due to settlement. Suggest patching/repairs/repainting.

3.2 Item 1(Picture) Cracking noted at wall by garage door, possibly due to settlement.

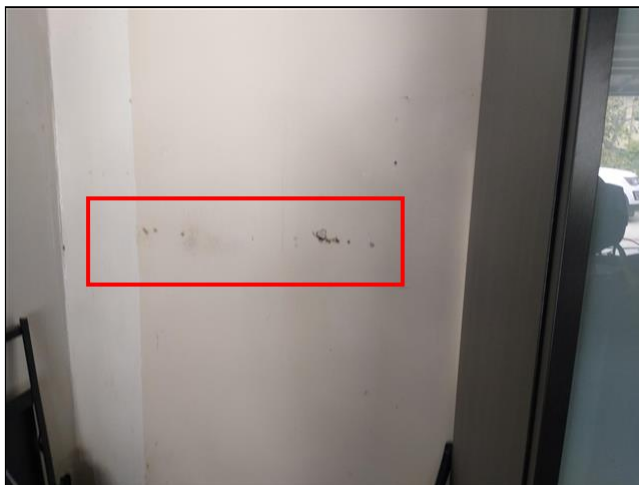
3.2 Item 2(Picture) Wear/damage noted at garage drywall. Suggest patching/repairs/repainting

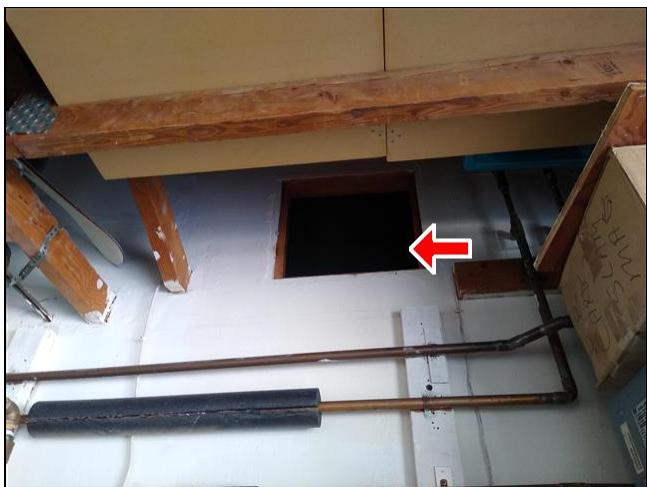
Attic access opening does not have a fire-rated door assembly. Consult a qualified contractor for further evaluation and repairs as needed for fire-life safety.

3.2 Item 3(Picture) Attic access opening does not have a fire-rated door assembly.

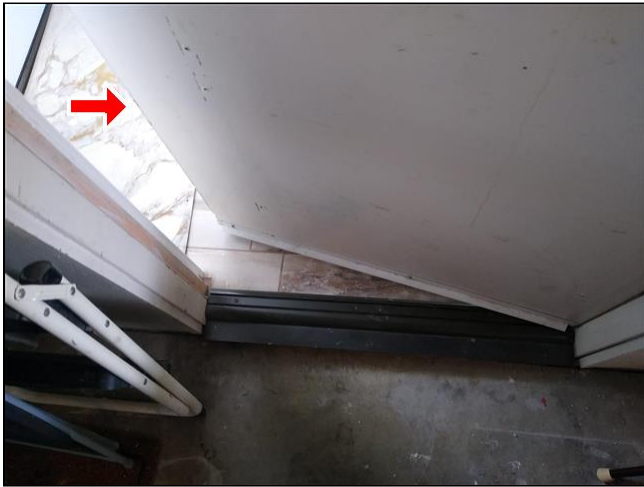
(3) Solid door between house and garage needs to be a minimum 20min fire-rated and have a self-closing hinge so the door acts as a proper fire barrier between house and garage. Door should also self-latch. Recommend repairs / corrections to hardware for proper operation for safety.

3.2 Item 4(Picture) Door admitting to the garage does not self-close/self-latch

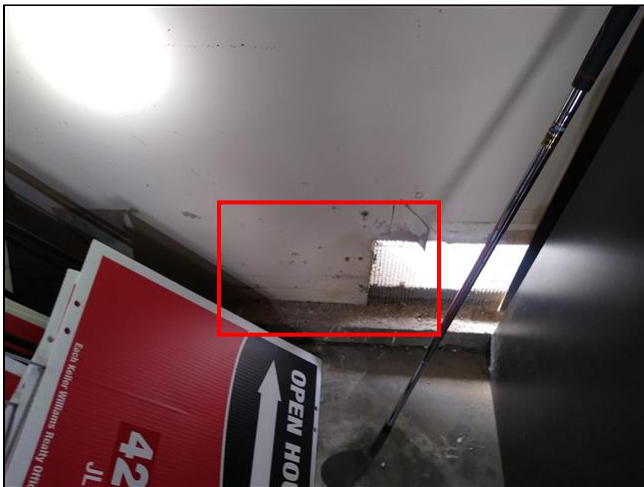
(4) Staining noted at drywall by garage vent. Contact qualified contractor for further evaluation and repairs as needed. Check for hidden damage.

3.2 Item 5(Picture) Staining noted at drywall by garage vent opening.

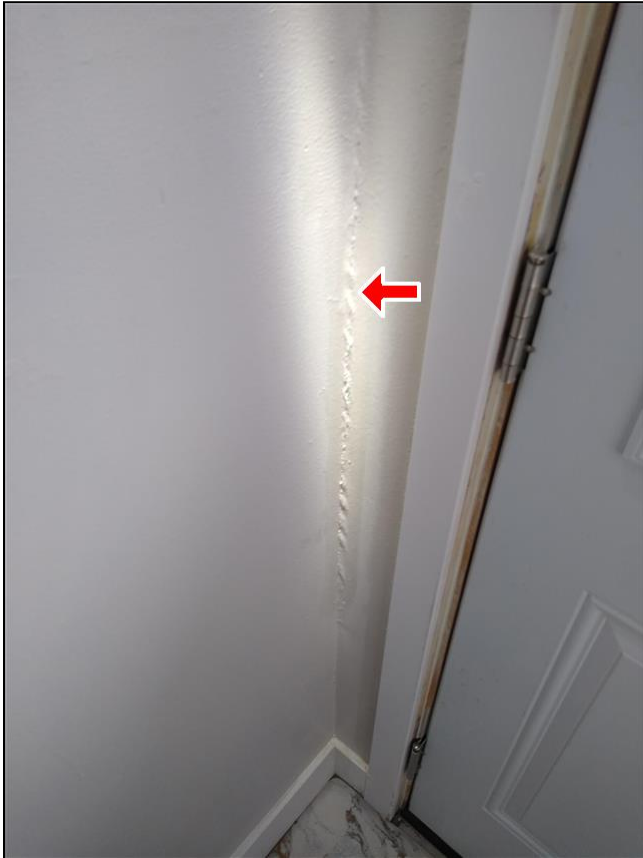
Item 1 - Blistering noted at corner of walls by laundry area. Ask seller for history regarding any prior water intrusion. Contact qualified contractor for further evaluation and to check for hidden damage.

4.0 Item 1(Picture) Blistering noted at corner near laundry area. Ask seller for history.

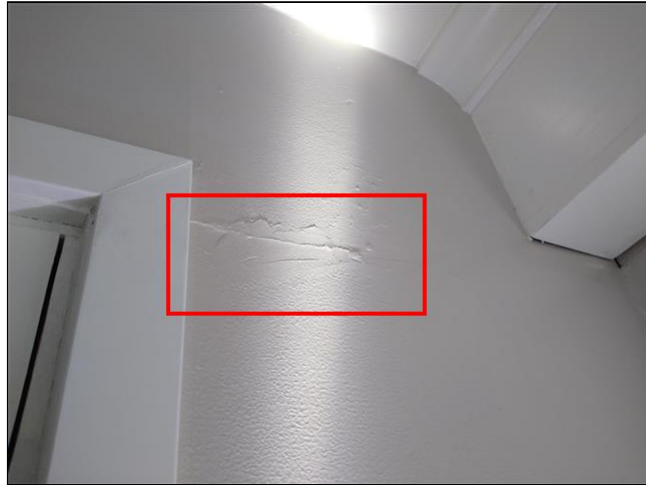
4.0 (1) Evidence of repairs noted at walls/ceilings at various locations. Ask seller regarding history.

4.0 Item 2(Picture) Patching/repairs noted at wall near laundry area

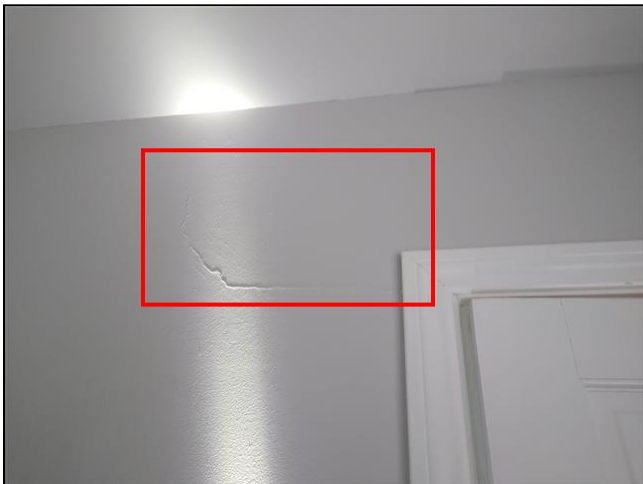
4.0 Item 3(Picture) Cracking noted in Master bedroom at wall by door, possibly due to settlement. Suggest repairs/repainting.

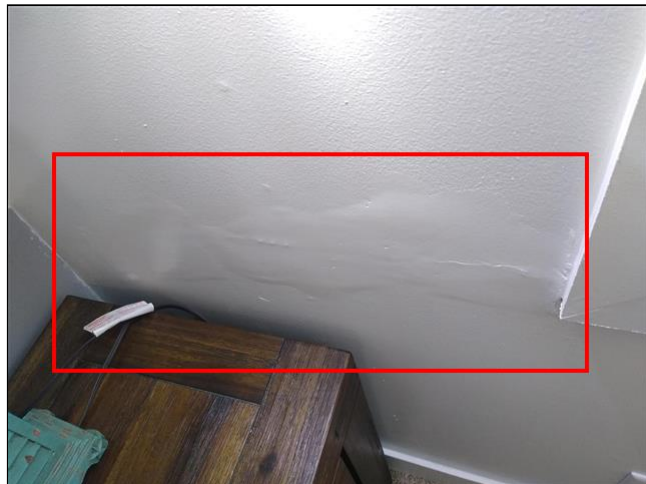
4.0 Item 4(Picture) Patching/repairs noted at front bedroom wall by window

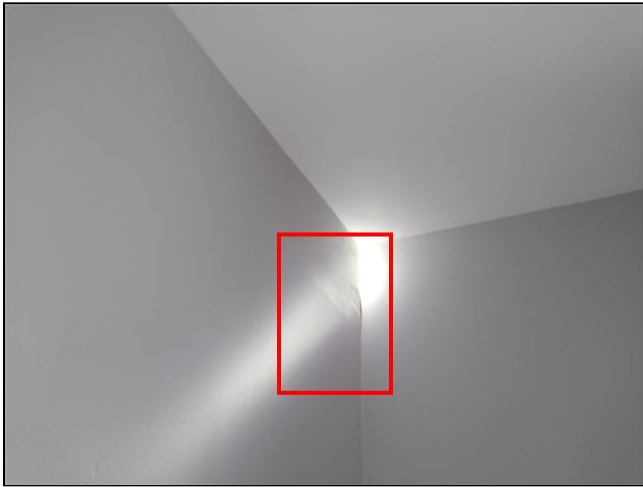
4.0 Item 5(Picture) Repairs noted at rear corner of living room wall by ceiling. Ask seller for history.

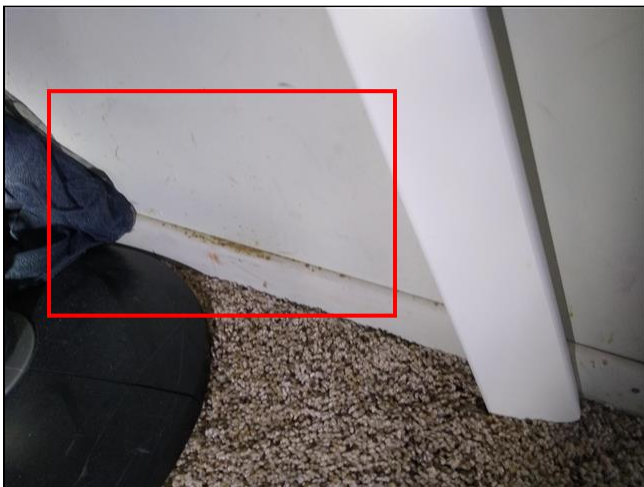
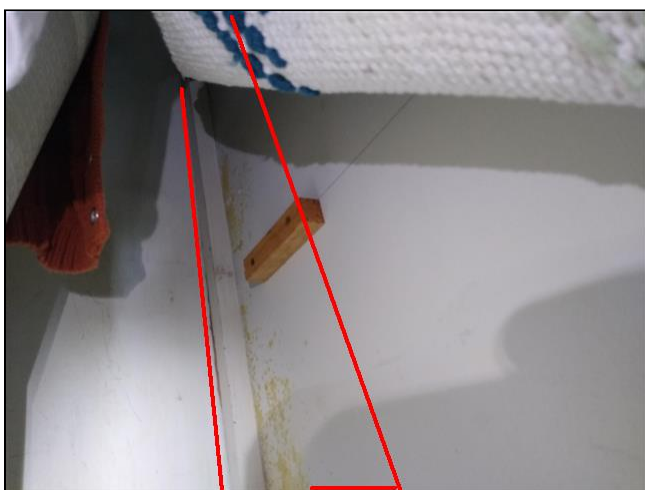
(2) Staining/discoloration noted at walls in bedroom closets which may be indicative of mold growth. Mold growth presents a health hazard. Recommend further testing by certified mold inspector to determine whether mold is present. Conditions behind concealed areas remain indeterminate.

4.0 Item 7(Picture) SE front bedroom - Area of concern - Discoloration, possible mold growth noted.

4.0 Item 10(Picture) SE front bedroom - Area of concern - Discoloration, possible mold growth noted.

Consult licensed remediator for further evaluation and professional repairs/removal of any contaminated/water-damaged materials. Contractors should check for hidden damage.

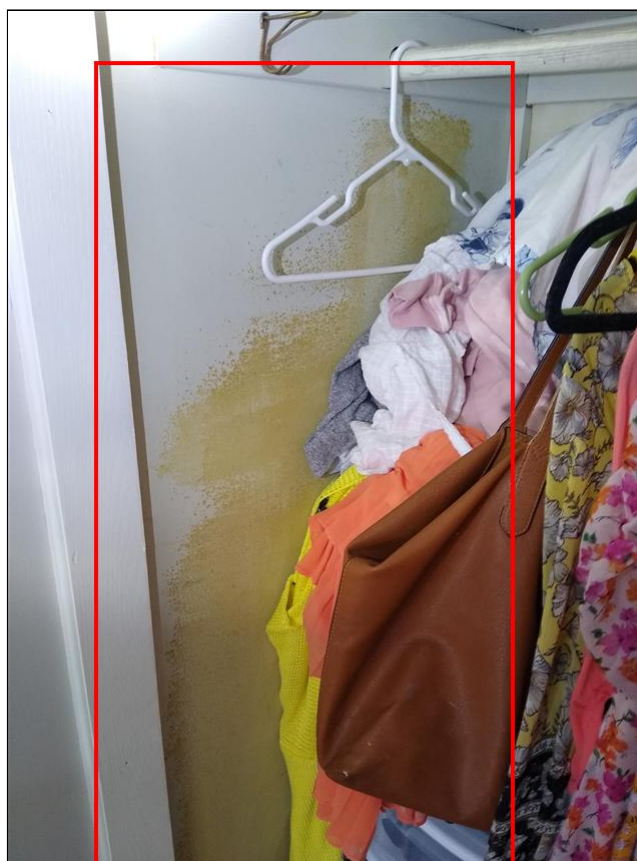
4.0 Item 11(Picture) NE rear bedroom (Master) - Area of concern - Discoloration, possible mold growth noted.

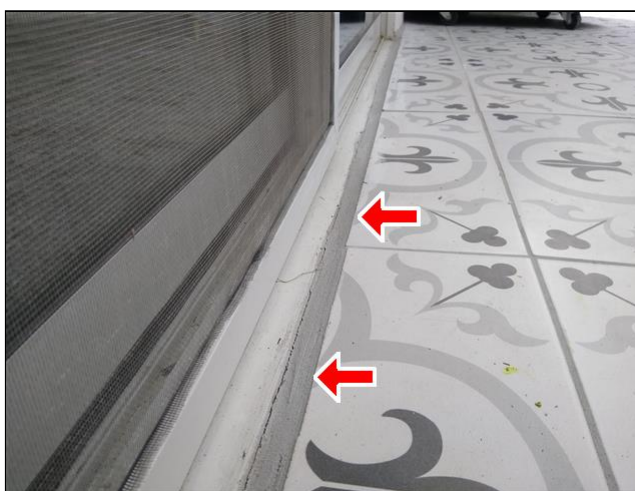
Item 2 - Area of drainage concern - Tile surface creates a negative grading which angles towards patio sliding doors. Recommend contacting qualified contractor for repairs for proper drainage to prevent water intrusion.

4.4 Item 2(Picture) Area of drainage concern.
Negative slope noted by patio sliding doors

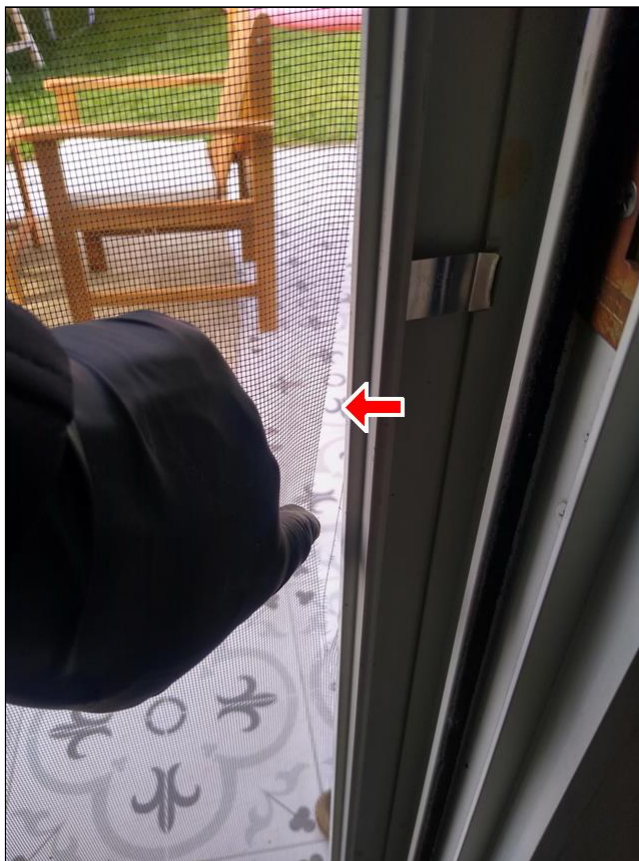
Item 3 - Wear noted at sliding screen door. Recommend repairs/replacement to prevent insect pest intrusion.

4.4 Item 4(Picture) Wear noted at sliding screen door

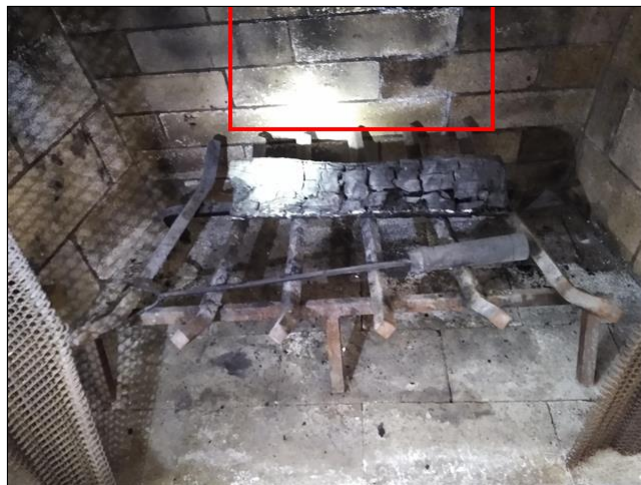
4.6 Item 2(Picture) Efflorescence noted, which may indicate water intrusion from exterior. (See comments under Roofing: Chimney section).

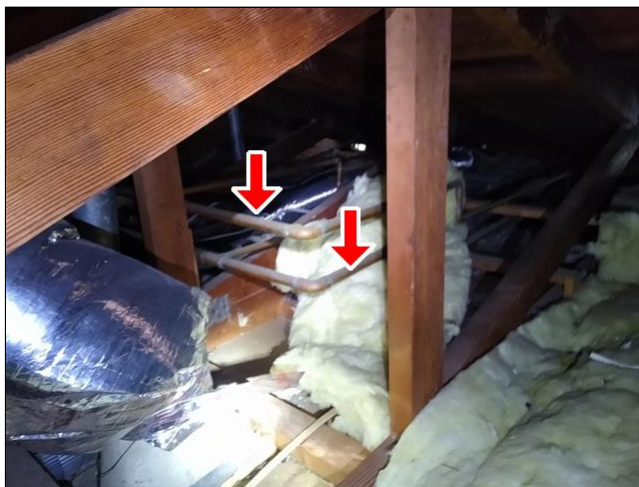
6.0.A Item 2(Picture) OPTION: Insulate copper supply piping in attic area for improved efficiency in retaining temperature

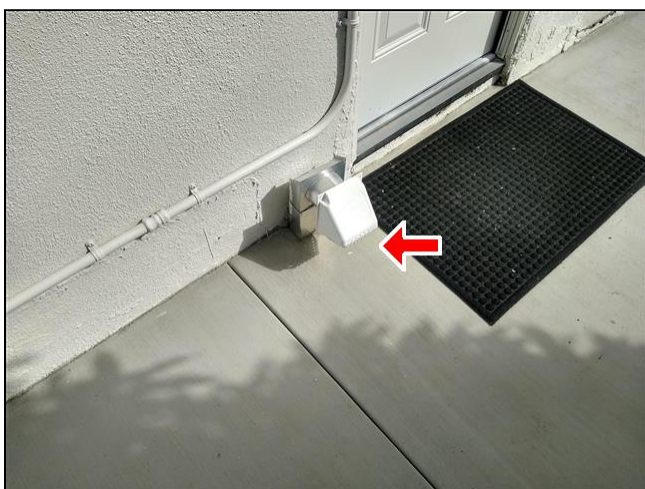
6.4.A Item 4(Picture)

(2) Dryer vent terminates closer than 12" from grade, which may cause blockages of lint and require more frequent than normal maintenance/cleaning. Suggest relocating vent termination. Consult qualified contractor for repairs as desired.

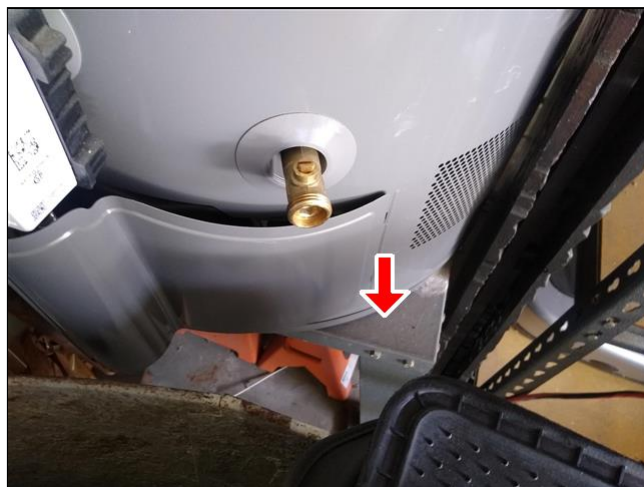
Item 2 - No overflow pan noted. Pan should be installed under water heater to protect interior from moisture damage. Drain pipe on pan should also terminate at an exterior location. Consult qualified plumber for further evaluation and proper installation. (Overflow tray should consist of a watertight pan of corrosion-resistant materials installed beneath the water heater with not less than 3/4 of an inch (20 mm) diameter drain to an approved location. Such pan shall be not less than 1 1/2 inches (38 mm) in depth.)

6.6.A Item 2(Picture) No overflow pan noted.

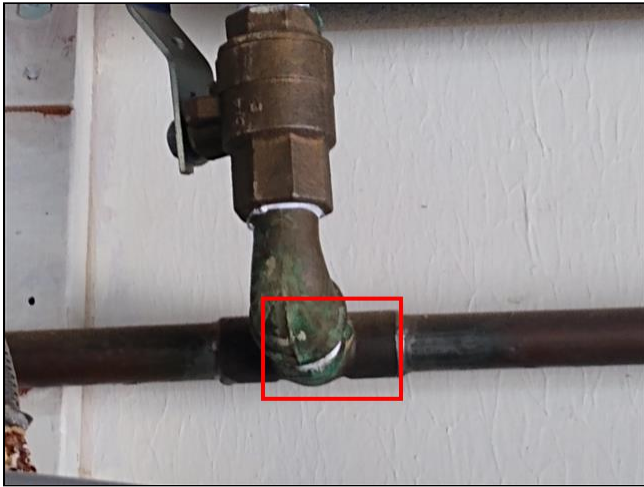
(2) Corrosion noted at various locations of piping by water heater. Contact licensed plumber for further evaluation and repairs as needed to prevent leaks.

6.6.A Item 5(Picture) Corrosion noted

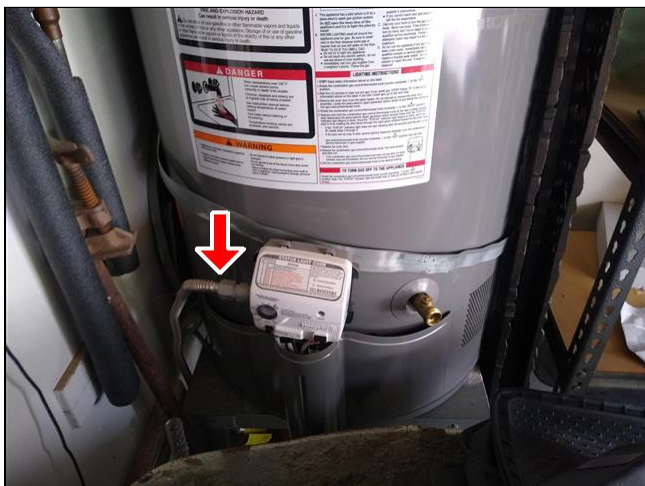
6.8.A Sediment trap was not installed at water heater gas line. Sediment trap should be positioned where the gas flow in piping changes direction. Consult licensed plumber for proper installation as desired.

6.8.A Item 1(Picture) No sediment trap noted

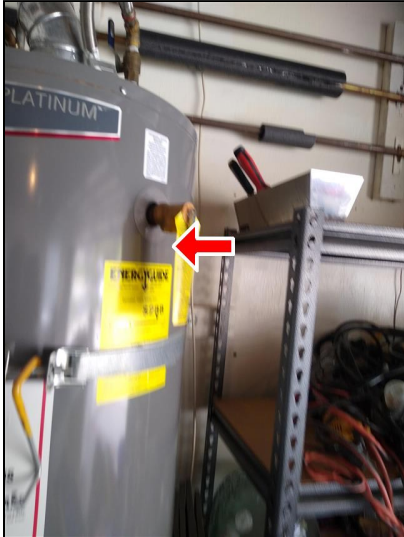
6.9.A Item 1(Picture)

6.9.A TPRV (temperature pressure relief valve) discharge piping is not installed. Piping should consist of compatible materials (able to handle 150PSI and 210F) and terminate at an approved location (i.e. outside) at a visible location where it will not cause damage. Termination clearance should be no closer than 6 inches or further

than 24 inches from grade. TPR valve discharge pipe must be aimed downward with no threads on the end of piping. Consult licensed plumber for proper installation to prevent water damage and for safety.
