Staci's Home Inspections
310-948-9675

Inspection Report

Property Address:
6953 Purple Ridge Dr.
Rancho Palos Verdes CA 90275

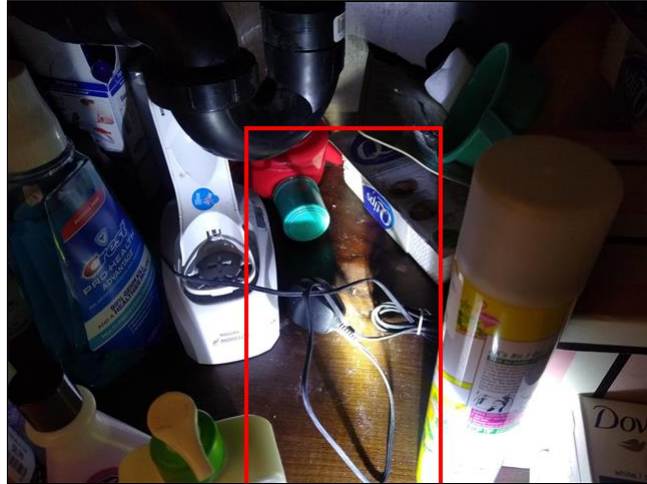
6.0.B Item 2 - Staining/ moisture damage noted under sink area. Monitor condition and have repairs made as needed to prevent leaks. Anticipate repairs and/or replacement of shut off valves and/or trap.

6.0.B Item 2(Picture) Staining/moisture damage noted

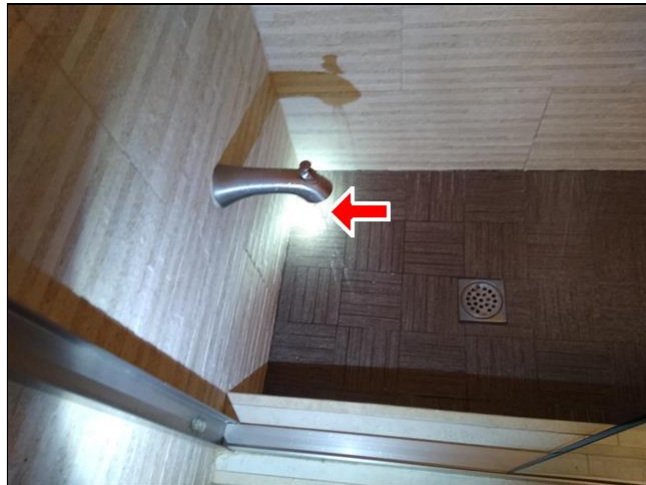
6.2.B Item 2 - Shower diverter does not properly operate. Not all water diverts to shower head when shower diverter is pulled. Contact licensed plumber for repairs and/or replacement.

6.2.B Item 2(Picture) Shower diverter does not work properly

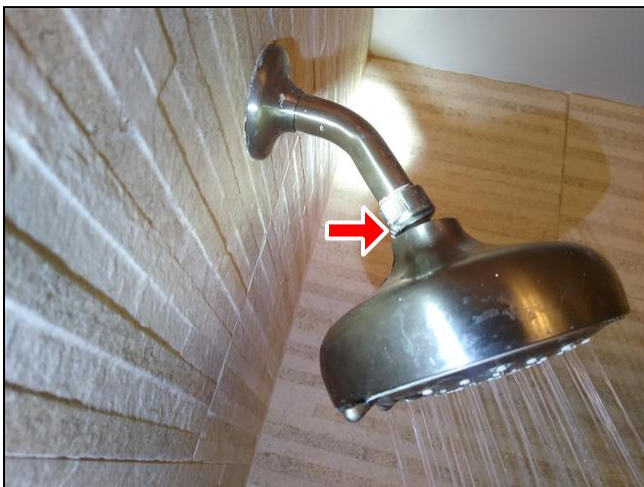
Item 3 - Shower head is leaking. Have connection of shower head retaped and resecured. Contact licensed plumber as needed.

6.2.B Item 3(Picture) Leak noted at shower head

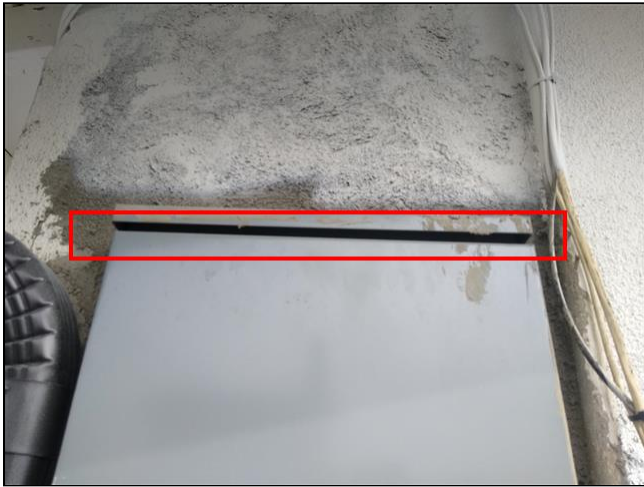
Item 3 - Gap noted above electric panel enclosure. Suggest further evaluation and repairs as needed to prevent moisture intrusion, especially by wind-driven rain--and to prevent pest intrusion.

7.1 Item 3(Picture) Gap noted at upper portion of electrical panel enclosure

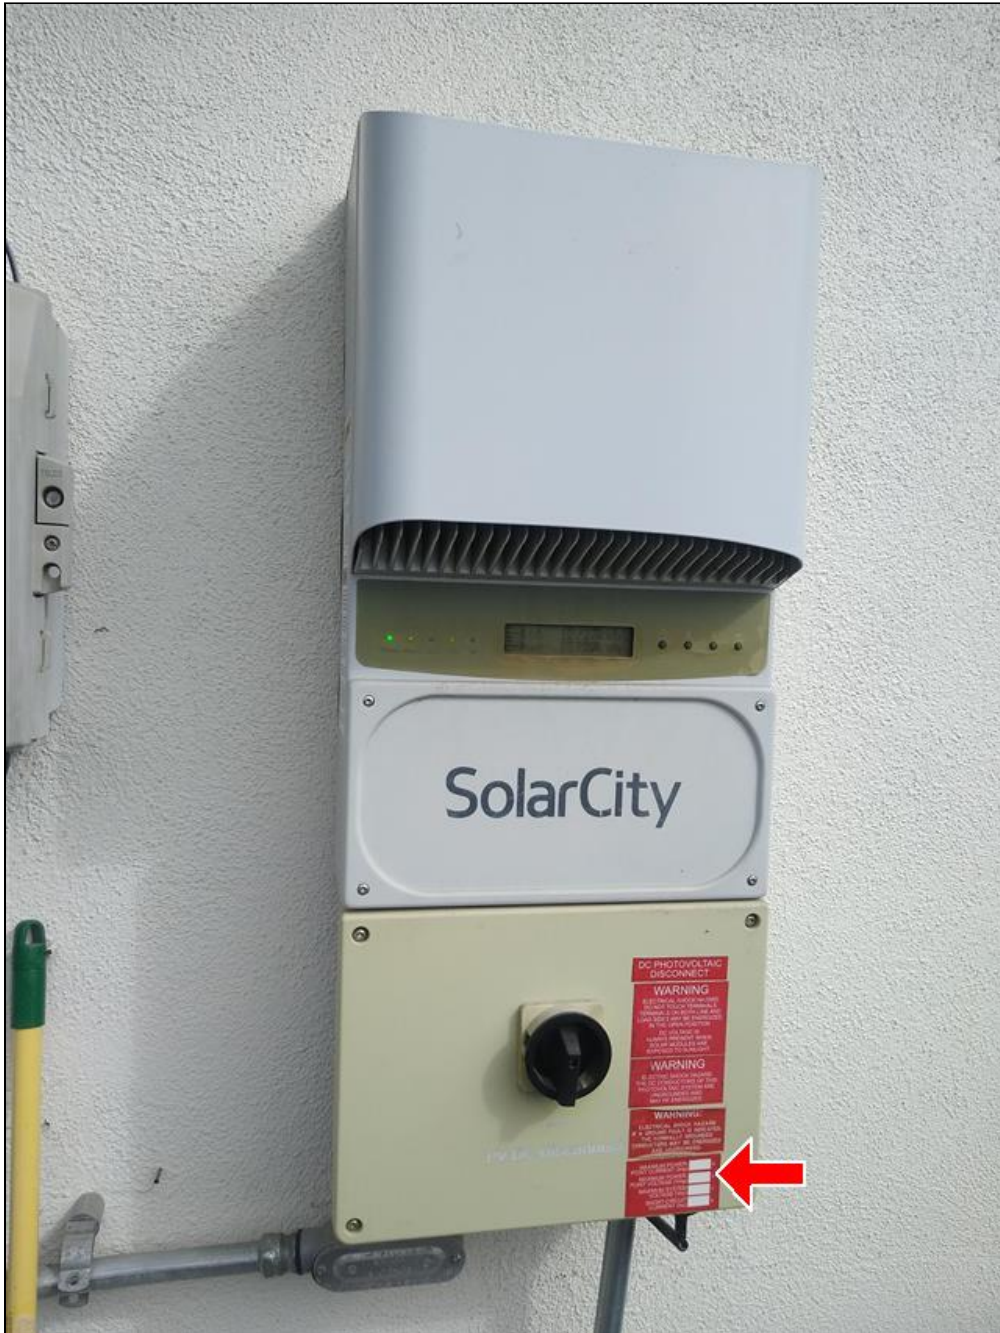
NOTE: (Red arrow mark-up) Solar system equipment is required to display current and voltage for the Fire Department for safety during emergencies. Consult service provider for further evaluation and proper labeling of solar equipment.

7.1 Item 5(Picture) Voltage and amperage are not on display for emergency services

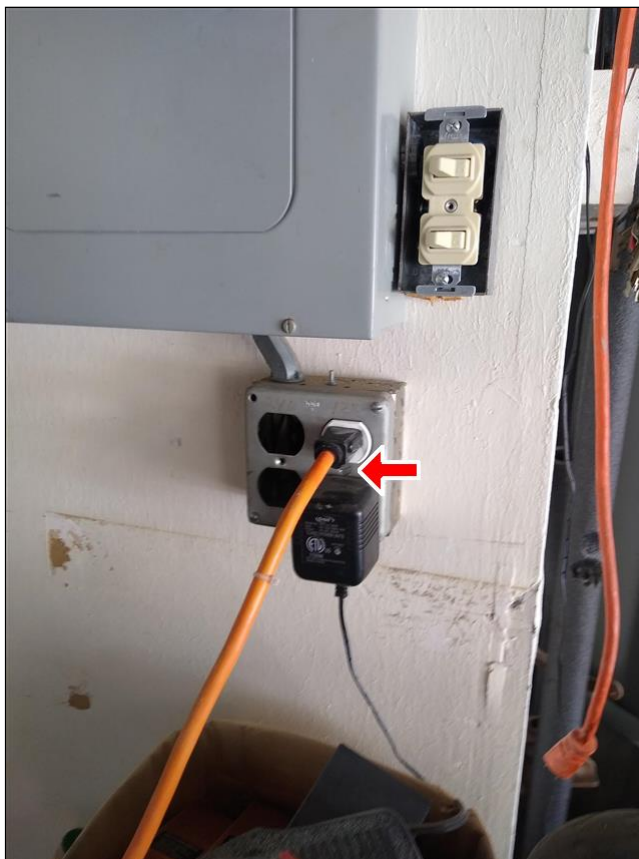
7.3 Item 2(Picture) Garage outlets, Not GFCI

7.3 Recommend upgrades to GFCI (Ground Fault Circuit Interrupter) type outlets for added safety at all applicable locations. Suggest testing trip buttons on regular basis to ensure proper operation of GFCI system. Consult a licensed electrician for locations and installation for safety.

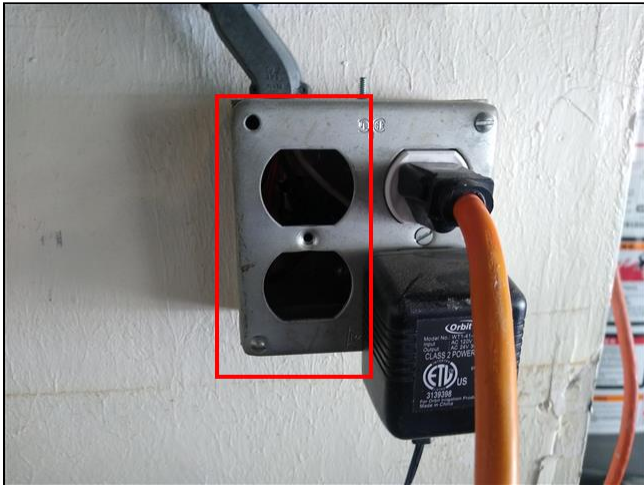
7.3 Item 3(Picture) Open knock-outs noted at garage receptacle. Recommend coverplate/fillers to protect wiring and for safety.

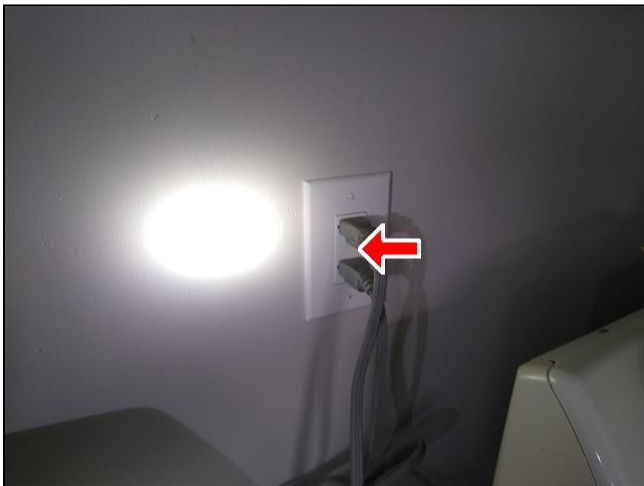
7.3 Item 5(Picture) Laundry area outlets, Not GFCI

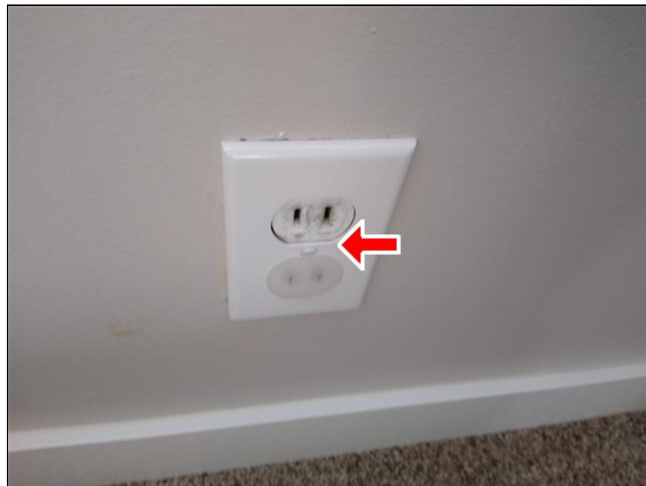
7.3 Item 6(Picture) Two prong outlets noted at front bedroom under window

Two-prong outlets noted throughout, which are not grounded. Recommend upgrading as desired. Consult a licensed electrician for further evaluation.

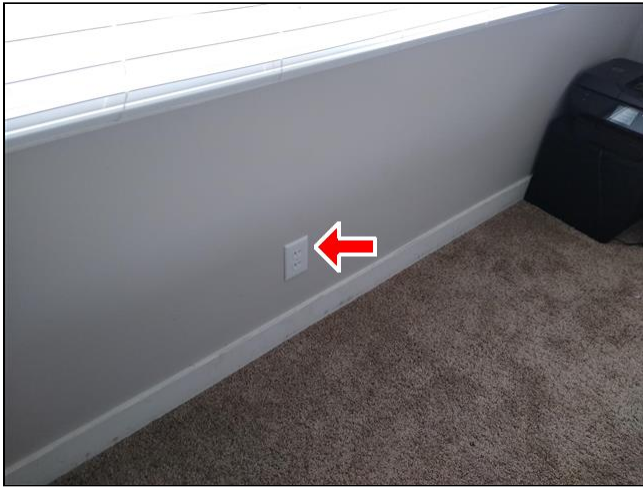
7.3 Item 7(Picture) Two prong outlets noted under Master bedroom window

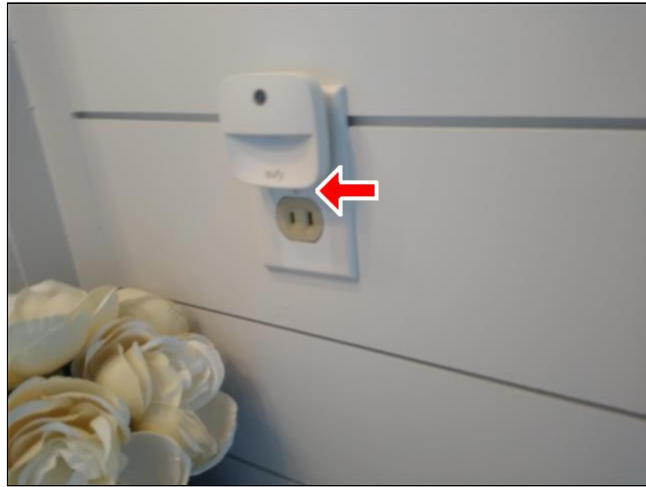
7.3 Item 8(Picture) Master bathroom outlets are Two-prong, Not GFCI

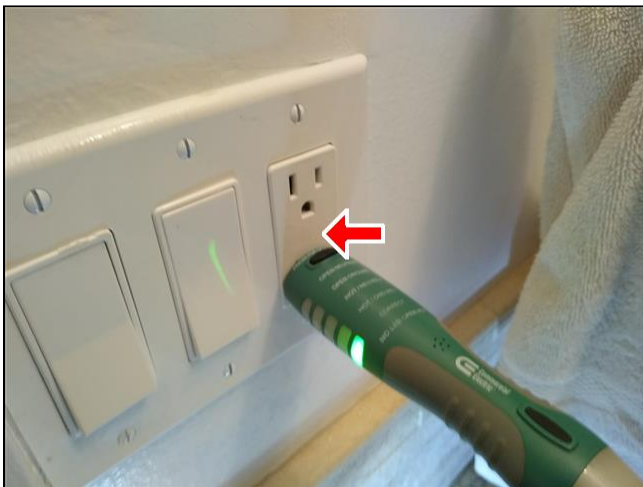
7.3 Item 9(Picture) Shared bathroom outlets, Not GFCI

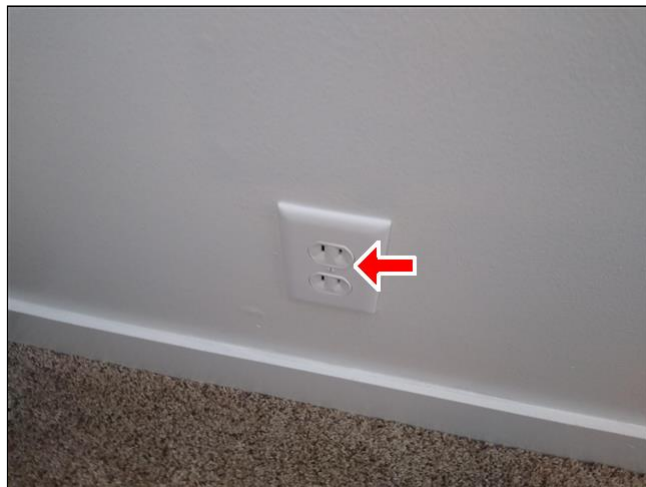
7.3 Item 10(Picture) Two-prong outlets noted, living room

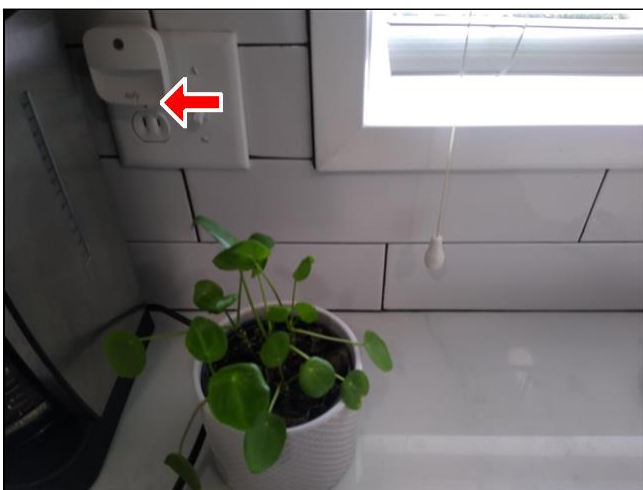
7.3 Item 11(Picture) Kitchen countertop outlets are Two-prong, Not GFCI

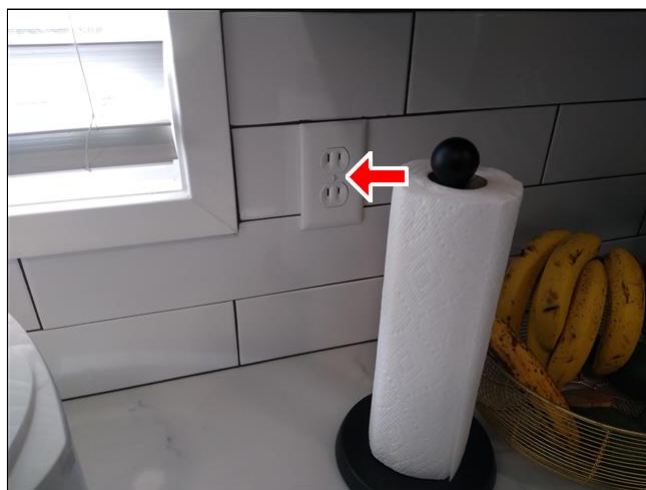
7.3 Item 12(Picture) Kitchen countertop outlets are Two-prong, Not GFCI

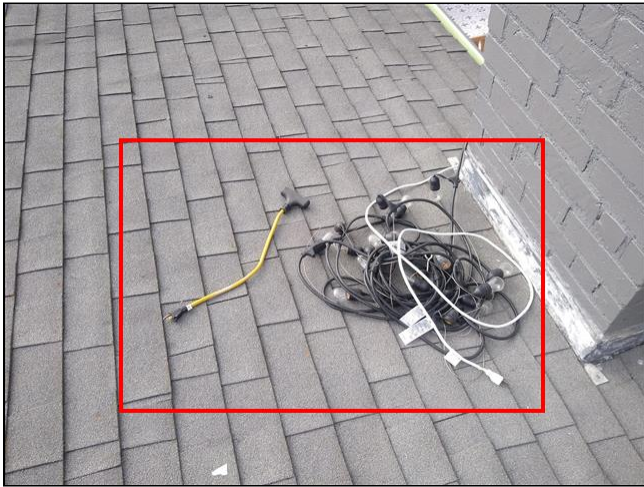
7.4 (1) Extension cord wiring noted at exterior area where it may be exposed to moisture/weather. Suggest removal and upgrades to hard wired outlets with GFCI protection for added safety. Consult a licensed electrician for further evaluation and repairs/upgrades as desired.

7.4 Item 1(Picture) Extension cord wiring noted behind chimney

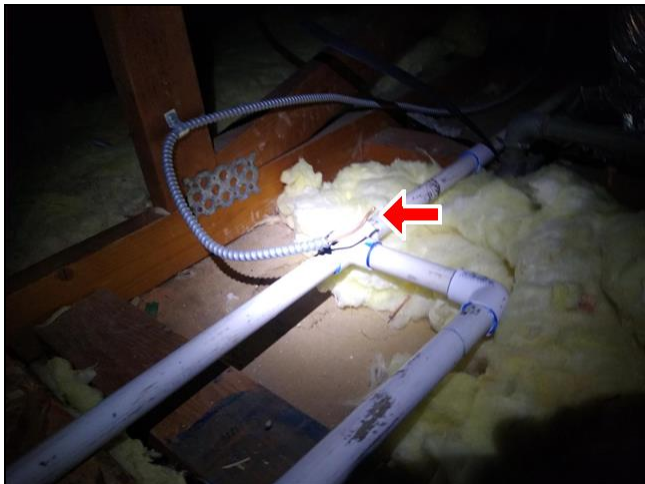
(2) Item 2 - Exposed wiring noted in attic area. Contact licensed electrician for further evaluation and repairs as needed for proper termination of wiring for safety.

7.4 Item 2(Picture) Exposed wiring noted in attic area

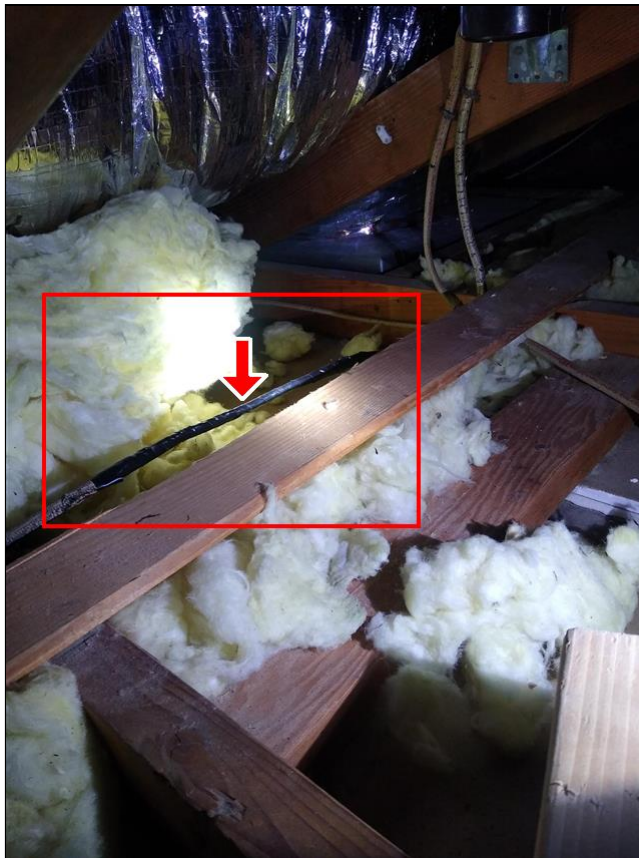
7.4 Item 3(Picture) Electrical tape repairs noted at cabling in attic area

Open junction boxes and/or exposed wiring noted at various locations. Add cover plates at open junction boxes. Enclose wiring in conduit and/or properly terminate wiring for safety. Consult a licensed electrician for further evaluation and repairs as needed for proper installation.

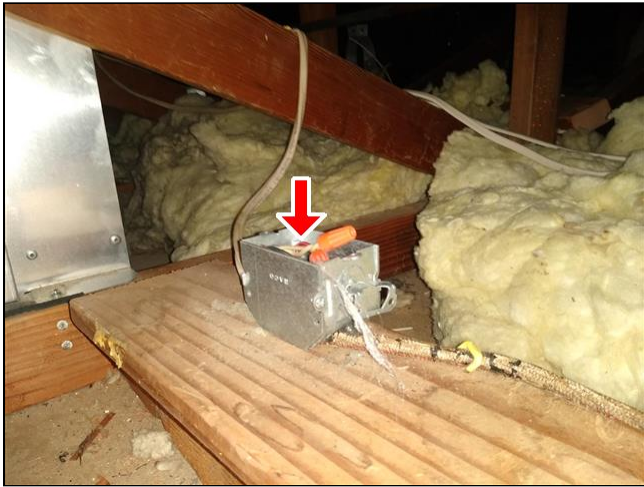
7.4 Item 4(Picture) Open junction box noted near attic access door

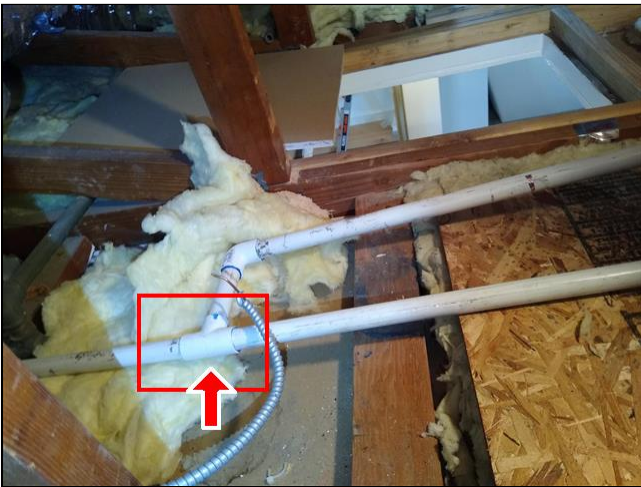
8.3 Unconventional installation noted at condensate piping. Condensate lines are not properly separated in attic area (lines are connected together). This is not allowed and may increase the likelihood of leaks and subsequent water damage if the line becomes clogged. Recommend further evaluation by licensed HVAC technician and repairs as needed for proper installation in order to prevent clogs/leaks.

8.3 Item 1(Picture) Primary and secondary condensate lines connect, which is not permitted

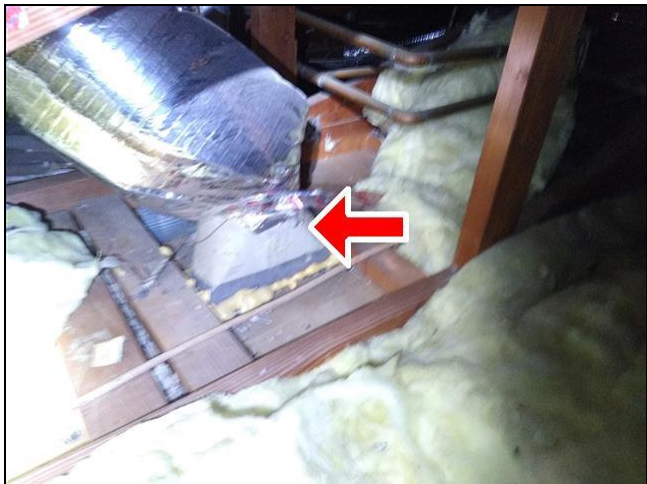
Older insulated ducting at boots in attic area may have asbestos-containing materials (ACM). No analysis was performed; however, suspect asbestos-containing materials were noted. If removal is desired, consult licensed asbestos inspector for testing to confirm presence and licensed asbestos abatement contractor for removal. **Otherwise, avoid disturbing.** NOTE: Any worn/damaged ducting boot insulation with ACM may present a health hazard if materials are drawn into forced air system (i.e. due to any damaged/gaps in nearby ducts).

8.4 Item 1(Picture) Possible asbestos-containing material noted at duct boot

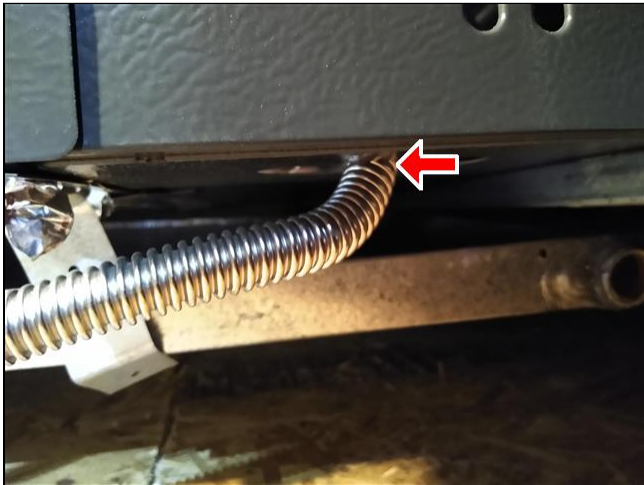
8.6 Item 1 - Flex gas connector should link to rigid gas pipe before passing through the "knock-out"/hole at the side of the furnace for safety. Otherwise the metal edge on heating unit "knock-out"/hole may cause damage and shear the flex gas line in the event of seismic activity or normal vibration that occurs during the operation of heating equipment. Consult licensed HVAC technician for repairs as needed for proper installation and safety.

8.6 Item 1(Picture) Flex gas connector passes through knock-out where it may be sheared.

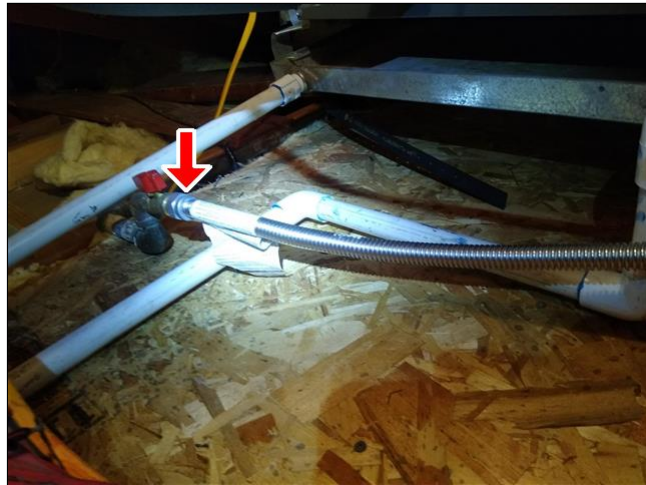
Item 2 - Sediment trap was not installed at heating unit gas line. Sediment trap should be positioned where the gas flow in piping changes direction. Consult licensed HVAC technician for proper installation as desired. Sediment trap not properly installed at gasline for furnace.

8.6 Item 2(Picture) No sediment trap noted

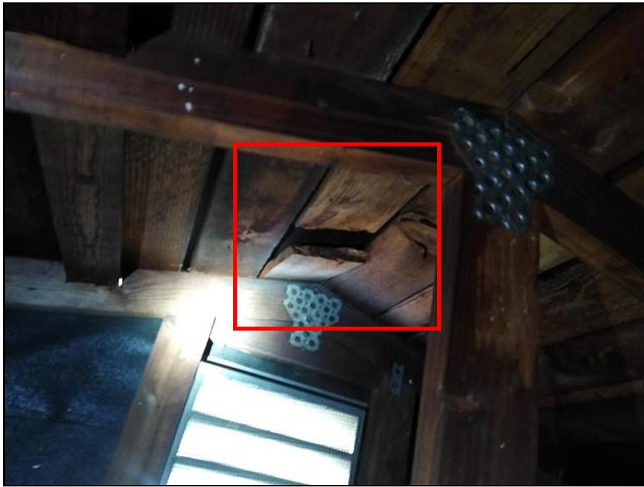
Item 1 - No ridge board/beam noted, which is common in older structures. Item 2 - Broken sheathing noted at E gable ridge area. Item 3 - Over-notching noted at rafter by attic area fan. Recommend further evaluation by licensed roofer and repairs as needed for enduring stability.

9.0 Item 2(Picture) Broken sheathing noted at ridge area, E

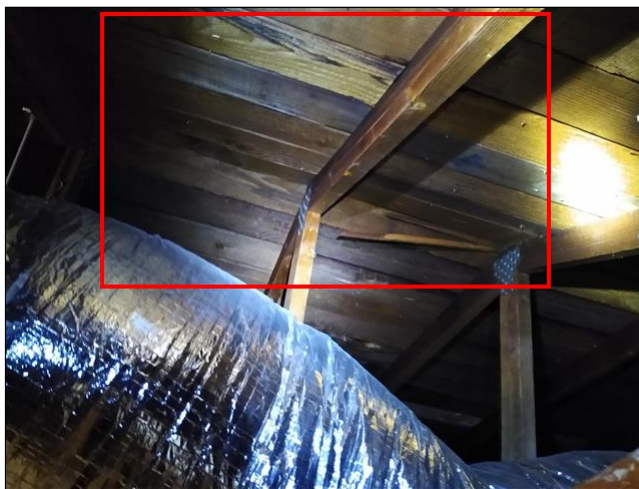
9.1 Stains noted at various locations of framing in the attic area. Unable to determine if active. Monitor condition and repair leaks as needed to prevent moisture penetration and damage. Any notation of leakage or stains does not preclude additional areas of leakage and/or hidden damage. Any ongoing and/or questionable situations should be assessed and corrected.

9.1 Item 2(Picture) Staining noted

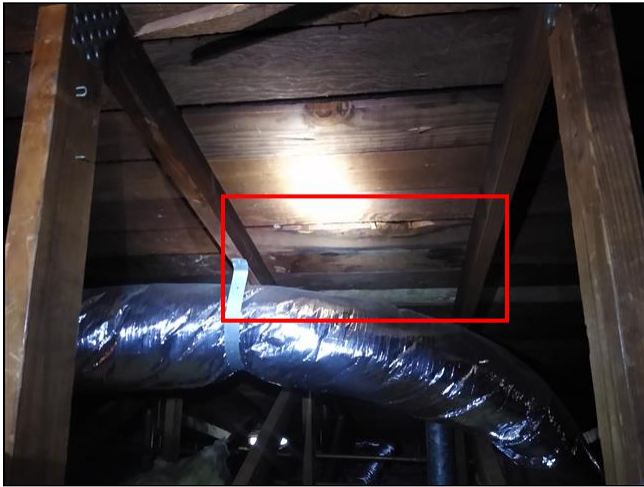
9.1 Item 3(Picture) Staining noted

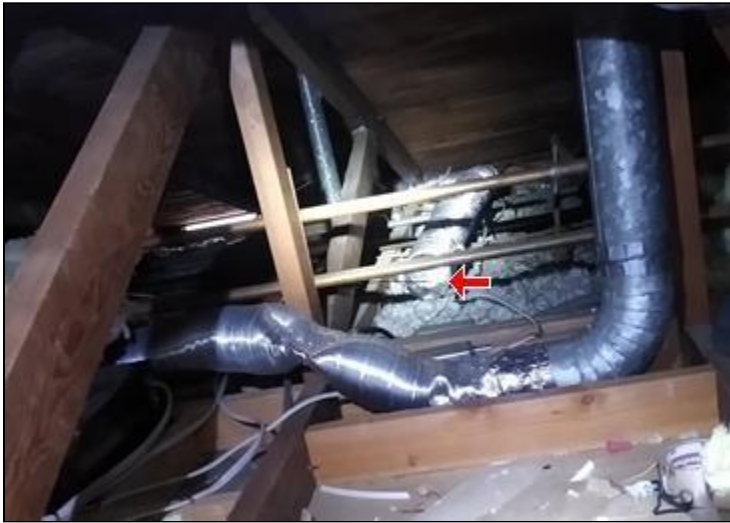
Item 2 - Bath exhaust vent terminates in attic, where water vapor from showering/bathroom can cause excessive moisture and the possibility of consequential environmental damage. Redirect vent to discharge at an exterior location with proper termination covering and damper. Consult qualified contractor for repairs as needed for proper installation.

9.2 Item 2(Picture) Exhaust ducting terminates in attic area

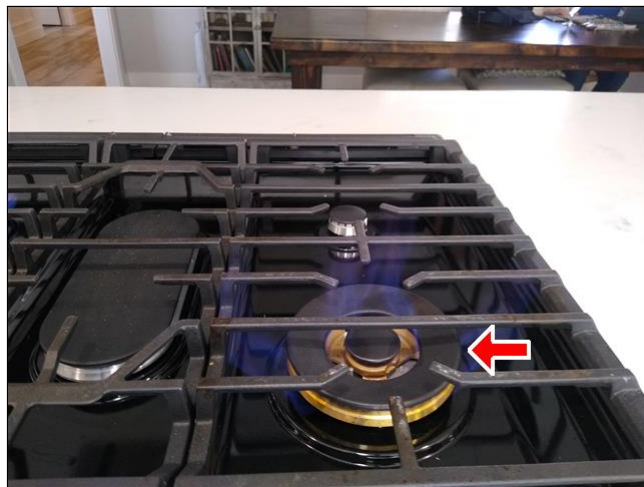
10.2 Item 2 - Cooking unit DID NOT operate properly at the time of the inspection and front right burner produced uneven corona of flames. Suggest further evaluation/ repairs needed by a qualified technician.

10.2 Item 2(Picture) Front right burner produced uneven flames

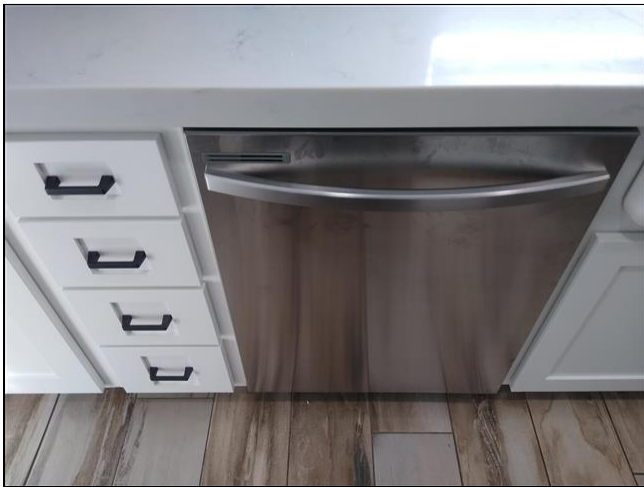
10.5 Item 1(Picture)

10.5 No air gap was present at countertop by sink. Some dishwashers have built-in backflow prevention devices (i.e. check valve), which make the air gap unnecessary. Unable to determine at time of inspection. Consult manufacturer's instructions to determine whether integral backflow prevention is present with dishwasher. If not, then recommend qualified appliance technician for proper installation of air gap or check valve as needed

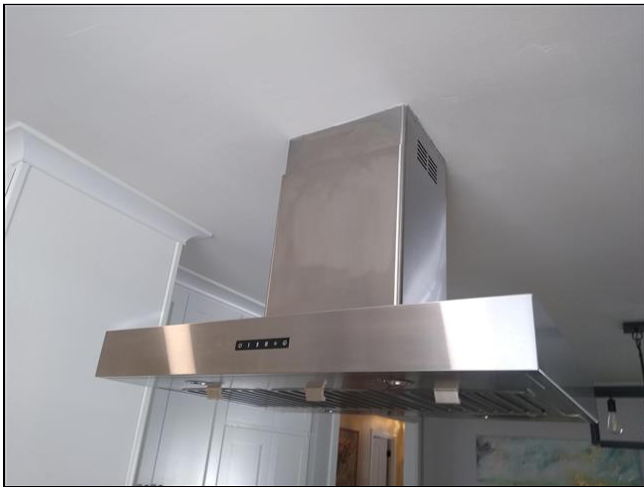
10.7 Item 1(Picture)

10.7 Ventilator - Satisfactory.

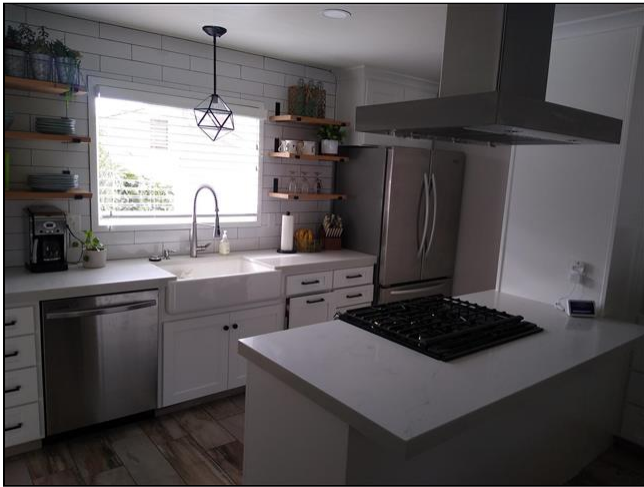
10.8 Item 1(Picture)

10.8 Kitchen Cabinetry - Satisfactory.

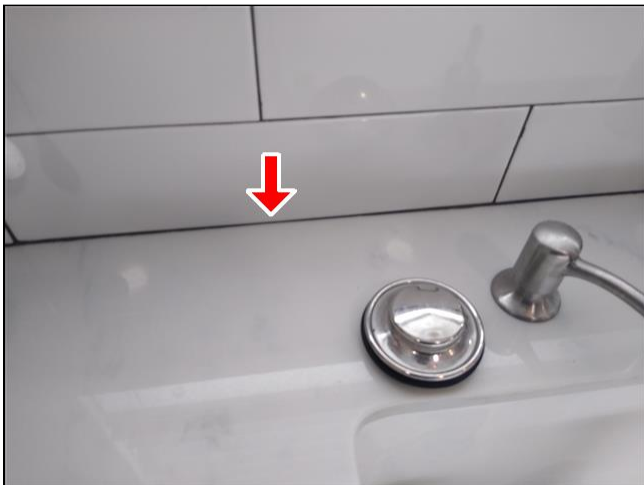
10.9 Item 1(Picture) Recommend caulking where countertop meets backsplash

10.9 MAINTENANCE TIP: Recommend caulking where countertop meets backsplash now and as part of routine maintenance to prevent water seepage behind cabinets.
