Inspection Report

7 Cinchring Rd
Rolling Hills, CA 90274

Friday, September 27, 2019

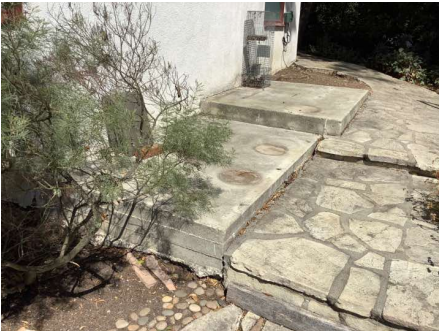
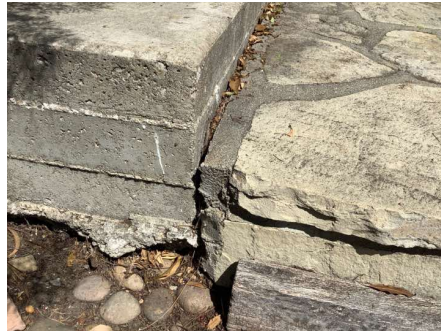
FE s-28: The hardscape has settled or moved away from the left side of the building. Due to the hillside location, we suggest a qualified Geotechnical engineer should evaluate the entire property to assess soil stability or potential for movement.

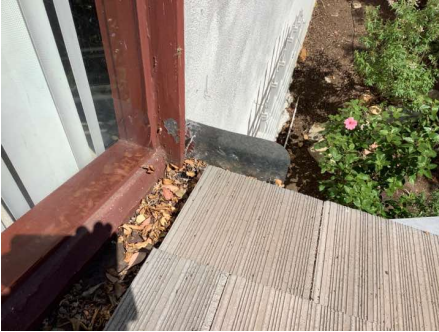
CR s-57: On the front of the roof the kick out flashing at the end of the sidewall flashing is installed improperly. Leaks and/or water damage is possible. We suggest a qualified roofer should evaluate the entire roof and install proper kick out flashings as necessary.

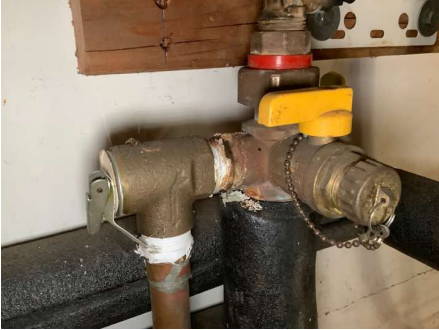
CR s-113: The water connections are heavily corroded and leaks may occur. We suggest a qualified plumber should replace the corroded connections.

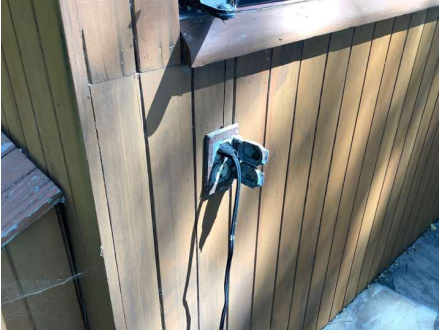
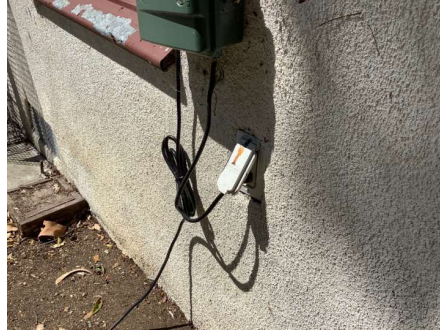
CR s-140: There is a permanently installed extension cord on several sides of the building. All permanently installed cords are required to have a cover that allows the plug to be installed and still maintain a weather-tight enclosure. We suggest approved weatherproof covers should be installed as needed.

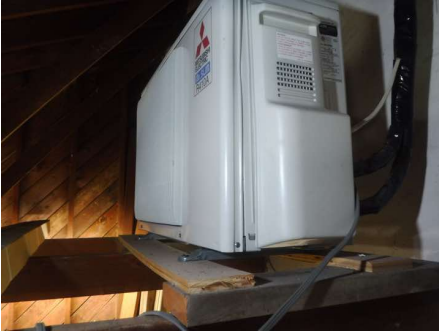
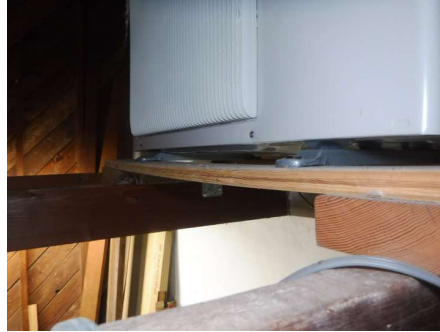
CR s-169: The condensing unit is not loaded on the exterior of the building. It is also improperly mounted on garage roof framing and the planks are sagging. We suggest a qualified HVAC technician should relocate the unit per manufactures specifications.

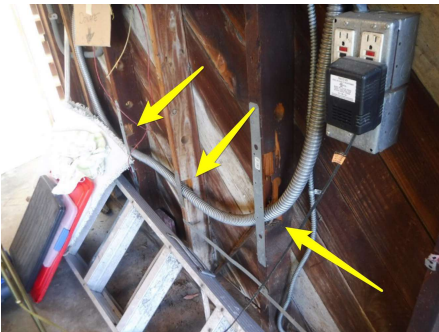
CR s-182: One or more of the wall studs in the garage is over notched. This could affect its ability to support the structure above. We suggest a qualified carpenter could evaluate the studs and make repairs or modifications as necessary.

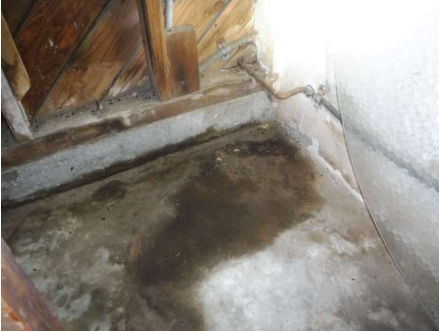
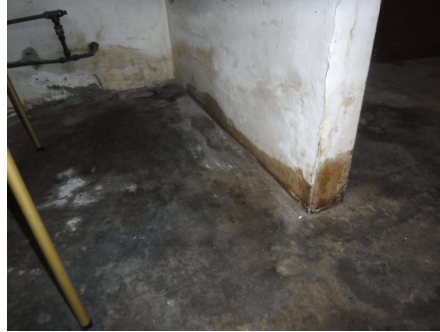
FE CR s-184: There are dark stains on the garage floor adjacent wall surfaces. This may indicate motor oil spills. We suggest a qualified environmental specialist should evaluate the staining to advise on necessary repairs.

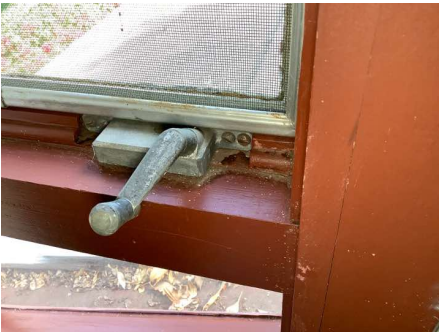
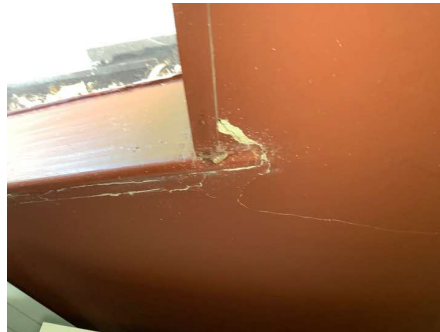
Upper floor

FE CR s-191: In the area(s) listed below there are water stains and/or damage at the wall or sill near the window(s). The leaks that caused the damage may still exist. We suggest a qualified technician should identify and repair all leaks. If damage to finished surfaces and underlying materials are discovered during the course of repairs, repairs should be made as necessary.

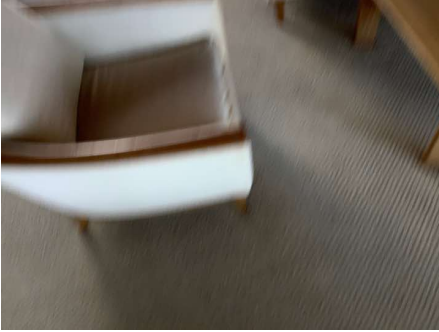
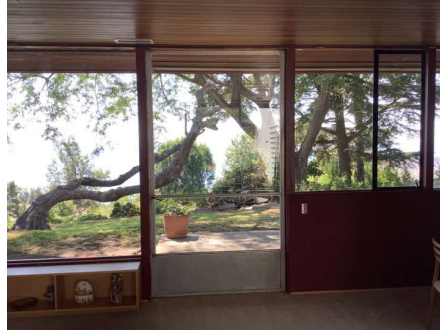
SC RU s-192: The glass in the older original openings has no markings that indicates that it is safety glass. However, the glass in the newer doors and/or windows did have such markings. Non-safety glass can be hazardous if broken. We recommend that glass be upgraded as appropriate to provide safety glazing in all locations where present industry standards require.

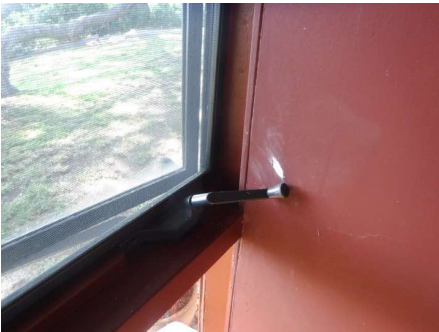
FE CR s-195: In the area(s) listed below one or more cranking handles on the casement windows are obstructed by the adjacent wall. We suggest shorter handles should be installed the the proper operation of the windows should be confirmed.

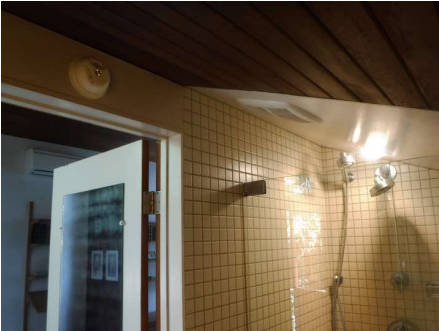
CR s-203: The smoke alarm in the upper floor bathroom is improperly located. Smoke alarms should be at least 3 feet away from a bathroom to prevent nuisance alarms. We suggest that any improperly located smoke alarms should be moved and reinstalled in locations specified in the manufacturer's instructions.

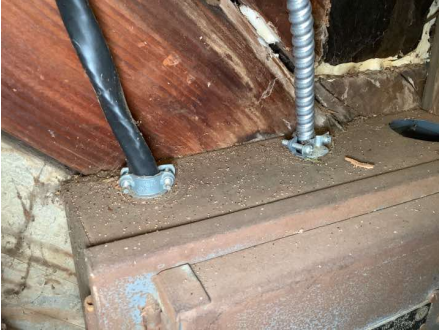
Garage

FE s-206: In the areas listed below there are dropping or pellets that may indicate the presence of wood destroying organisms. Review of a current pest control operator's report, if available is recommended to determine what action might be appropriate. If no current report is available, a report should be ordered from a qualified, licensed pest control operator.

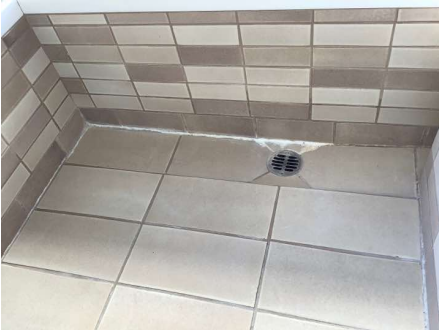
CR s-241: There are mineral deposits above some of the shower pan tiles. The mineral deposits are hard and can be abrasive. This can indicate the shower pan drains are obstructed or the shower pan under the tiles is not properly sloped. We suggest a qualified shower pan technician should evaluate this condition and make repairs or modifications as necessary.

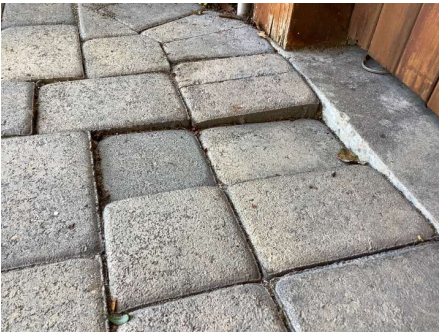
SC s-29: Uneven sections were observed in the driveway surface. This condition poses a trip hazard. We recommend correcting the condition(s) noted for safety reasons.

SC 29: Uneven sections were observed in the driveway surface. This condition poses a trip hazard. We recommend correcting the condition(s) noted for safety reasons.

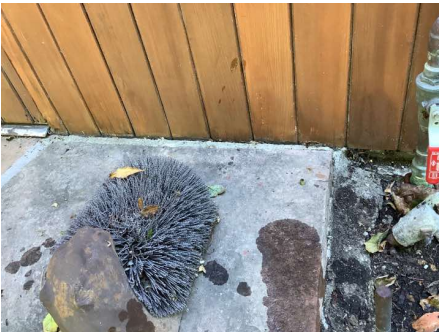
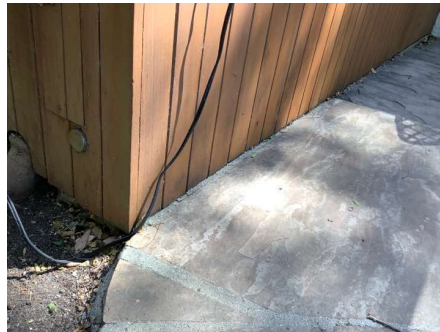
CR s-35: The wood siding is in contact with or covered by hardscape. This condition is conducive to moisture intrusion and deterioration. We recommend further evaluation and corrections by a specialist in the appropriate trade.

CR 35: The wood siding is in contact with or covered by hardscape. This condition is conducive to moisture intrusion and deterioration. We recommend further evaluation and corrections by a specialist in the appropriate trade.

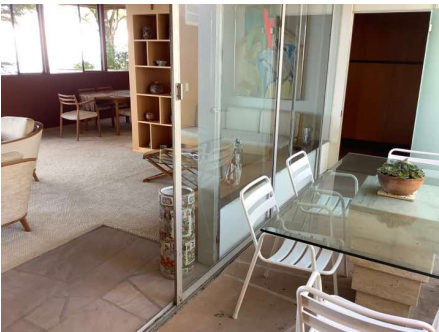
CR s-40: The sliding door is difficult and doesn't fully open. We suggest the sliding door and its associated hardware should be repaired or replaced as needed.

CR 40: The sliding door is difficult and doesn't fully open. We suggest the sliding door and its associated hardware should be repaired or replaced as needed.

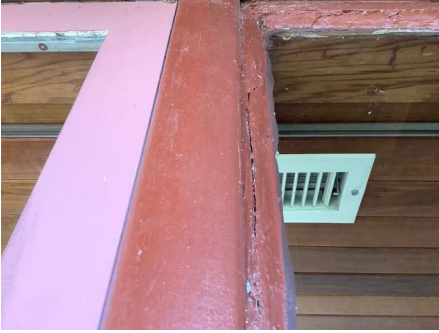
CR s-41: Glazing putty is dry and cracked at the window(s) on several sides of the building. Some putty is loose or missing. This can promote water entry or loose panes. We suggest a qualified window technician should check all windows make repairs or modifications as necessary.

CR 41: Glazing putty is dry and cracked at the window(s) on several sides of the building. Some putty is loose or missing. This can promote water entry or loose panes. We suggest a qualified window technician should check all windows make repairs or modifications as necessary.

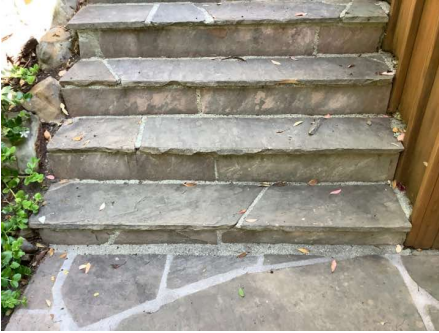
SC s-44: The height of individual stairs are different on the right side of the building. This could present a hazard to the safety of persons who might use them. Standard trade practices dictate that all steps be almost identical in "rise" and "run" for safety. We suggest the stairs should be repaired or replaced by a qualified technician to conform to standard trade practices. If the stairs are not modified or rebuilt, users of the stairs should exercise caution to avoid personal injury.

SC 44: The height of individual stairs are different on the right side of the building. This could present a hazard to the safety of persons who might use them. Standard trade practices dictate that all steps be almost identical in "rise" and "run" for safety. We suggest the stairs should be repaired or replaced by a qualified technician to conform to standard trade practices. If the stairs are not modified or rebuilt, users of the stairs should exercise caution to avoid personal injury.

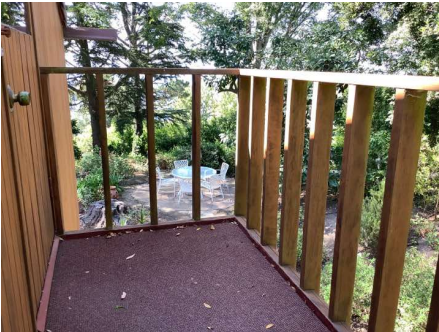
SC s-45: The railing openings between the balusters are wider than the current industry standards on the right side of the building. Although this may have been allowed at the time of construction, this is a safety hazard to small children who could fall through them. Modification in accordance with current standards is recommended as an upgrade.

SC 45: The railing openings between the balusters are wider than the current industry standards on the right side of the building. Although this may have been allowed at the time of construction, this is a safety hazard to small children who could fall through them. Modification in accordance with current standards is recommended as an upgrade.

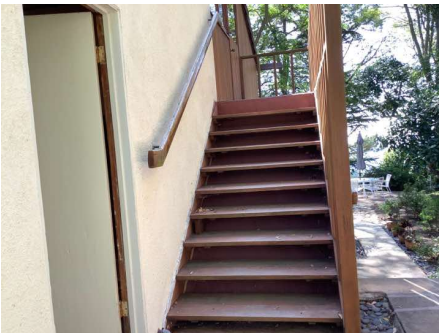
SC 46: The stair handrails are too high on the right side of the building. We suggest the height of the existing railings could be lowered, or new railings with the proper height could be installed.

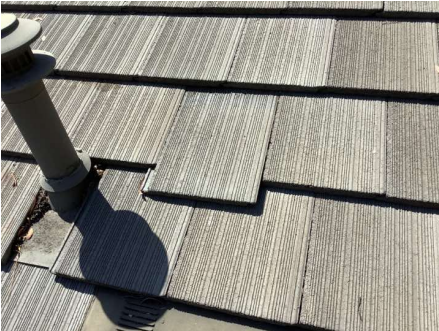
CR s-53: There are a number of cracked, damaged or dislodged tiles on the roof. We suggest a qualified roofer should evaluate the entire roof and make repairs or modifications as necessary.

CR 53: There are a number of cracked, damaged or dislodged tiles on the roof. We suggest a qualified roofer should evaluate the entire roof and make repairs or modifications as necessary.

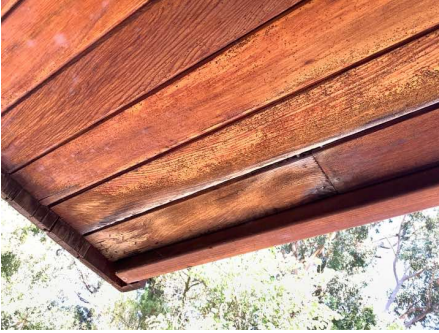
FE s-54: There are water stains on the underside of the eaves at the right front of the building. These visible conditions strongly indicate a prior or active leak. We suggest the source of the water penetration should be located and appropriate repairs made to prevent more damage to the eaves.

FE 54: There are water stains on the underside of the eaves at the right front of the building. These visible conditions strongly indicate a prior or active leak. We suggest the source of the water penetration should be located and appropriate repairs made to prevent more damage to the eaves.

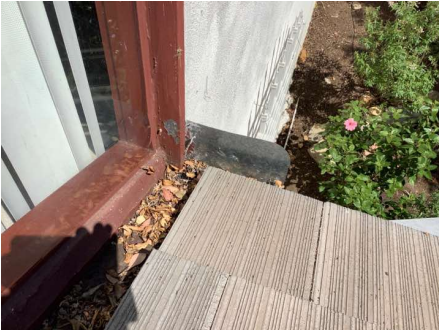
CR 57: On the front of the roof the kick out flashing at the end of the sidewall flashing is installed improperly. Leaks and/or water damage is possible. We suggest a qualified roofer should evaluate the entire roof and install proper kick out flashings as necessary.

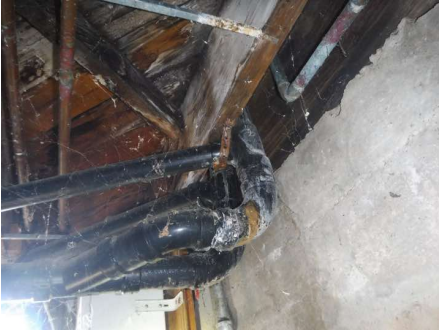
FE s-75: There are water stains on the subfloor and plumbing drain under the master bathroom. The areas were dry at the time of this inspection. Inquires should be made to the sellers as to their knowledge of the leaks and what repairs were performed. If concerns remain we suggest a qualified plumber evaluate the plumbing components in this area.

FE 75: There are water stains on the subfloor and plumbing drain under the master bathroom. The areas were dry at the time of this inspection. Inquires should be made to the sellers as to their knowledge of the leaks and what repairs were performed. If concerns remain we suggest a qualified plumber evaluate the plumbing components in this area.

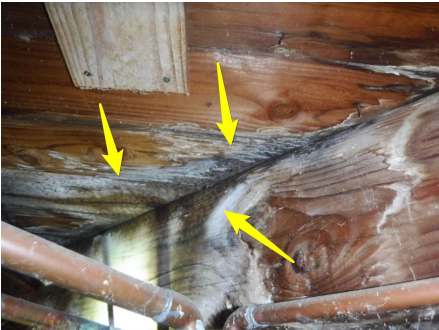
FE CR s-76: There is surface growth on the subflooring under the master bathroom. This may indicate the presence of mold, fungus or other microbial organisms. The identification of molds, fungus and other microbial organisms is outside the scope of this inspection. A qualified environmental specialist should be retained to evaluate the surfaces and make further recommendations. Testing and remediation of mold growth can only be accomplished by a qualified environmental specialist. If strict protocol is not followed, spores can be released into the interior of the building and may create a health hazard for those with low tolerances to such organisms.

FE CR 76: There is surface growth on the subflooring under the master bathroom. This may indicate the presence of mold, fungus or other microbial organisms. The identification of molds, fungus and other microbial organisms is outside the scope of this inspection. A qualified environmental specialist should be retained to evaluate the surfaces and make further recommendations. Testing and remediation of mold growth can only be accomplished by a qualified environmental specialist. If strict protocol is not followed, spores can be released into the interior of the building and may create a health hazard for those with low tolerances to such organisms.

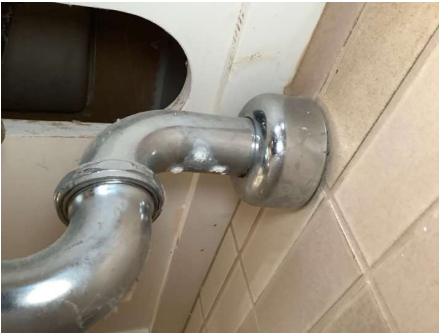
Max bathroom left wash basin

CR s-93: In the area(s) listed below although no active leak was observed, there is/are corroded and/or deteriorated drain line(s) with a limited useful life. We suggest considering replacing such drains before leaks occur.

CR 93: In the area(s) listed below although no active leak was observed, there is/are corroded and/or deteriorated drain line(s) with a limited useful life. We suggest considering replacing such drains before leaks occur.

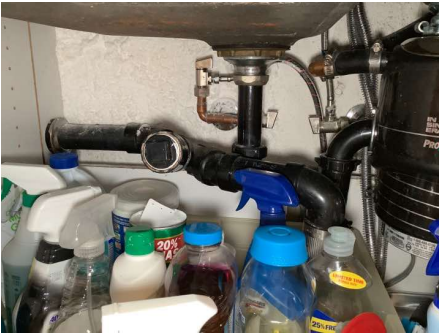
Kitchen sink

CR s-94: In the area(s) listed below the drain lines have an improper slope. Drains must slope down. Incorrect pipe slope can prevent proper drainage. We suggest a qualified plumber should make repairs or modifications as necessary.

CR 94: In the area(s) listed below the drain lines have an improper slope. Drains must slope down. Incorrect pipe slope can prevent proper drainage. We suggest a qualified plumber should make repairs or modifications as necessary.

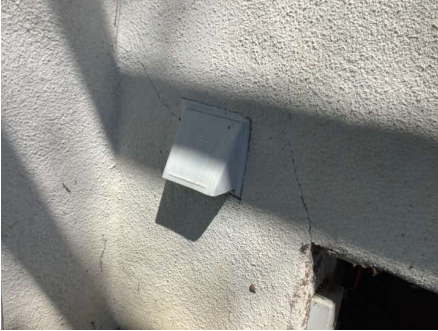
CR s-105: The tankless water heater has a category III stainless vent. The termination hood is not approved. We suggest a qualified plumber should install a vent cap approved by the water heater manufacture.

CR 105: The tankless water heater has a category III stainless vent. The termination hood is not approved. We suggest a qualified plumber should install a vent cap approved by the water heater manufacture.

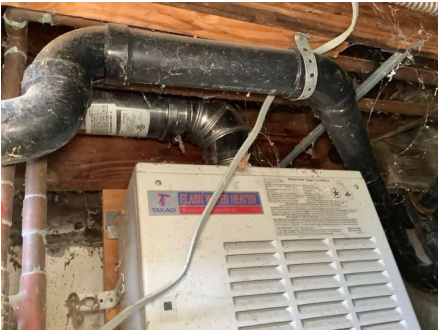
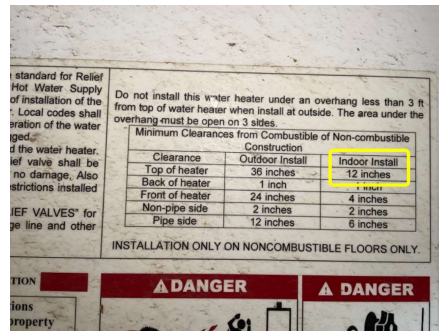
CR 107: The tankless water heater is installed too close to the surfaces above. This could be a fire hazard. We suggest a qualified plumber adjust the appliance location to provide adequate clearance to meet the manufacturer's specifications.

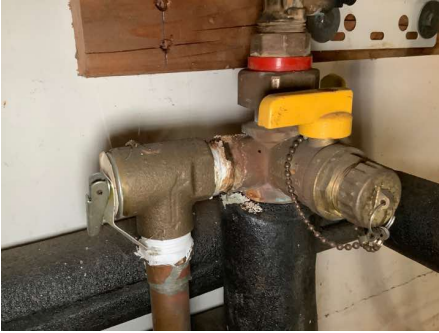
CR 113: The water connections are heavily corroded and leaks may occur. We suggest a qualified plumber should replace the corroded connections.

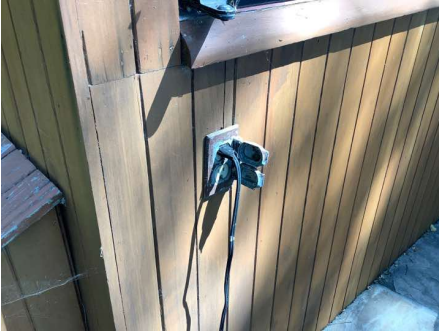
CR 140: There is a permanently installed extension cord on several sides of the building. All permanently installed cords are required to have a cover that allows the plug to be installed and still maintain a weather-tight enclosure. We suggest approved weatherproof covers should be installed as needed.

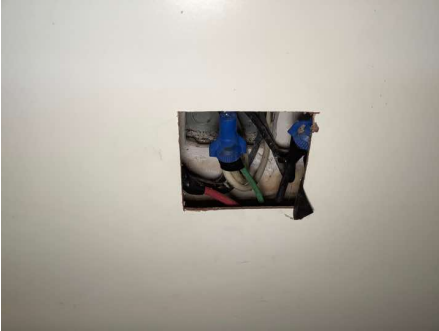
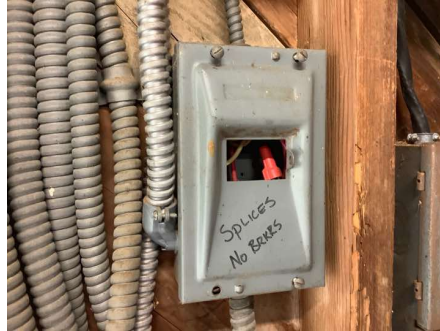
CR 146: In the area(s) listed below there is open junction box(es). Lack of covers on junction boxes is a shock or fire hazard. We DID NOT necessarily list all locations. We suggest a qualified electrician should check the system and install a proper cover on all junction boxes.

Kitchen cabinet under the cooktop

Garage

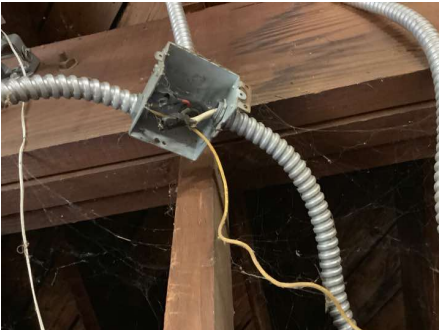
CR 147: In the area(s) listed below there is an open wire splice(s). We DID NOT necessarily list all locations. Open splices can be a shock or fire hazard. We suggest a qualified electrician should properly splice all wiring inside covered junction boxes.

Garage

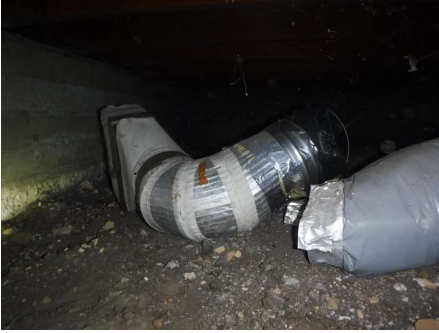
FE CR 158: The original ducts are made a material that may contain asbestos. Some of the ducts are abandoned and generally in poor condition or damaged. We suggest the abandoned ducts are removed by a licensed asbestos abatement contractor as necessary.

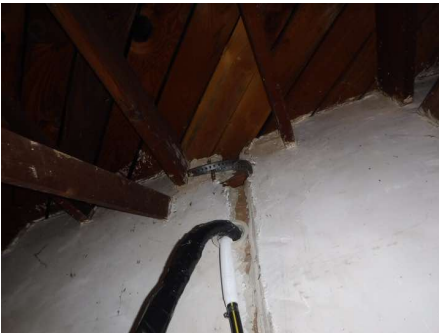
CR 181: There are holes/damage in the fire-resistive barrier between the garage and interior or attic. This condition can allow more rapid spread of smoke and flames in the event of a fire. We suggest all voids should be repaired per current industry standards.

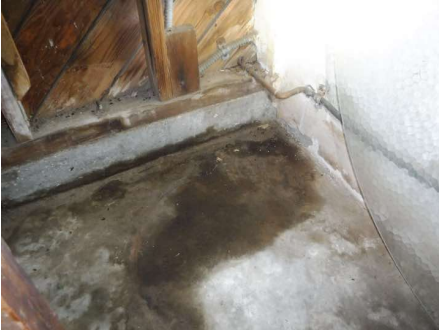
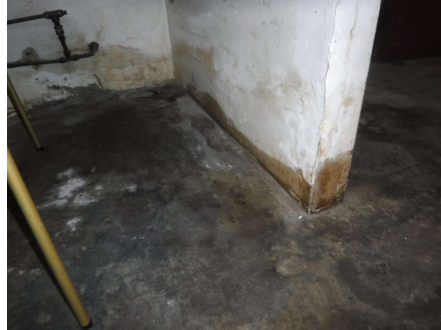
FE CR 184: There are dark stains on the garage floor adjacent wall surfaces. This may indicate motor oil spills. We suggest a qualified environmental specialist should evaluate the staining to advise on necessary repairs.

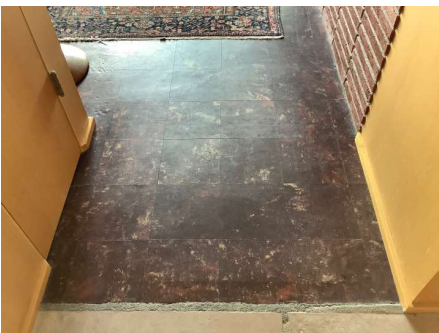
FE 185: The floor tile material in the middle room and master closet may contain asbestos. Asbestos content can be determined only by laboratory testing. We suggest you to obtain further information on asbestos from a licensed asbestos consultant or abatement contractor.

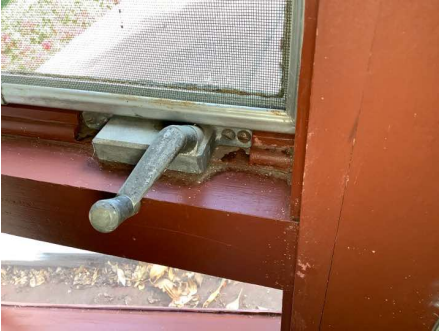
FE CR 191: In the area(s) listed below there are water stains and/or damage at the wall or sill near the window(s). The leaks that caused the damage may still exist. We suggest a qualified technician should identify and repair all leaks. If damage to finished surfaces and underlying materials are discovered during the course of repairs, repairs should be made as necessary.

Upper floor

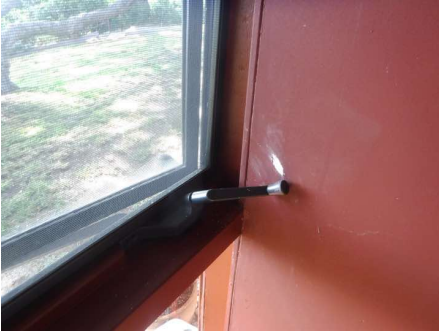
FE CR 195: In the area(s) listed below one or more cranking handles on the casement windows are obstructed by the adjacent wall. We suggest shorter handles should be installed the the proper operation of the windows should be confirmed.

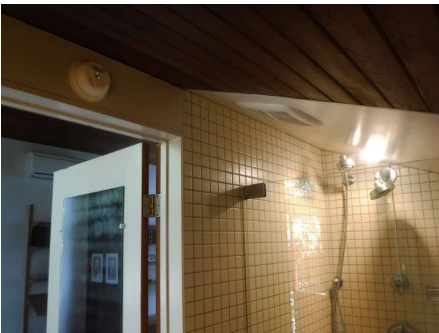
CR 203: The smoke alarm in the upper floor bathroom is improperly located. Smoke alarms should be at least 3 feet away from a bathroom to prevent nuisance alarms. We suggest that any improperly located smoke alarms should be moved and reinstalled in locations specified in the manufacturer's instructions.

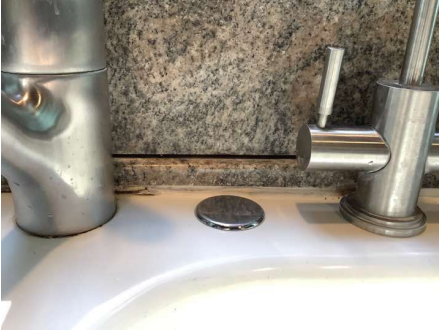
CR 209: The joint between the countertop and the backsplash is cracked or open and subject to moisture damage from water penetration. Water stains and/or damaged were present in the cabinet below. We suggest a qualified technician re-caulking the backsplash and repair the cabinet as necessary.

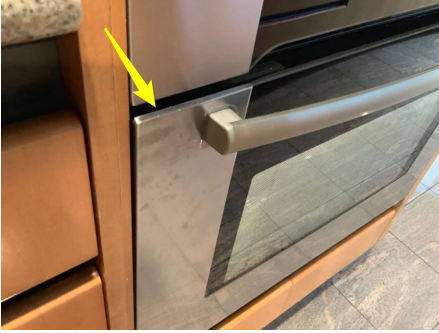
CR 216: The oven door does not fully close, preventing the door from sealing properly. We suggest having a qualified appliance technician repair the appliance as needed.

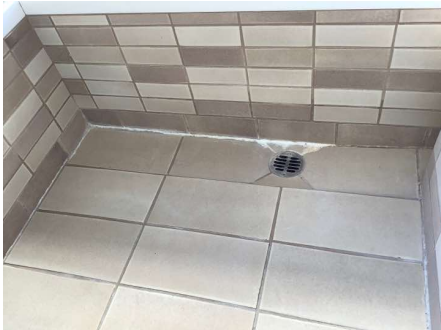
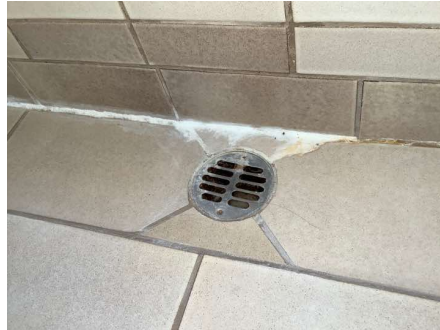
CR 241: There are mineral deposits above some of the shower pan tiles. The mineral deposits are hard and can be abrasive. This can indicate the shower pan drains are obstructed or the shower pan under the tiles is not properly sloped. We suggest a qualified shower pan technician should evaluate this condition and make repairs or modifications as necessary.
