# ***Cornerstone Inspection***

## **Property Inspection Report**

***2138 Callender Road, Arroyo Grande, CA 93420***  
***Inspection prepared for: Scott and Tina Dye***  
***Real Estate Agent: Jim Settle - Century 21 Hometown Realty***

***Date of Inspection: 6/5/2017 Time: 1:00 PM Size: 1800***  
***Order ID: 2150***

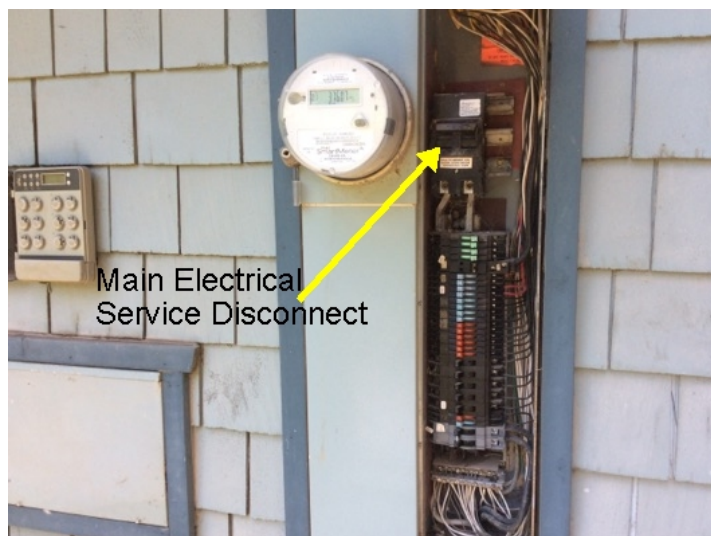
1.10. The interior cover panel for the main electrical panel is missing, and should be replaced.

1.11. Various circuits are not labeled, which is recommended.
