Home Inspection Services Home Inspection Report

Address: 6620 Atascadero Ave, Atascadero - 3/30/18

Inspector: John Ramsey, CCI 3321 Via Del Sueno Atascadero, CA 93422 (805) 801-7129

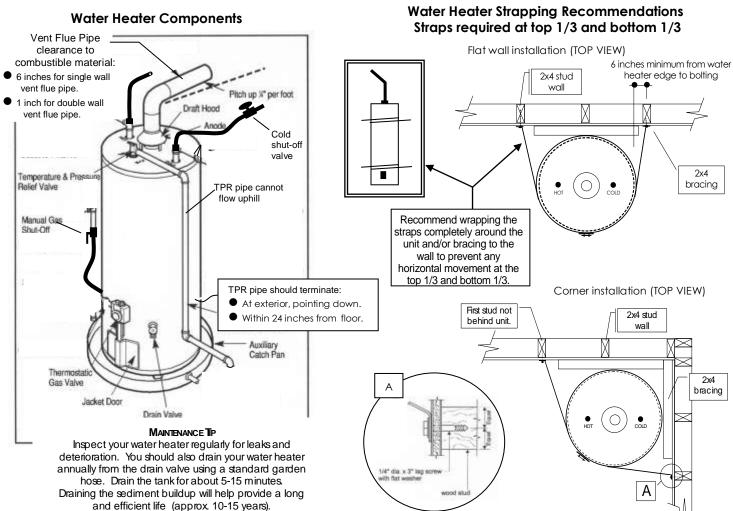
Water Heater TPR (TEMPERATURE PRESSURE RELIEF) VALVE INSTALLED pipe improperly flows uphill from TPR valve. ①② - See example at photo page)
 Recommend a drain pipe from catch pan under the water heater to floor / exterior
 Missing / Recommend a proper storm collar per standards at the water heater vent pipe at the roof termination ③
 Recommend / Missing the insulation on the hot and cold water supply pipes alop the water heater per standards. ③
 Water heater circulation pump operated when tested. ☐ Evidence of past / active leaking & corrosion at the HOT & COLD water supply piping atop the water heater ender the end of its useful life. Replacement may be warranted soon. ②
 Water heater thermal blanket covers ID & safety placard,. ⑤ - See example at photo page)
 Water heater themperature over 105 ° F can cause burns or scalding. Checking the water temperature is not part of this home ins
