L.A. PRIVATE EYES ENGINEERS

December 5, 2018
Job No. 12TI18

Subject: **Limited Geotechnical Inspection**
7080 Via Del Mar
Lot 19, Tract 37818
Los Angeles, California

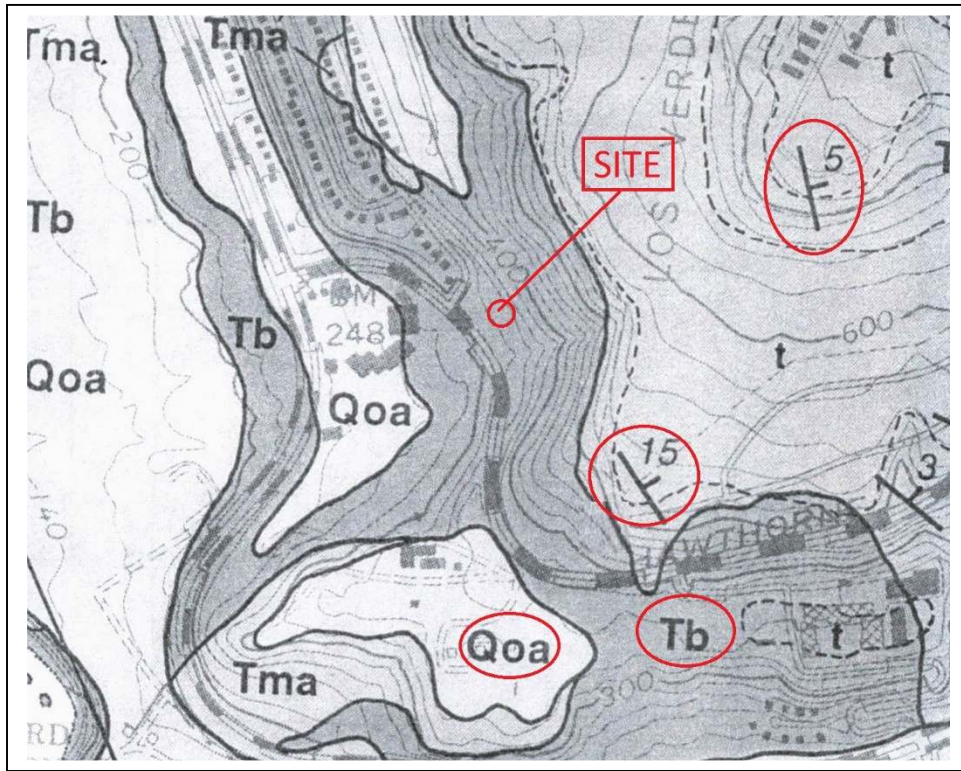
Fig 3-Dibblee Geologic Map

- The property was originally underlain by terrace deposits and volcanic basalt; such rocks are generally very dense and strong. In addition to volcanic bedrock, the original hillside and its environs were underlain by sedimentary terrace deposits. As shown on Fig 3-Dibblee Geologic Map, the bedrock layers dip down to the east by as much as 15 degrees. From a slope stability viewpoint, this bedding attitude is considered to be favorable as it dips into the west-facing slope.

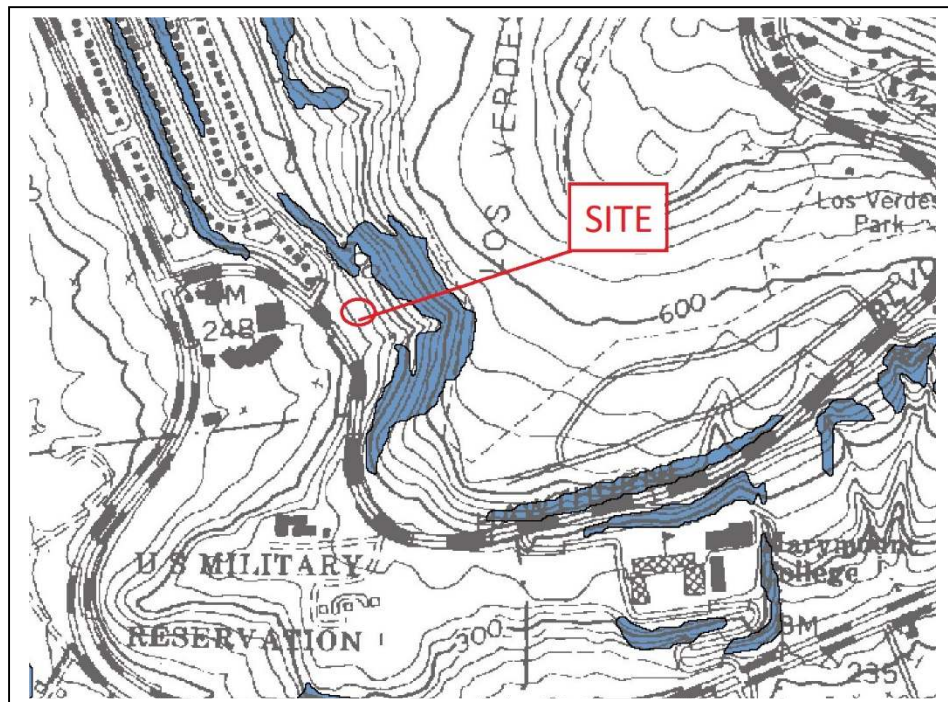
Fig 4-Seismic Hazards Map

- No prior landslides have been mapped at this property. The property is not located in a seismically unstable slope area. The stability of the slopes at the site was evaluated by the geotechnical consultant of records from the tract who found the slopes to be stable. This conclusion was reviewed and concurred with by the City before a permit for development of the site was issued.
