# Inspection Report

**Property Address:**  
1327 S Helberta Ave  
Redondo Beach CA 90277

**Ferguson Home Inspections**

<b>Date:</b> 1/5/2021	<b>Time:</b> 09:00 AM	<b>Report ID:</b> 01052021Helberta
<b>Property:</b> 1327 S Helberta Ave Redondo Beach CA 90277	<b>Customer:</b> Bob Crowe	<b>Real Estate Professional:</b> Bilge Coskun

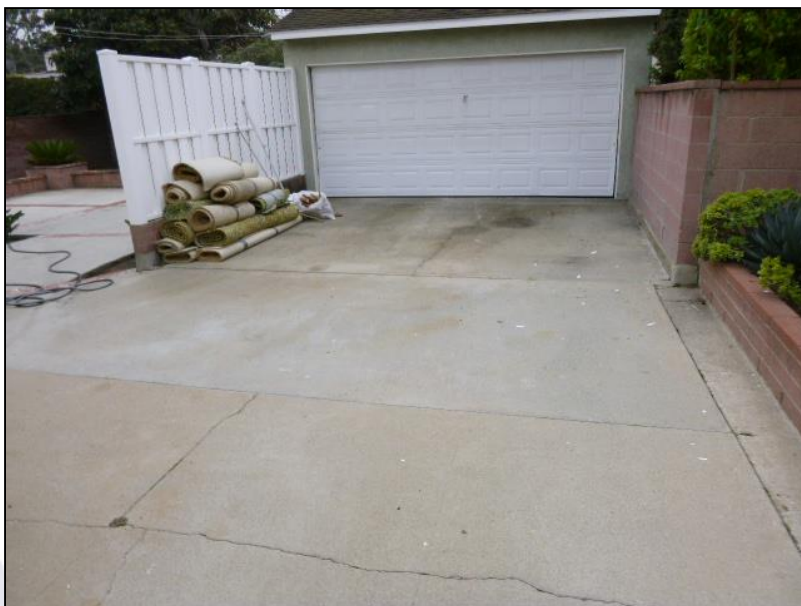
1.0 Item 1(Picture)

**1.0** The driveway slopes toward the main garage door, during heavy rains water may intrude into the garage area. Suggest review with a licensed contractor for installation costs to re-grading, swale or drain installation to divert water away from the garage and the main garage door.

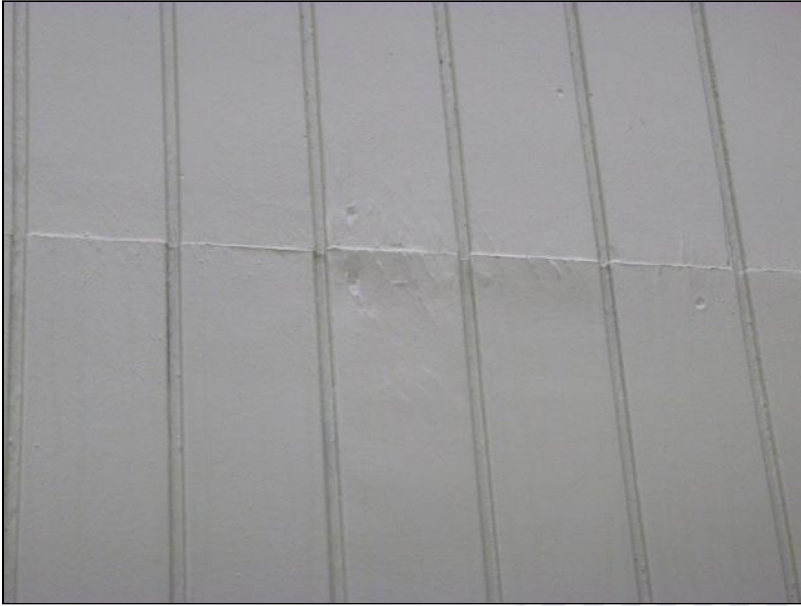
1.3 Item 2(Picture)

**1.3 (1)** Patched areas, open seams and deterioration noted at various wood siding areas. Suggest review with a licensed termite company and/or a licensed contractor for repair/replacement costs as needed.

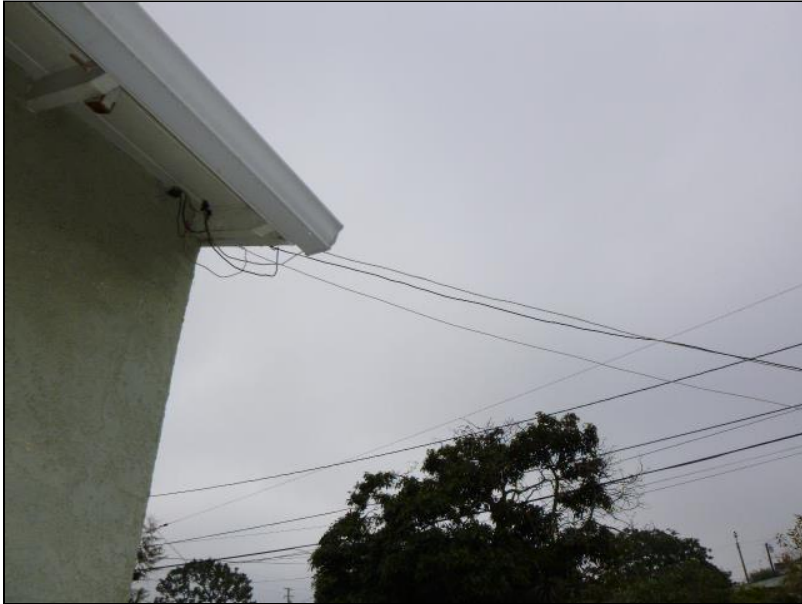
1.7 Item 2(Picture)

1.7 (2) Open wiring and splices noted from the dwelling to the garage, common for the age of the dwelling. This is a potential safety hazard, suggest review with a licensed electrician to upgrade the electrical supply to garage for safety.

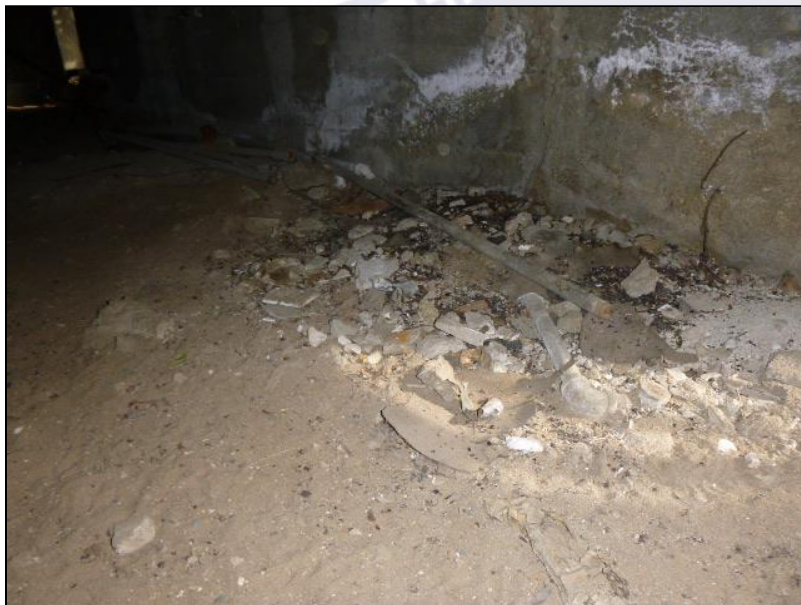
4.0 Item 1(Picture)

**4.0** Suggest removal of debris and construction items from the crawl area.

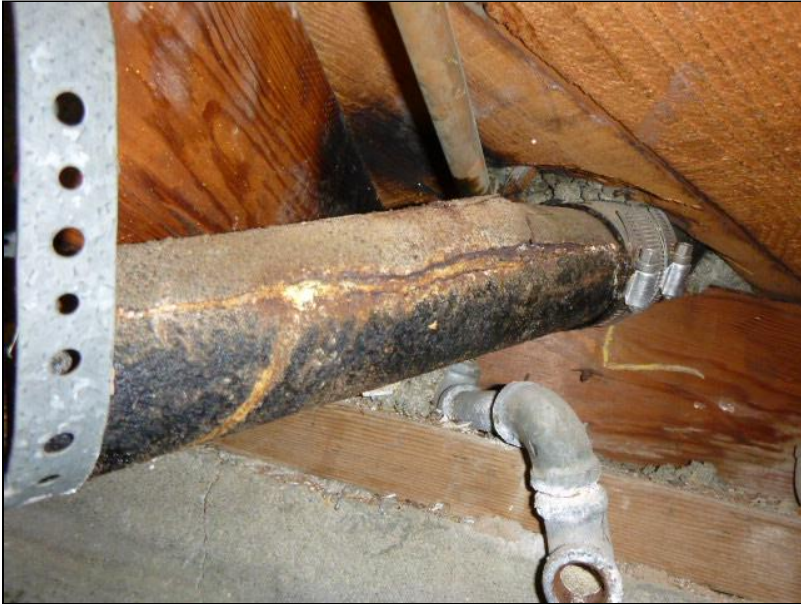
4.4 Item 1(Picture)

**4.4** (1) Excessive rust, seepage and corrosion noted at various cast iron drain lines within the crawl space. Suggest review by a licensed plumbing contractor for replacement costs as needed to prevent future leakage at the crawl area.

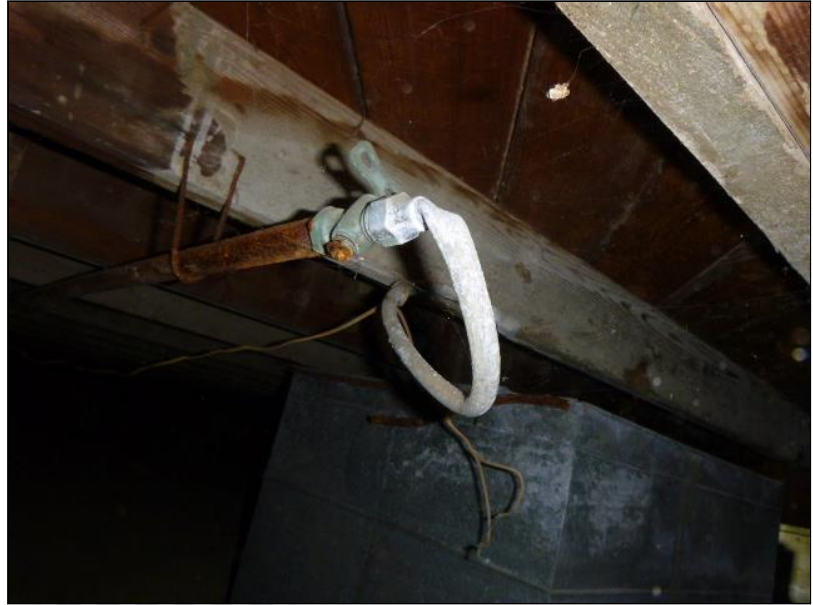
4.5 Item 2(Picture)

**4.5 (2)** Suggest review with a licensed plumber to disconnect and cap the gas feed line to the abandoned floor heater at the crawl area for safety.

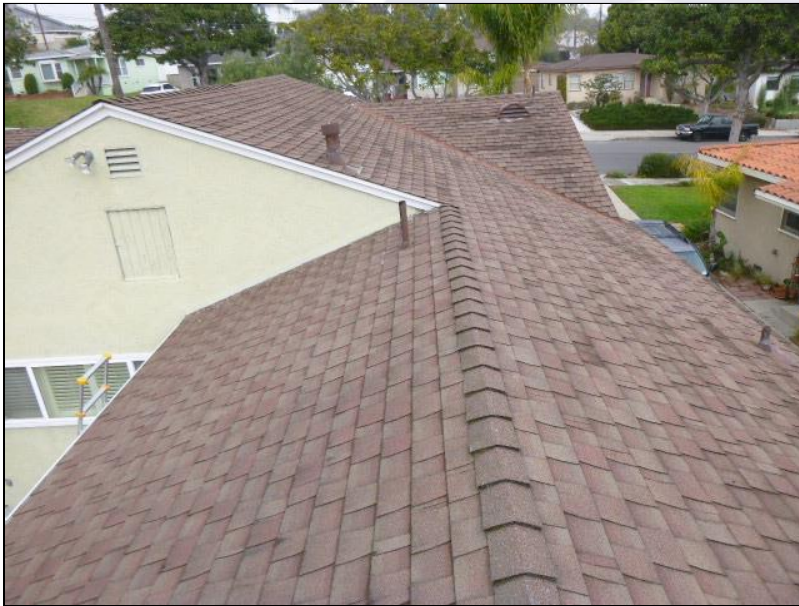
5.0 Item 1(Picture)

**5.0 (1)** The roof shows normal wear for its age and type, suggest periodic review with a licensed roofer for maintenance as needed.

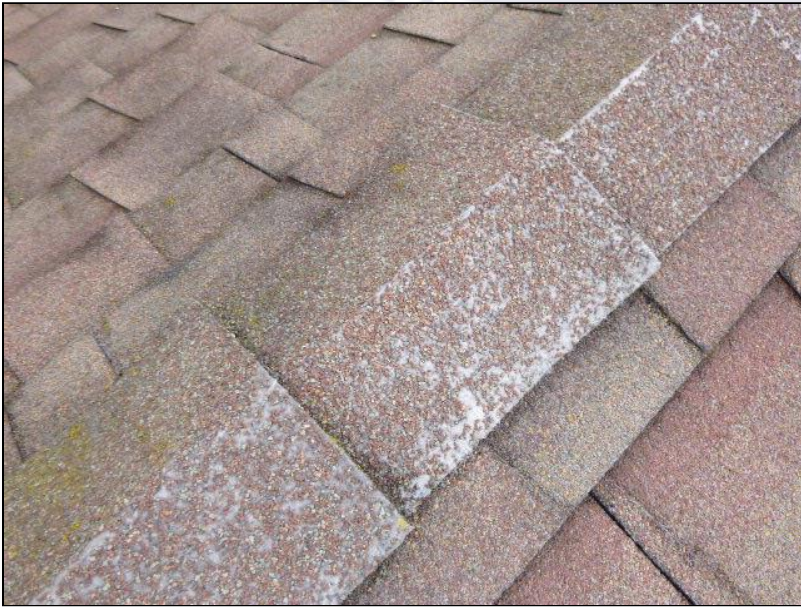
5.0 Item 5(Picture)

**5.0 (2)** Deteriorated ridge caps noted at the pitched roof, suggest review by licensed roofer for replacement costs and replace as needed.

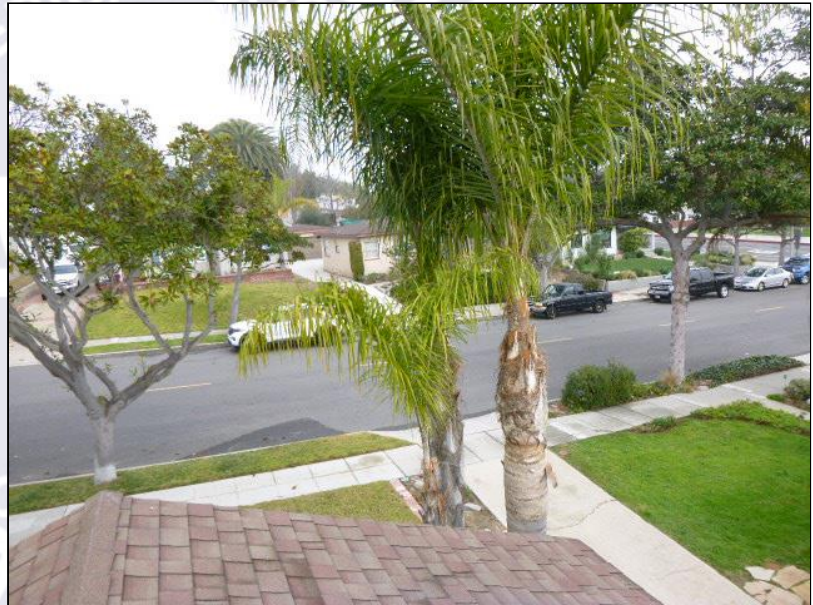
5.0 Item 7(Picture)

**5.0 (3)** The tree limbs that are in contact with roof or hanging near roof should be trimmed to prevent damaging the roof. Suggest trimming as needed.

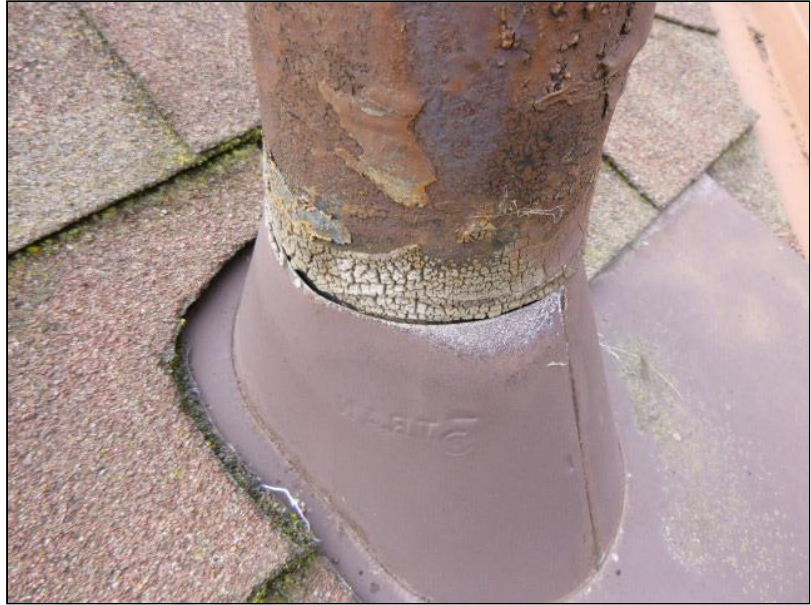
5.2 Item 1(Picture)

**5.2** Suggest review by a licensed roofer and seal all penetrations at the roof to prevent water intrusion.

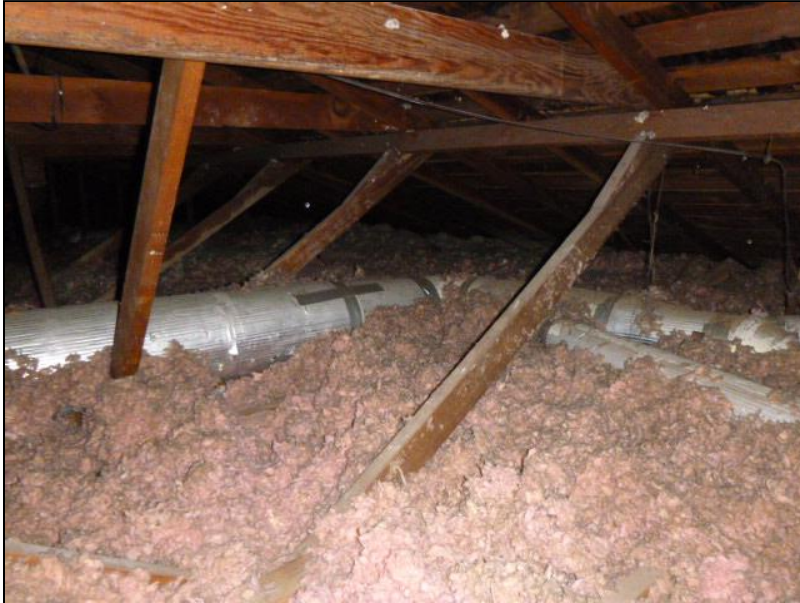
6.4 Item 1(Picture)

**6.4 (1)** Possible asbestos like material, tape and wrap noted at ducting and joints. Tape and wrap, torn and loose in the several areas, suggest review by licensed contractor for repairs/replacement or removing material or encapsulating the damaged areas.

**6.4 (2)** Generally a certification of the existing ducting is required when replacing the heating to determine and confirm no leakage will occur which can/will result in the asbestos insulation being damaged and blown through the dwelling/attic area. Suggest review with the sellers and the heater installation company for confirmation of this requirement and/or costs to replace the existing asbestos ducting as required.

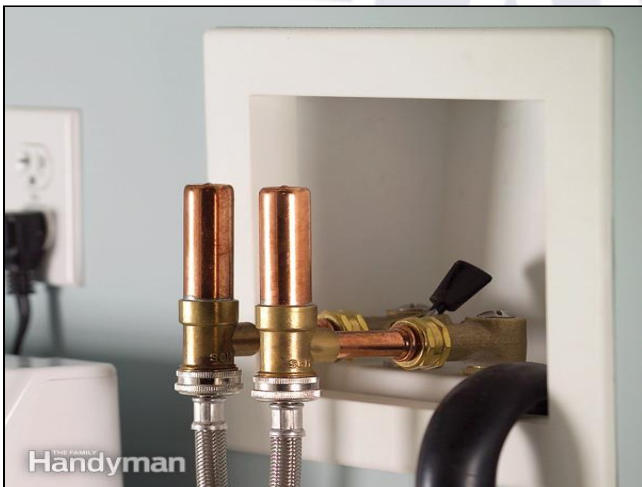
**7.6** Suggest upgrading with 'hammer valve' plumbing supply systems if a water sensor/efficient/smart washing machine is to be installed at this area.

7.6 Item 1(Picture) HV

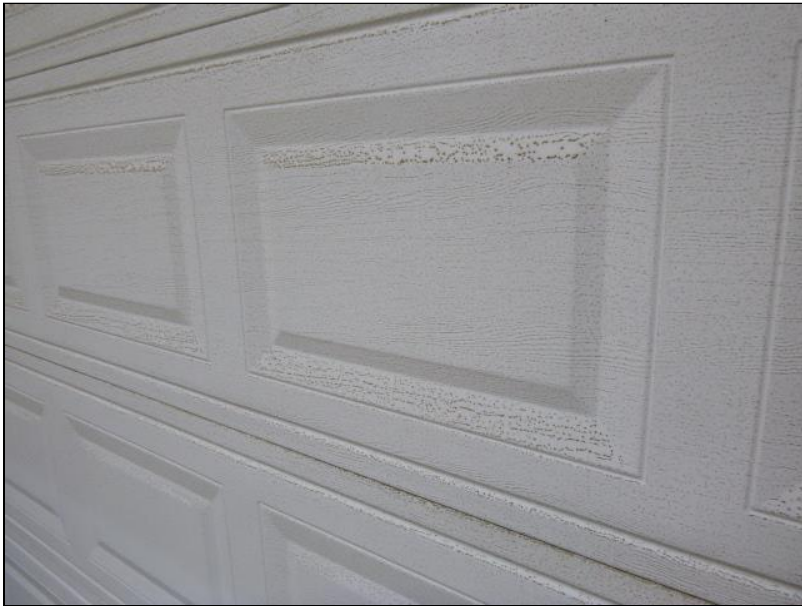
10.4 Item 2(Picture)

10.4 (2) Surface rust and corrosion noted at the garage door panels, suggest repair/replace as needed.

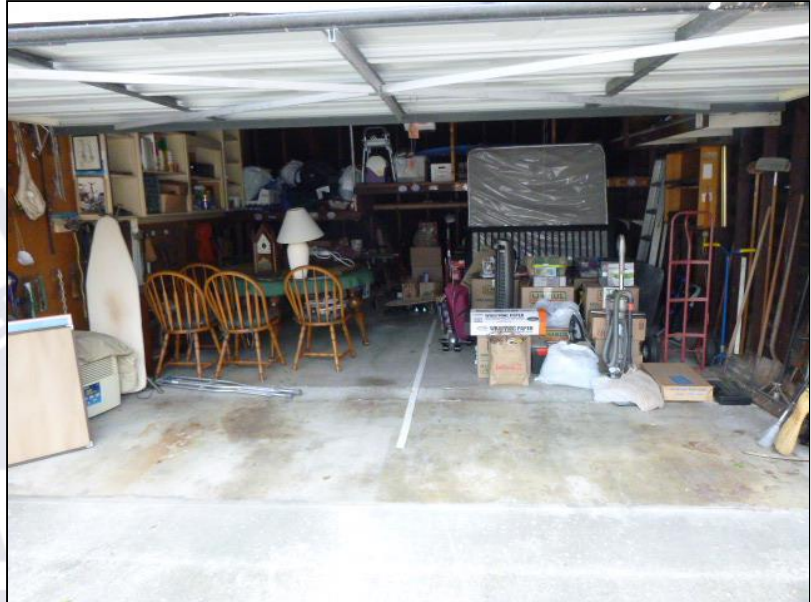
10.9 Item 1(Picture)

**10.9** Access within this area was blocked or severely limited at the time of the inspection. An inspection of this area can be performed by appointment and at an additional cost when the area is made accessible.

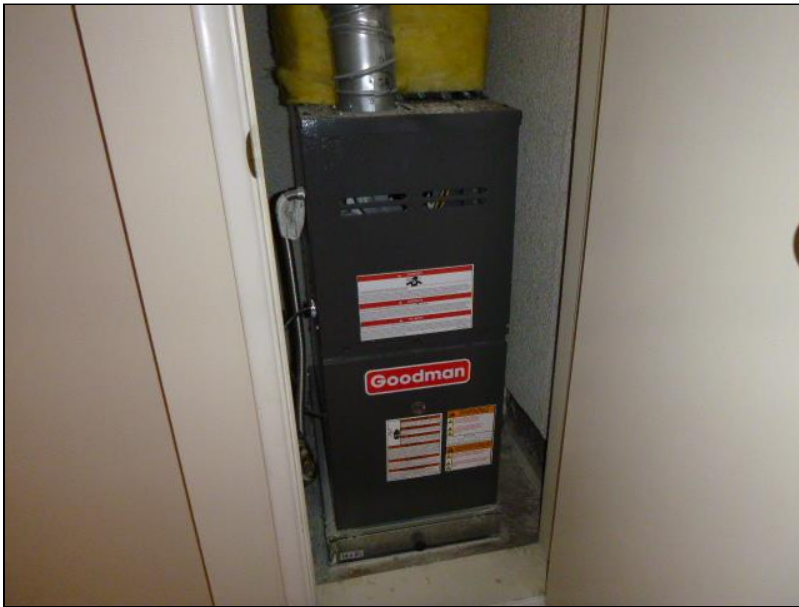
11.0 Item 1(Picture)

11.0 (1) The heating unit was tested and was operational at the time of the inspection.

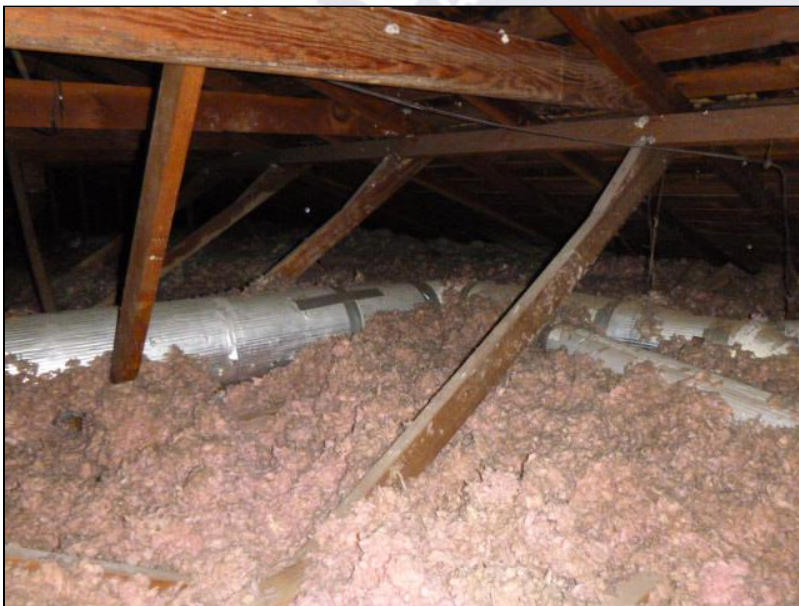
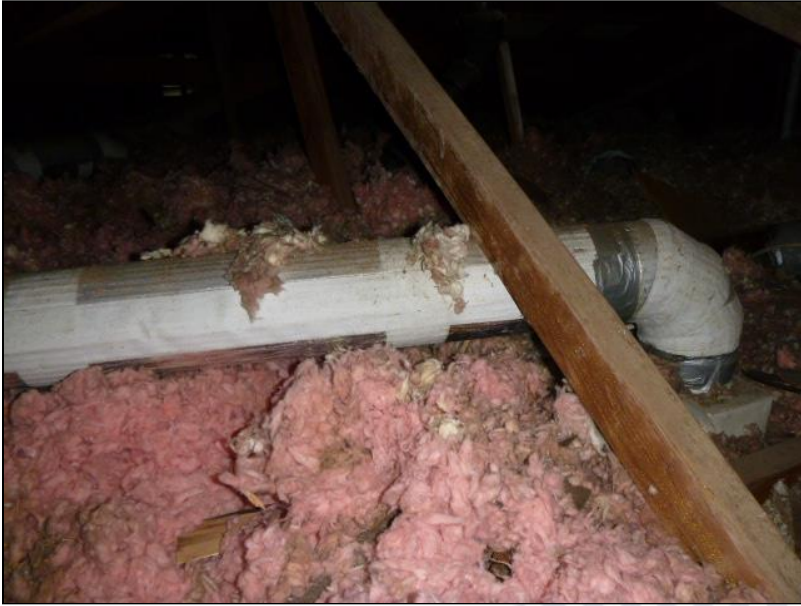
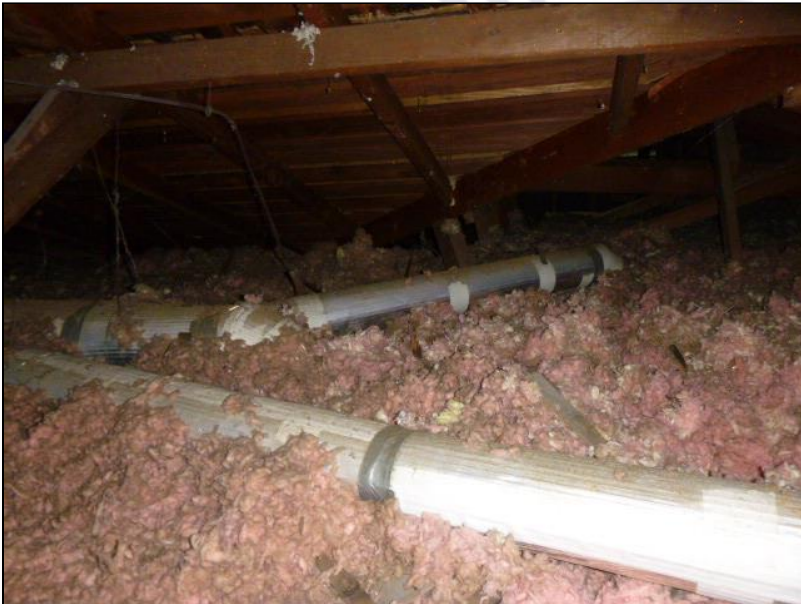
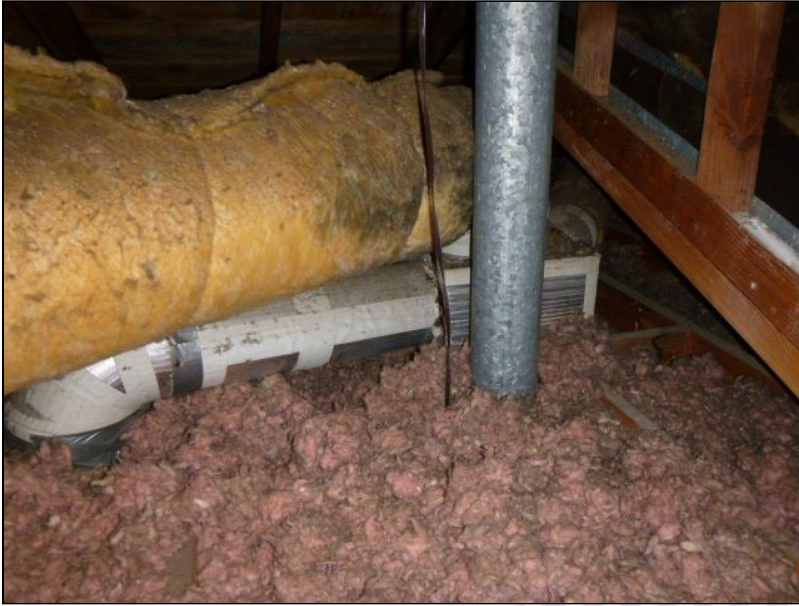
**11.3 (1)** Possible asbestos like material, tape and wrap noted at ducting and joints. Tape and wrap, torn and loose in the several areas, suggest review by licensed contractor for repairs/replacement or removing material or encapsulating the damaged areas.

**11.3 (2)** Generally a certification of the existing ducting is required when replacing the heating to determine and confirm no leakage will occur which can/will result in the asbestos insulation being damaged and blown through the dwelling/attic area. Suggest review with the sellers and the heater installation company for confirmation of this requirement and/or costs to replace the existing asbestos ducting as required.

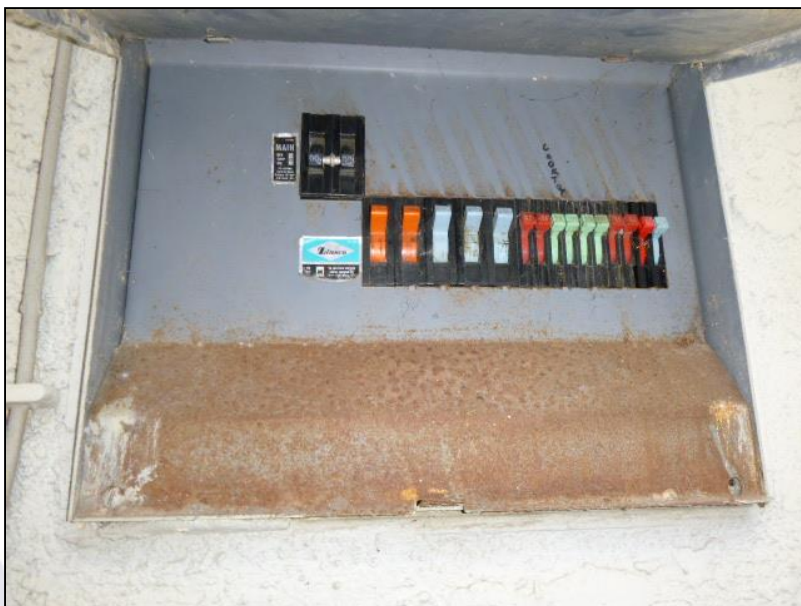
12.1 Item 1(Picture)

**12.1 (1)** The main electrical panel is a Zinsco brand panel box, a product that hasn't been manufactured for many years. There are problems with these panels that can, in some cases, be serious. Some Zinsco panels have aluminum bus bars (the bars that run down the middle of the panel to which the breakers connect). Over a period of years, oxide forms on the aluminum causing a poor connection with the breakers and leading to arcing, overheating, and, eventually, breaker failure. Other problems with Zinsco panels include circuit breakers (depending on the vintage) with a dismal performance record and the possibility of unbalanced multi-wire circuits. Also, please be aware that various insurance companies will not insure homes with this style of electrical panel. Suggest review by a licensed electrician for replacement costs as needed.

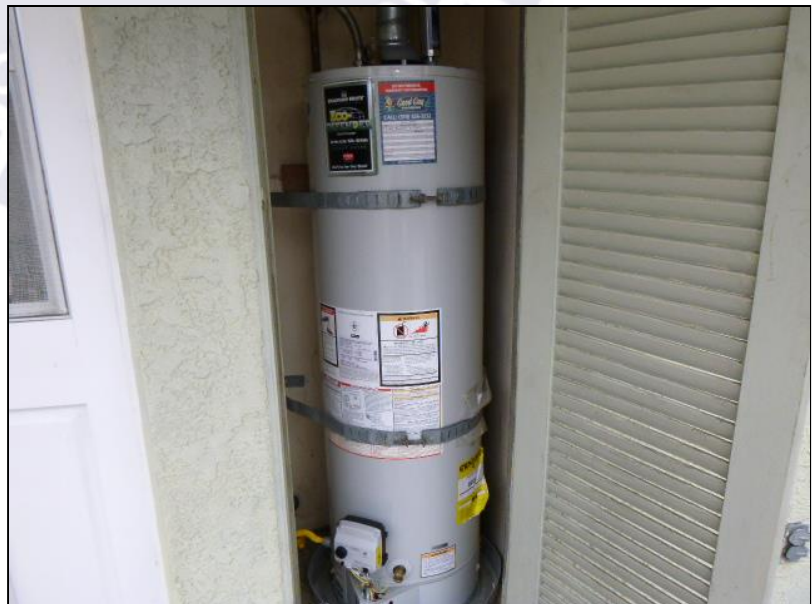
15.0 Item 1(Picture)

**15.0 (1)** The water heater was operational at the time of the inspection.

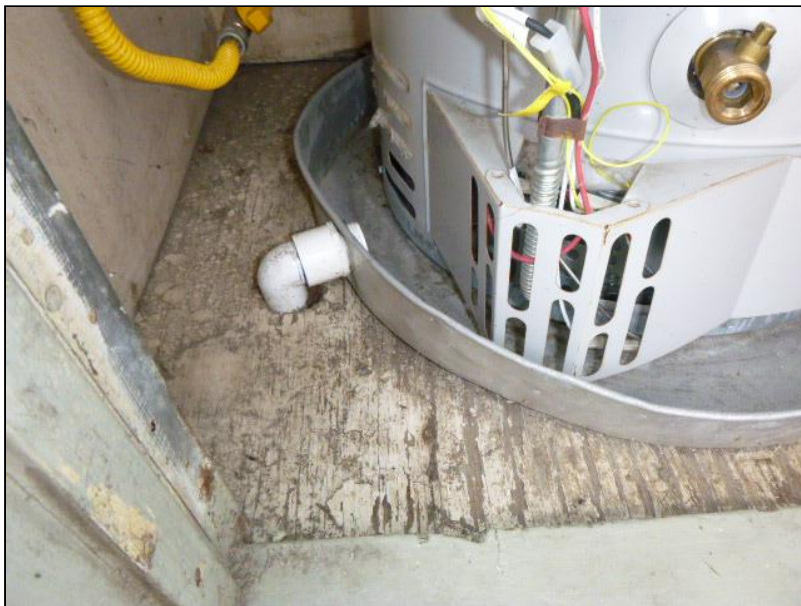
15.0 Item 2(Picture)

**15.0 (2)** A Spill/smitty pan is installed under the water heater, but the drain exits into the crawl area. Suggest installing the drain line to the exterior of the dwelling as required when installed.

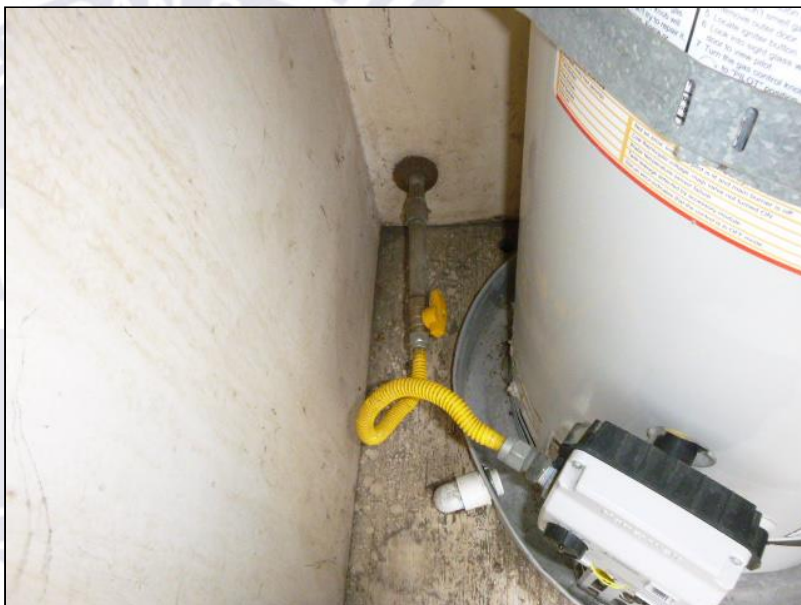
15.0 Item 3(Picture)

**15.0 (3)** Currently no gas supply line drip leg/sediment trap is installed, please be aware that various cities do not enforce/require this installation. Suggest review with the local City Building Department and/or with a licensed plumbing contractor for installation costs as needed.

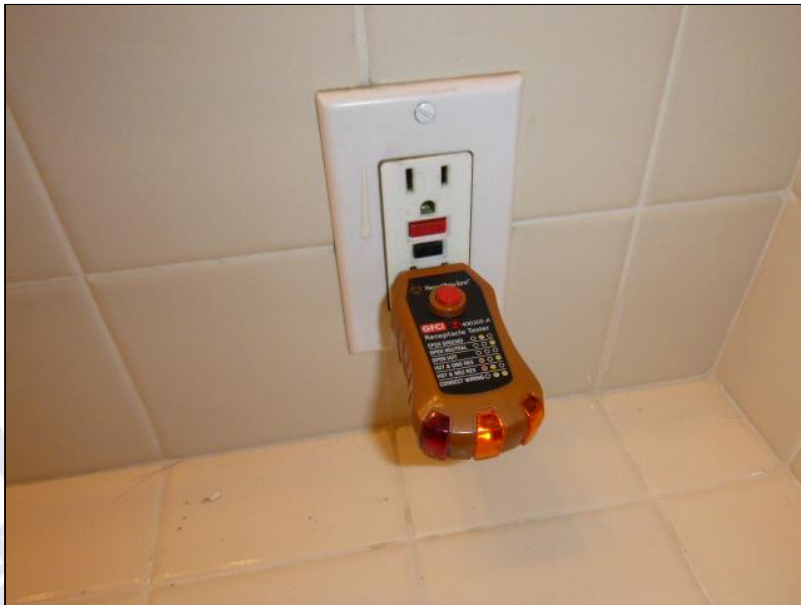
17.6 Item 1(Picture)

**17.6** The GFCI outlet(s) at this area are not grounded. The GFCI should still provide GFCI protection but the outlet should generally be grounded. Suggest review by a licensed electrician for repair/grounding cost as needed and required for safety.

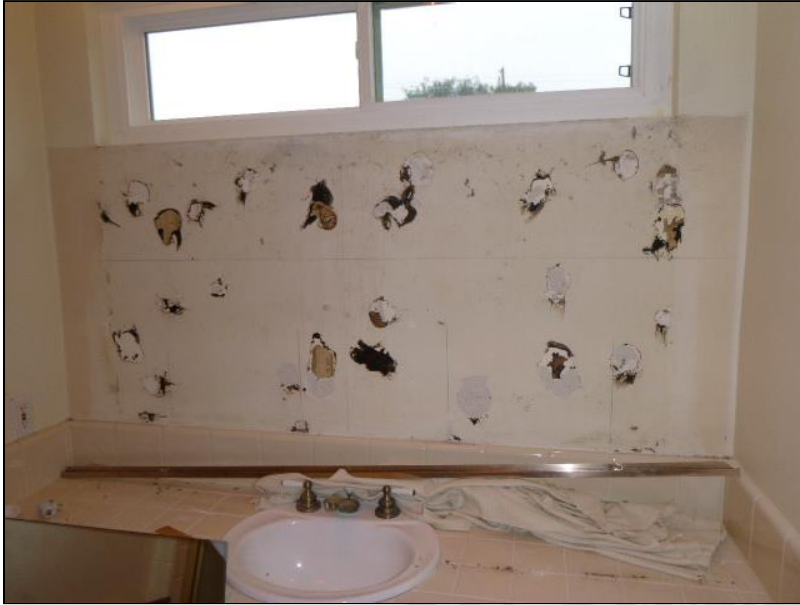
18.17 Item 1(Picture)

**18.17** The wall mirror and cabinet were missing/removed at the time of the inspection. Suggest review with the seller and/or a licensed contractor for installation costs as needed.

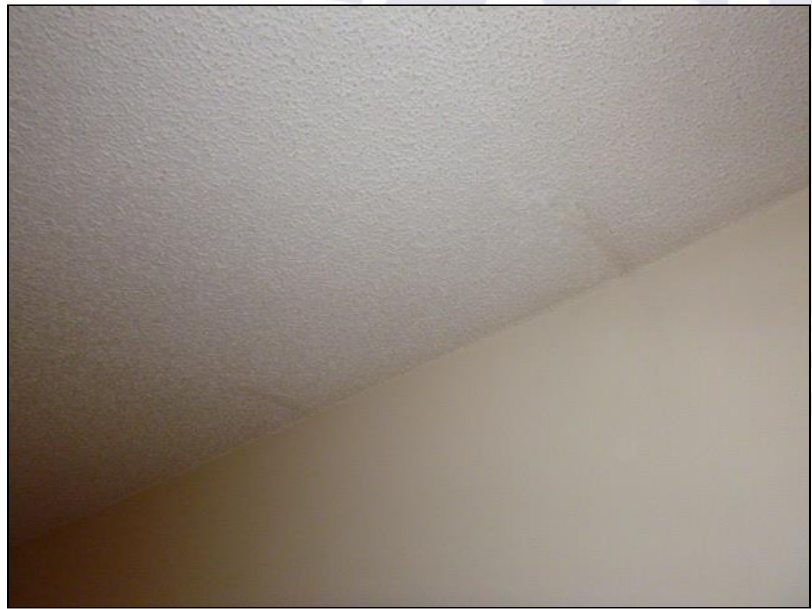
22.2 Item 2(Picture)

**22.2 (1)** Patched and uneven areas of the ceiling noted, suggest review with the seller on the cause and any repairs needed. Suggest repair as needed.

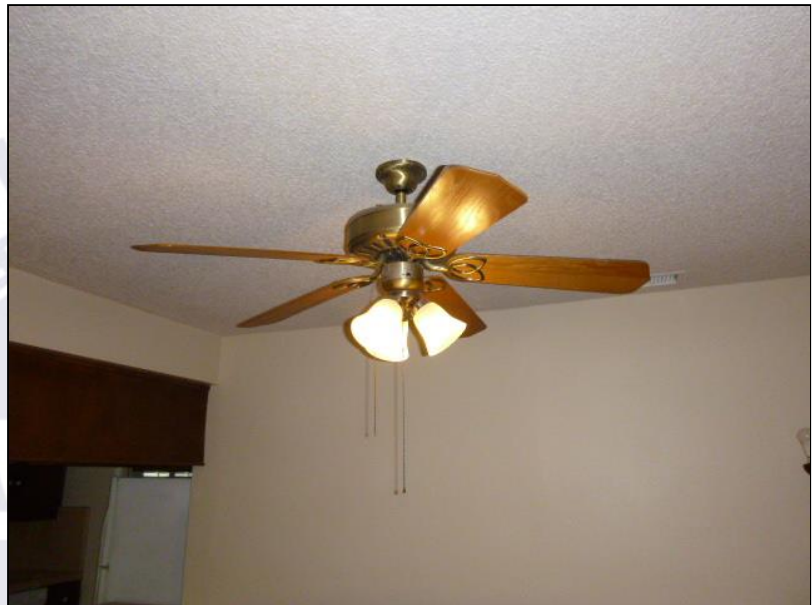
22.7 Item 1(Picture)

**22.7** The ceiling fan system was operational at the time of the inspection.

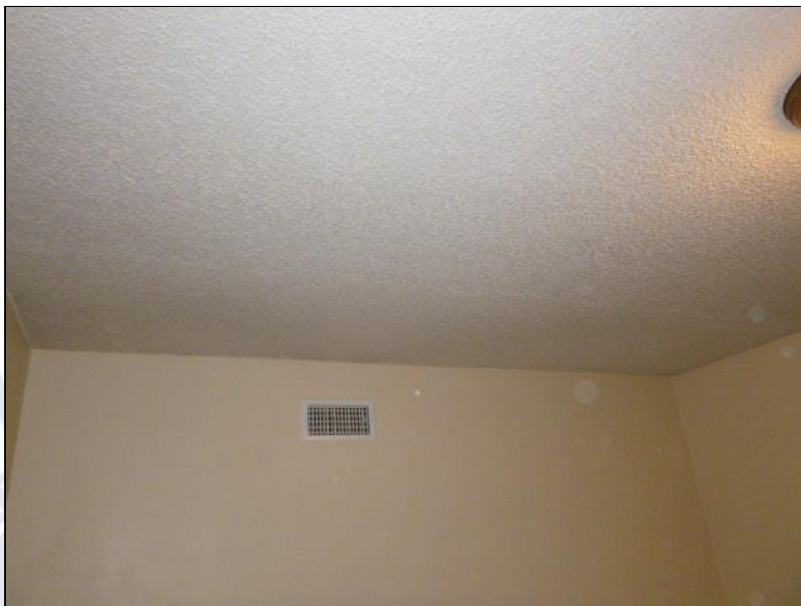
26.2 Item 1(Picture)

**26.2 (1)** Settling cracks and patching was noted, suggest repair as needed.

**26.2 (2)** Patched and uneven areas of the ceiling noted, suggest review with the seller on the cause and any repairs needed. Suggest repair as needed.

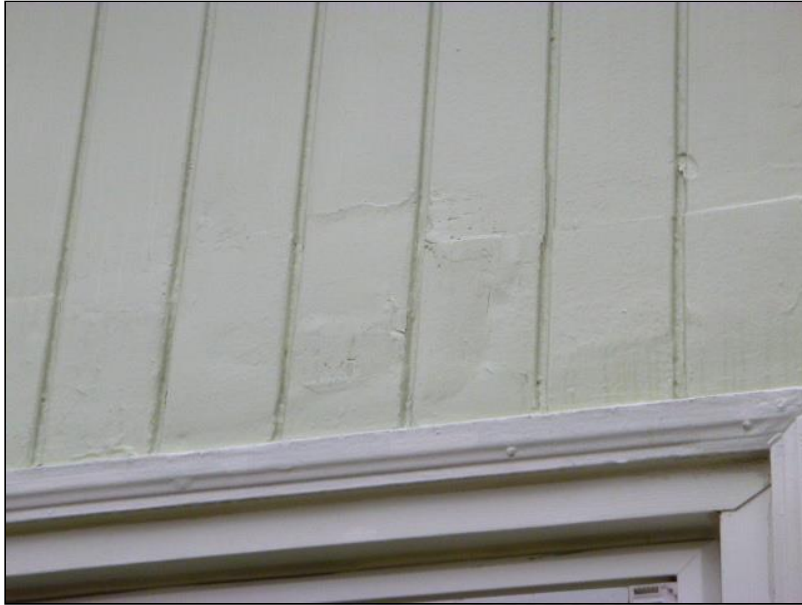
1.3 Item 1(Picture)

(1) Patched areas, open seams and deterioration noted at various wood siding areas. Suggest review with a licensed termite company and/or a licensed contractor for repair/replacement costs as needed.

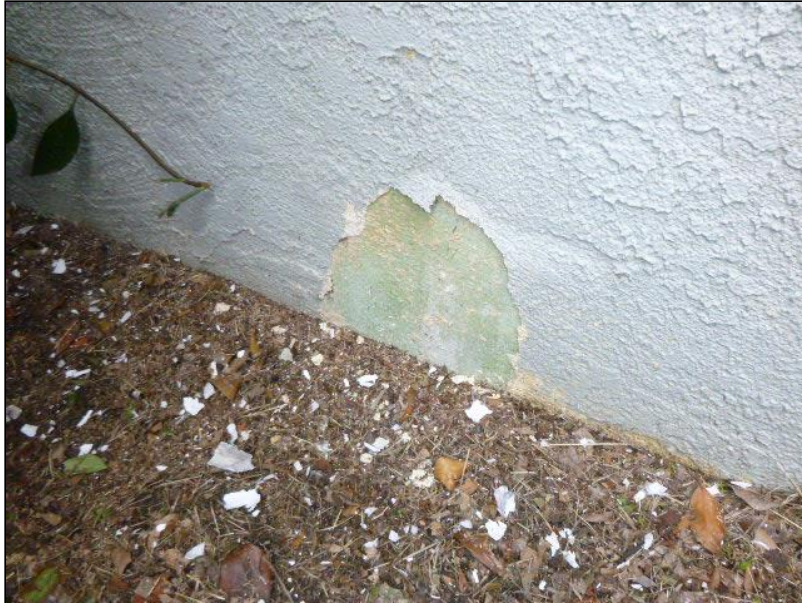
1.3 Item 4(Picture)

(2) Deteriorated and blistering stucco noted at various areas. See the Lot/Drainage comments and review with a licensed contractor to repair as needed and divert water away from the foundation areas.

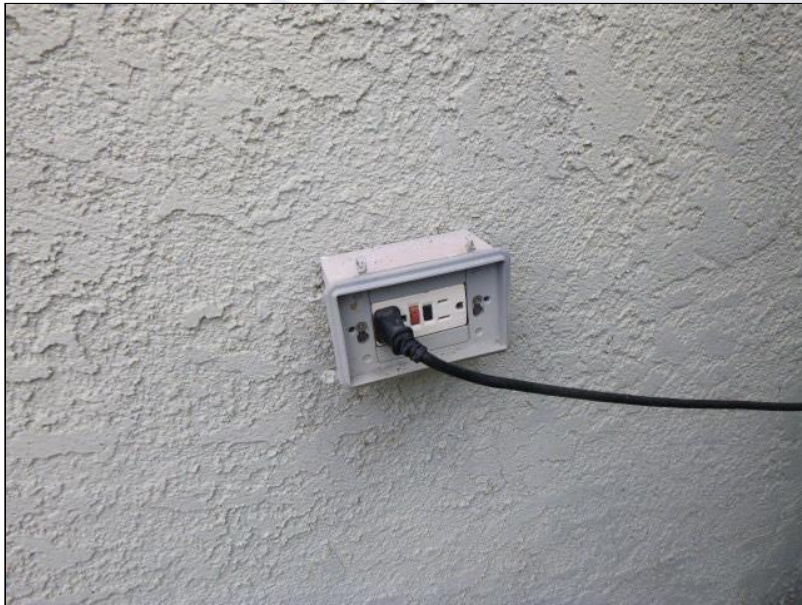
1.7 Item 1(Picture)

(1) The exterior outlet(s) are missing the weather cover(s). Suggest installation for safety and as required.

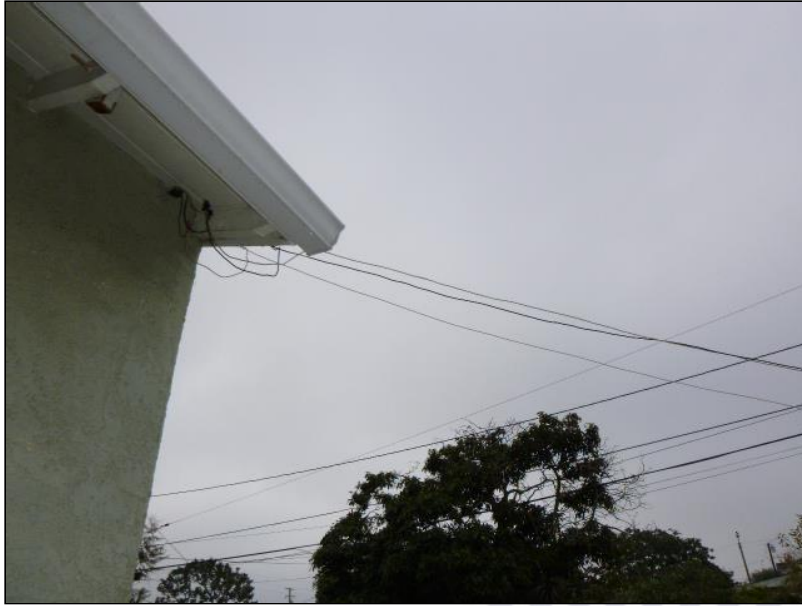
1.7 Item 2(Picture)

(2) Open wiring and splices noted from the dwelling to the garage, common for the age of the dwelling. This is a potential safety hazard, suggest review with a licensed electrician to upgrade the electrical supply to garage for safety.

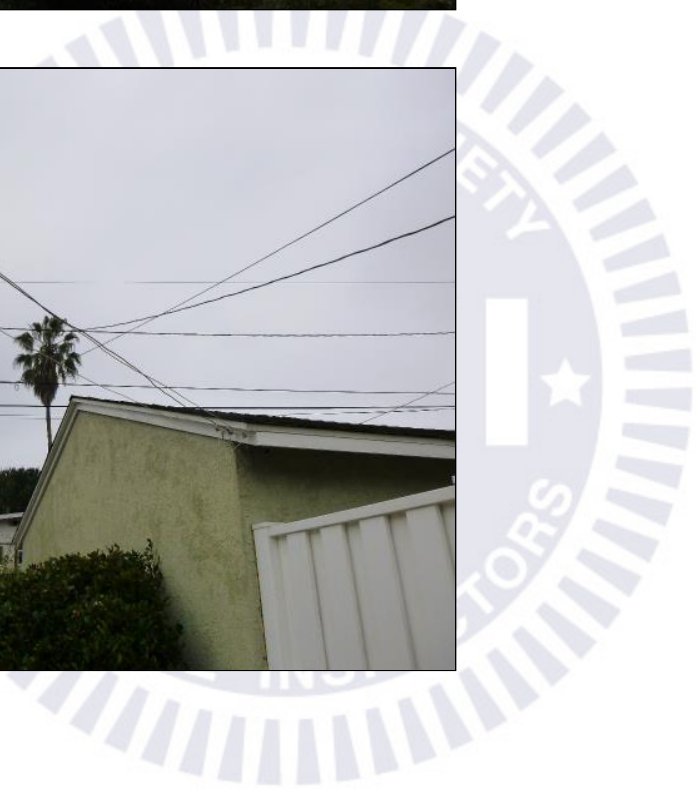
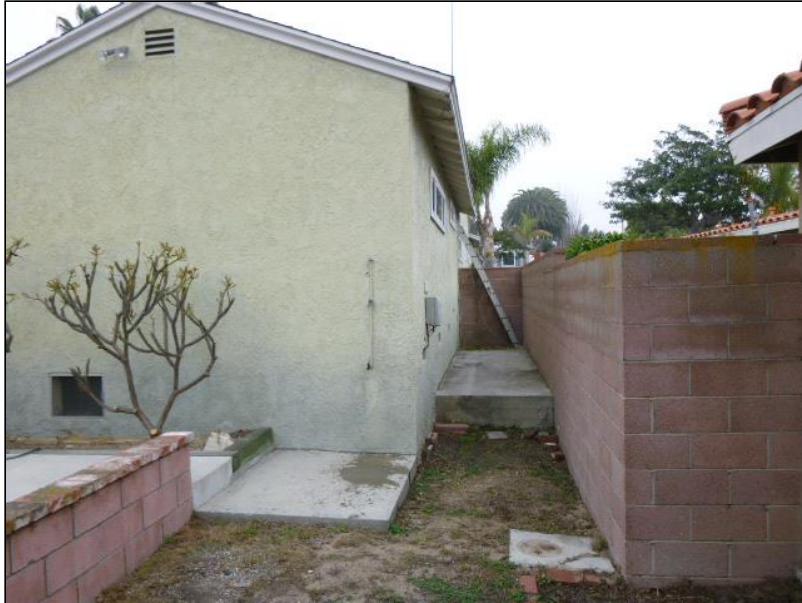
1.8 Item 1(Picture)

Suggest installation of gutters throughout all eave areas and installation of an area drainage system to divert the water away from the foundation to the street as an upgrade.

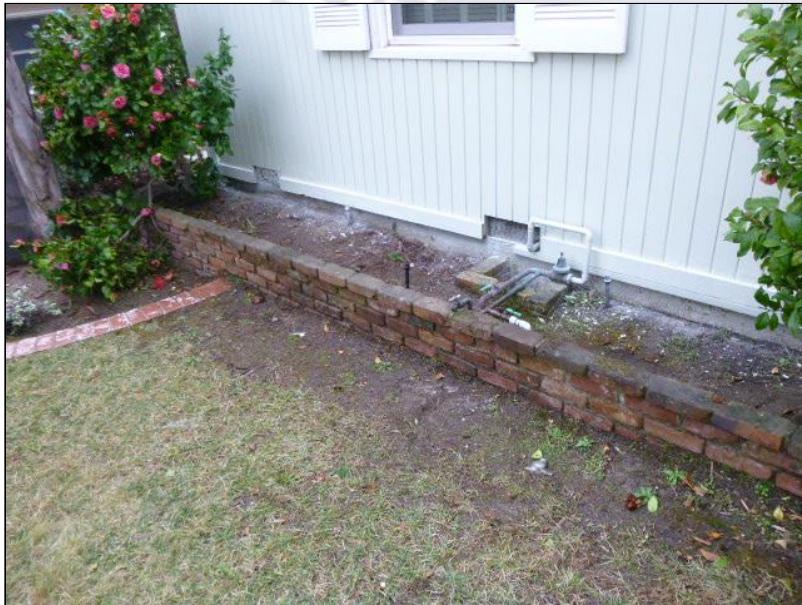
1.10 Item 1(Picture)

No drain holes noted in the planter(s). Suggest installing drain holes to prevent ponding during the rainy season.

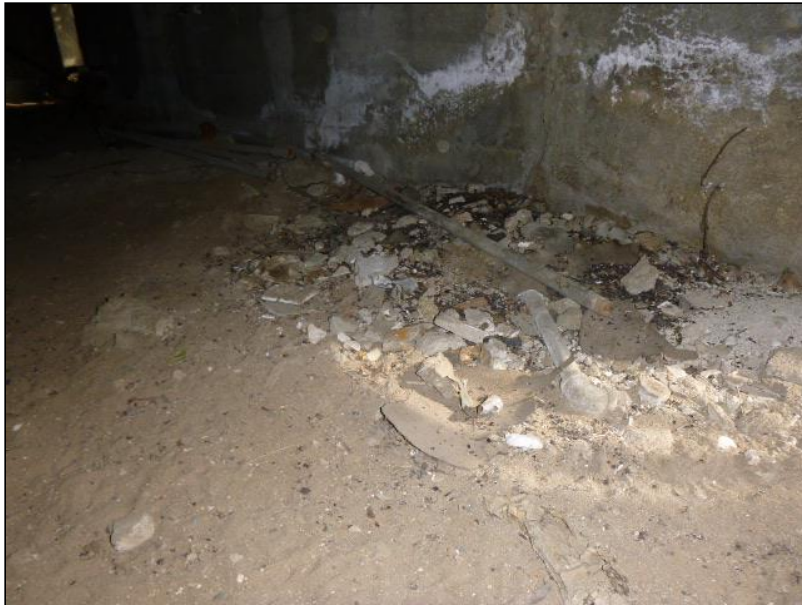
4.0 Item 1(Picture)

Suggest removal of debris and construction items from the crawl area.

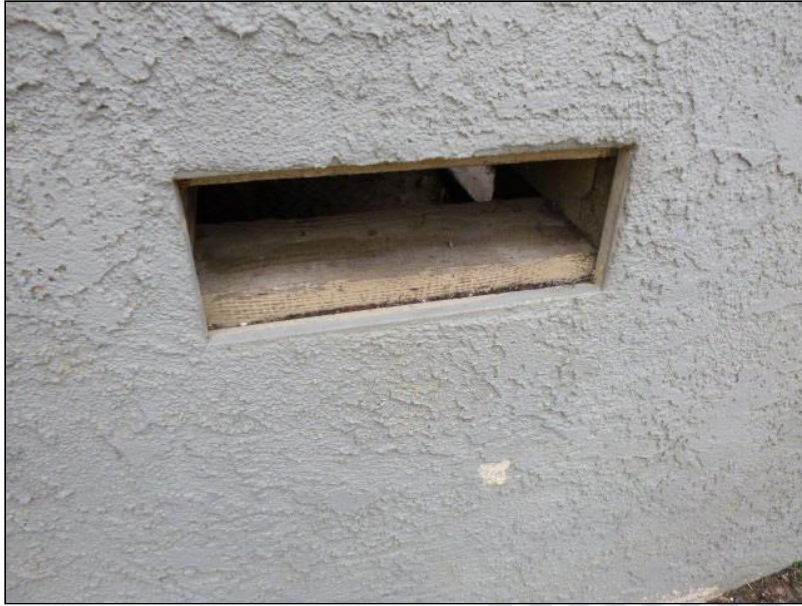
4.2 Item 1(Picture)

Loose, missing or deteriorated vent screens noted. Suggest re-screening missing and/or deteriorated vent screens as needed to prevent rodent and insect intrusion .

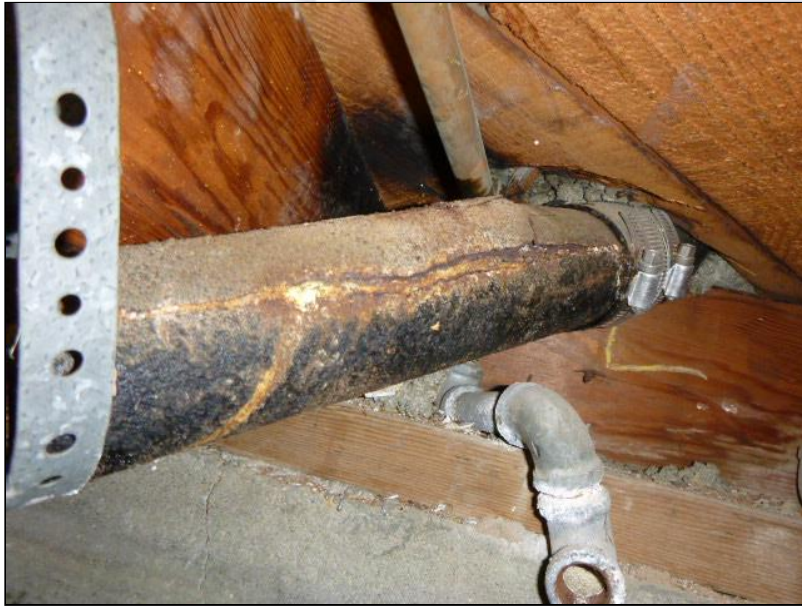
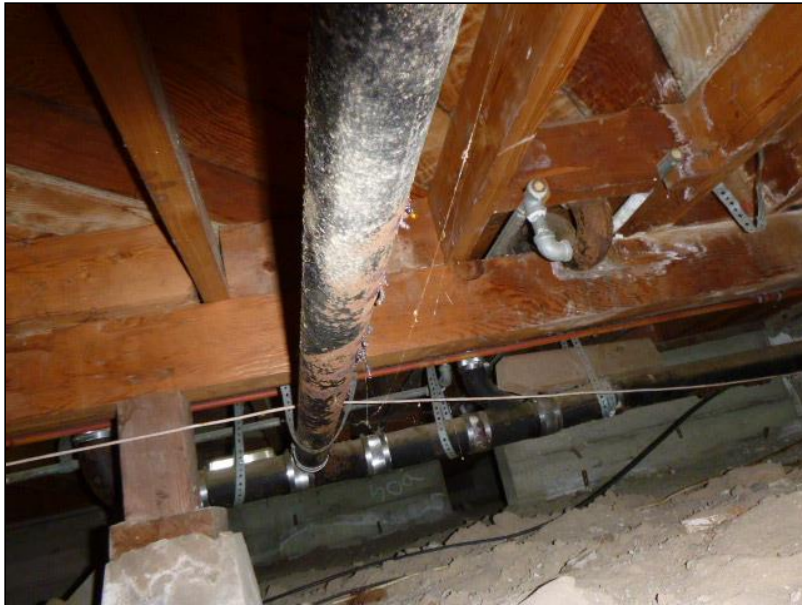
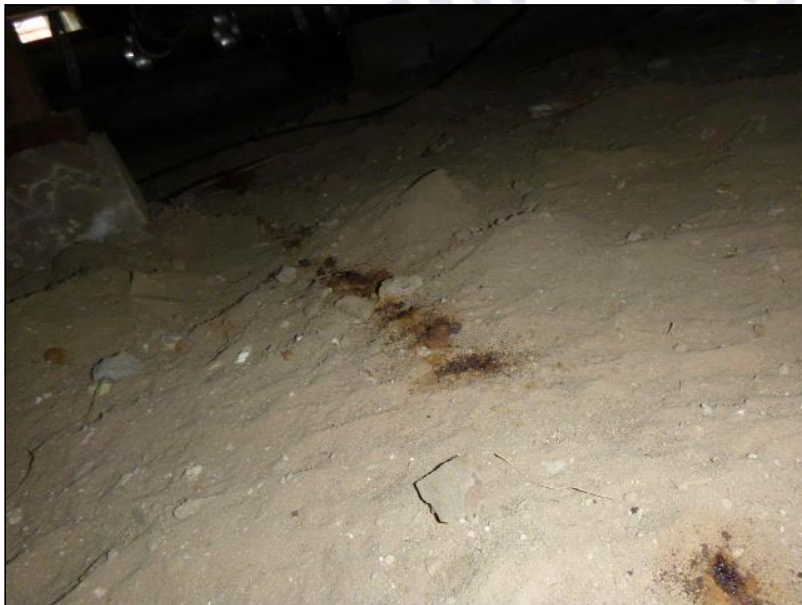
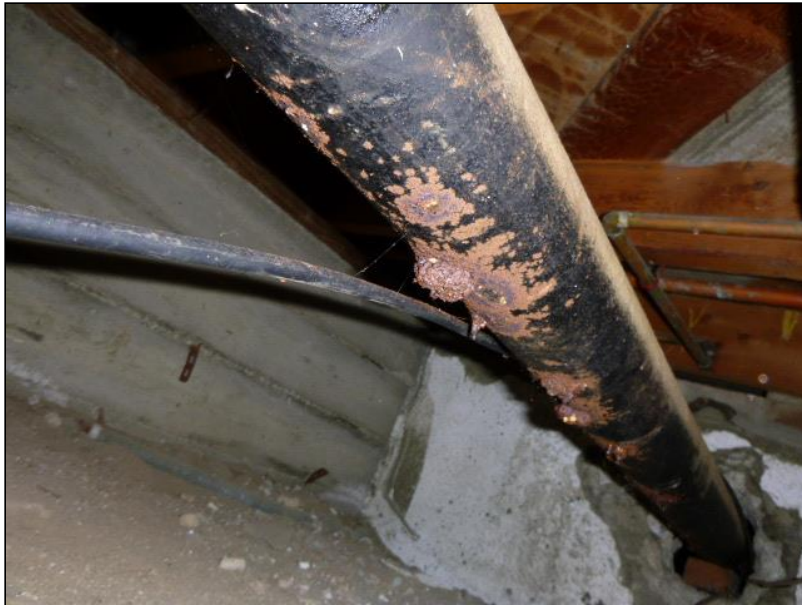
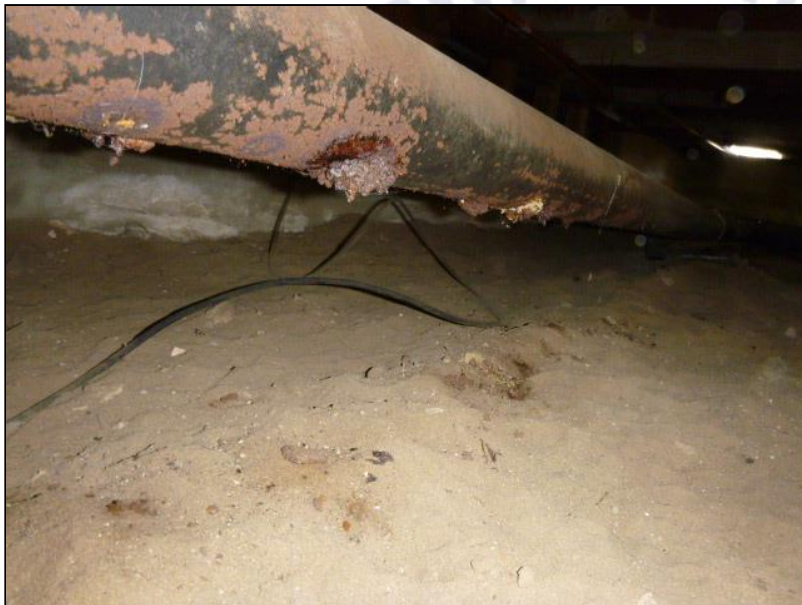
(1) Excessive rust, seepage and corrosion noted at various cast iron drain lines within the crawlspace. Suggest review by a licensed plumbing contractor for replacement costs as needed to prevent future leakage at the crawl area.

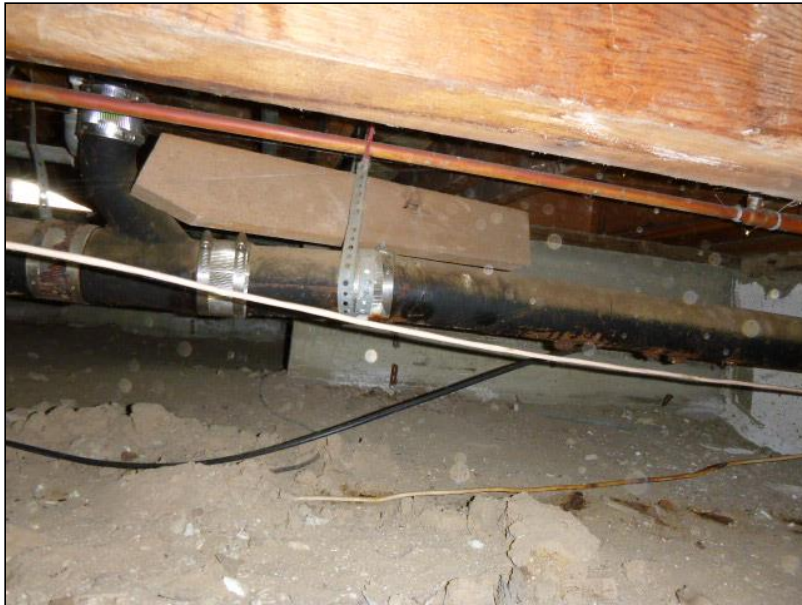
4.4 Item 6(Picture)

(2) Inadequate slope noted at various drains in the crawl area, suggest review with a licensed plumber for costs to re-slope the drains as required/needed.
