# Inspection Report

**Property Address:**  
1327 S Helberta Ave  
Redondo Beach CA 90277

**Ferguson Home Inspections**

<b>Date:</b> 1/5/2021	<b>Time:</b> 09:00 AM	<b>Report ID:</b> 01052021Helberta
<b>Property:</b> 1327 S Helberta Ave Redondo Beach CA 90277	<b>Customer:</b> Bob Crowe	<b>Real Estate Professional:</b> Bilge Coskun

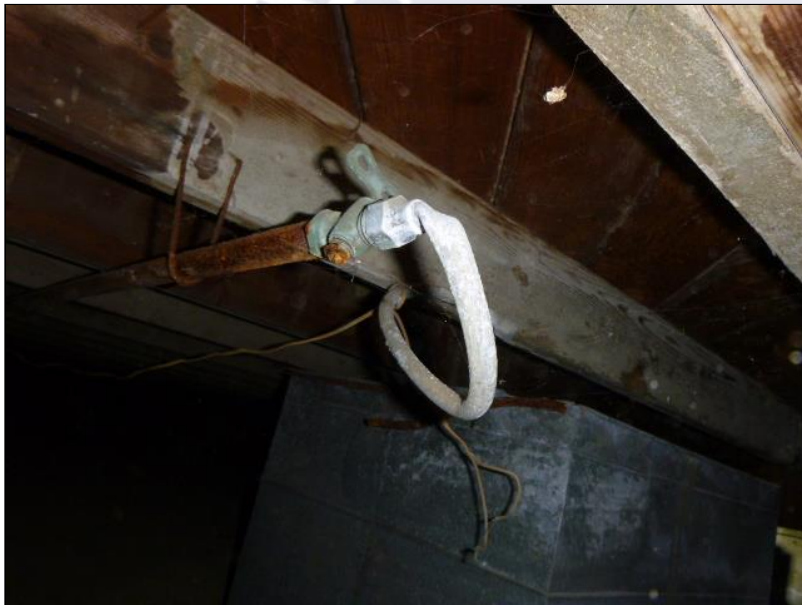
4.5 Item 2(Picture)

(2) Suggest review with a licensed plumber to disconnect and cap the gas feed line to the abandoned floor heater at the crawl area for safety.

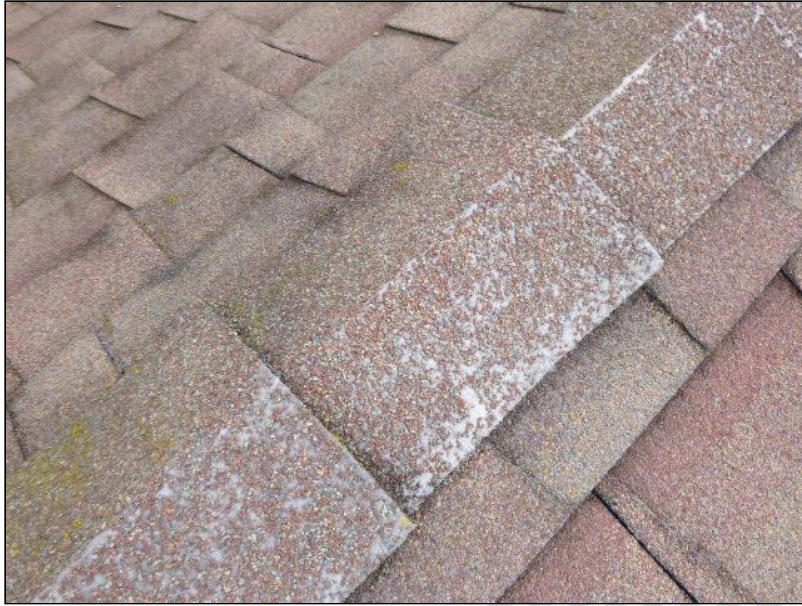
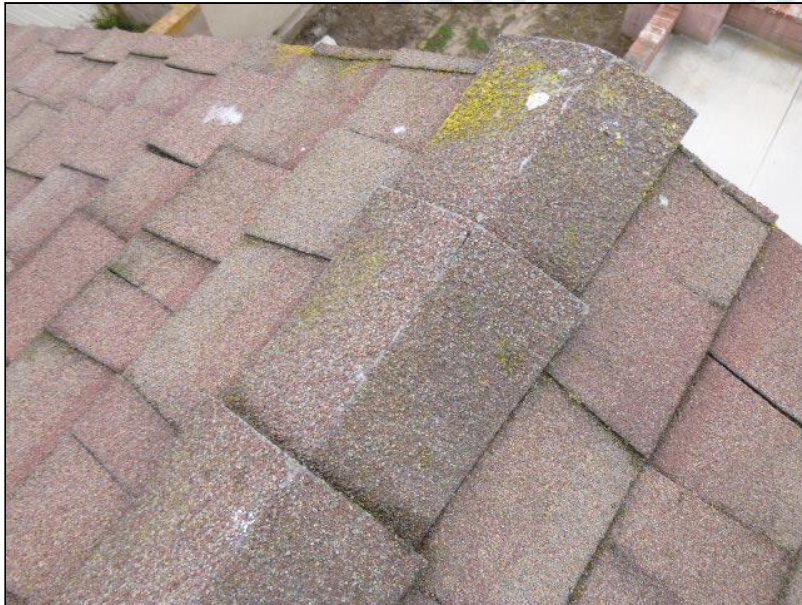
(2) Deteriorated ridge caps noted at the pitched roof, suggest review by licensed roofer for replacement costs and replace as needed.

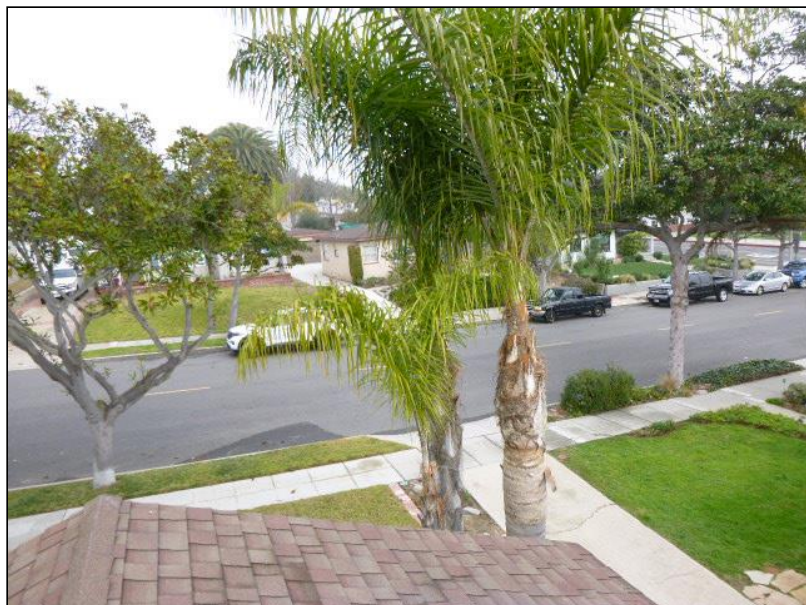
5.0 Item 7(Picture)

(3) The tree limbs that are in contact with roof or hanging near roof should be trimmed to prevent damaging the roof. Suggest trimming as needed.

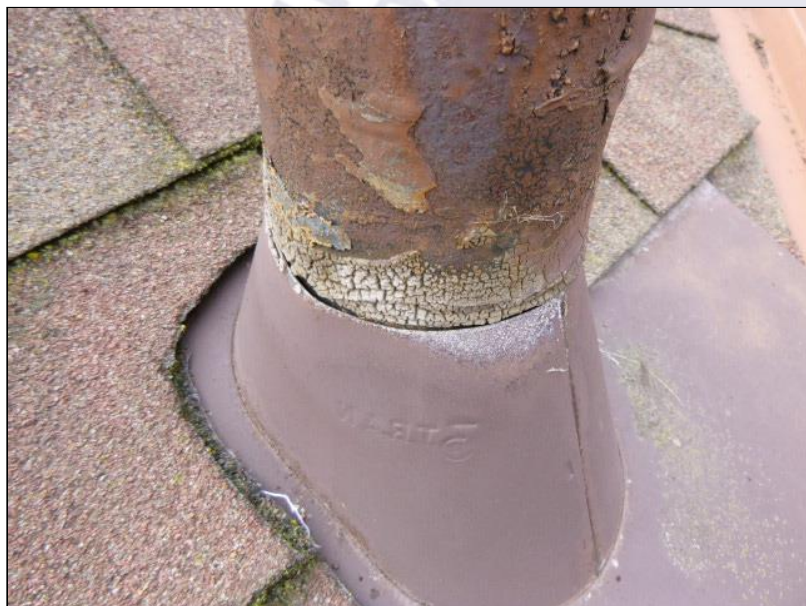
5.2 Item 1(Picture)

Suggest review by a licensed roofer and seal all penetrations at the roof to prevent water intrusion.

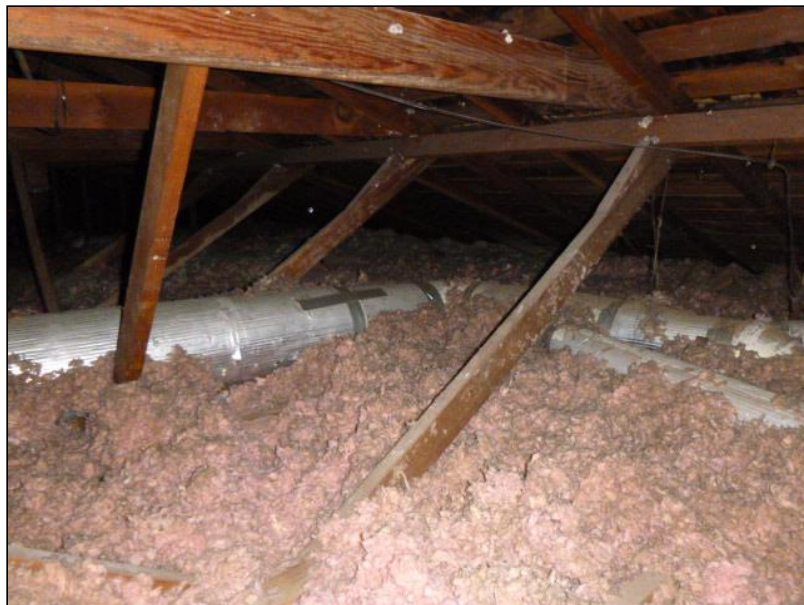
6.4 Item 1(Picture)

(1) Possible asbestos like material, tape and wrap noted at ducting and joints. Tape and wrap, torn and loose in the several areas, suggest review by licensed contractor for repairs/replacement or removing material or encapsulating the damaged areas.

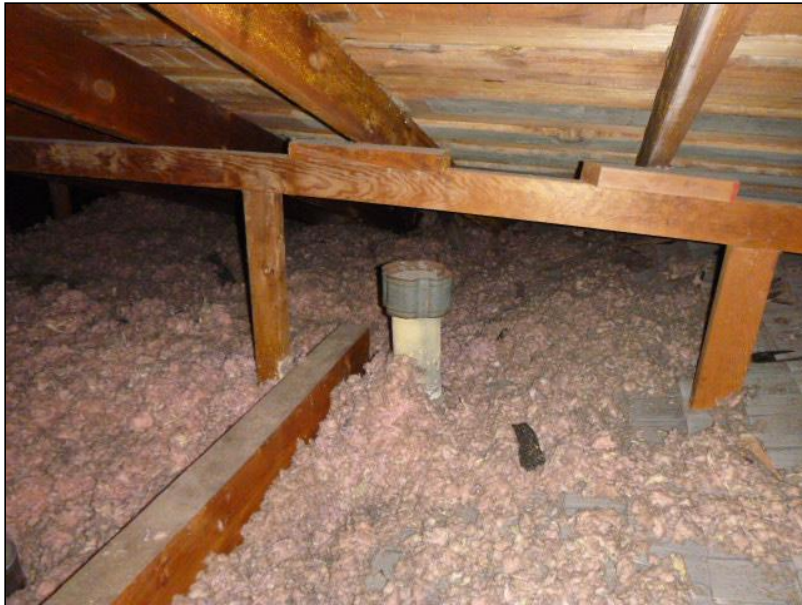
6.6 Item 1(Picture)

The kitchen oven vent currents exits/terminates in the rear attic. Suggest review with a licensed contractor for costs to repair/extend the vent through the roof as required.

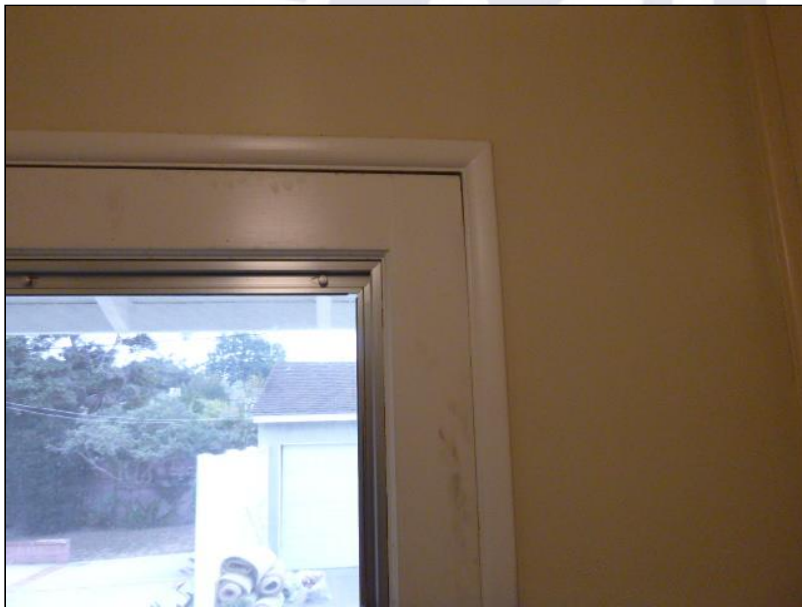
7.3 Item 1(Picture)

The door to the exterior impacts on the impacts/sticks on the jamb when operating, suggest repair as needed.

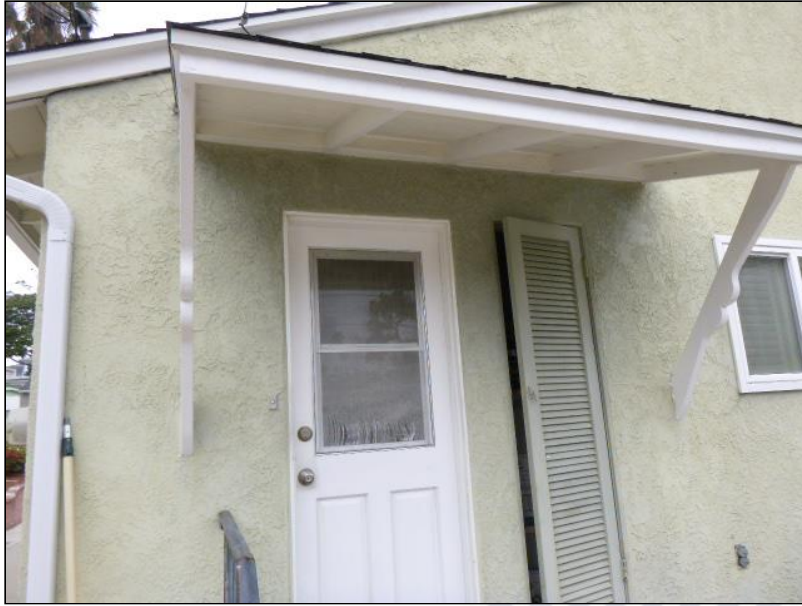
9.3 Item 1(Picture)

No light fixture installed at this area as required, this is a possible safety hazard. Suggest review with a licensed electrician for installation costs for a light fixture to enhance safety.

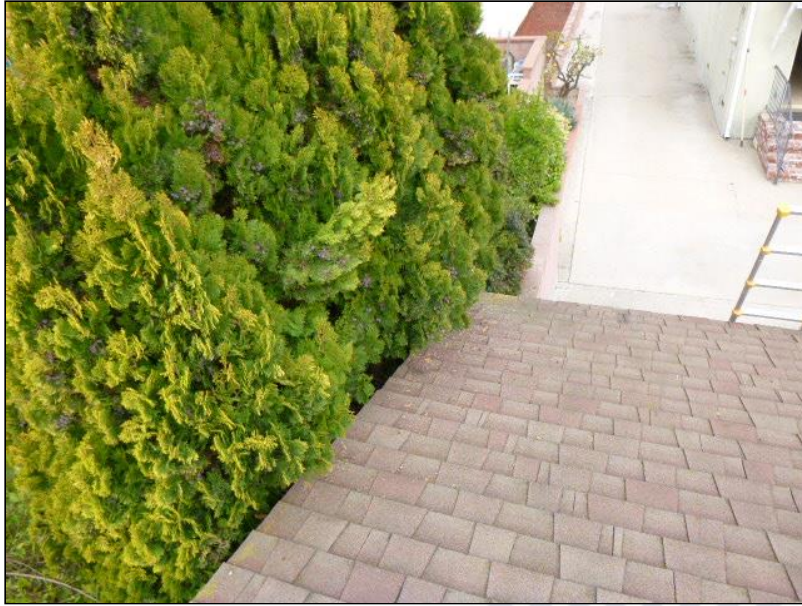
10.1 Item 2(Picture)

(2) The tree limbs that are in contact with roof or hanging near roof should be trimmed to prevent damaging the roof. Suggest trimming as needed.

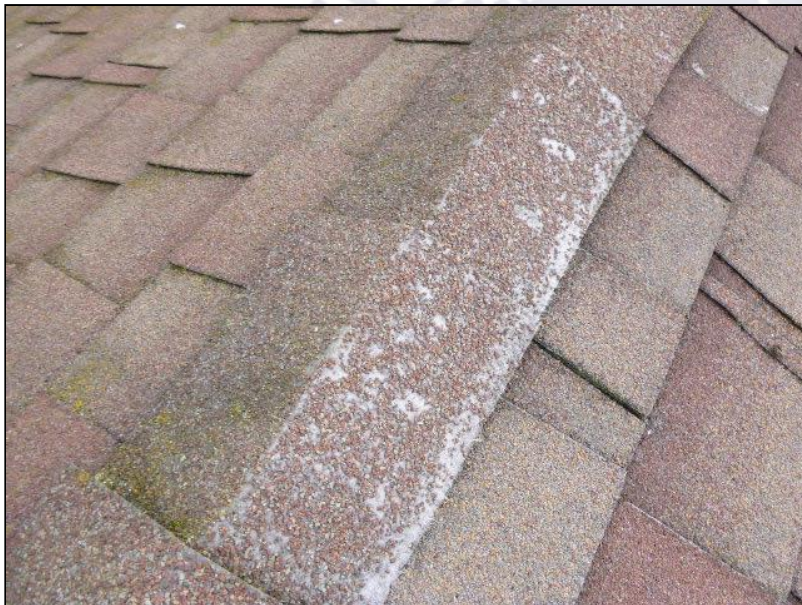
10.1 Item 3(Picture)

(3) Deteriorated ridge caps noted at the pitched roof, suggest review by licensed roofer for replacement costs and replace as needed.

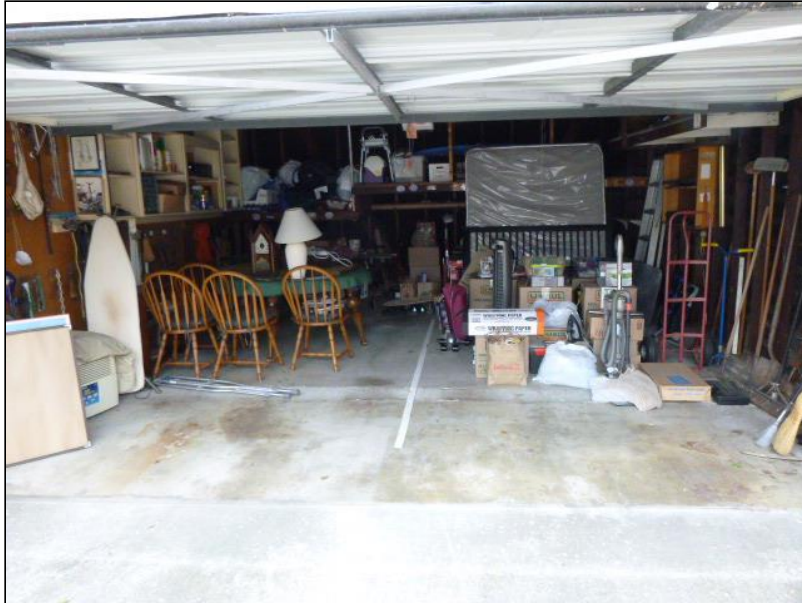
10.3 Item 1(Picture)

(1) Access within this area was blocked or severely limited at the time of the inspection. An inspection of this area can be performed by appointment and at an additional cost when the area is made accessible.

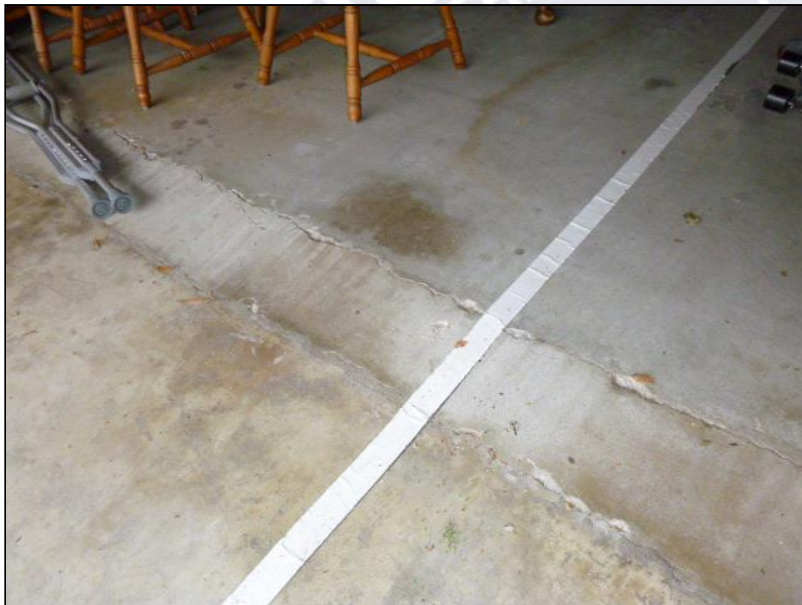
10.3 Item 2(Picture)

(2) Patched and repaired areas of the garage slab were noted. Suggest review with the seller on the cause and any repairs needed. Suggest repair/replace as needed.

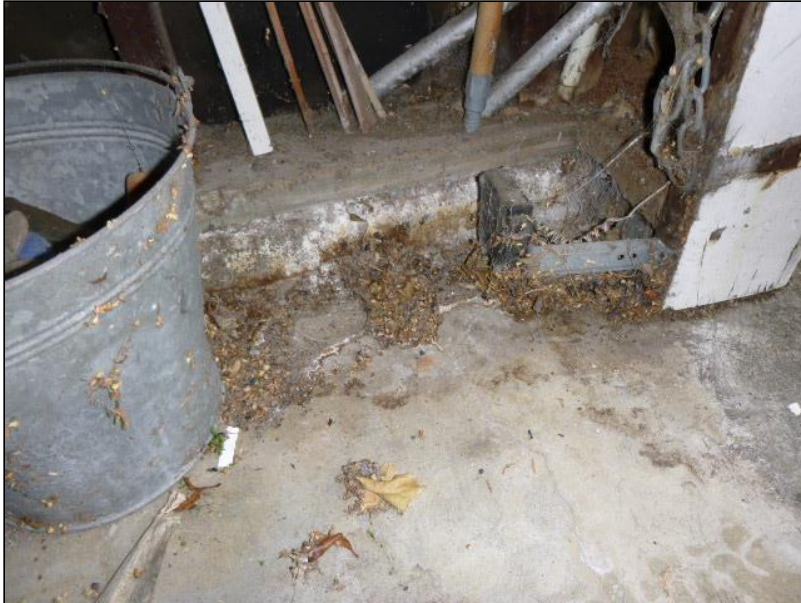
10.4 Item 1(Picture)

(1) Evidence of previous and possible ongoing water intrusion noted at the main door, see the driveway comments and repair/replace as needed.

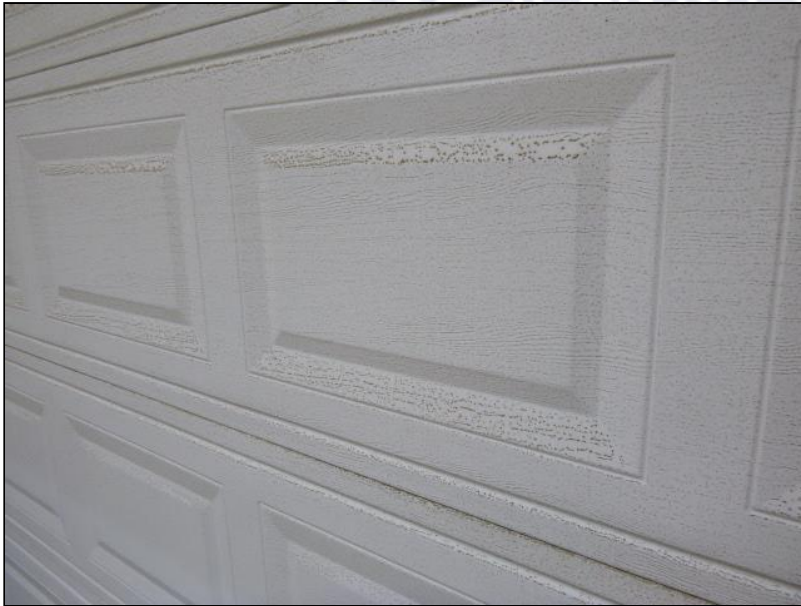
10.4 Item 2(Picture)

(2) Surface rust and corrosion noted at the garage door panels, suggest repair/replace as needed.

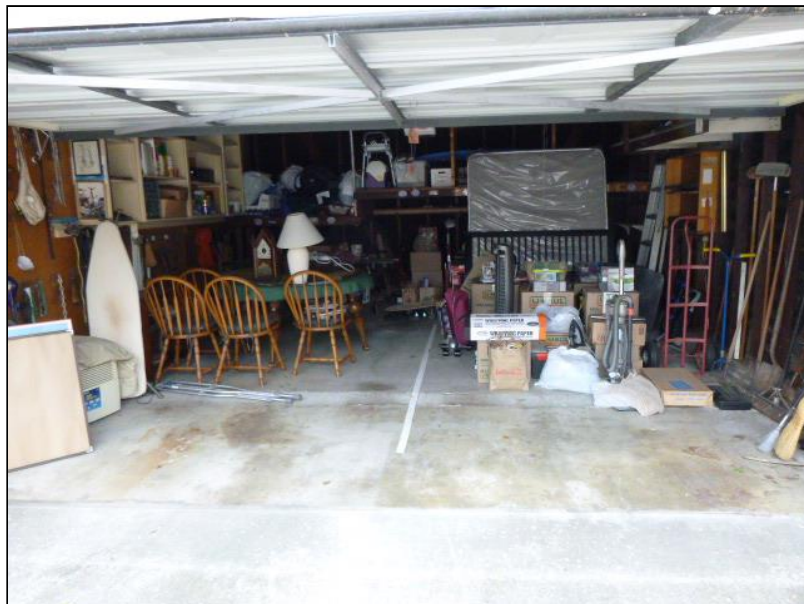
10.9 Item 1(Picture)

Access within this area was blocked or severely limited at the time of the inspection. An inspection of this area can be performed by appointment and at an additional cost when the area is made accessible.

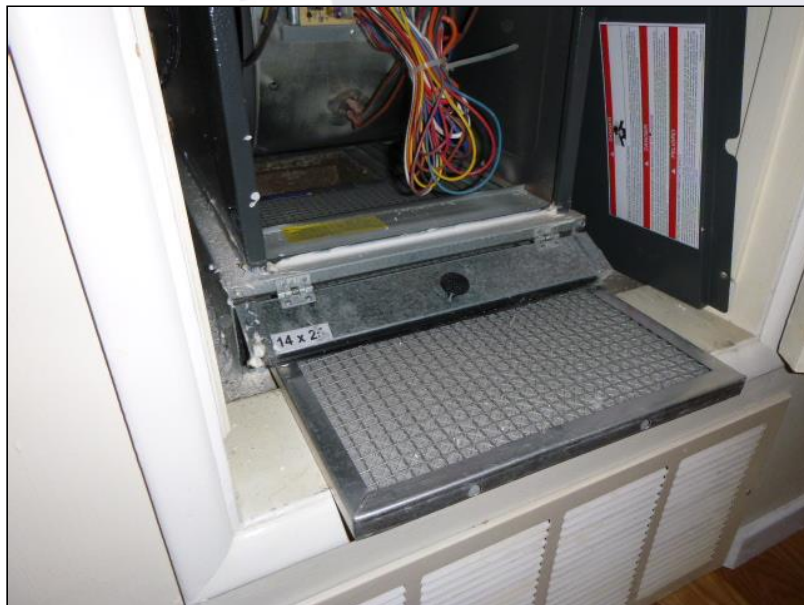
11.0 Item 3(Picture)

(2) Suggest replacing/cleaning the filter(s) as needed.

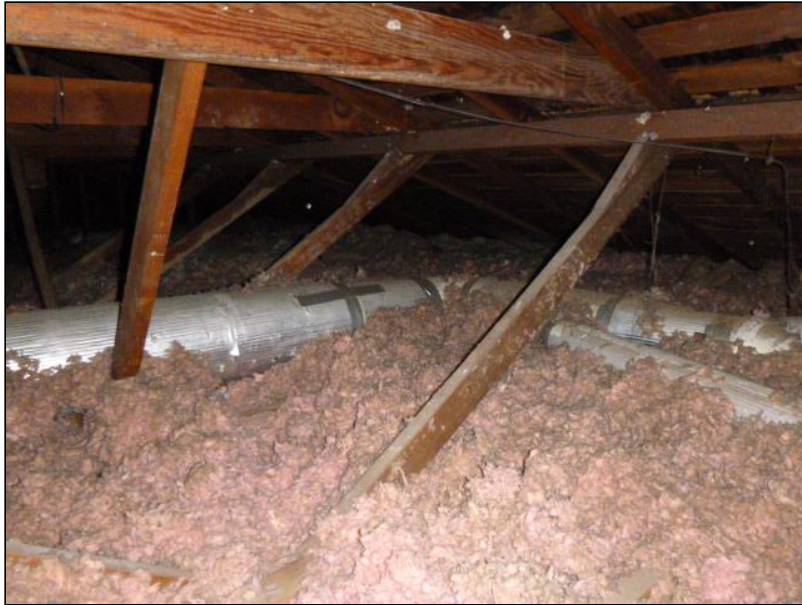
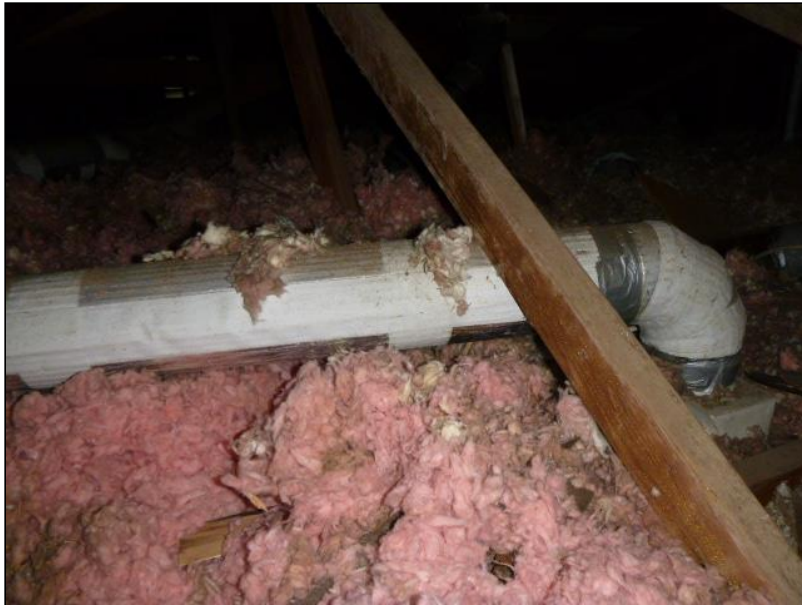
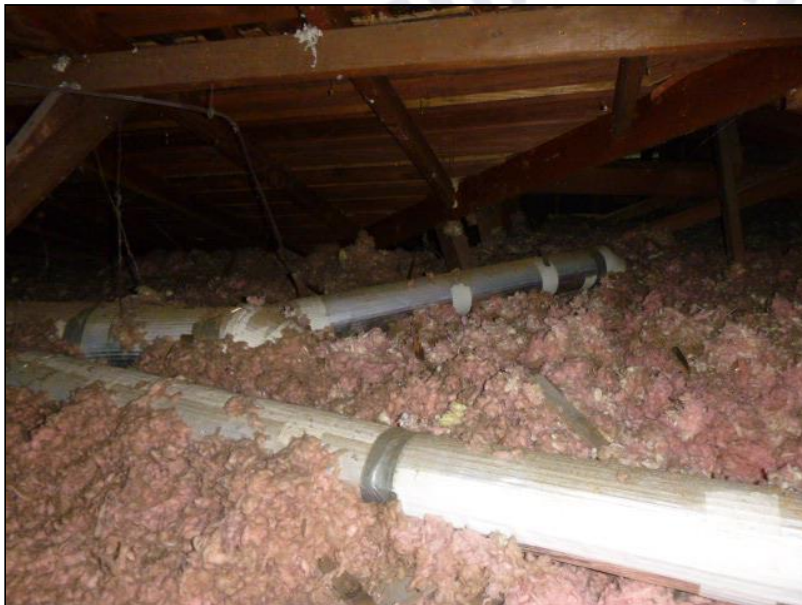
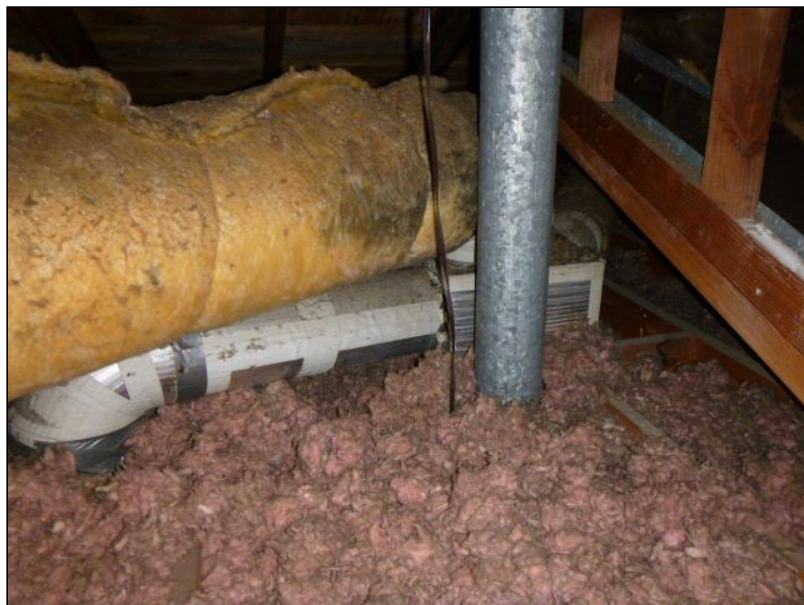
(1) Possible asbestos like material, tape and wrap noted at ducting and joints. Tape and wrap, torn and loose in the several areas, suggest review by licensed contractor for repairs/replacement or removing material or encapsulating the damaged areas.

(2) Generally a certification of the existing ducting is required when replacing the heating to determine and confirm no leakage will occur which can/will result in the asbestos insulation being damaged and blown through the dwelling/attic area. Suggest review with the sellers and the heater installation company for confirmation of this requirement and/or costs to replace the existing asbestos ducting as required.

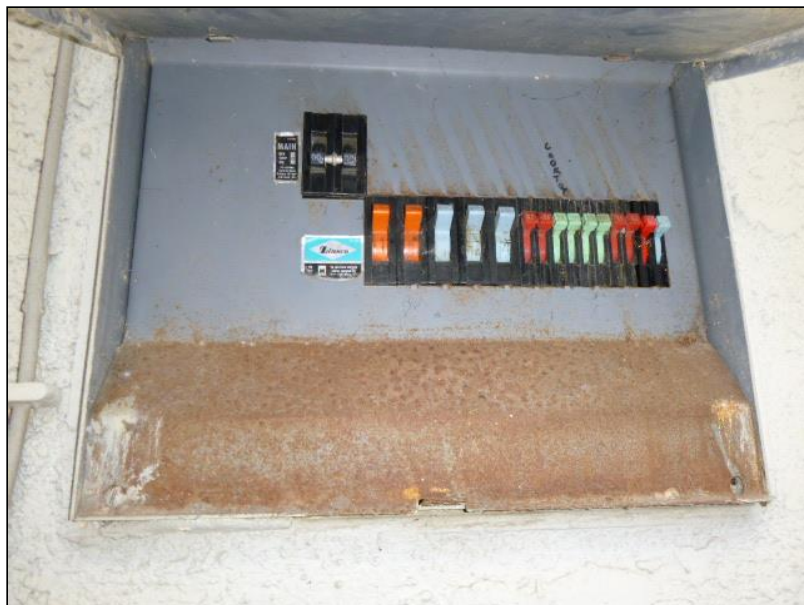
12.1 Item 1(Picture)

(1) The main electrical panel is a Zinsco brand panel box, a product that hasn't been manufactured for many years. There are problems with these panels that can, in some cases, be serious. Some Zinsco panels have aluminum bus bars (the bars that run down the middle of the panel to which the breakers connect). Over a period of years, oxide forms on the aluminum causing a poor connection with the breakers and leading to arcing, overheating, and, eventually, breaker failure. Other problems with Zinsco panels include circuit breakers (depending on the vintage) with a dismal performance record and the possibility of unbalanced multi-wire circuits. Also, please be aware that various insurance companies will not insure homes with this style of electrical panel. Suggest review by a licensed electrician for replacement costs as needed.

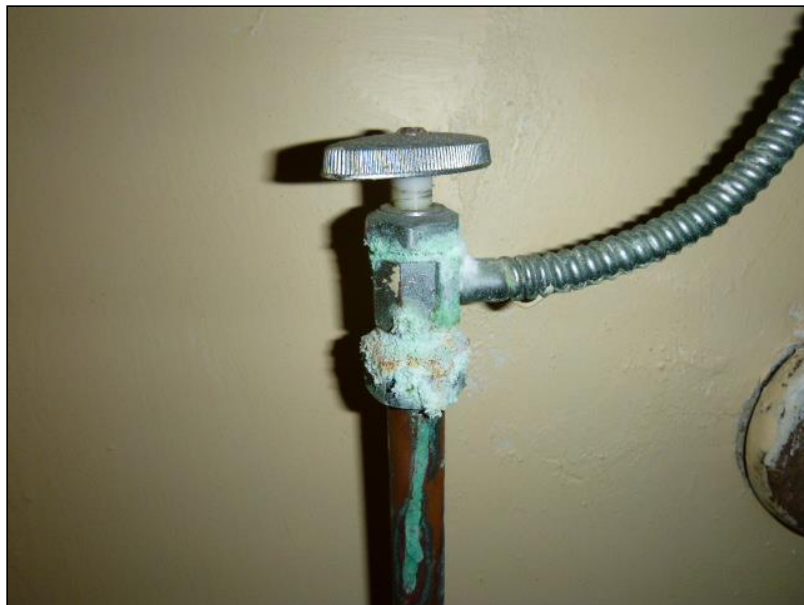
13.0 Item 2(Picture)

(2) Corroded plumbing and fittings noted at various areas within the dwelling. Suggest further review by a licensed plumber for repair/replacement costs as needed to prevent future leakage, pin hole leaks and possible stains/damage to the interior of the dwelling.

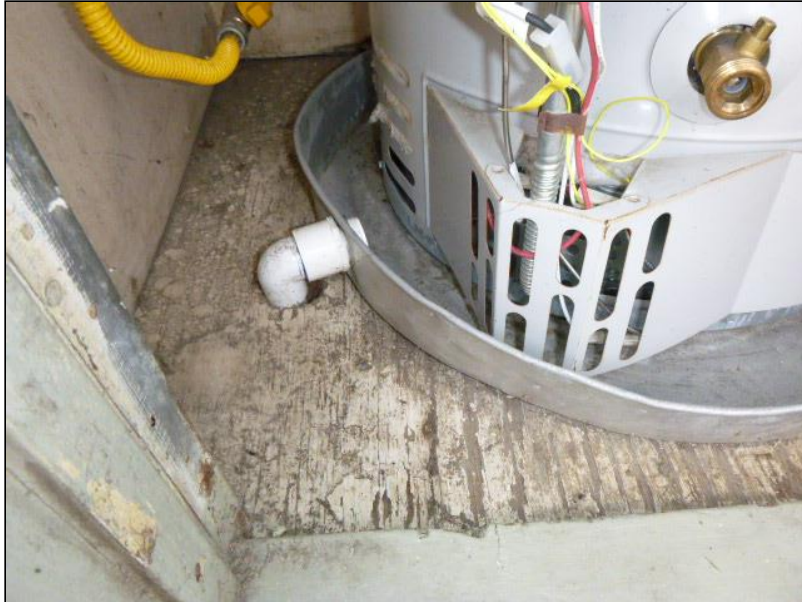
15.0 Item 2(Picture)

(2) A Spill/smitty pan is installed under the water heater, but the drain exits into the crawl area. Suggest installing the drain line to the exterior of the dwelling as required when installed.

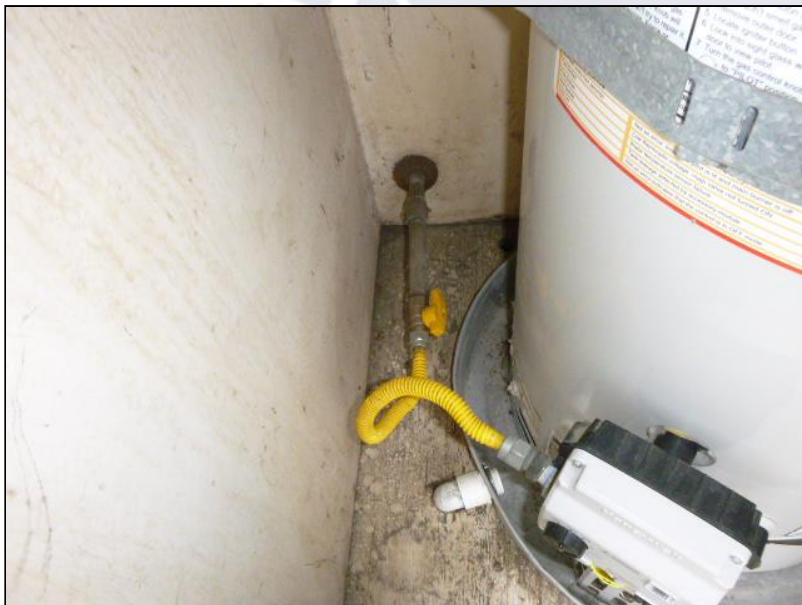
15.0 Item 3(Picture)

(3) Currently no gas supply line drip leg/sediment trap is installed, please be aware that various cities do not enforce/require this installation. Suggest review with the local City Building Department and/or with a licensed plumbing contractor for installation costs as needed.

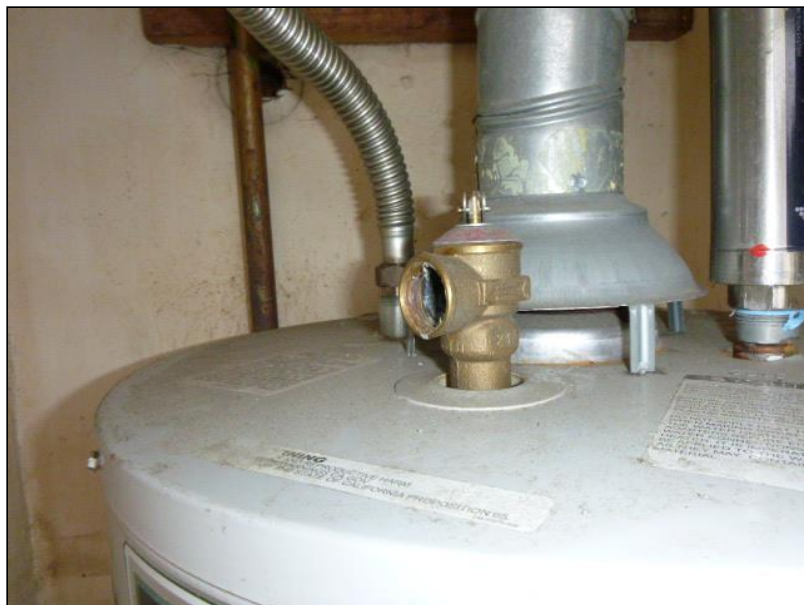
15.0 Item 4(Picture)

(4) No discharge pipe connected to the TP&R valve, this is a potential safety hazard. Suggest review by a licensed plumber for costs to install the TP discharge drain down to within 4-6 inches of the exterior grade/deck as required for safety.

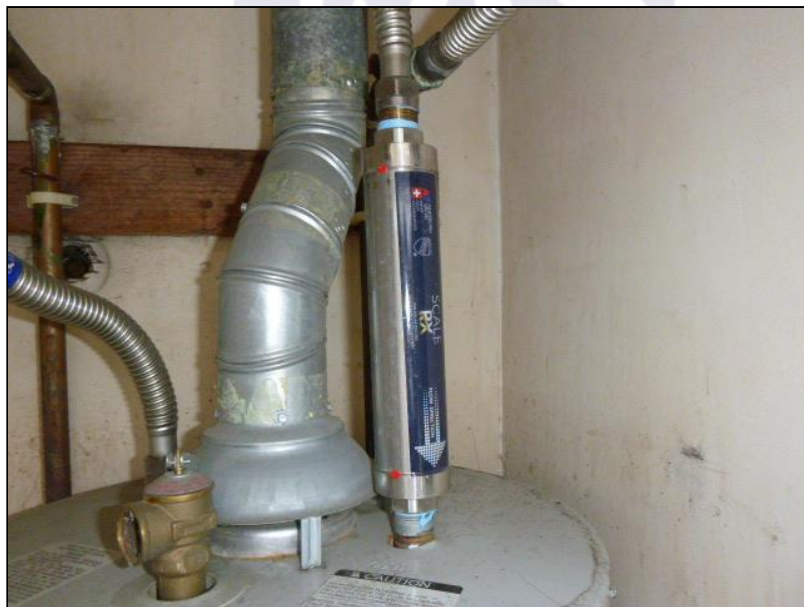
15.0 Item 5(Picture)

(5) The current water heater does not have a "Thermal Expansion tank" which is generally installed to prevent a possible leak at the T&P or "pop-off" valve and/or excessive pressure build-up at the internal plumbing, fixtures and joints. Recent changes ( 2012 ) require one when a new water heater is installed, but various cities do not enforce this installation for multiple reasons ( the home is not on a closed system and various tankless units do not require it ). There were no leaks or drips at the T&P valve during inspection. If your water heater does begin to drip or leak, then a thermal expansion tank may be needed. Suggest review with the city and/or a licensed plumber to determine if this installation is required and install as needed.

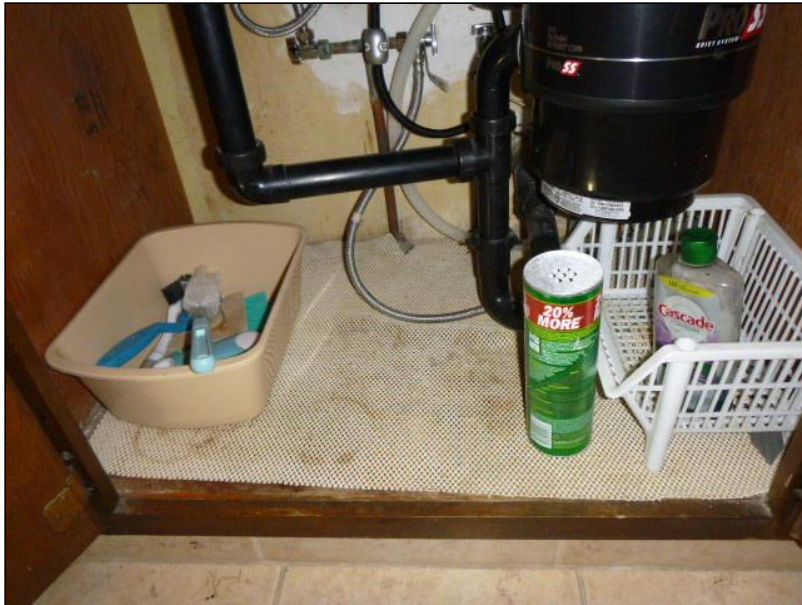
16.6 Item 1(Picture)

The base cabinet under the sink is deteriorated/stained from previous leaks, suggest repair/replace as needed.

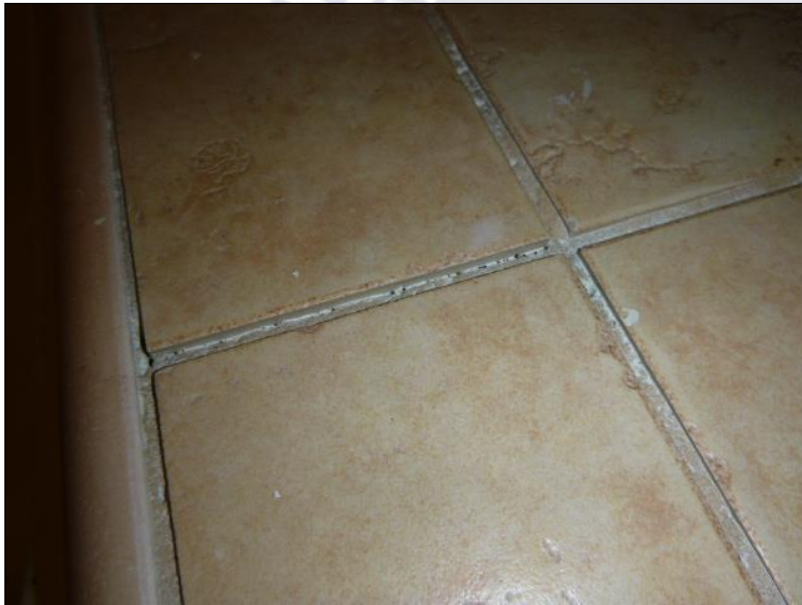
16.7 Item 1(Picture)

Deteriorated and missing grout noted at various areas of the tile countertop, suggest repair/replace as needed.

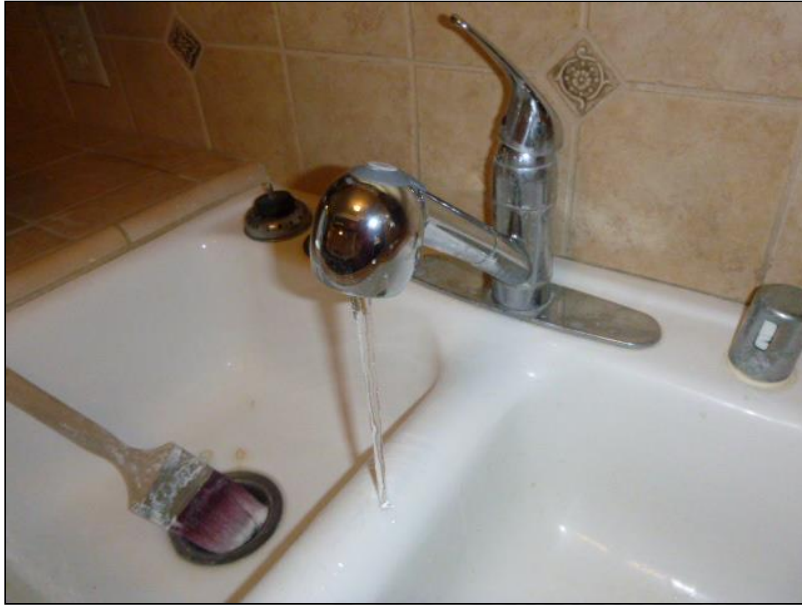
16.10 Item 1(Picture)

Poor water flow noted at the sink faucet, suggest review with a licensed plumber for repair/replacement costs as needed.

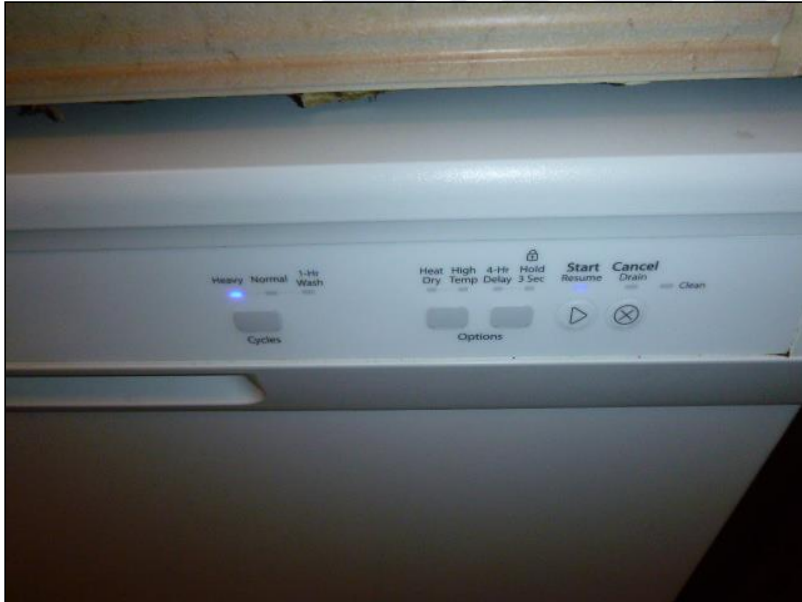
16.12 Item 1(Picture)

(1) The inspector was unable to select between the multiple washing cycles as needed, Suggest review with a licensed appliance contractor for repair/replacement costs as needed.

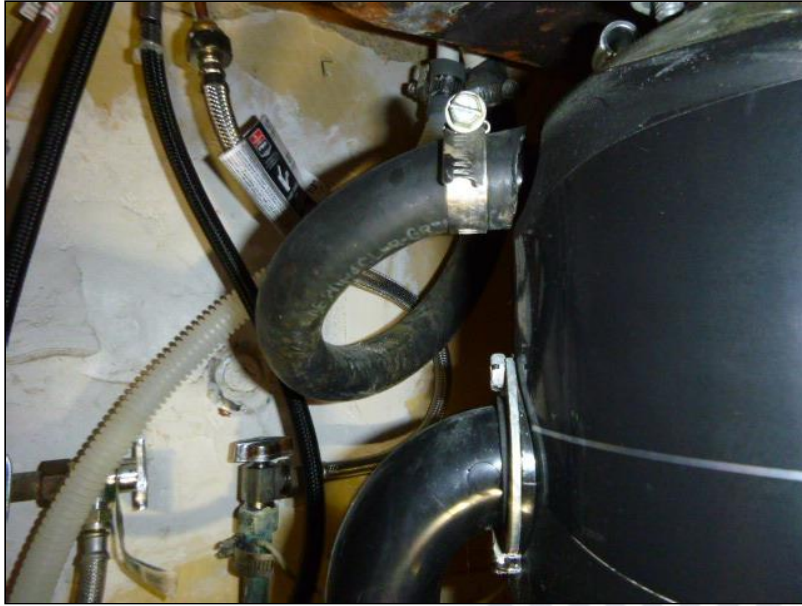
16.12 Item 2(Picture)

(2) Suggest review with a licensed plumber for costs to reduce the length of the drain from the air gap to the disposal as this has created a trap in the drainage system.

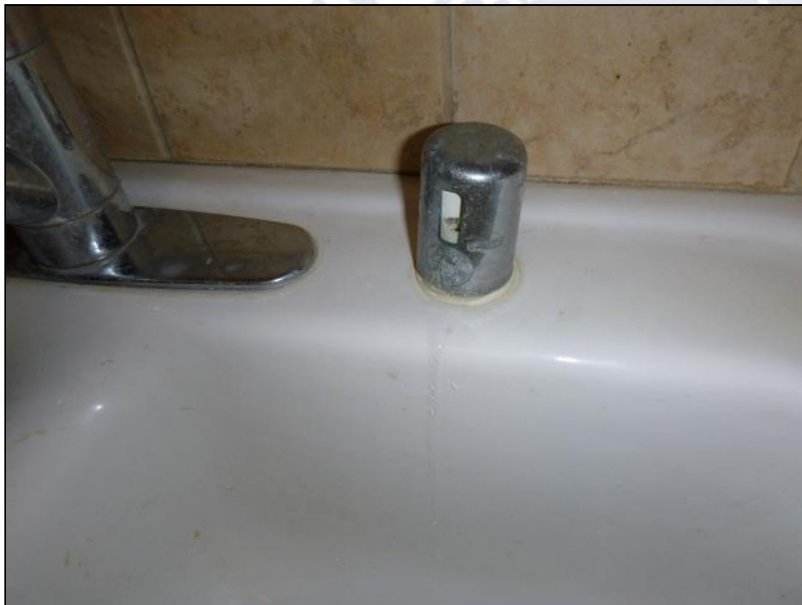
16.12 Item 3(Picture)

(3) The dishwasher partially drains over countertop/sink through air gap as there appears to be a blockage in the drain line. Suggest review by a licensed plumber and repair as needed.

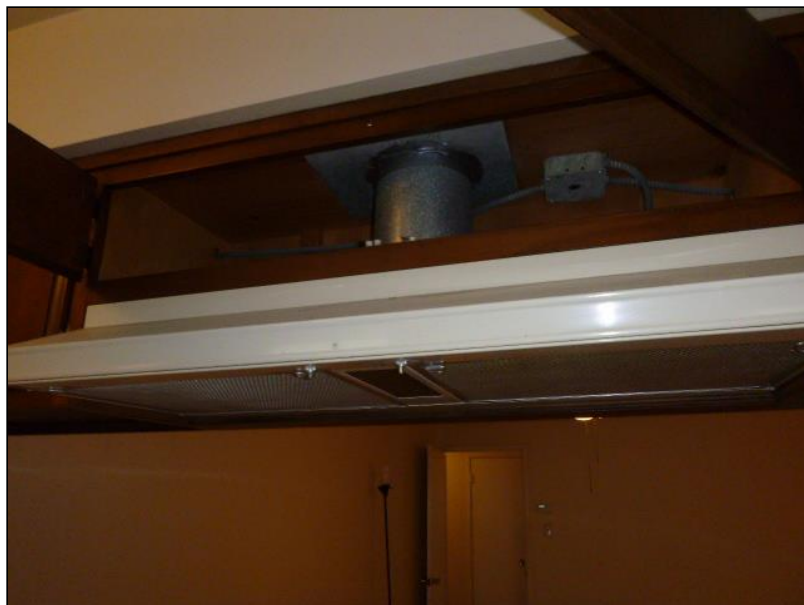
16.15 Item 1(Picture)

(1) The light bulbs at the vent hood were inoperable at the time of the inspection, suggest replacing the bulbs as needed.

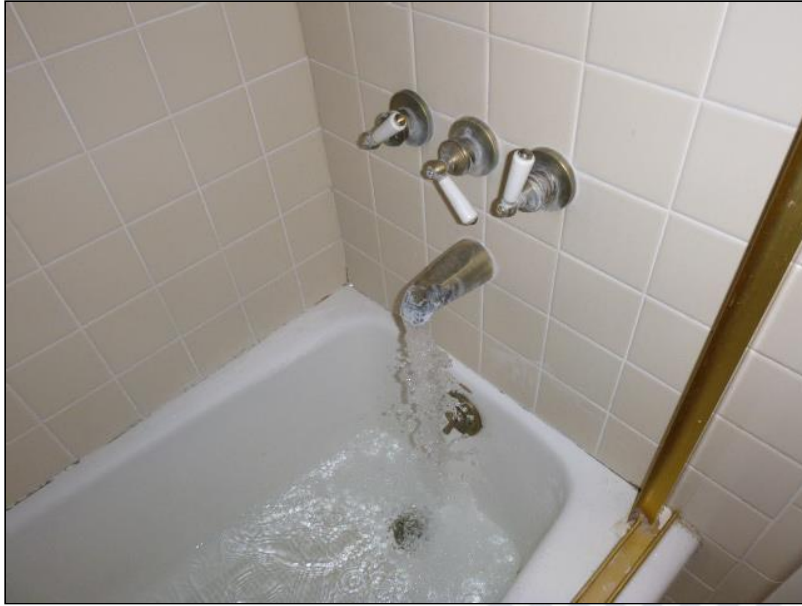
17.10 Item 1(Picture)

The existing tub faucet is not a low-flow system as required. Suggest review with a licensed plumber for costs to replace the existing tub faucet with a low flow faucet (2.2 gallons per minute) as required by the State of California as of January 1st, 2017. See the plumbing system comments for further details and a link to the State of California plumbing ordinance.

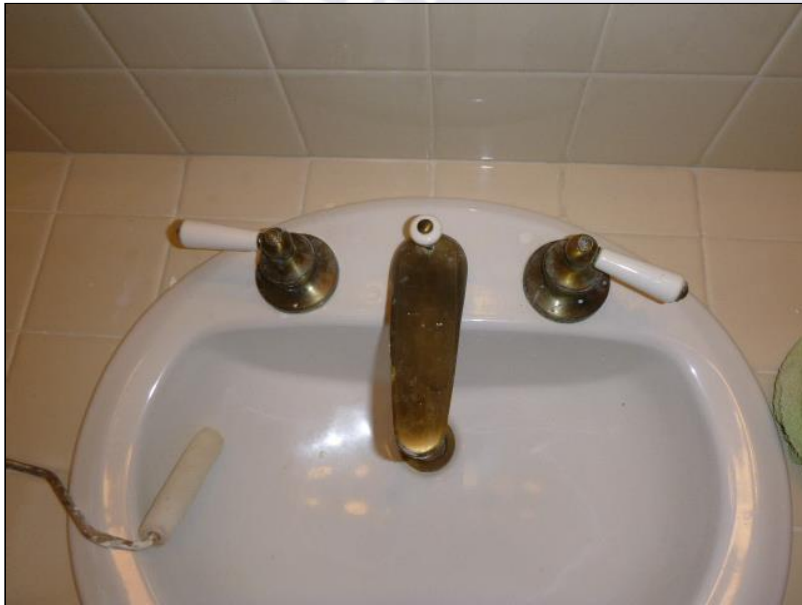
17.15 Item 1(Picture)

The sink faucet handles are not set square, suggest repair as needed.

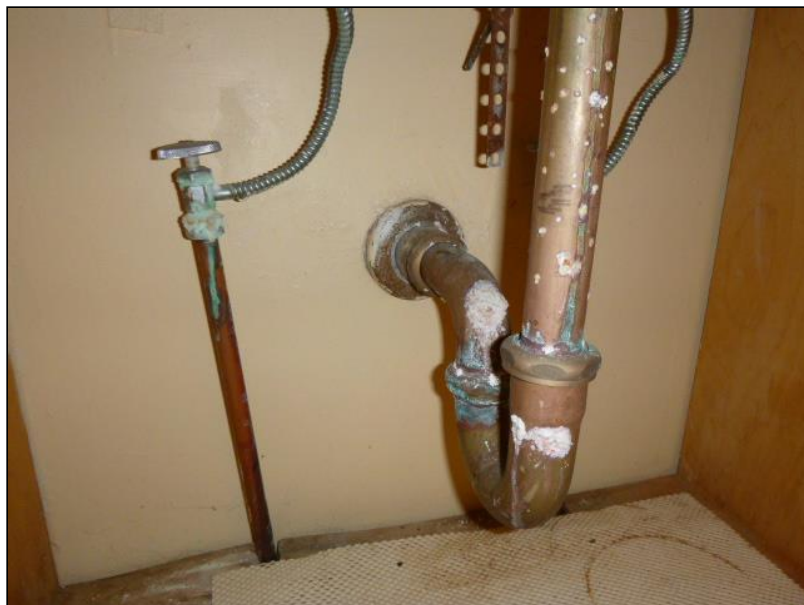
17.16 Item 1(Picture)

(1) Corrosion noted at the sink drain and angle valve(s), no leaking noted at the time of the inspection. Suggest review by a licensed plumber and repair/replace as needed.

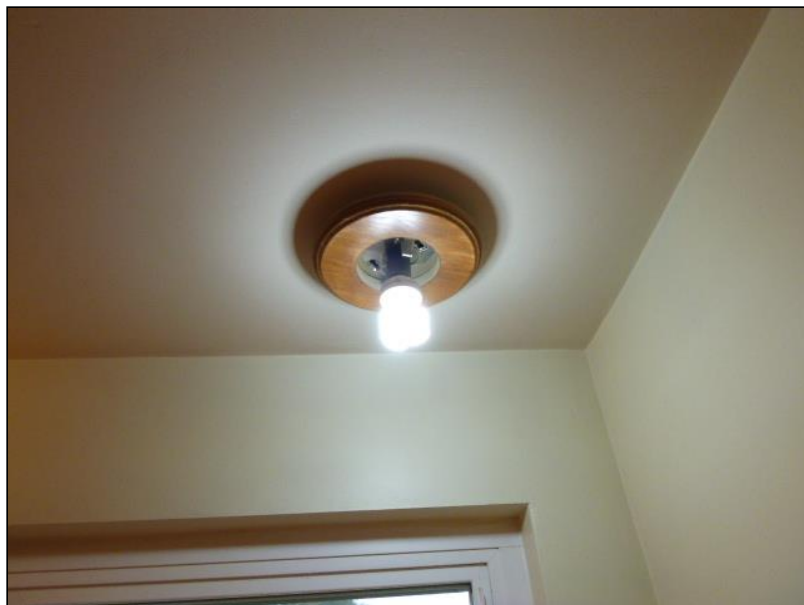
18.6 Item 1(Picture)

The cover globe(s) are missing at light fixture(s) at the time of the inspection. Suggest replacing the missing cover globe(s) for safety.

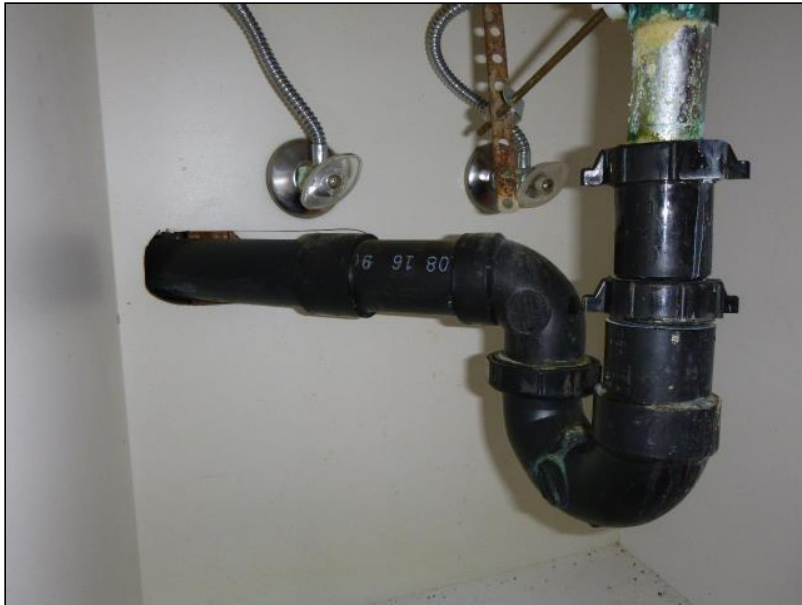
18.14 Item 1(Picture)

Corrosion noted at the sink drain and angle valve(s), no leaking noted at the time of the inspection. Suggest review by a licensed plumber and repair/replace as needed.

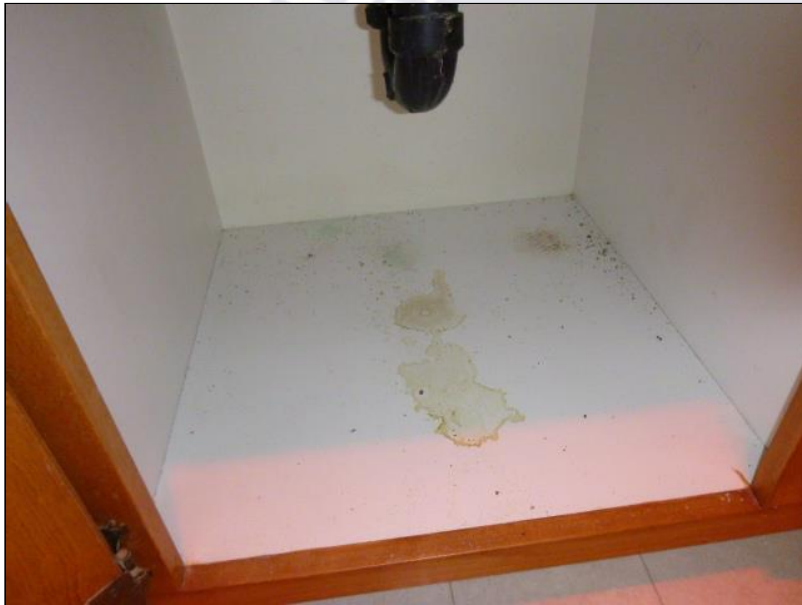
18.16 Item 1(Picture)

The base cabinet under the sink is deteriorated/stained from previous leaks, suggest repair/replace as needed.

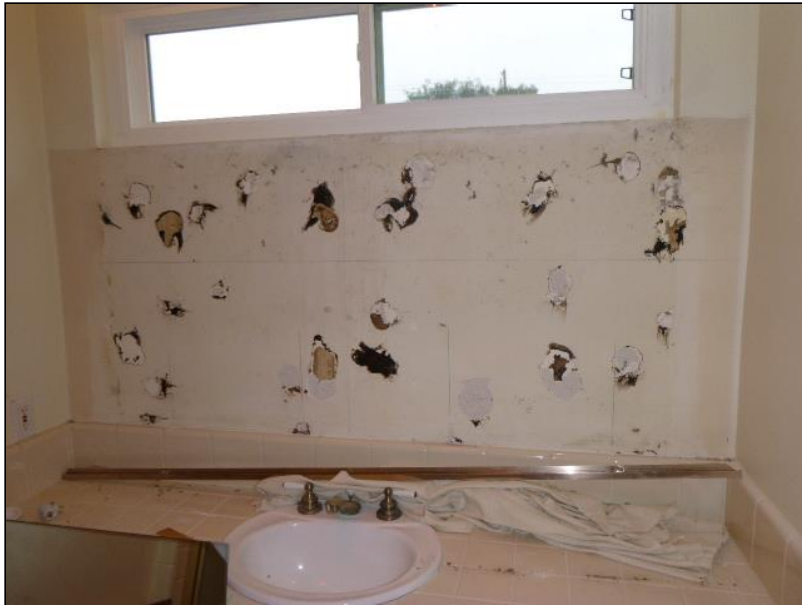
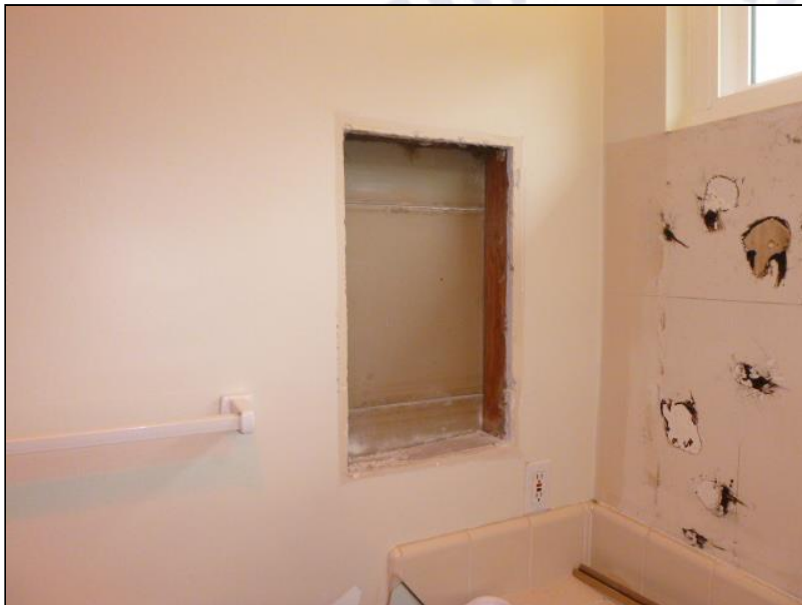
The wall mirror and cabinet were missing/removed at the time of the inspection. Suggest review with the seller and/or a licensed contractor for installation costs as needed.
