# Inspection Report

**Property Address:**  
1327 S Helberta Ave  
Redondo Beach CA 90277

**Ferguson Home Inspections**

<b>Date:</b> 1/5/2021	<b>Time:</b> 09:00 AM	<b>Report ID:</b> 01052021Helberta
<b>Property:</b> 1327 S Helberta Ave Redondo Beach CA 90277	<b>Customer:</b> Bob Crowe	<b>Real Estate Professional:</b> Bilge Coskun

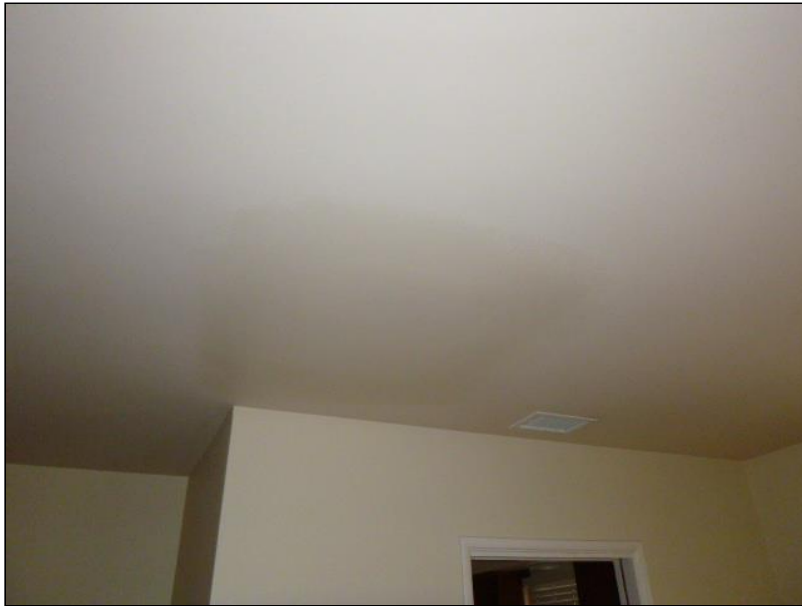
21.2 Item 1(Picture)

Patched and uneven areas of the ceiling noted, suggest review with the seller on the cause and any repairs needed. Suggest repair as needed.

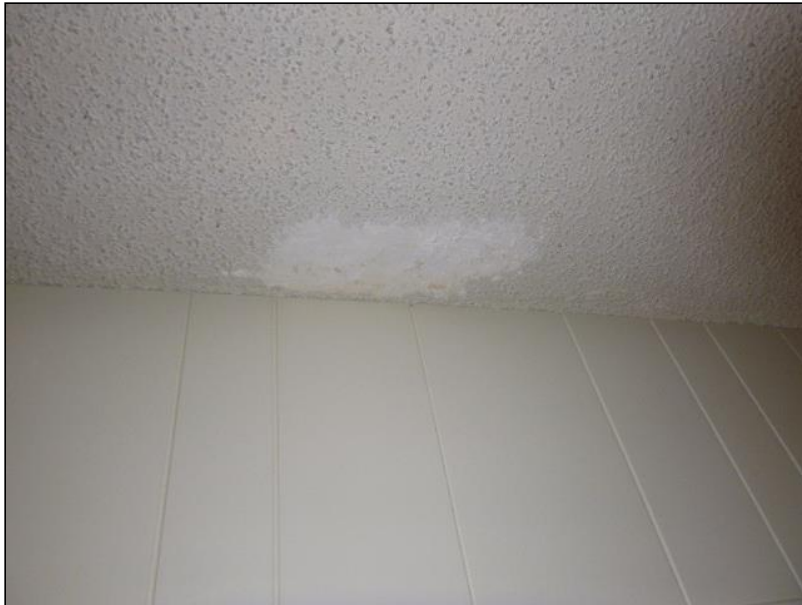
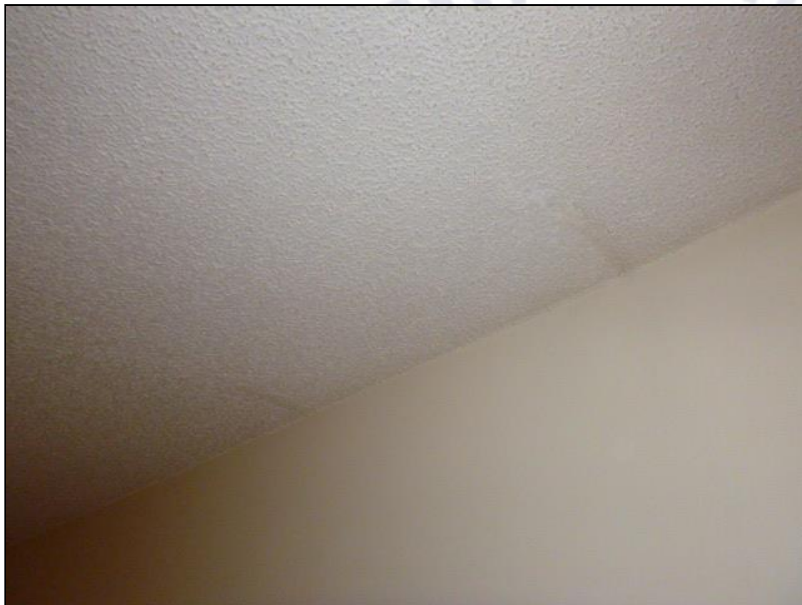
(1) Patched and uneven areas of the ceiling noted, suggest review with the seller on the cause and any repairs needed. Suggest repair as needed.

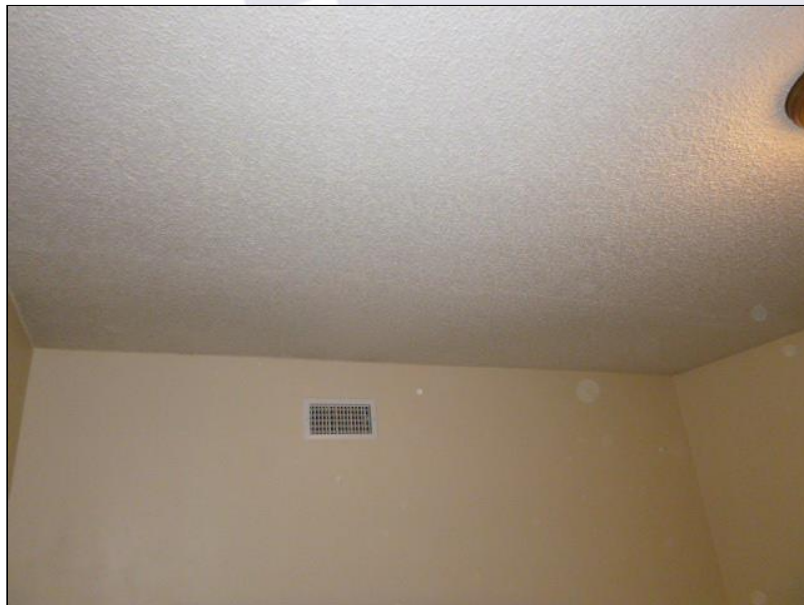
26.2 Item 1(Picture)

(2) Patched and uneven areas of the ceiling noted, suggest review with the seller on the cause and any repairs needed. Suggest repair as needed.
