# Inspection Report

5709 Sunmist Dr  
Rancho Palos Verdes, CA 90275

Thursday, August 27, 2020

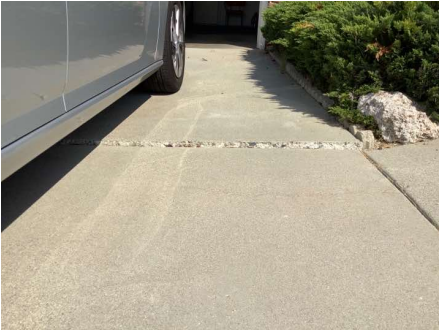
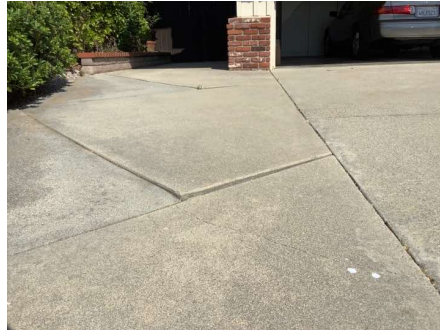
**SC s-27:** Uneven sections were observed in the driveway surface. This condition poses a trip hazard. We recommend correcting the condition(s) noted for safety reasons.

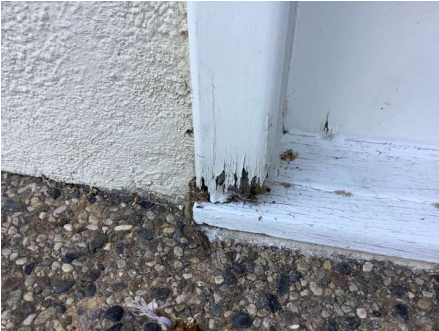
**CR s-46:** Some of the exterior trim is damaged and/or deteriorated on the left rear of the building. We have NOT listed every instance of trim damage. We suggest having a qualified contractor examine all exterior trim for deterioration, damage or missing parts, and repair or replace as necessary. Regular routine maintenance is recommended. NOTE: Review of a current pest control operator's report, if available is recommended to determine what action might be appropriate. If no current report is available, a report should be ordered from a qualified, licensed pest control operator.

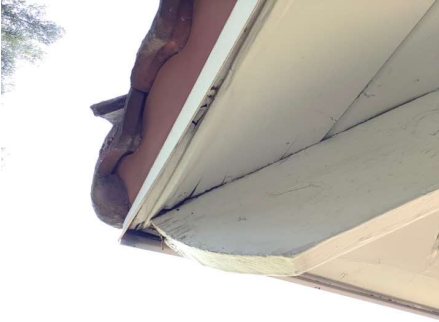
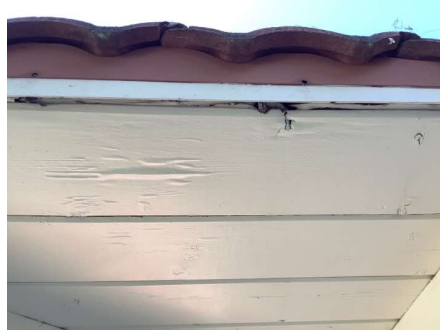
**FE s-60:** There are water stains on the underside of the eaves at the front of the building. These visible conditions strongly indicate an active leak. We suggest the source of the water penetration should be located and appropriate repairs made to prevent more damage to the eaves.

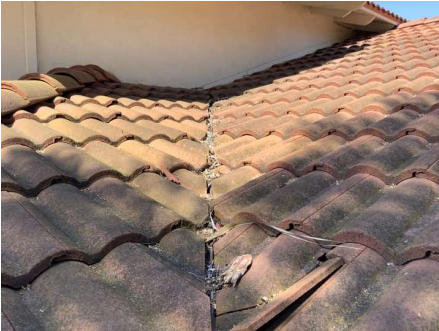
**FE CR s-62:** The valleys are obstructed by an accumulation of debris. The debris can promote moisture penetration of the roofing system. We suggest regular maintenance and clearing of all debris from the valleys is recommended as part of routine roof maintenance.

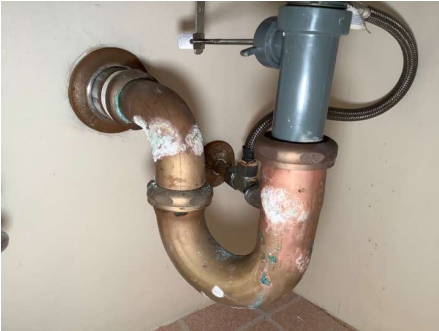
Upper floor hallway bathroom wash basin

**CR s-99:** In the area(s) listed below although no active leak was observed, there is/are corroded and/or deteriorated drain line(s) with a limited useful life. We suggest considering replacing such drains before leaks occur.

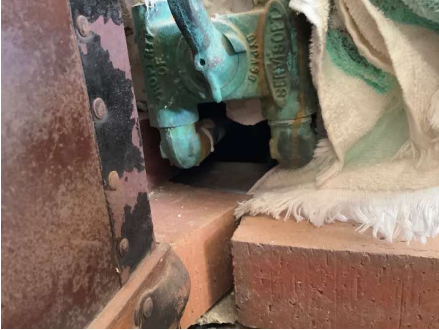
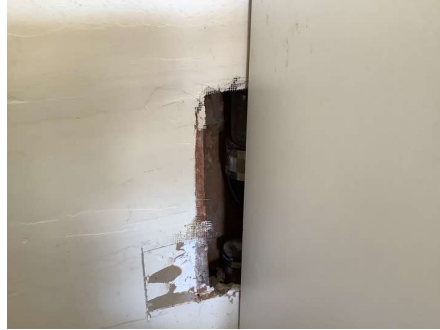
**CR s-168:** There are holes/damage in the fire-resistive barrier between the garage and interior or attic. This condition can allow more rapid spread of smoke and flames in the event of a fire. We suggest all voids should be repaired per current industry standards.

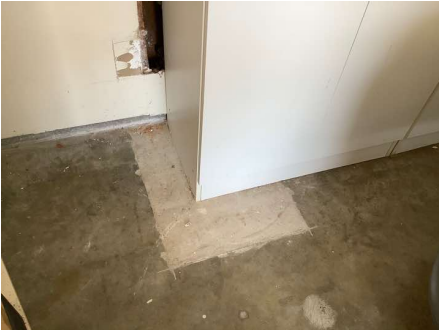
**FE CR s-171:** Prior repairs have been made in the garage slab. Inquiries should be made with the sellers as to the reason for the repairs. If concerns remain, we suggest a qualified technician should evaluate this condition and make repairs or modifications as necessary.

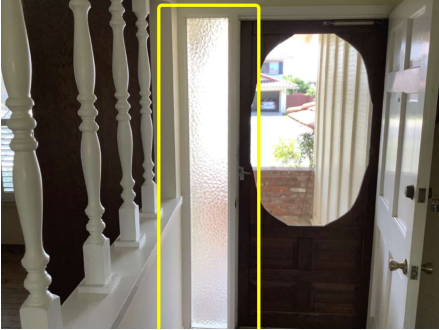
Entryway

**SC FE s-182:** In the area(s) listed below the glass at the window or door has no visible marking to indicate that it is tempered or laminated safety glass. We suggest if tempered or laminated safety glass cannot be confirmed at this location, a qualified glass company should be consulted to examine it and identify its composition. Non-safety glass can be hazardous if broken. If it is not safety glazing, we recommend modifying or replacing it with safety glass.

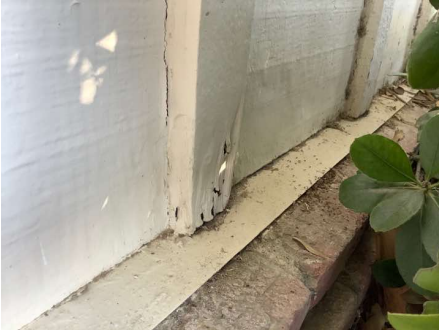
**CR s-40:** Sections of the siding are deteriorated. We suggest a qualified technician should repair or replace any deteriorated siding. NOTE: Review of a current pest control operator's report, if available is recommended to determine what action might be appropriate. If no current report is available, a report should be ordered from a qualified, licensed pest control operator.

**CR 40:** Sections of the siding are deteriorated. We suggest a qualified technician should repair or replace any deteriorated siding. **NOTE:** Review of a current pest control operator's report, if available is recommended to determine what action might be appropriate. If no current report is available, a report should be ordered from a qualified, licensed pest control operator.

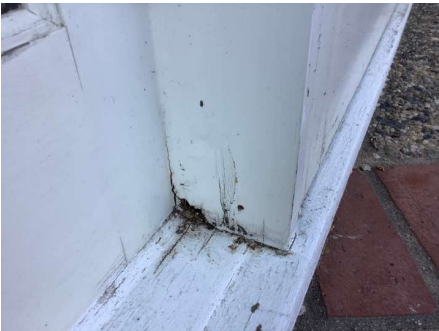
**FE CR s-42:** The exterior door is deteriorated on the left rear of the building. We suggest deteriorated doors should be repaired or replaced as necessary. NOTE: Review of a current pest control operator's report, if available is recommended to determine what action might be appropriate. If no current report is available, a report should be ordered from a qualified, licensed pest control operator.

**FE CR 42:** The exterior door is deteriorated on the left rear of the building. We suggest deteriorated doors should be repaired or replaced as necessary. **NOTE:** Review of a current pest control operator's report, if available is recommended to determine what action might be appropriate. If no current report is available, a report should be ordered from a qualified, licensed pest control operator.

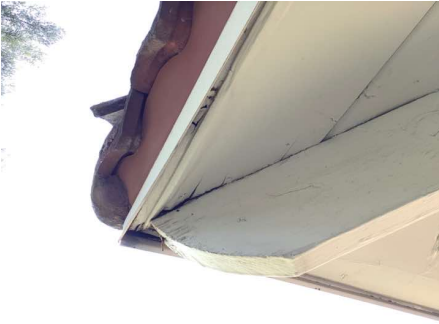
**FE 60:** There are water stains on the underside of the eaves at the front of the building. These visible conditions strongly indicate an active leak. We suggest the source of the water penetration should be located and appropriate repairs made to prevent more damage to the eaves.

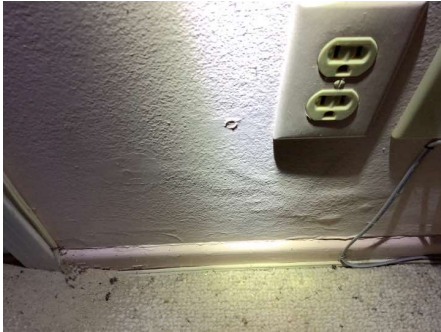
Living room

**FE CR 178:** In the area(s) listed below there are water stains and/or minor surface damage to the wall and ceiling. We suggest the source of the moisture should be identified and eliminated. The surface could be refinished as necessary.

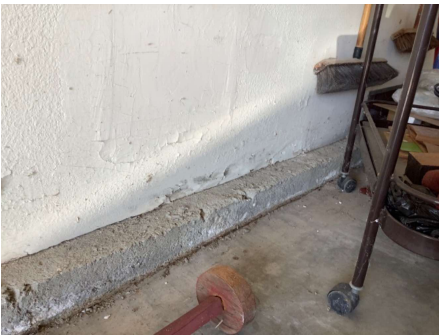
Garage

**FE 180:** In the area(s) listed below there is surface growth and/or an earthy odor on the walls. This may indicate the presence of mold, fungus or other microbial organisms. The identification of molds, fungus and other microbial organisms is outside the scope of this inspection. We suggest a qualified environmental specialist should be retained to evaluate the surfaces and make further recommendations. Testing and remediation of mold growth can only be accomplished by a qualified environmental specialist. If strict protocol is not followed, spores can be released into the interior of the building and may create a health hazard for those with low tolerances to such organisms.
