INSPECTION REPORT

For the Property at:
1067 PALOS VERDES BOULEVARD
REDONDO BEACH, CA 90277

Prepared for: RUTH RODGERS
Inspection Date: Friday, April 3, 2020
Prepared by: Robert Gaudreault

Report No. 1101

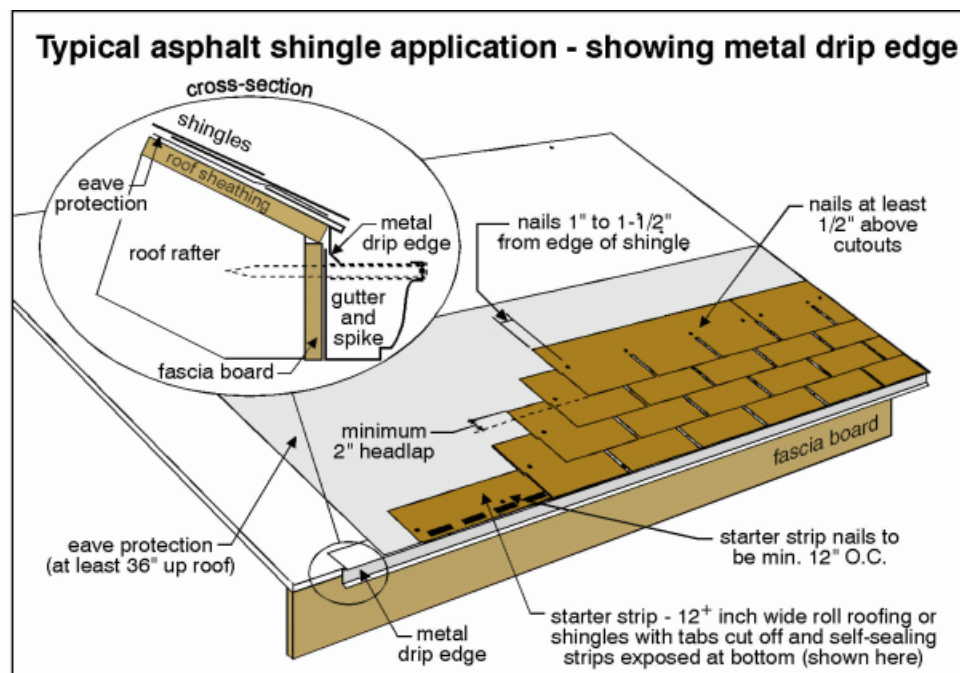
6. Condition: • [Above underlayment](#)

Implication(s): Chance of water damage to contents, finishes and/or structure

Location: Throughout

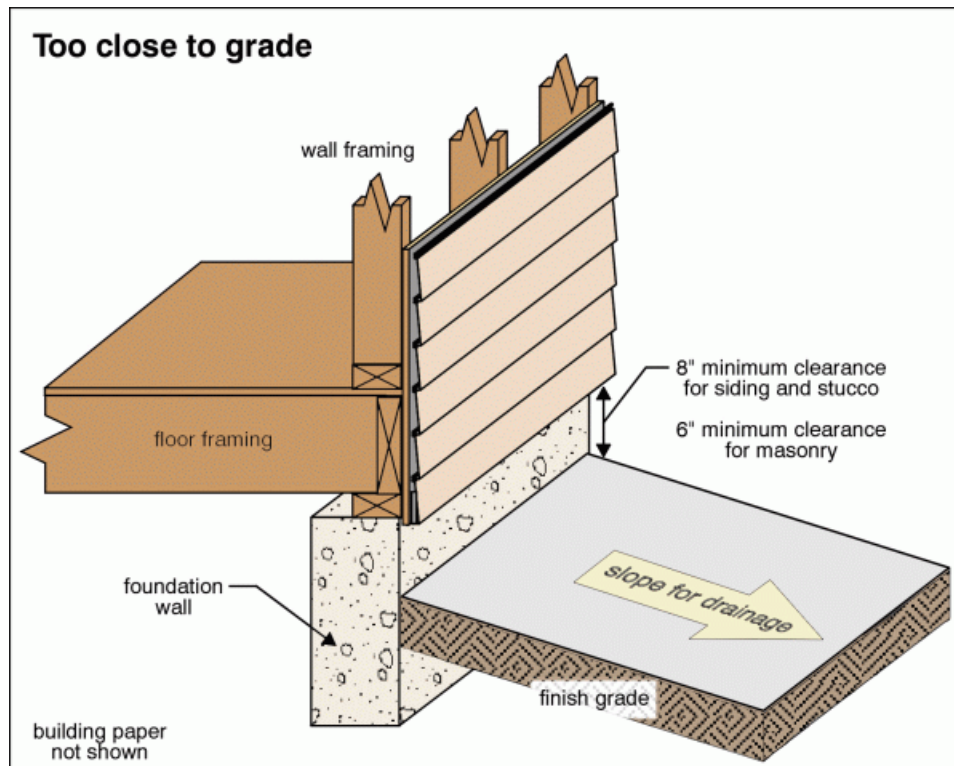
11. Condition: • [Too close to grade](#)

Implication(s): Chance of water damage to contents, finishes and/or structure | Material deterioration | Rot | Insect damage

Location: Along back side

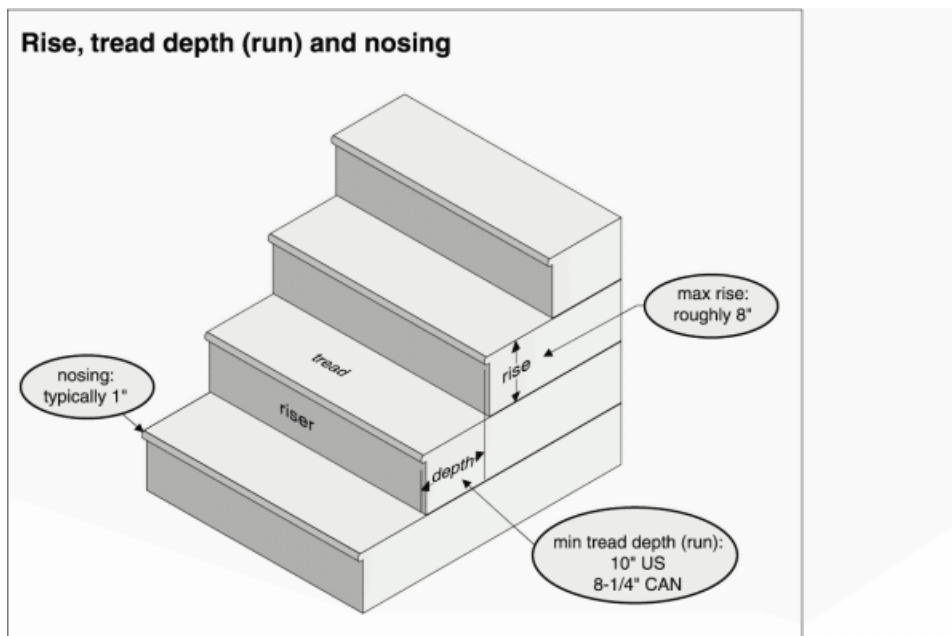
16. Condition: • [Stair run too small or not uniform](#)

Implication(s): Trip or fall hazard

Location: All back stairs

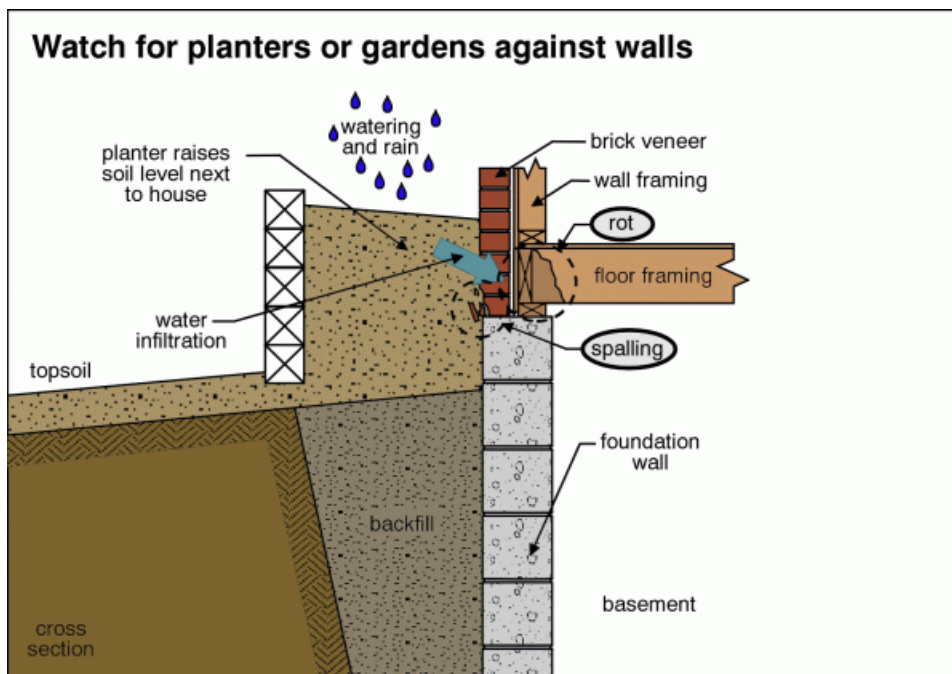
18. Condition: • [Planters and gardens against walls](#)

Implication(s): Chance of water entering building | Chance of damage to structure | Chance of structural movement

Location: To the left of garage

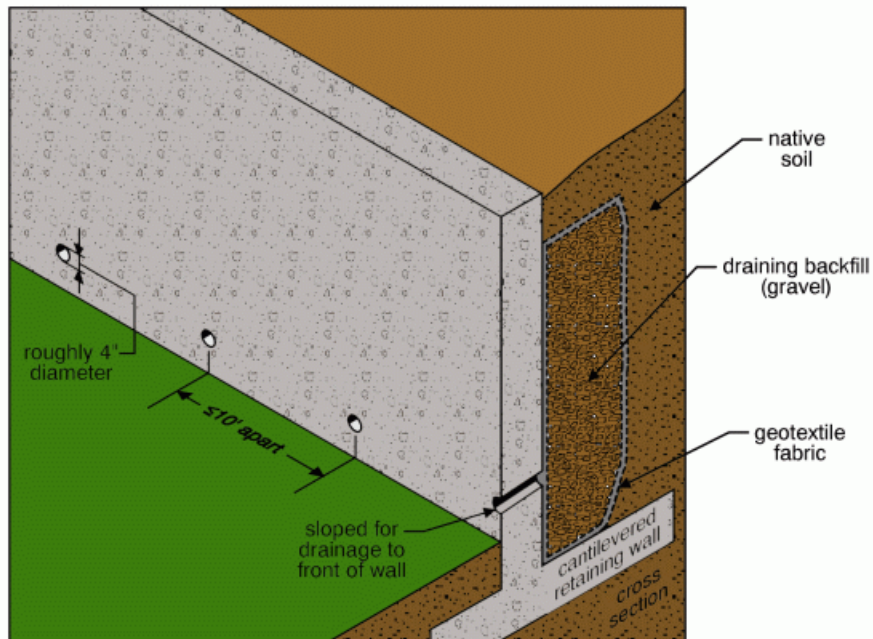
22. Drainage system missing

23. Condition: • [Drainage system missing](#)

Some fractures also noted

Task: Further evaluation be licensed mason

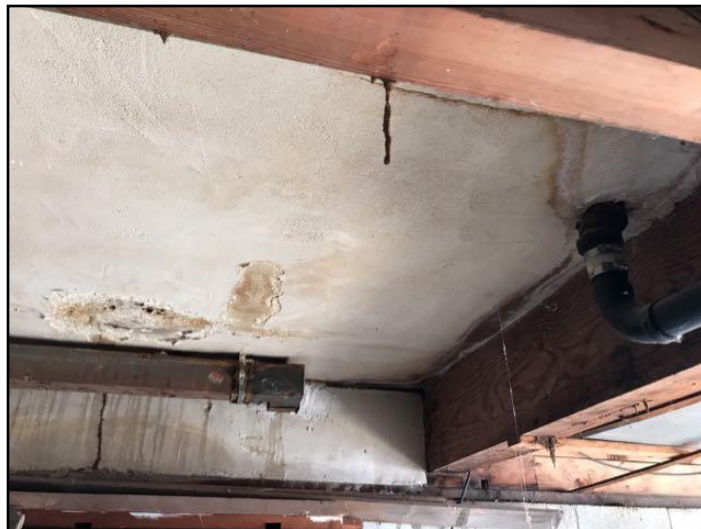
27. Condition: • Water stains at ceiling under kitchen from prior leak

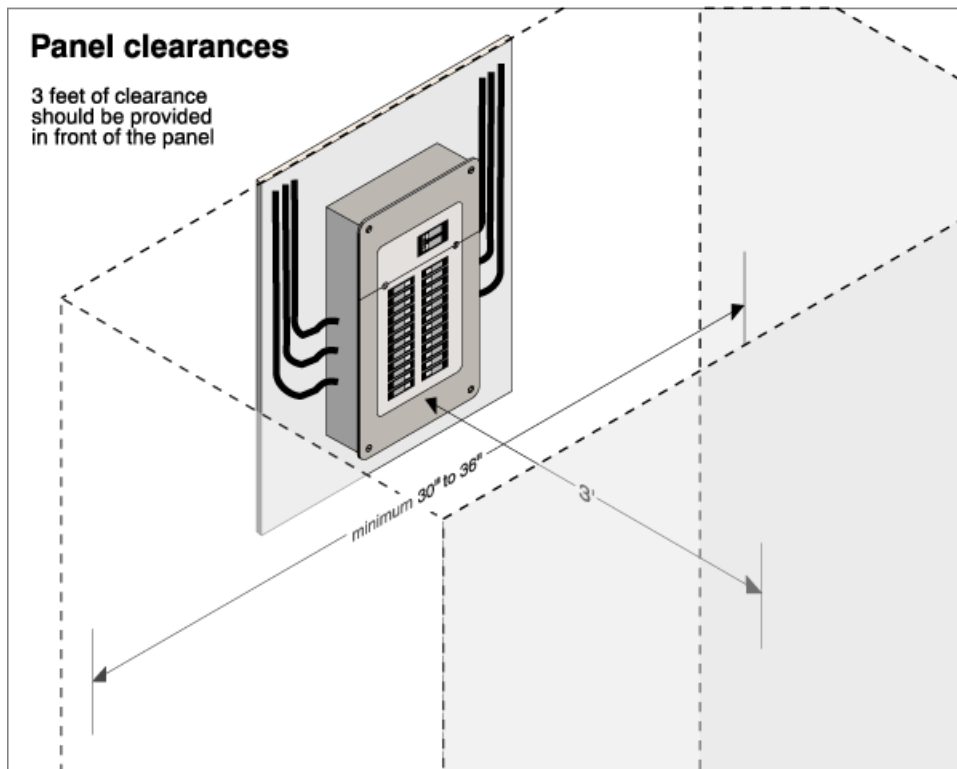
42. **Condition:** • [Box location poor](#)

Implication(s): Difficult access | Difficult to service
