## **Inspection Report**

**Property Address:**  
12 Sussex Ct  
Rancho Mirage CA 92270

**Livingston Home Inspections**

<b>Date:</b> 4/27/2020	<b>Time:</b> 09:30 AM	<b>Report ID:</b> 20200427-12-Sussex-Ct
<b>Property:</b> 12 Sussex Ct Rancho Mirage CA 92270	<b>Customer:</b> Pro-Com Products Inc Johnny Zhu James Park	<b>Real Estate Professional:</b> Joe Chung Compass

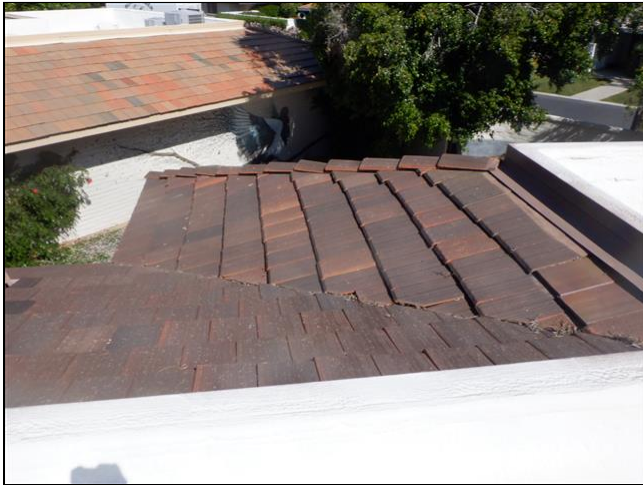
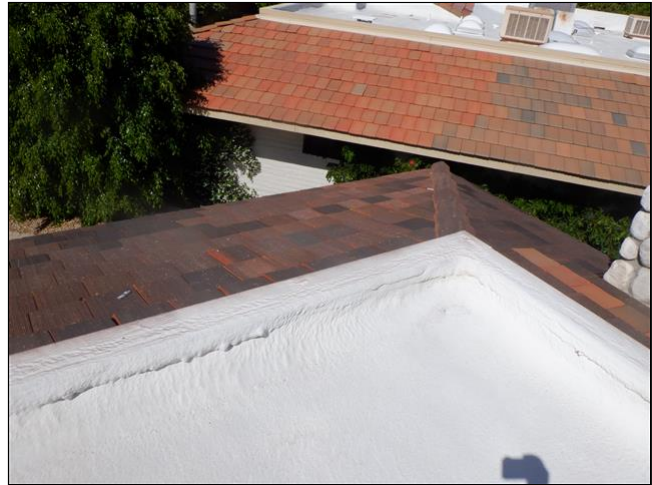
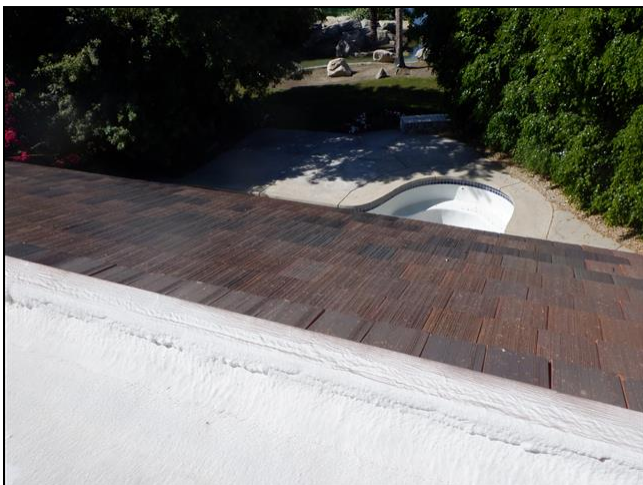
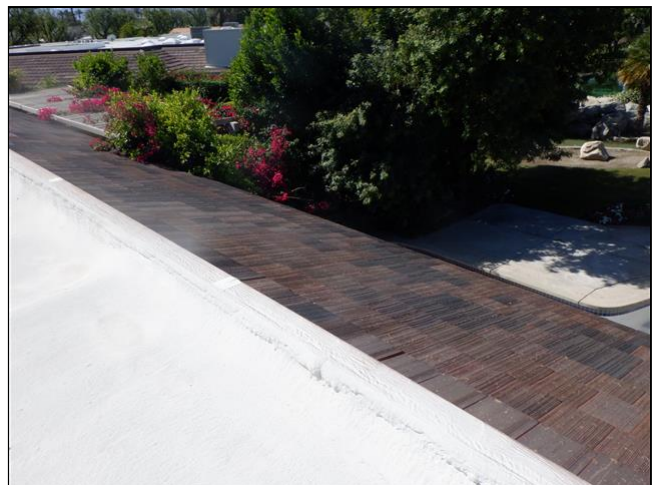
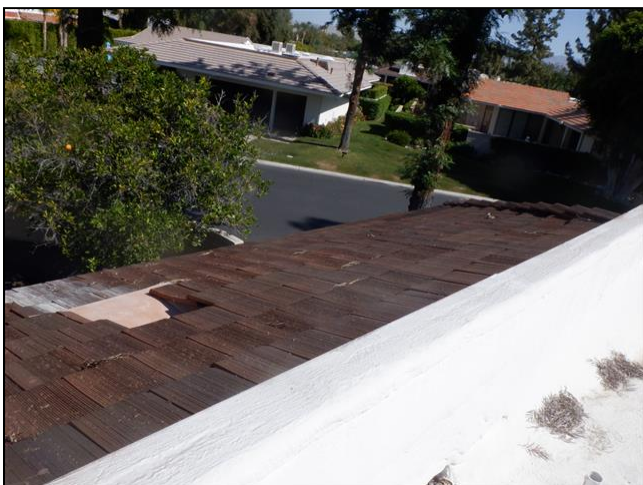
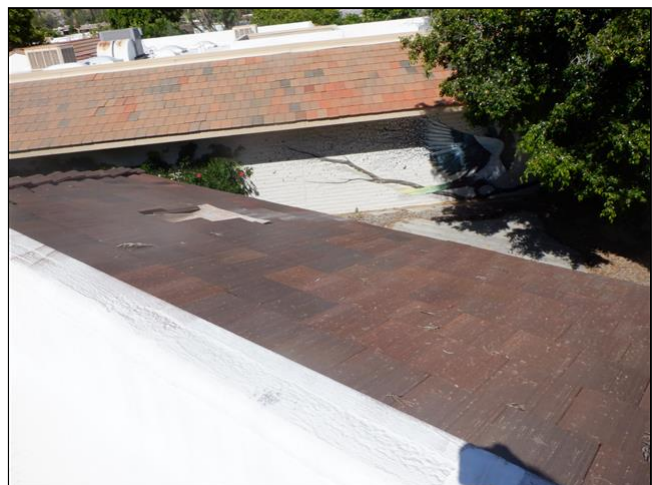
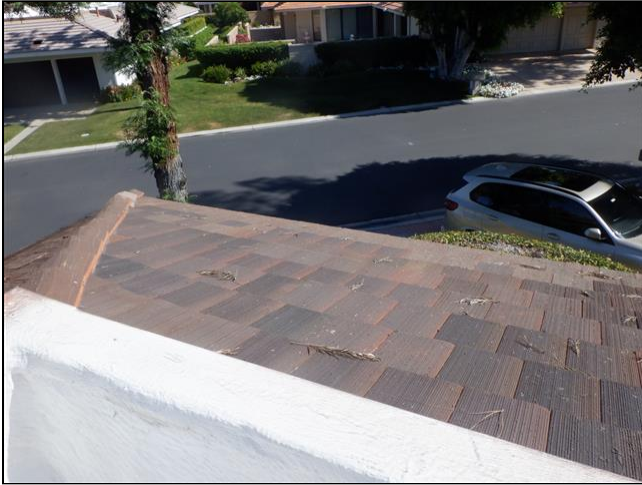
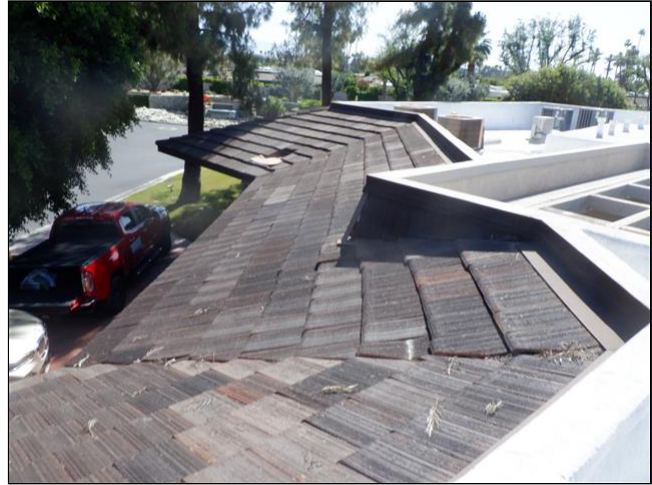
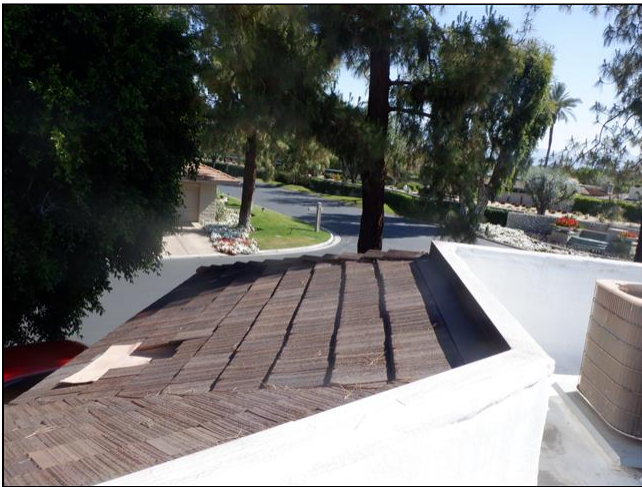
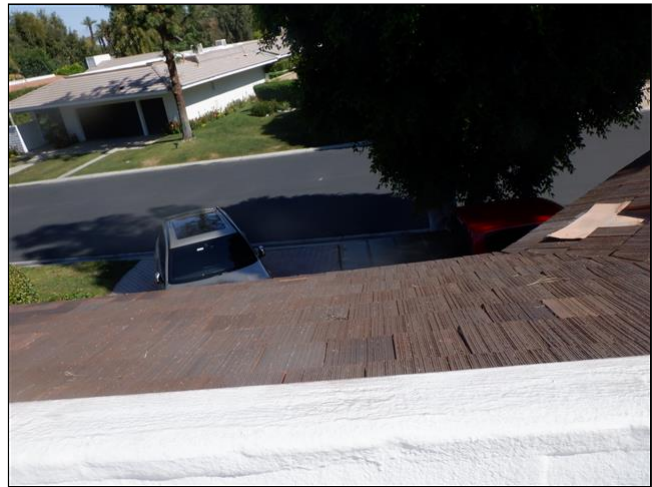
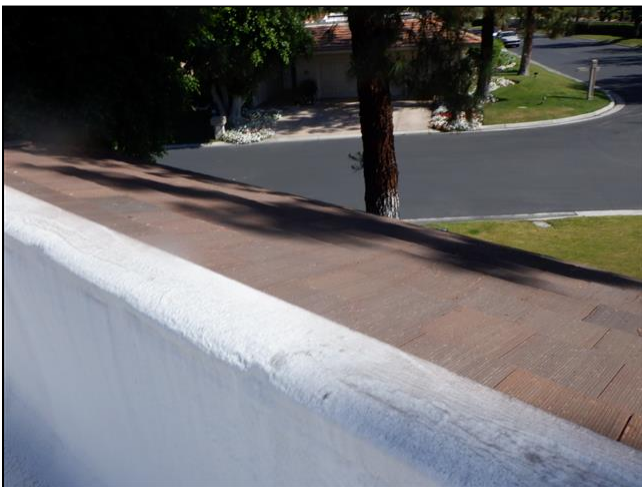
1.0 (1) This roof appeared to be in good condition at the time of inspection. This mansard style roof consist of concrete tiles, no damaged, slipped, cracked, or missing tiles were noted.

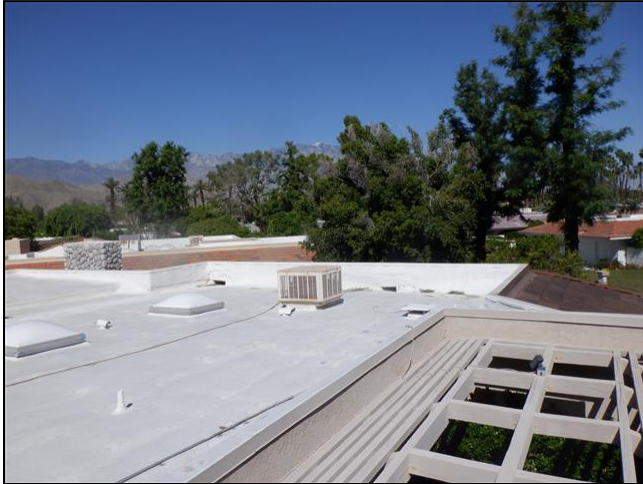
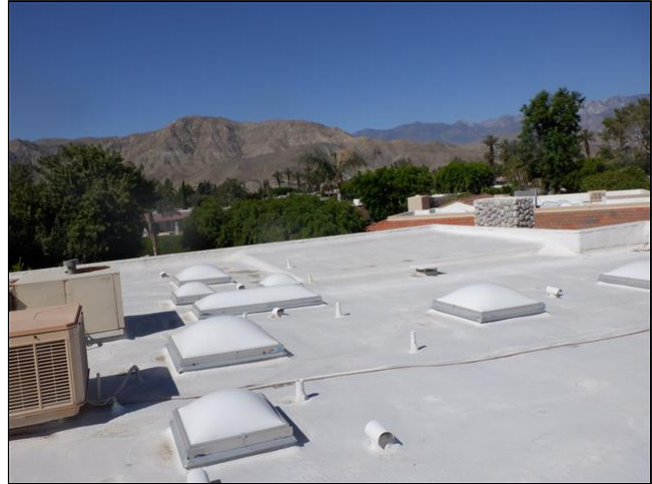
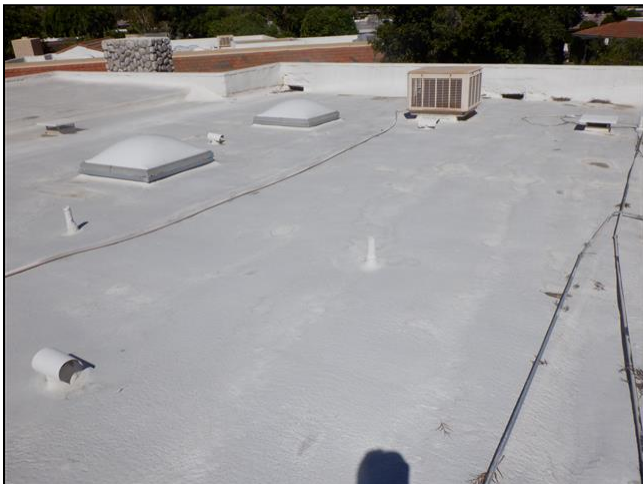
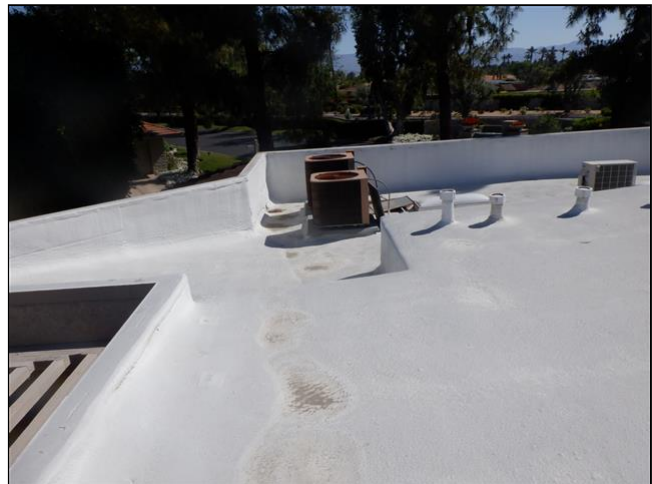
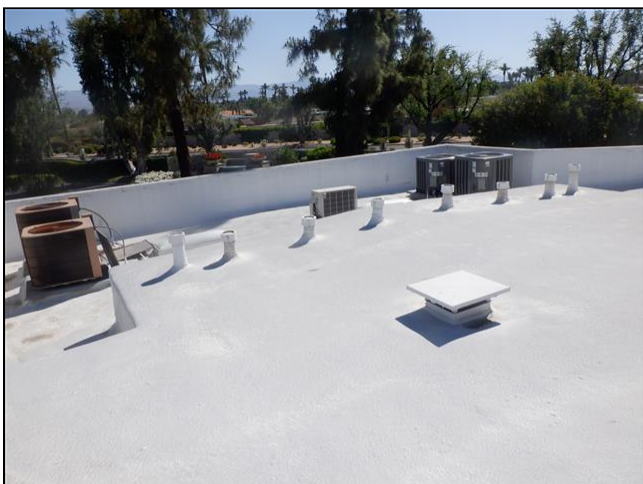
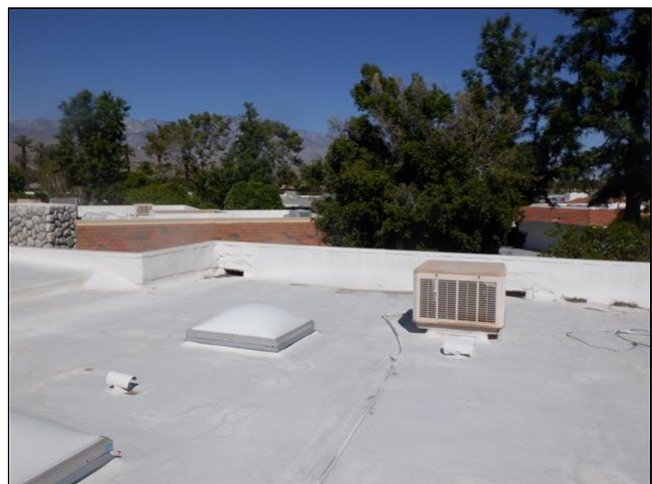
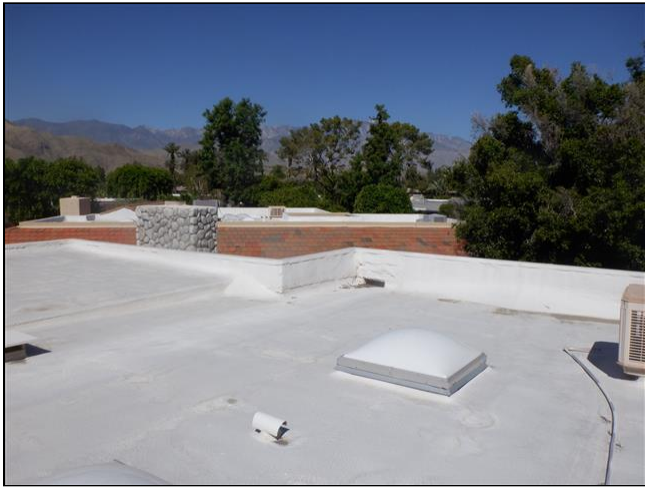
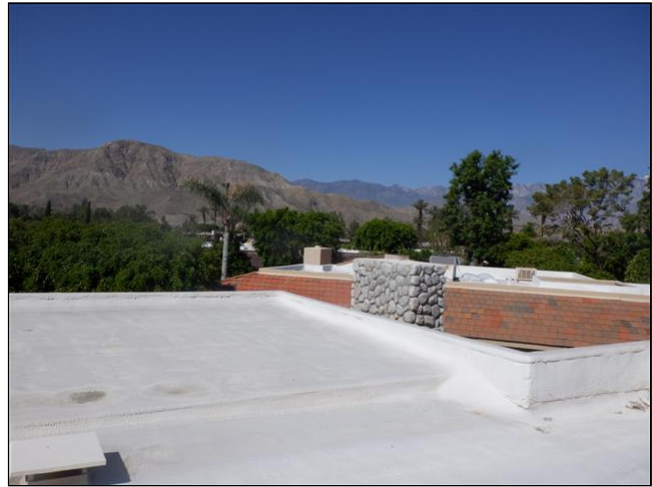
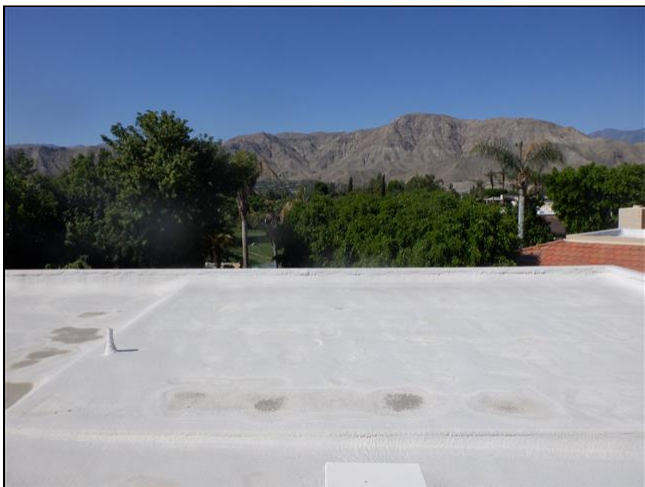
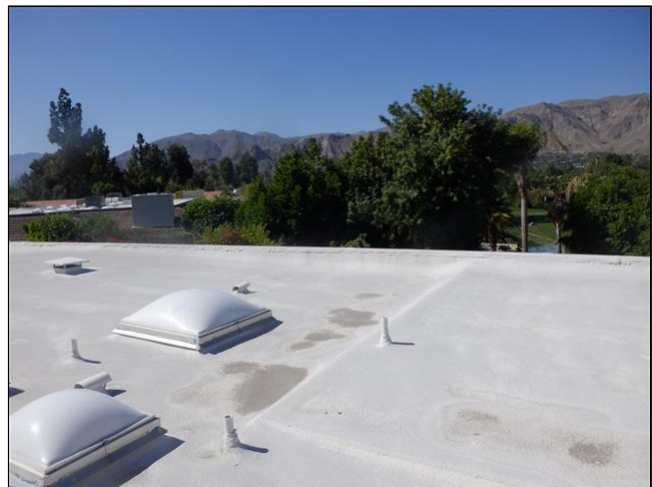
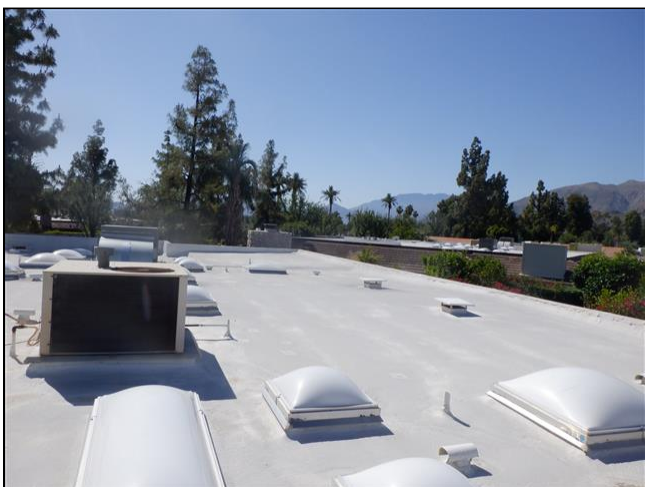
1.0 (2) Low slope and flat roofs are prone to leakage however we did not note any irregularities in this roof at time of inspection. This roof consist of polyurethane foam with a coating. This roof appeared to be in good condition.

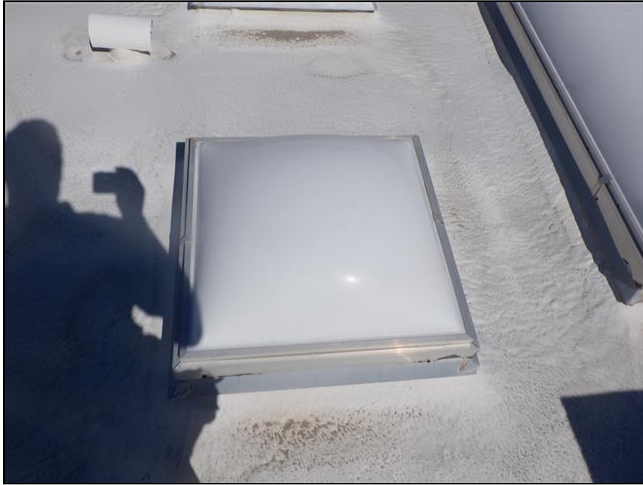
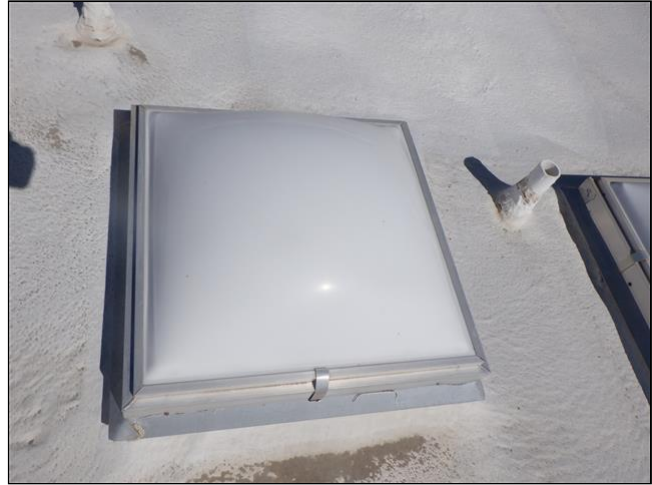
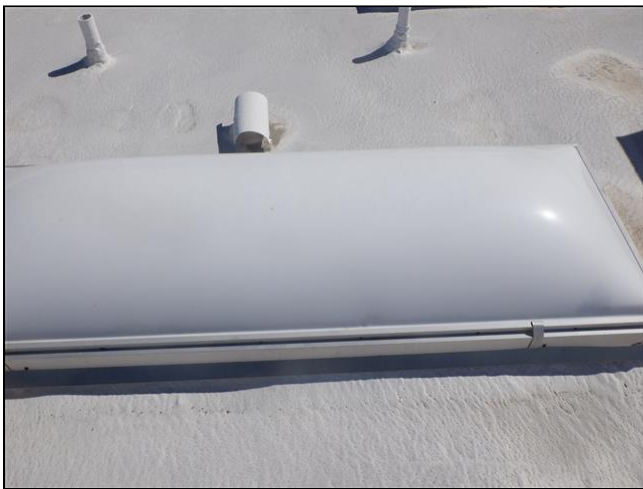
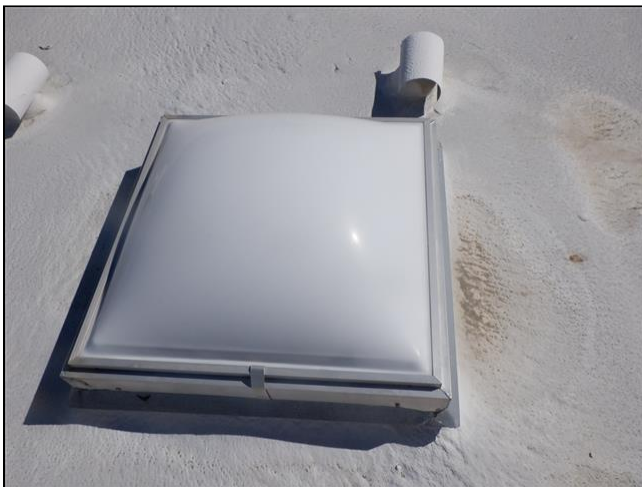
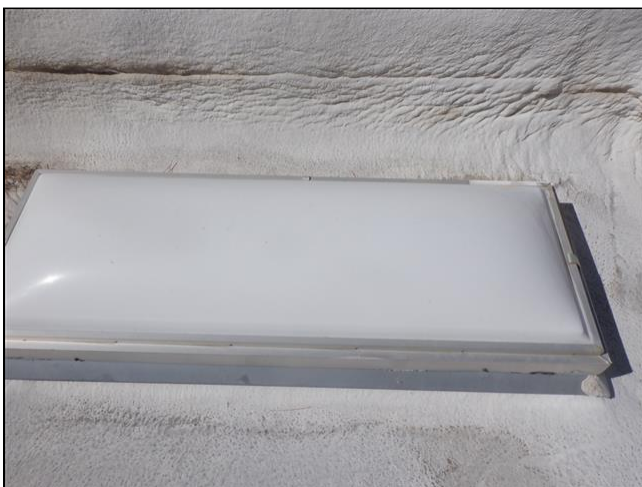
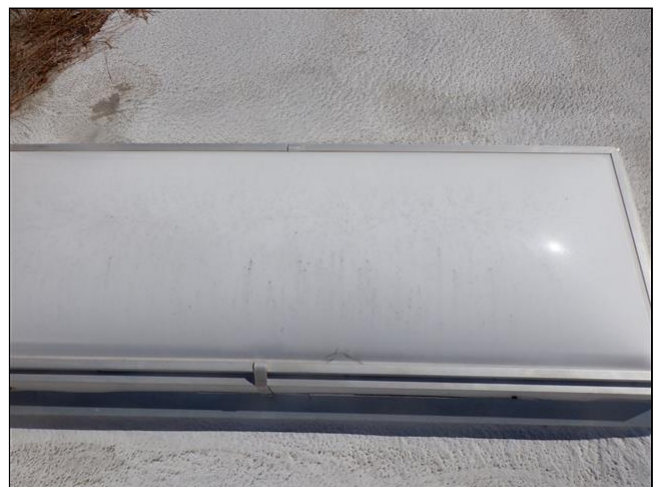
1.2 Item 3(Picture) Skylight 2 Good Condition

1.2 Item 4(Picture) Skylight 3 Good Condition

1.2 Item 5(Picture) Skylight 4 Good Condition

1.2 Item 9(Picture) Skylight 8 Good Condition

1.2 Item 10(Picture) Skylight 9 Good Condition

1.2 Item 11(Picture) Skylight 10 Good Condition

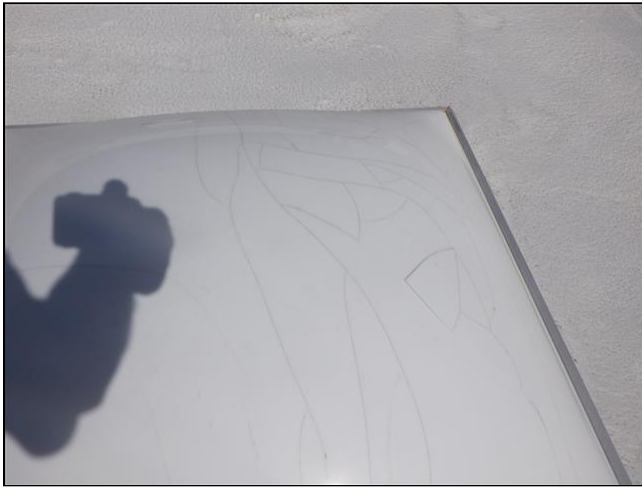
**1.2 (2)** Skylights are prone to leakage. We noted several of these skylights appeared to have cracks in the outer panes, ten skylights total and at least four of those were cracked. Damaged skylights will eventually lead to leakage. Recommend evaluation and replacement by a licensed roofing contractor.

1.2 Item 7(Picture) Skylight 6 Cracked

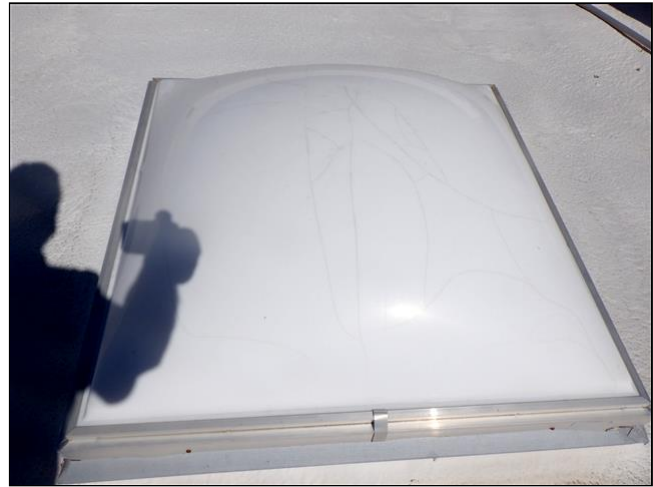
1.2 Item 8(Picture) Skylight 7 Cracked

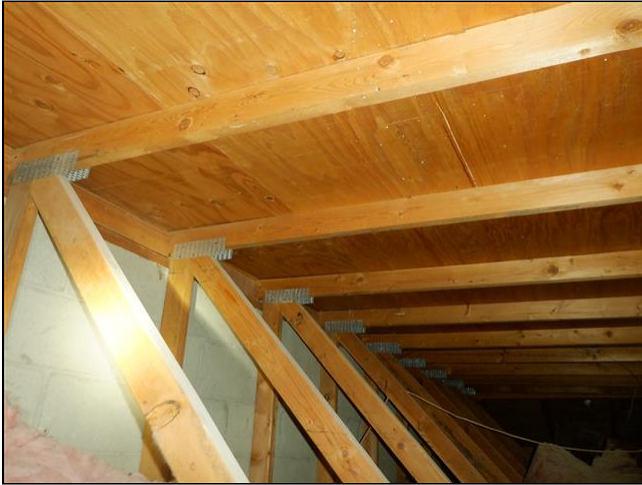
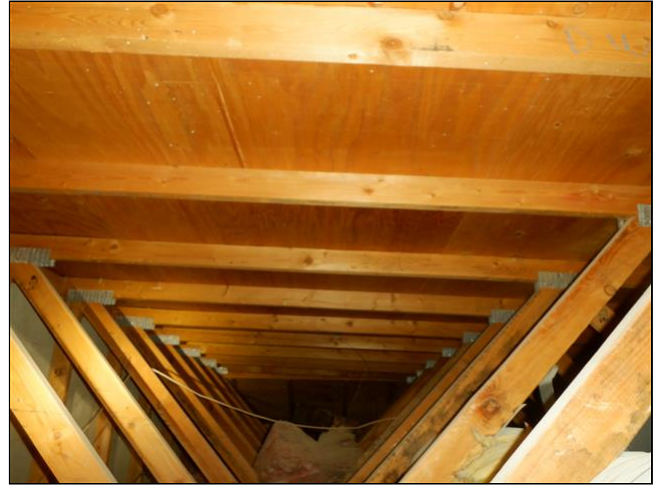
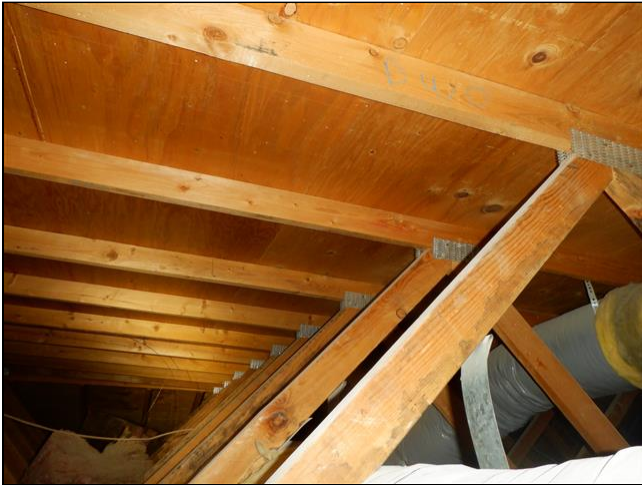
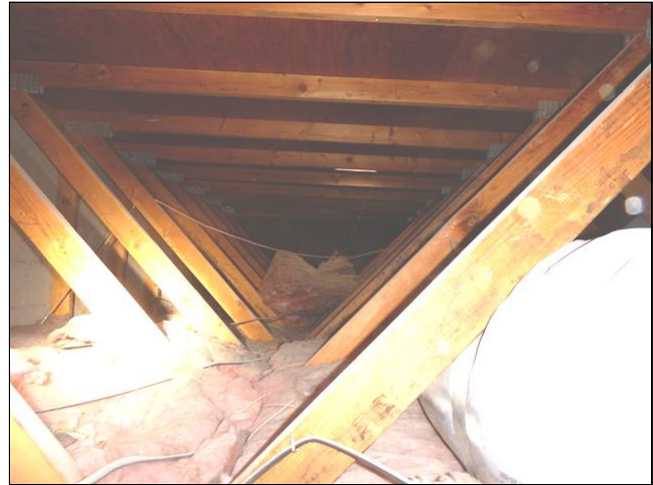
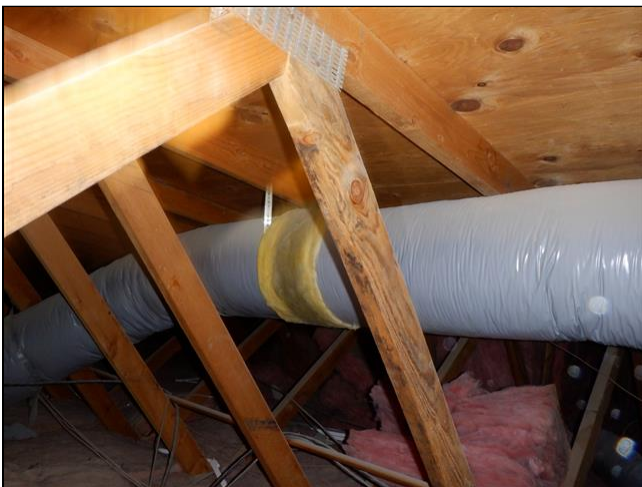
1.5 Visible portions of the roof decking/sheathing had no evidence of leaks or staining at the time of inspection, as well as all of the portions of the ceilings in the house.

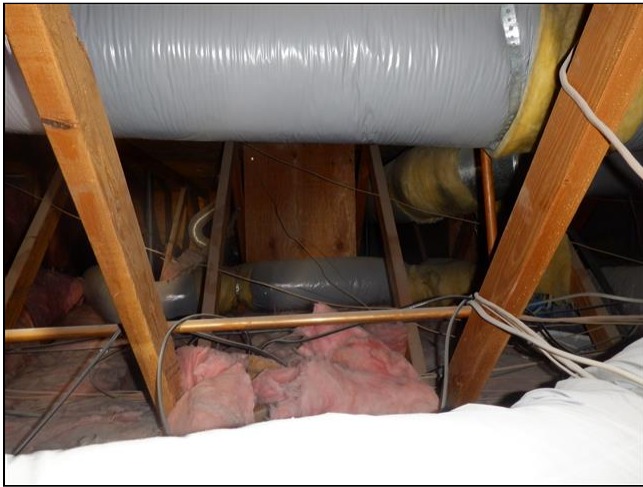
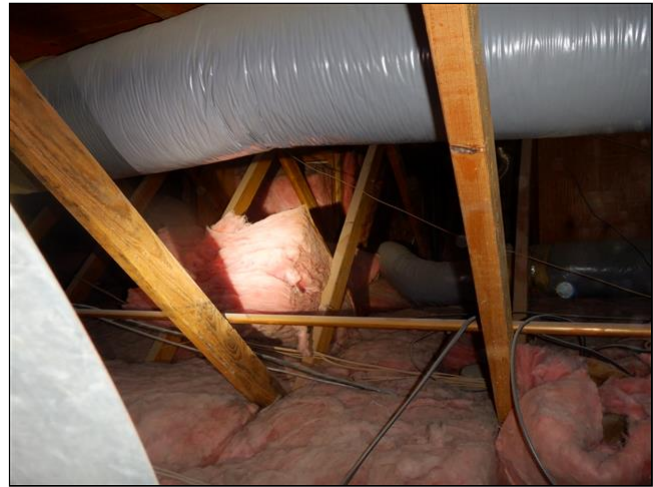
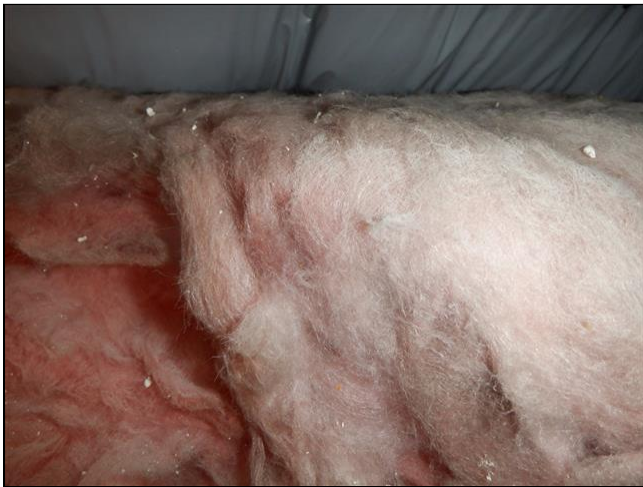
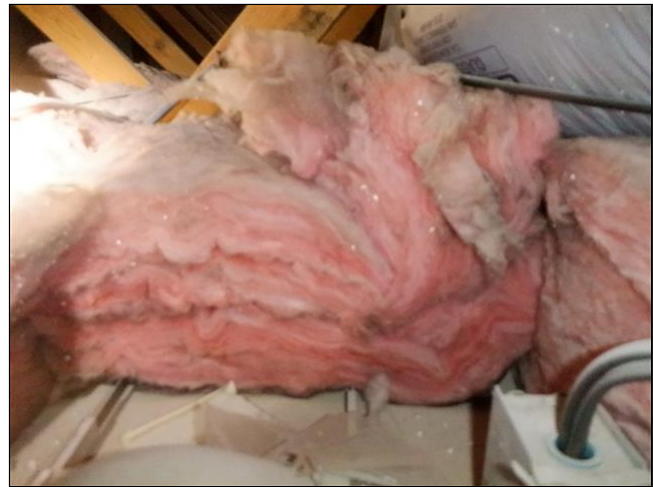
1.6 This attic was insulated with fiberglass batt that was at least 8-10 inches thick.

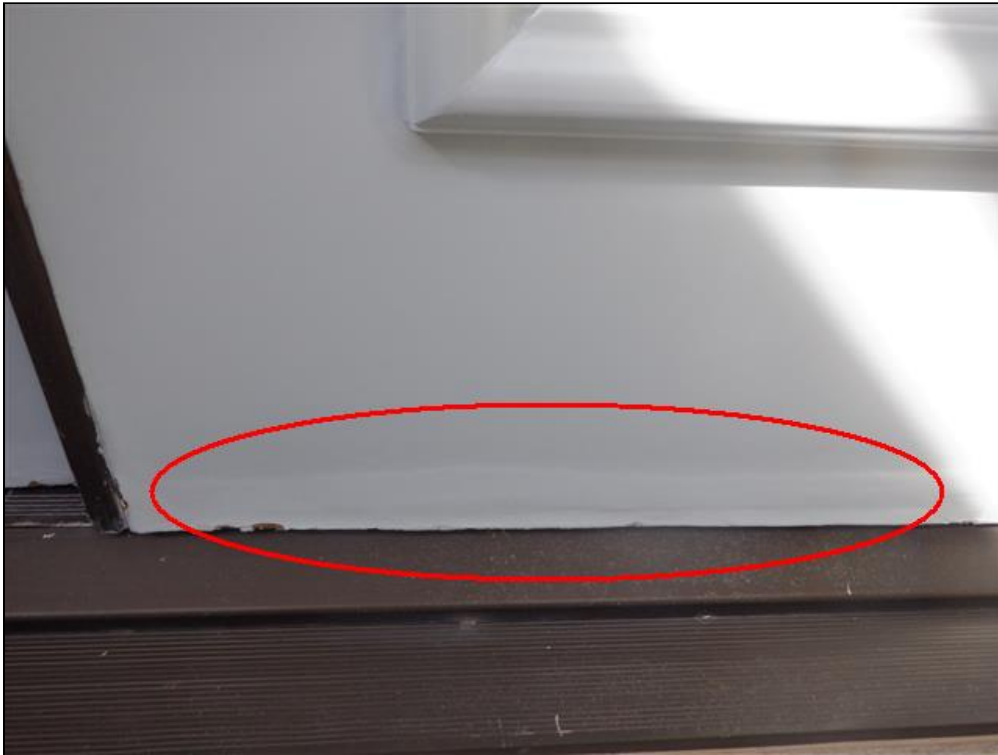
**2.1** We noted that the front door appeared weathered at the bottom. Recommend evaluation by a licensed contractor repair replace as needed.

2.1 Item 2(Picture) Front Doors Weathered

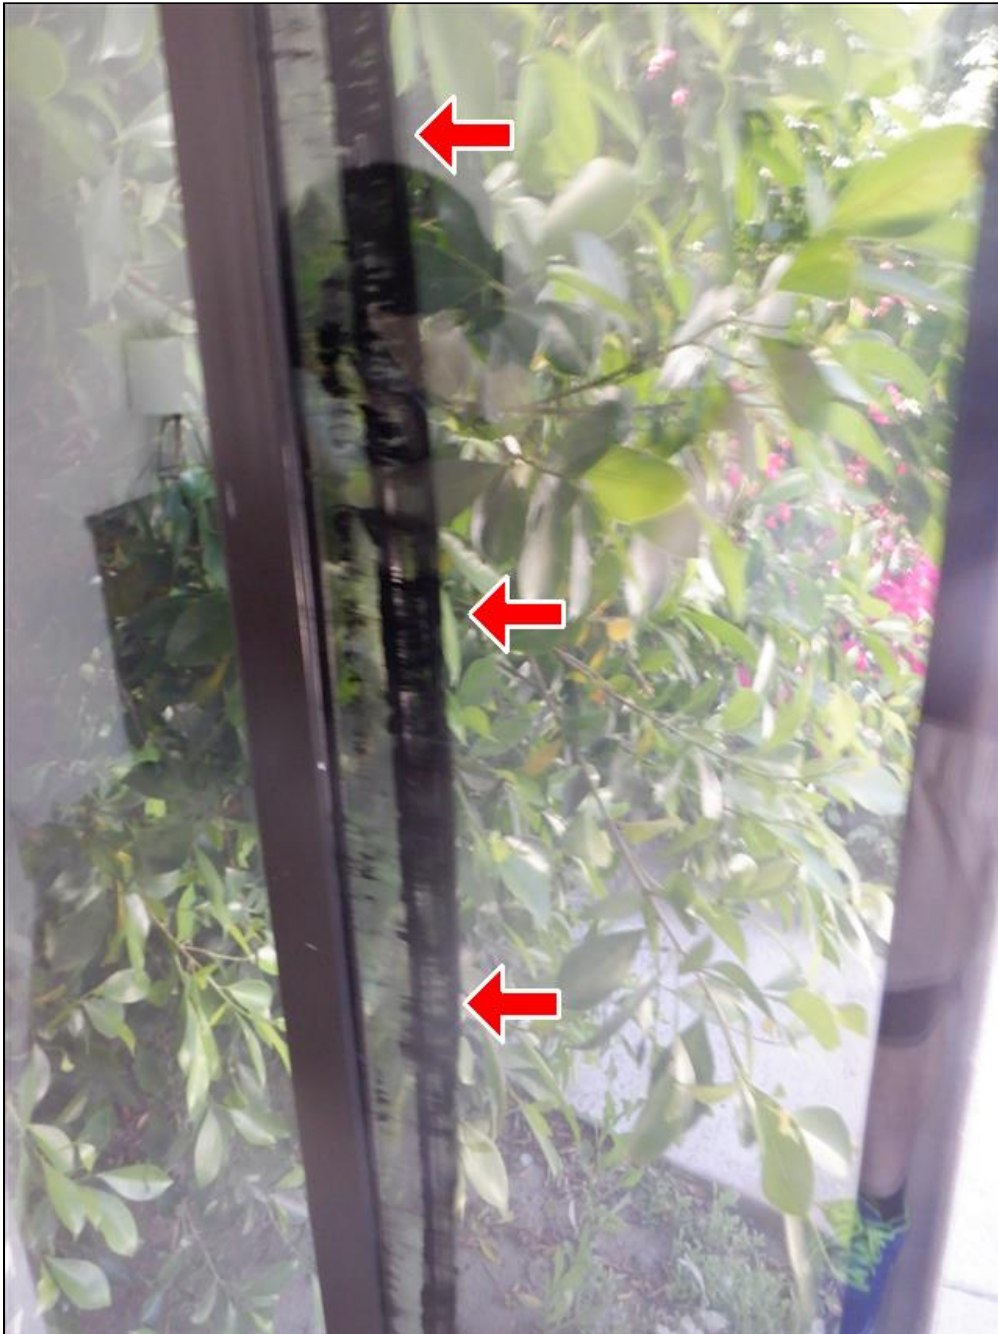
**2.2 (2)** We noted at least one of the sliding glass doors (master bedroom) appeared to have a bad seal, we also noted that at least two of the living room sliding glass doors were either hard to operate or were inoperable and at least one of them failed to lock. Recommend evaluation by a licensed sliding glass door specialist to repair or replace as needed for proper operation.

2.2 Item 2(Picture) Master Bedroom Slider Bad Seal

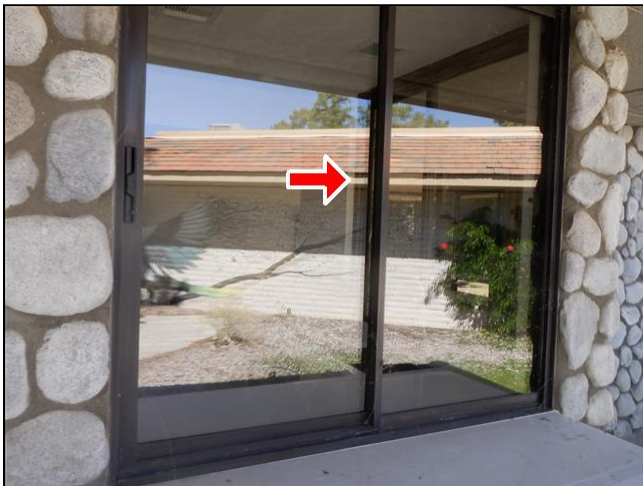
2.2 (3) We noted that at least one of the bar windows was inoperable at time of inspection, this window was stuck shut. Recommend evaluation by a licensed window specialist to repair or replace as needed for proper operation.

2.2 Item 4(Picture) Bar Window Inoperative

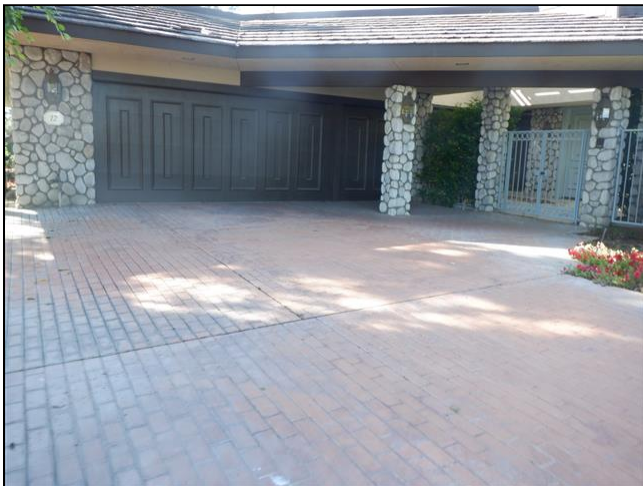
2.4 Item 1(Picture) Driveway

**2.4 (1)** We noted that several of the bricks in the driveway were cracked. These cracks are normal shrinkage cracks for this climate, none of which exceeded 1/8 inch in size. Recommend replace as needed.

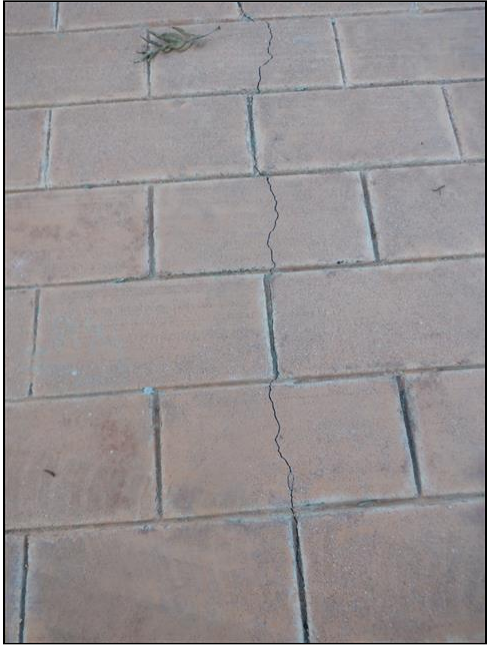
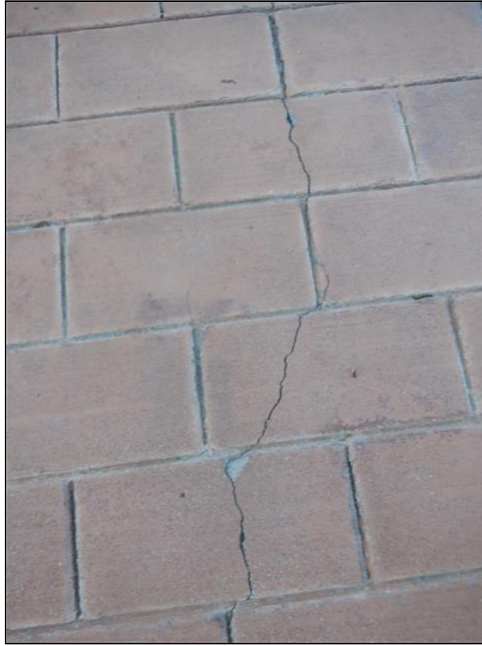
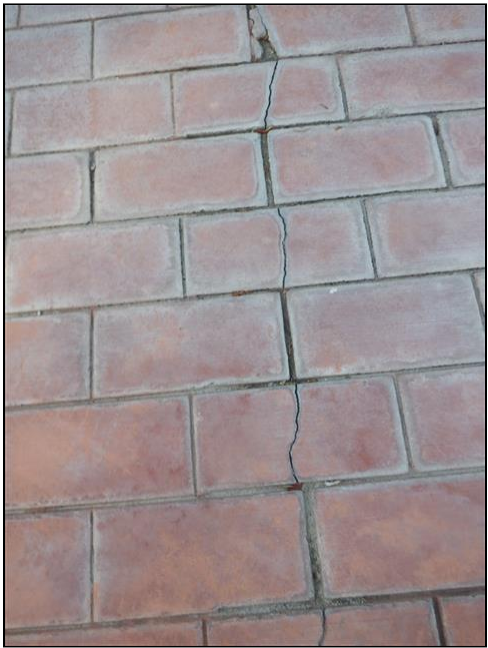
2.4 Item 3(Picture) Driveway Cracked Bricks

2.4 Item 4(Picture) Driveway Cracked Bricks

2.4 Item 5(Picture) Driveway Cracked Bricks

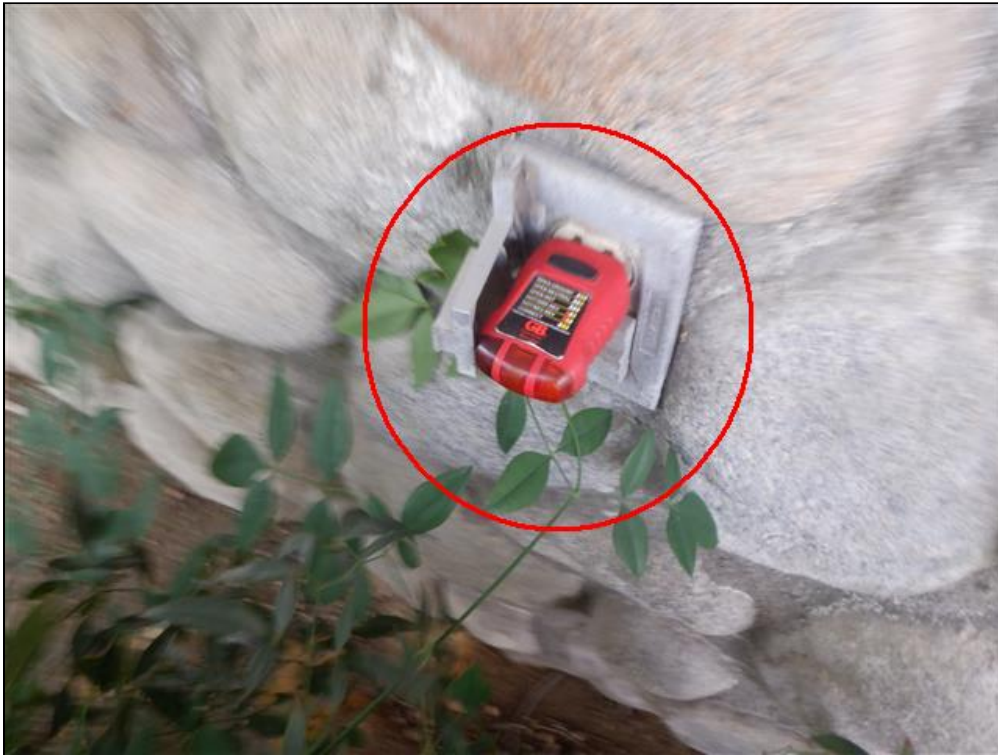
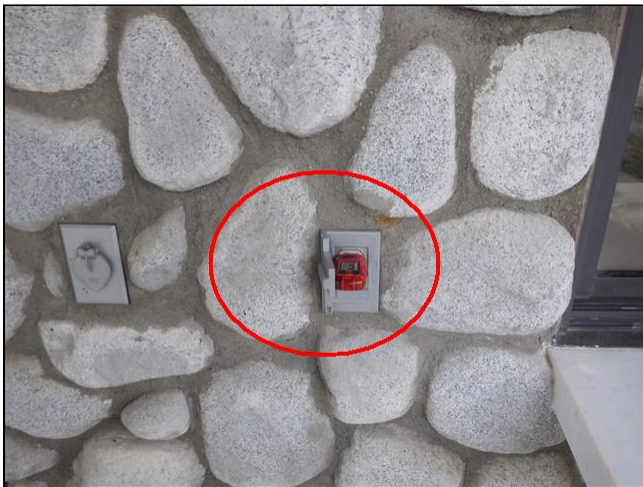
2.7 (2) We noted several exterior outlets that had no power, 2 on the north patio and 1 on the west patio, we also cannot confirm if these outlets are GFCI protected. Recommend evaluation by a licensed electrical contractor to restore power and confirm GFCI protection repair replace as needed.

2.7 Item 4(Picture) North Patio Outlet No Power

2.7 Item 5(Picture) North Patio Outlet No Power

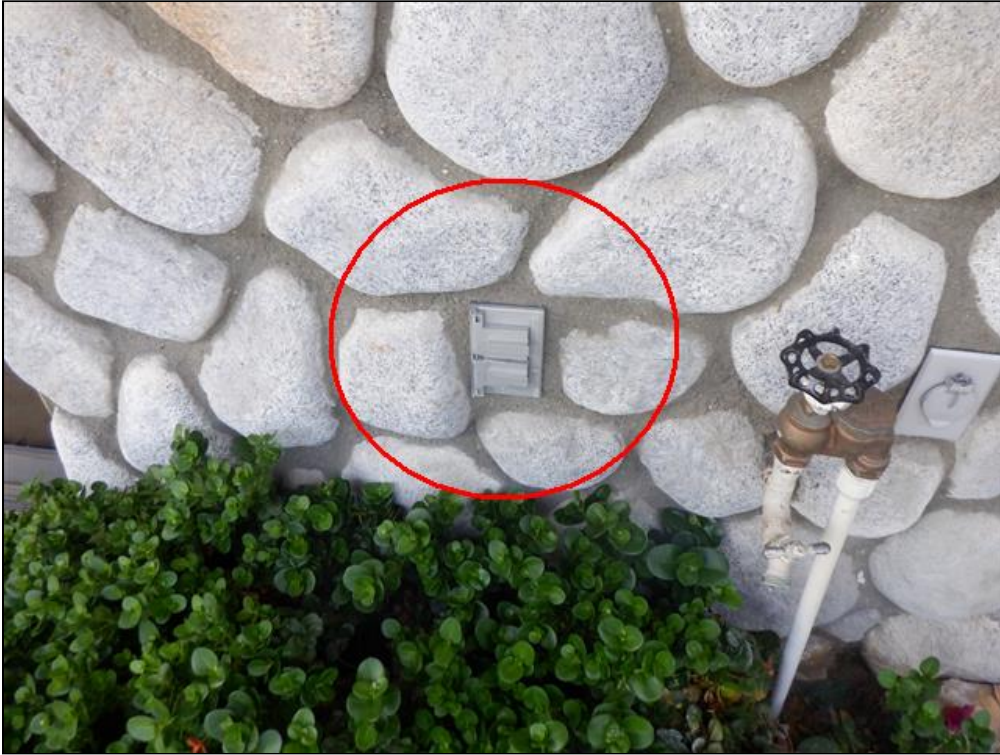
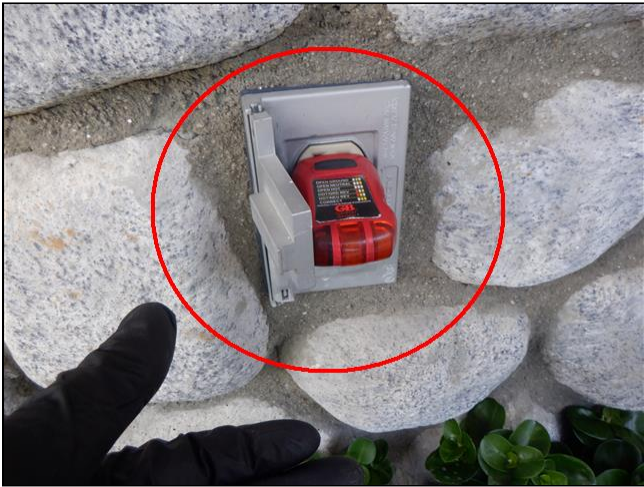
2.7 Item 6(Picture) West Patio Outlet No Power

2.7 Item 7(Picture) West Patio Outlet No Power

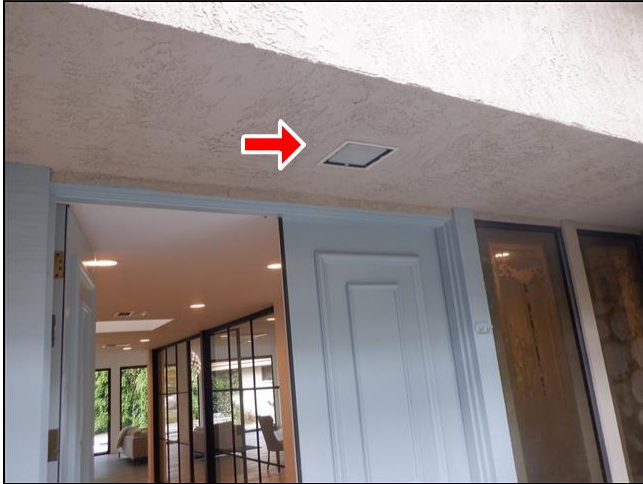
**2.8** We noted several exterior light fixtures that were not functioning. These lights are in the courtyard and back patio. Recommend bulb replacement and further evaluation if needed.

2.8 Item 1(Picture) Courtyard Light Fixture Not Functioning

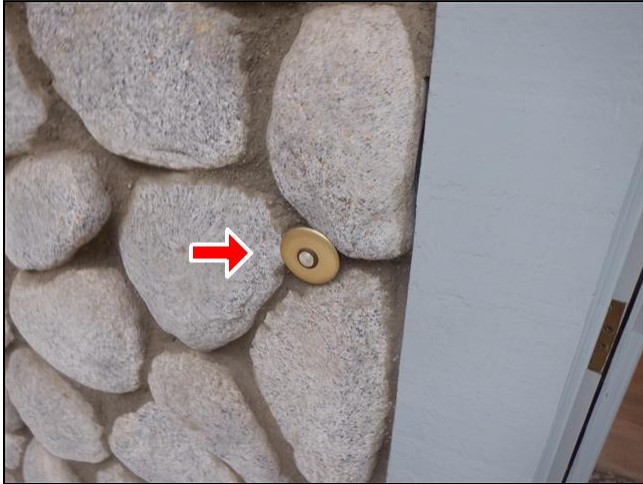
2.9 We noted that the door bells were inoperative at time of inspection. Recommend evaluation/repair/replace as needed.

2.9 Item 1(Picture) Door Bell Not Functioning

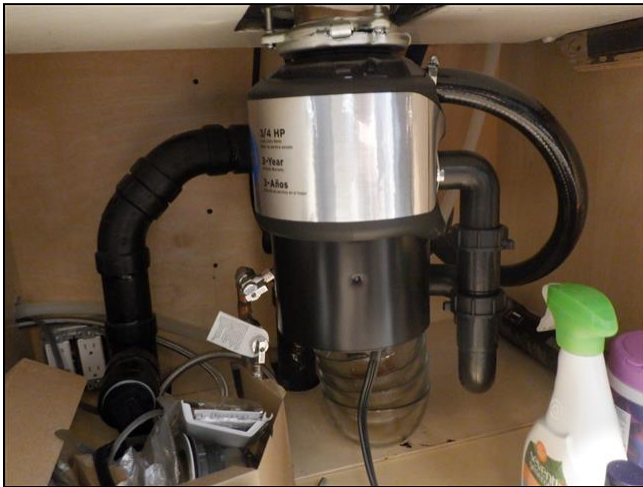
4.11 Although functioning when plugged in we noted that this food waist disposer has no activation switch or button, it appears that one was never installed. Recommend evaluation by a licensed contractor to install and activation switch for proper operation of this unit.

4.11 Item 1(Picture) Disposer No Activation Switch

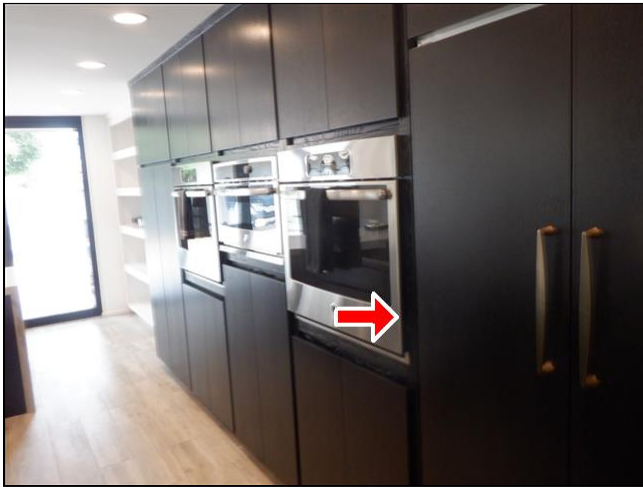
4.17 Item 1(Picture) Refrigerator

**4.17** Although this refrigerator appeared to be functioning properly we noted that it was not producing ice. We noted that the ice maker was on. Recommend evaluation and confirmation of proper operation of ice maker repair replace as needed by a licensed appliance contractor.

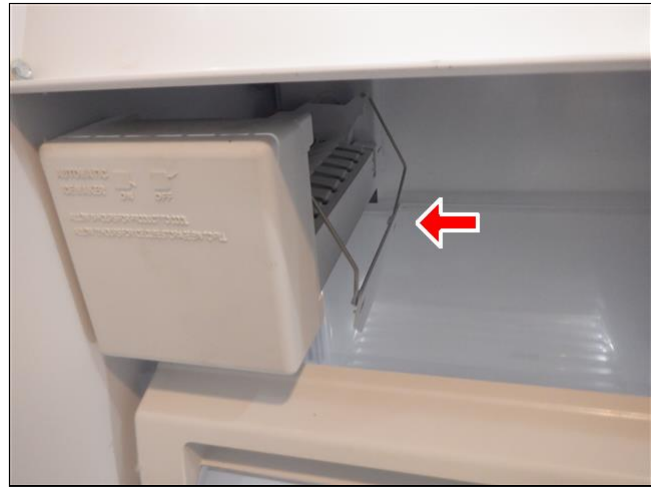
4.17 Item 2(Picture) Refrigerator Ice Maker On

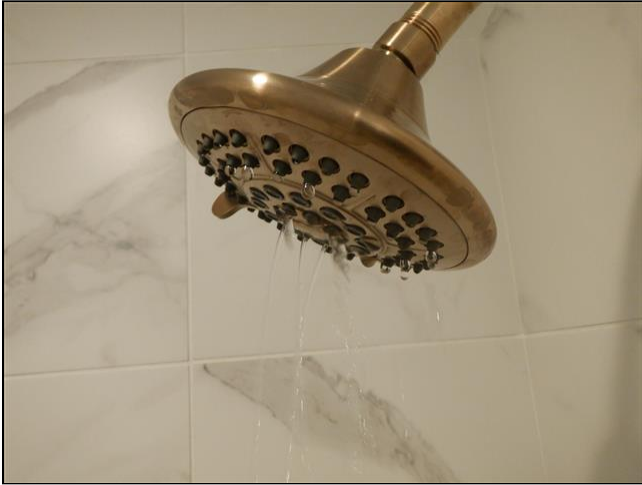
**6.4.B** We noted that the water supply to the shower head was low. This issue is isolated to this shower fixture only and its possible that the aerator is clogged. Recommend cleaning of aerator and further evaluation as needed by a licensed plumbing contractor.

6.4.B Item 2(Picture) Shower Head Low Flow

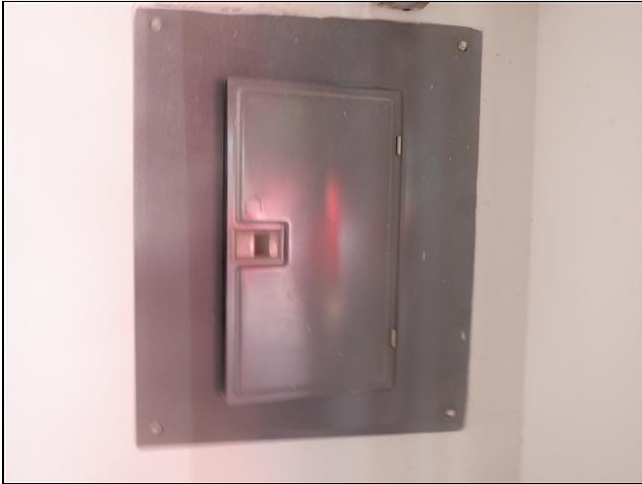
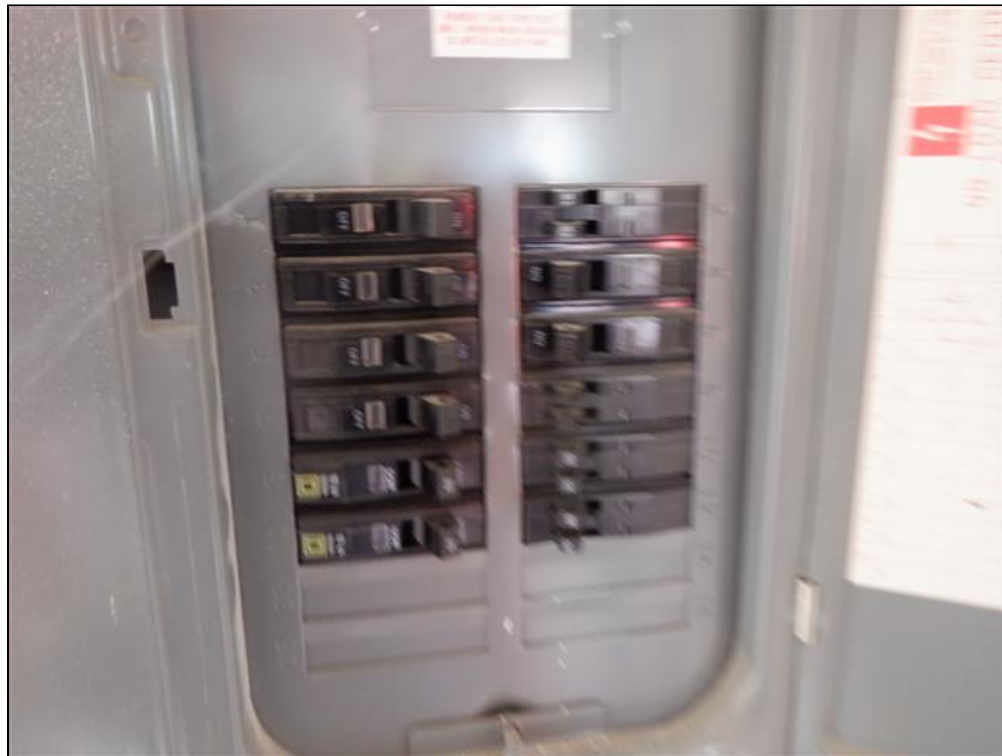
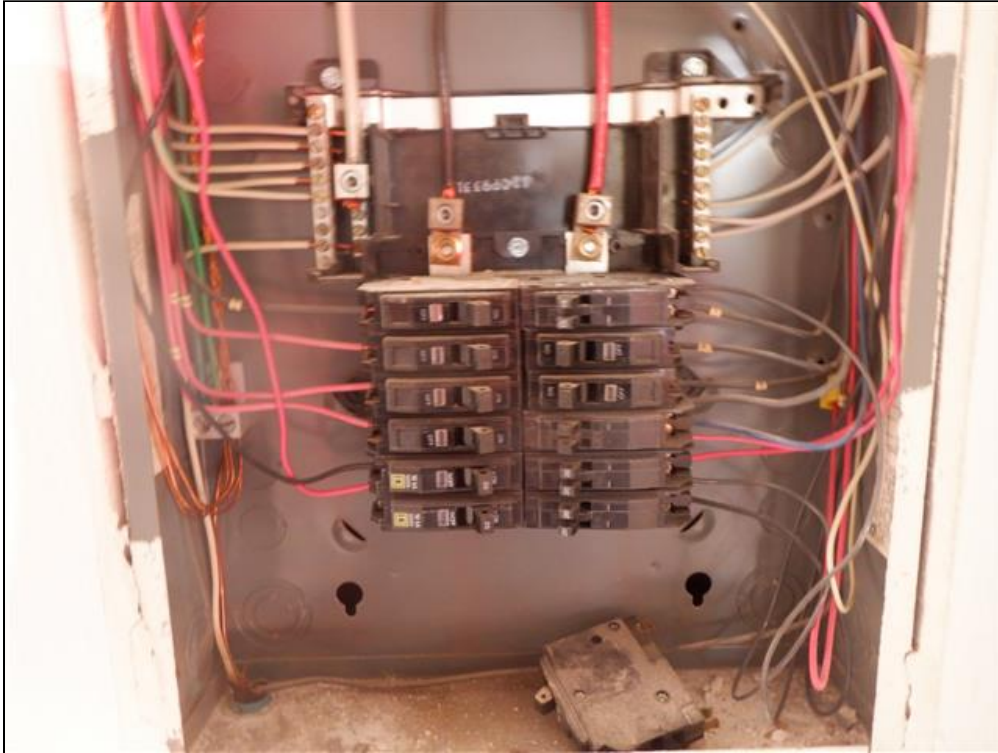
**9.1 (2)** The electrical sub panel is located in the garage it has a 60 amp main breaker that's located in the main panel. Although we did not find any irregularities in this panel, we noted that not all the circuit breakers were clearly labeled. Recommend evaluation and labeling of all circuits for proper identification and ease of use by a licensed electrician.

9.1 Item 6(Picture) Electrical Sub Panel

9.1 Item 8(Picture) Electrical Sub Panel Distribution

9.1 Item 9(Picture) Electrical Sub Panel Breakers/Conductors
