## **Inspection Report**

**Property Address:**  
12 Sussex Ct  
Rancho Mirage CA 92270

**Livingston Home Inspections**

<b>Date:</b> 4/27/2020	<b>Time:</b> 09:30 AM	<b>Report ID:</b> 20200427-12-Sussex-Ct
<b>Property:</b> 12 Sussex Ct Rancho Mirage CA 92270	<b>Customer:</b> Pro-Com Products Inc Johnny Zhu James Park	<b>Real Estate Professional:</b> Joe Chung Compass

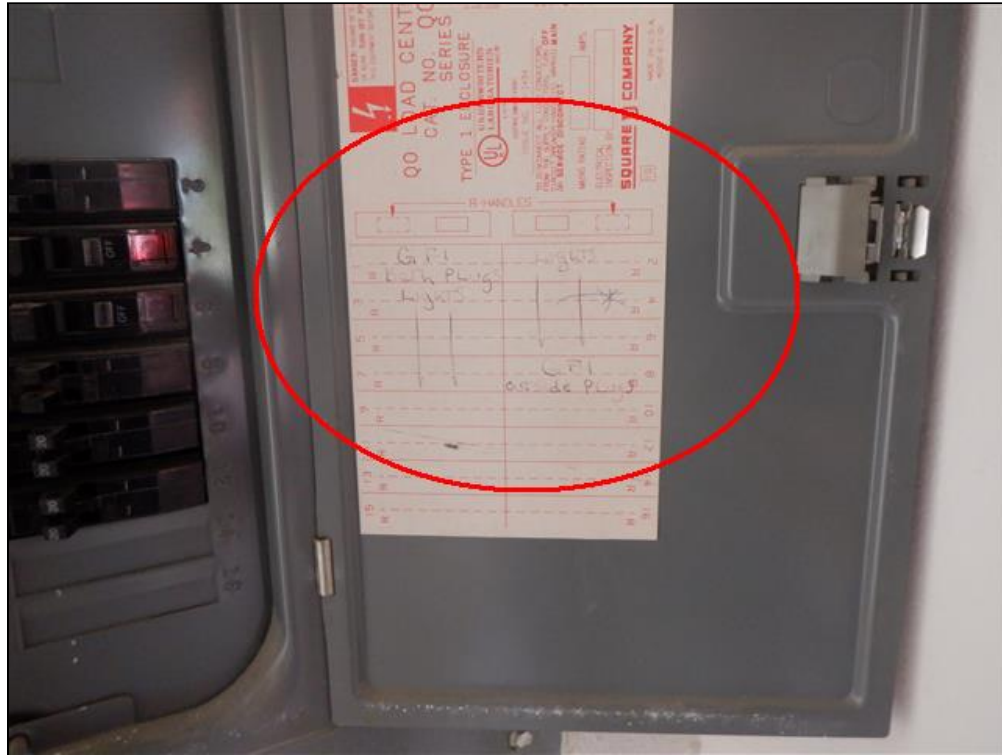
**9.1 (2)** The electrical sub panel is located in the garage it has a 60 amp main breaker that's located in the main panel. Although we did not find any irregularities in this panel, we noted that not all the circuit breakers were clearly labeled. Recommend evaluation and labeling of all circuits for proper identification and ease of use by a licensed electrician.

9.1 Item 7(Picture) Electrical Sub Panel Breakers Not Clearly Labeled

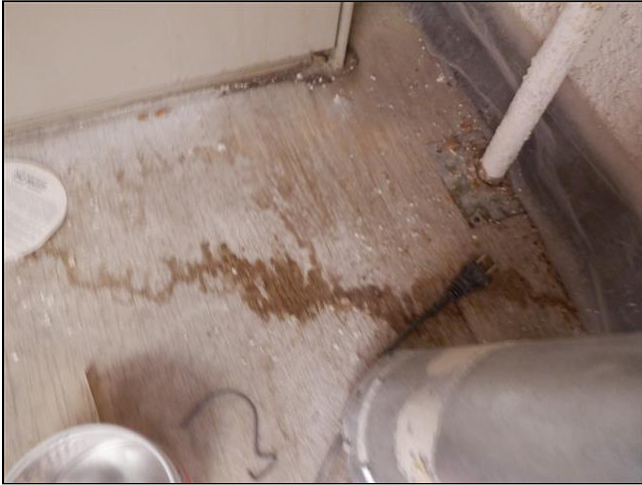
10.3.A Item 2(Picture) Moisture Stains Furnace Landing

**10.3.A** We noted moisture staining on the furnace landing around both of the heating units. We believe that these units have been leaking condensate. Recommend evaluation and servicing by a licensed HVAC contractor to confirm that condensate lines are clear of debris and draining properly.

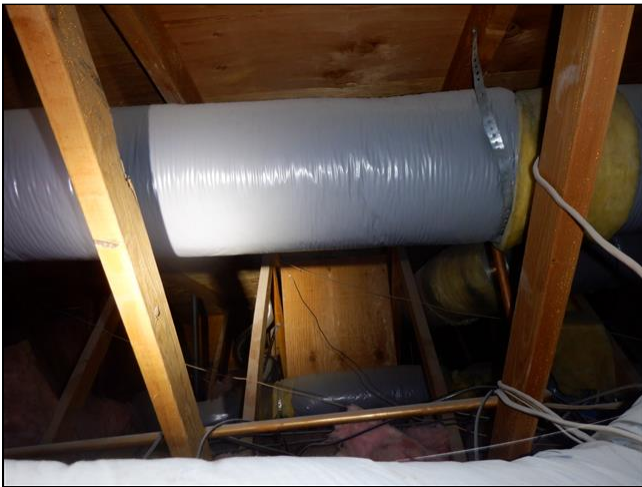
10.4.A Item 1(Picture) HVAC Ducting

**10.4.A** Although the HVAC ducting in this home was providing air to the registers we believe that this ducting material is older. These ducts should be tested and evaluated by a licensed HVAC contractor for integrity. Recommend evaluation and testing of ducts by a licensed HVAC contractor repair if needed.

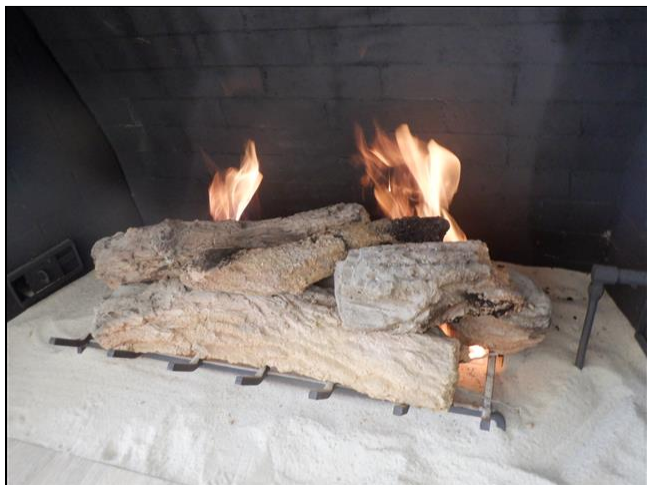
10.7.A Item 1(Picture) Fireplace

**10.7.A** Level 2 fireplace inspection is required upon the sale or transfer of a property or after an operation malfunction or external event that is likely to have caused damage to the chimney. Building fires, chimney fires, seismic events as well as weather events are all indicators that this level of inspection is warranted. There are no specialty tools (i.e. demolition equipment) required to open doors, panels or coverings in performing a Level 2 inspection. A Level 2 inspection shall also include a visual inspection by video scanning or other means in order to examine the internal surfaces and joints of all flue liners incorporated within the chimney. No removal or destruction of permanently attached portions of the chimney or building structure or finish shall be required by a Level 2 inspection. We highly recommend a level 2 fireplace inspection by a licensed fireplace specialist. Call all seasons Fireplaces at 760.365.6668 Rick Newsom.

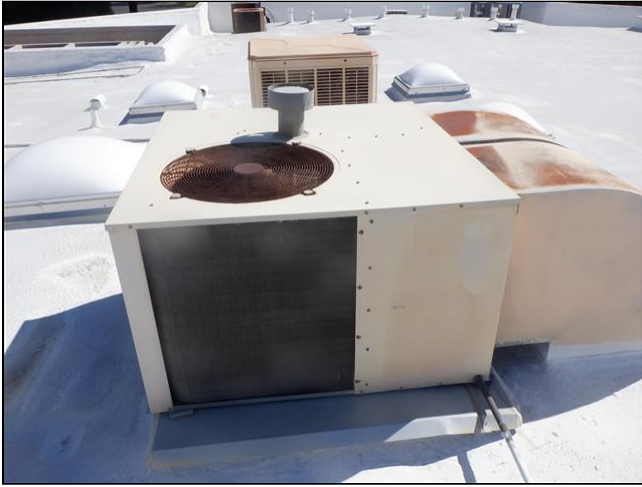
**10.0.B** This unit is called a packaged unit (gas pac) it provides hot and cold air, this unit is extremely old at 36 years and although this unit was producing cold and hot air we do not believe that it was operating at peak performance. Recommend evaluation and servicing by a licensed HVAC contractor. FYI the refrigerant in this unit is R-22. This refrigerant will be phased out in a few years

10.0.B Item 1(Picture) Heating Unit 1 Flex Fuel Line

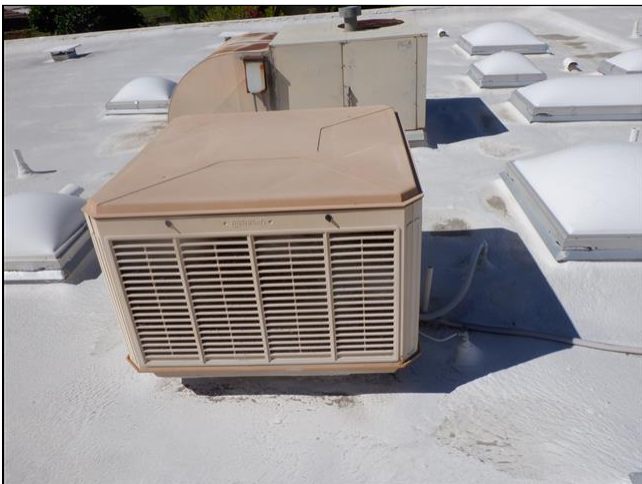
**10.4.B** We noted 2 evaporative coolers on the roof of this home. We also noted that there are no controls on the interior of this home for these units. We believe that these units have been abandon. Recommend removal of units.

10.4.B Item 1(Picture) Evaporative Cooler 1

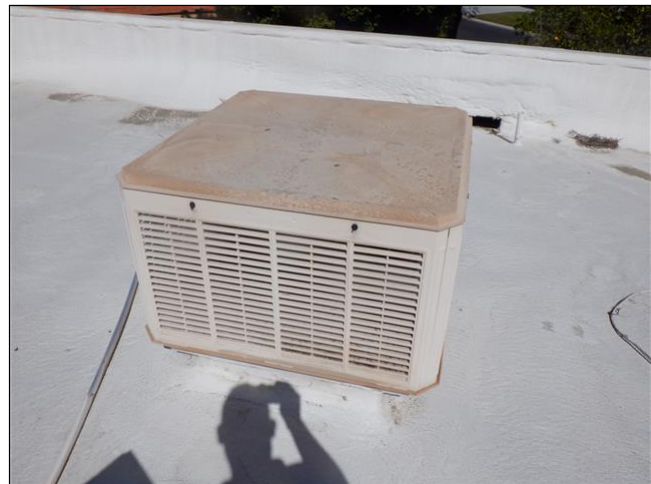
10.4.B Item 2(Picture) Evaporative Cooler 2

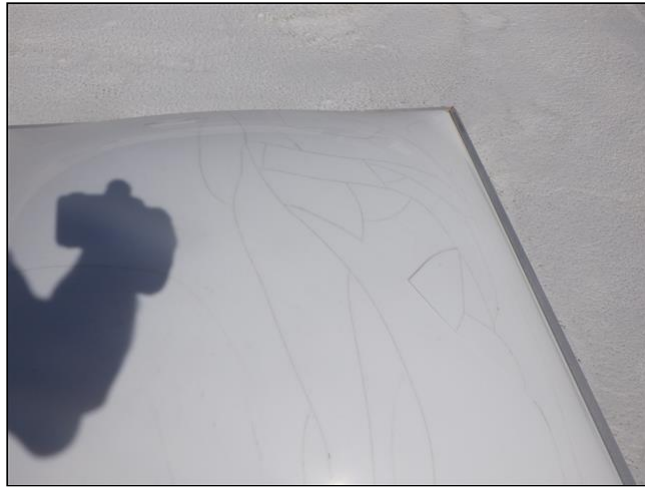
(2) Skylights are prone to leakage. We noted several of these skylights appeared to have cracks in the outer panes, ten skylights total and at least four of those were cracked. Damaged skylights will eventually lead to leakage. Recommend evaluation and replacement by a licensed roofing contractor.

1.2 Item 7(Picture) Skylight 6 Cracked

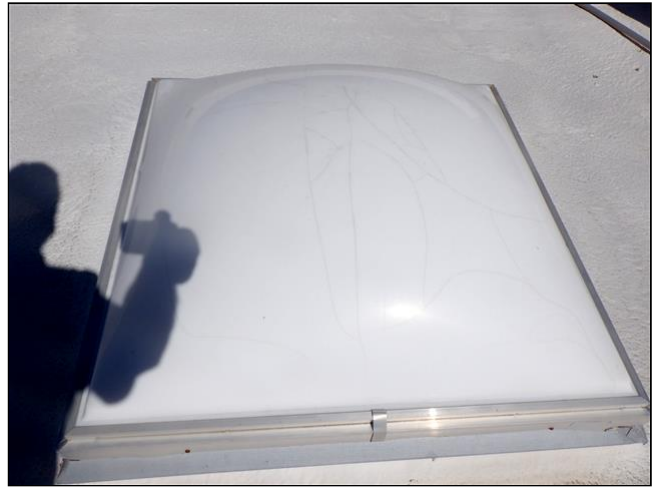
1.2 Item 8(Picture) Skylight 7 Cracked

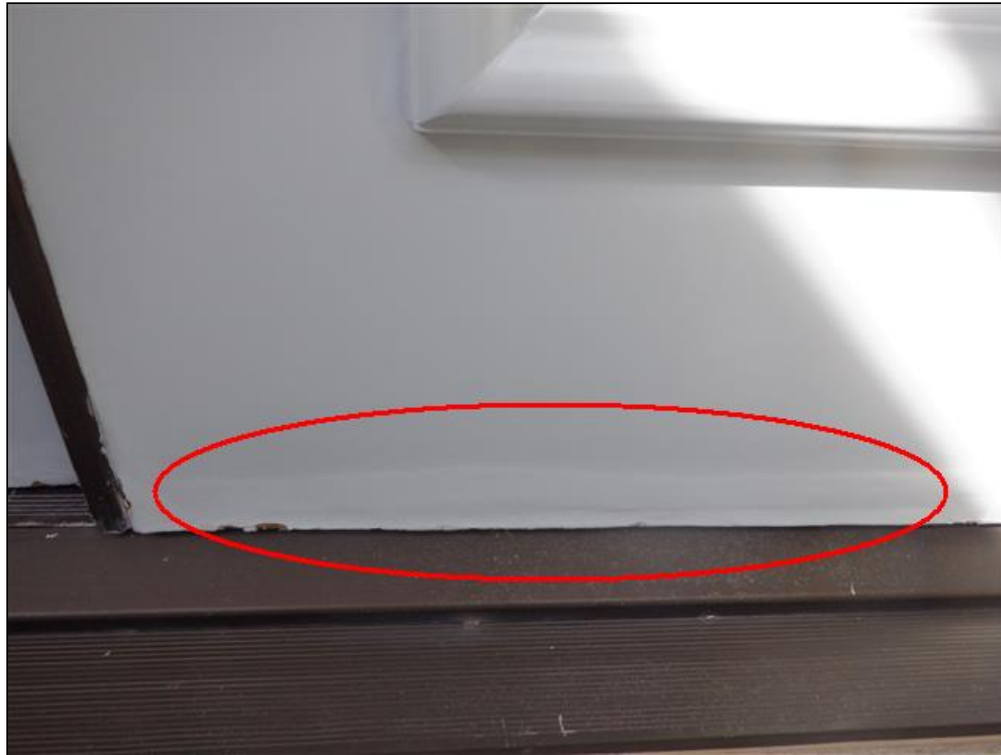
We noted that the front door appeared weathered at the bottom. Recommend evaluation by a licensed contractor repair replace as needed.

2.1 Item 2(Picture) Front Doors Weathered

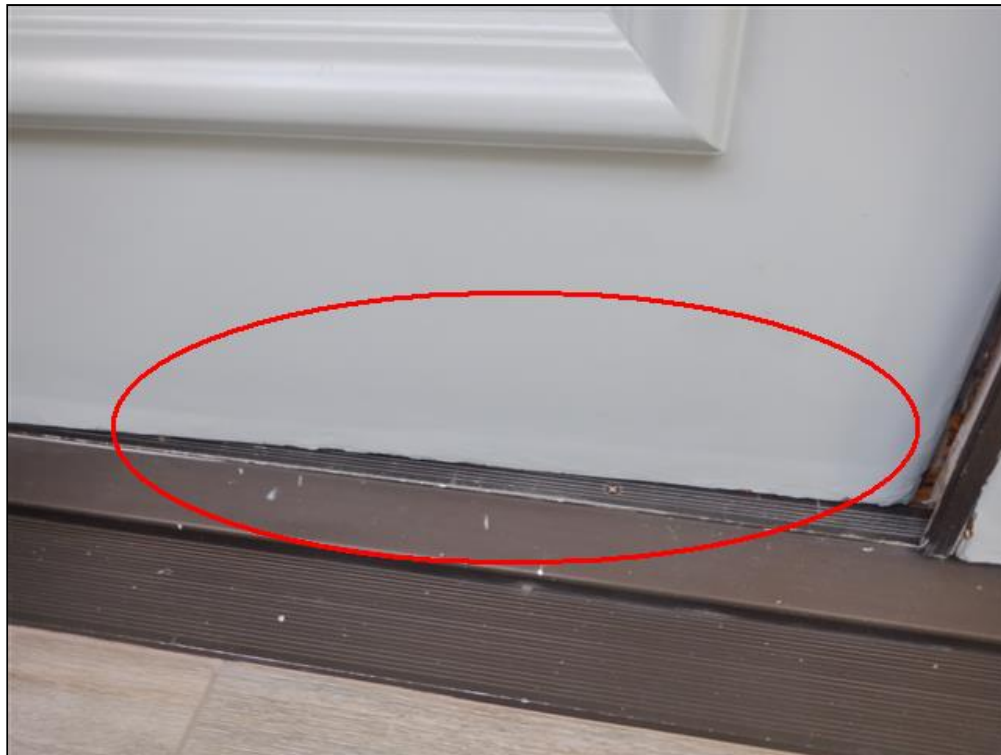
2.1 Item 3(Picture) Front Doors Weathered

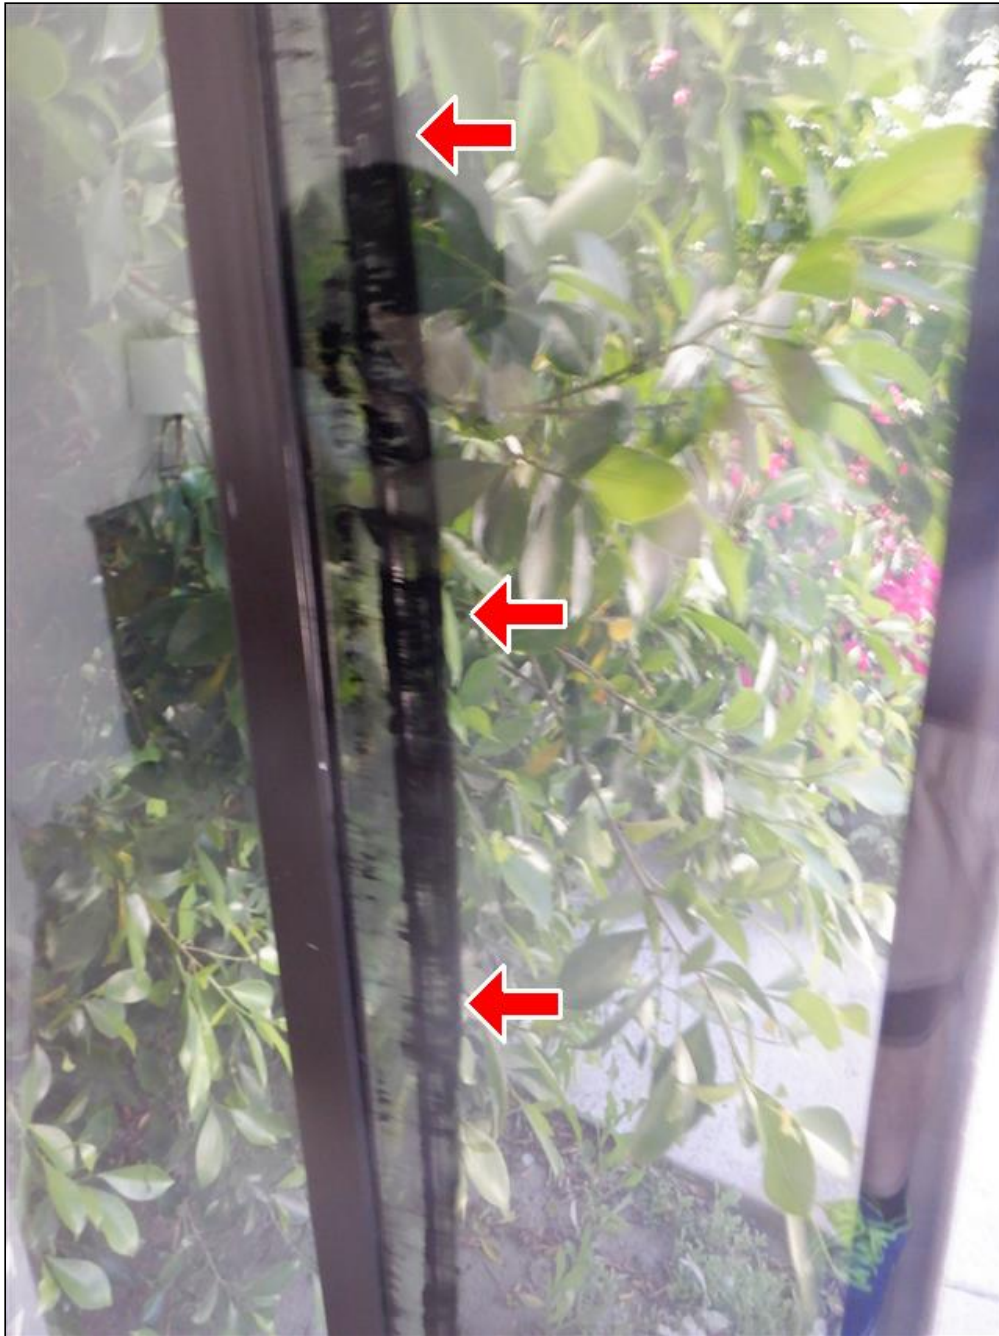
(2) We noted at least one of the sliding glass doors (master bedroom) appeared to have a bad seal, we also noted that at least two of the living room sliding glass doors were either hard to operate or were inoperable and at least

one of them failed to lock. Recommend evaluation by a licensed sliding glass door specialist to repair or replace as needed for proper operation.

2.2 Item 2(Picture) Master Bedroom Slider Bad Seal

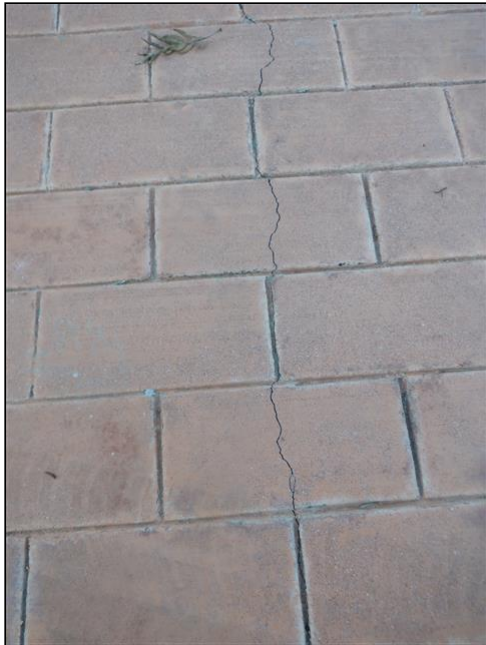
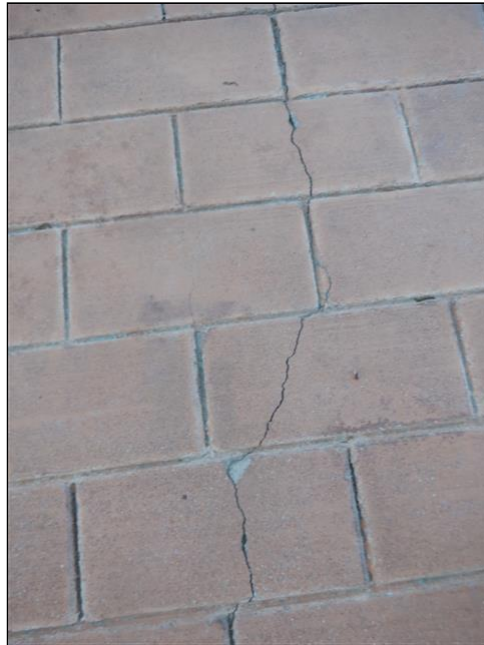
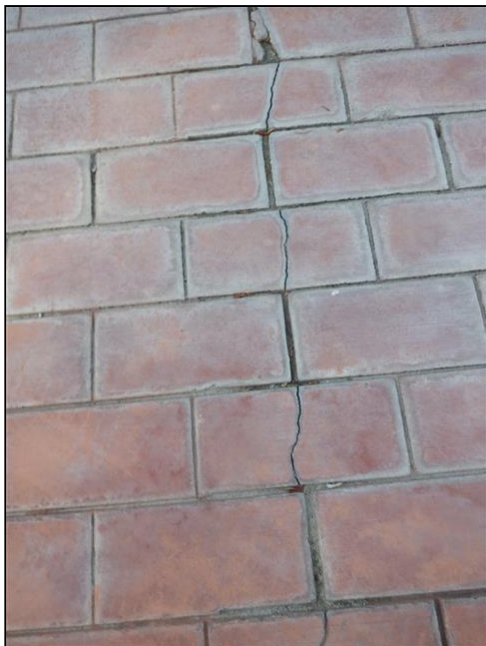
(1) We noted that several of the bricks in the driveway were cracked. These cracks are normal shrinkage cracks for this climate, none of which exceeded 1/8 inch in size. Recommend replace as needed.

2.4 Item 3(Picture) Driveway Cracked Bricks

2.4 Item 4(Picture) Driveway Cracked Bricks

2.4 Item 5(Picture) Driveway Cracked Bricks

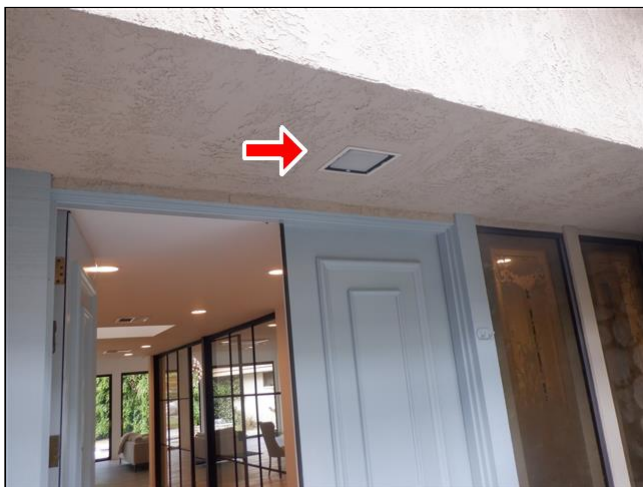
We noted several exterior light fixtures that were not functioning. These lights are in the courtyard and back patio. Recommend bulb replacement and further evaluation if needed.

2.8 Item 1(Picture) Courtyard Light Fixture Not Functioning

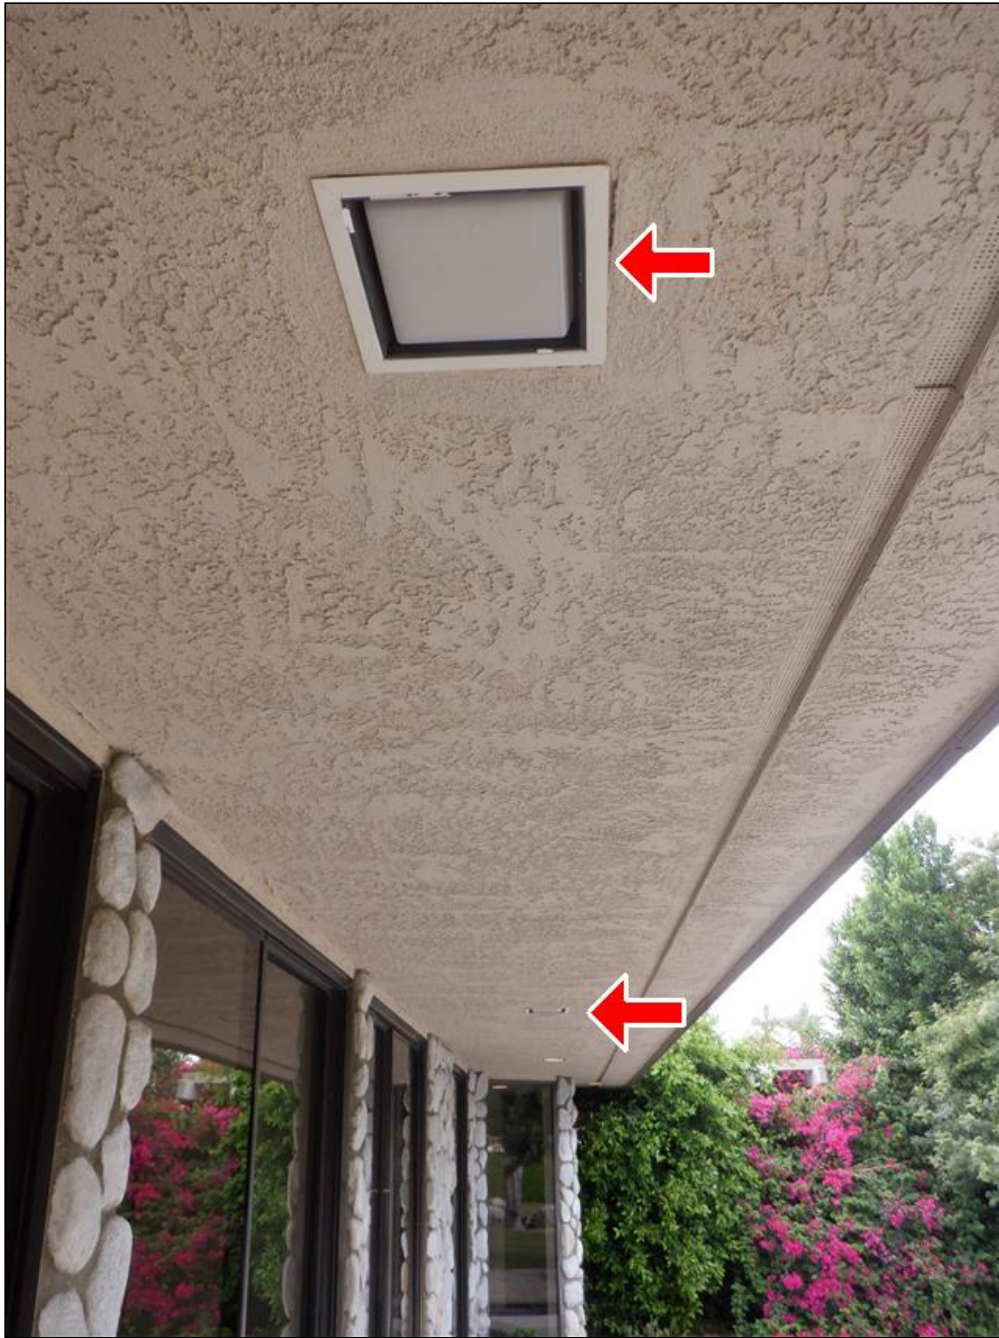
2.8 Item 2(Picture) Patio Light Fixtures Not Functioning

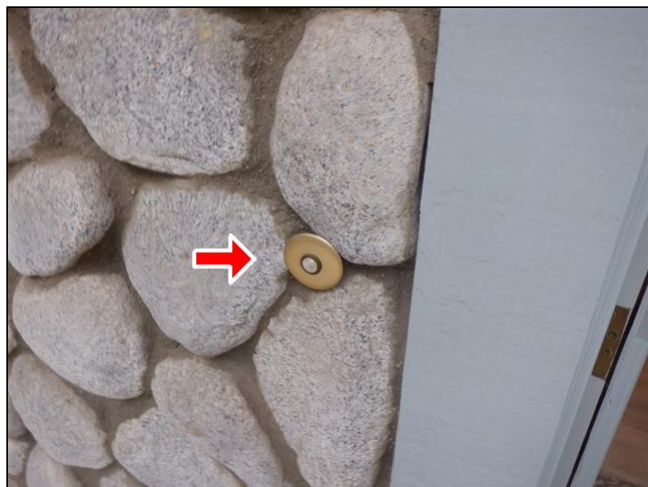
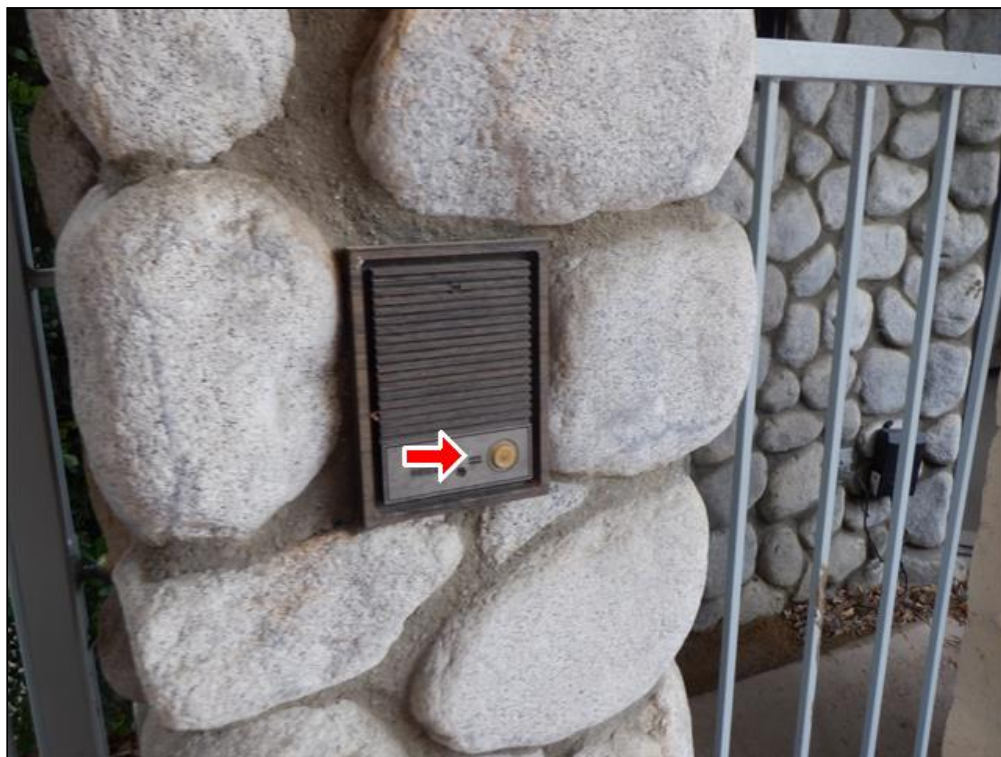
We noted that the door bells were inoperative at time of inspection. Recommend evaluation/repair/replace as needed.

2.9 Item 1(Picture) Door Bell Not Functioning

2.9 Item 2(Picture) Door Bell Not Functioning

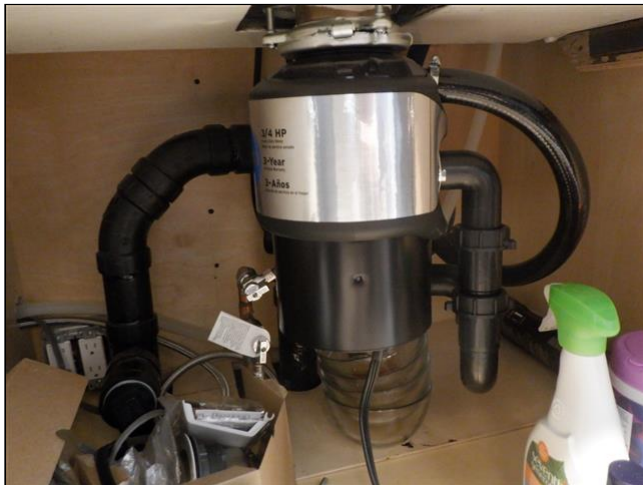
Although functioning when plugged in we noted that this food waist disposer has no activation switch or button, it appears that one was never installed. Recommend evaluation by a licensed contractor to install and activation switch for proper operation of this unit.

4.11 Item 1(Picture) Disposer No Activation Switch

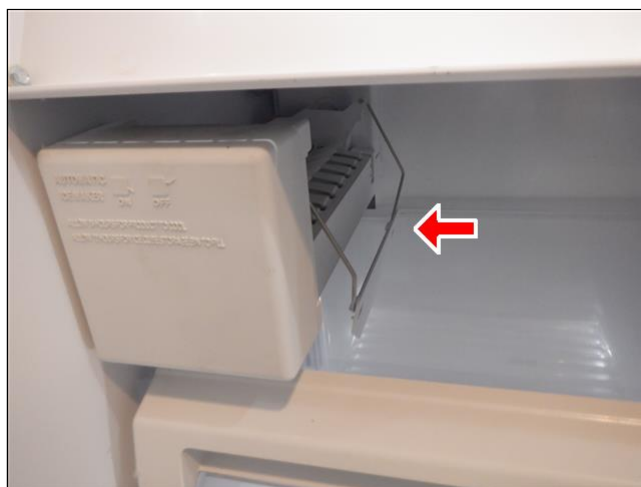
Although this refrigerator appeared to be functioning properly we noted that it was not producing ice. We noted that the ice maker was on. Recommend evaluation and confirmation of proper operation of ice maker repair replace as needed by a licensed appliance contractor.

4.17 Item 2(Picture) Refrigerator Ice Maker On

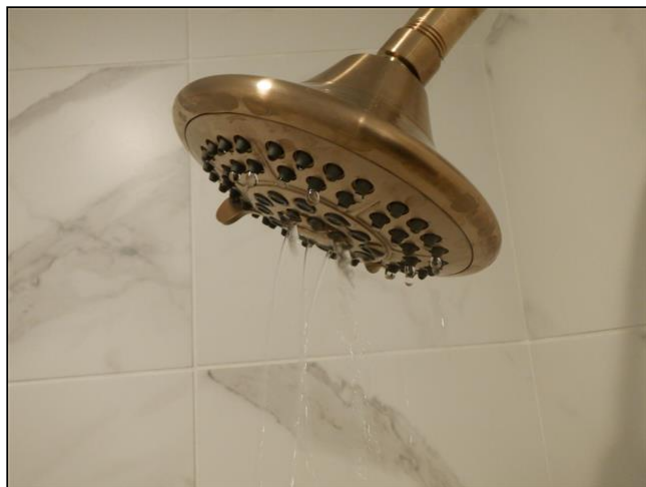
We noted that the water supply to the shower head was low. This issue is isolated to this shower fixture only and its possible that the aerator is clogged. Recommend cleaning of aerator and further evaluation as needed by a licensed plumbing contractor.

6.4.B Item 2(Picture) Shower Head Low Flow

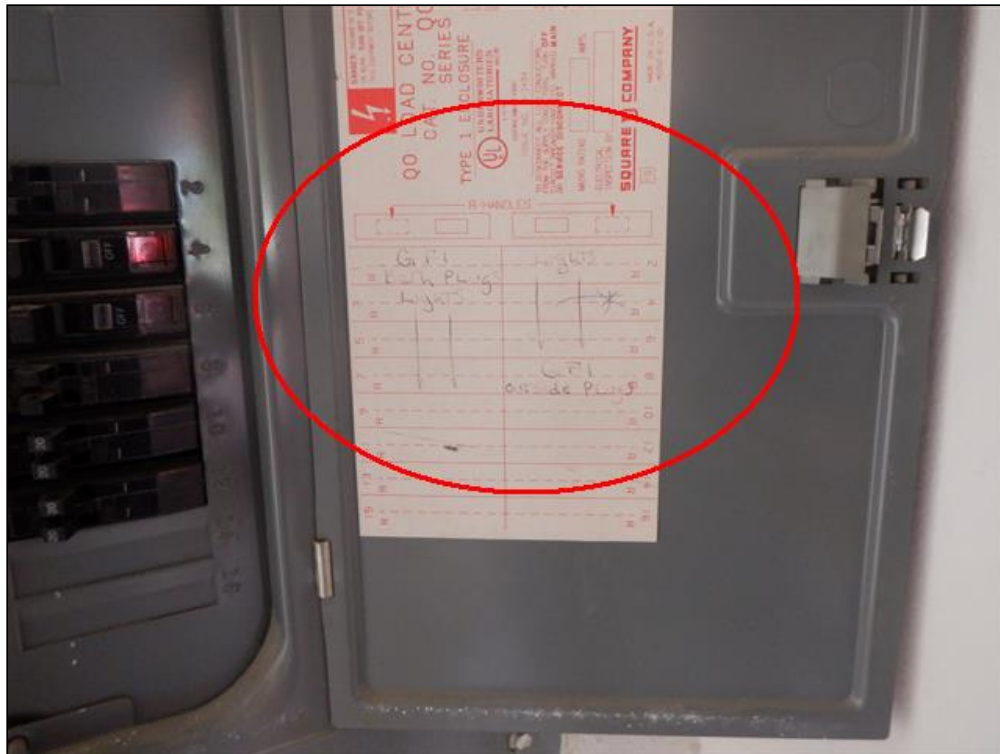
(2) The electrical sub panel is located in the garage it has a 60 amp main breaker that's located in the main panel. Although we did not find any irregularities in this panel, we noted that not all the circuit breakers were clearly labeled. Recommend evaluation and labeling of all circuits for proper identification and ease of use by a licensed electrician.

9.1 Item 7(Picture) Electrical Sub Panel Breakers Not Clearly Labeled

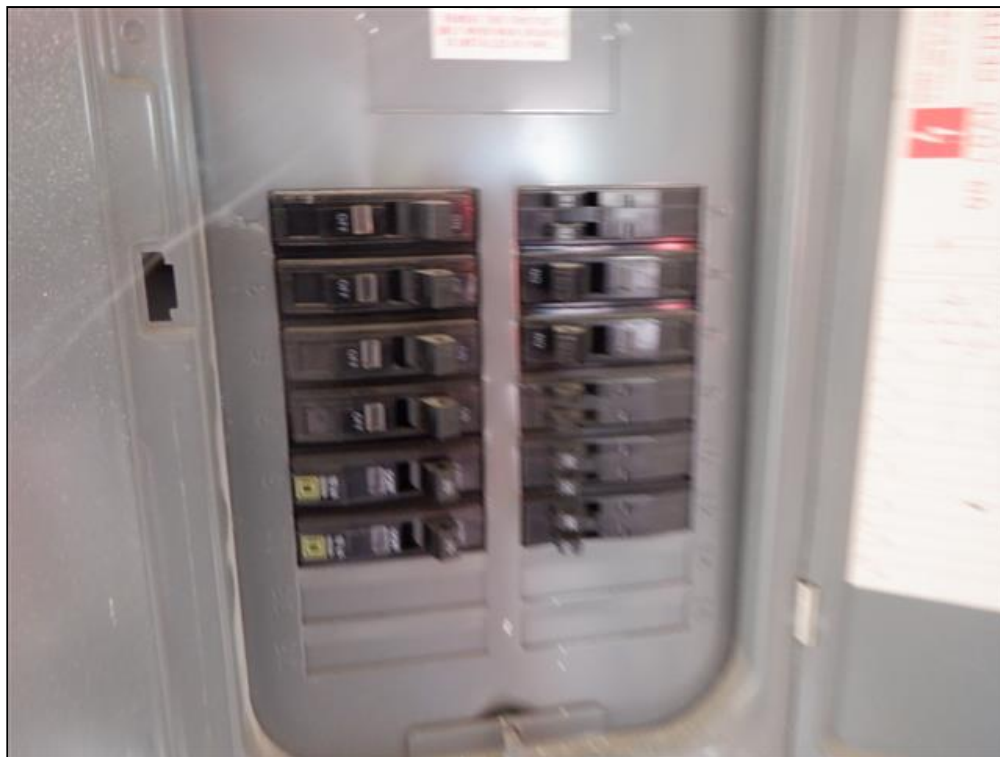
9.1 Item 8(Picture) Electrical Sub Panel Distribution

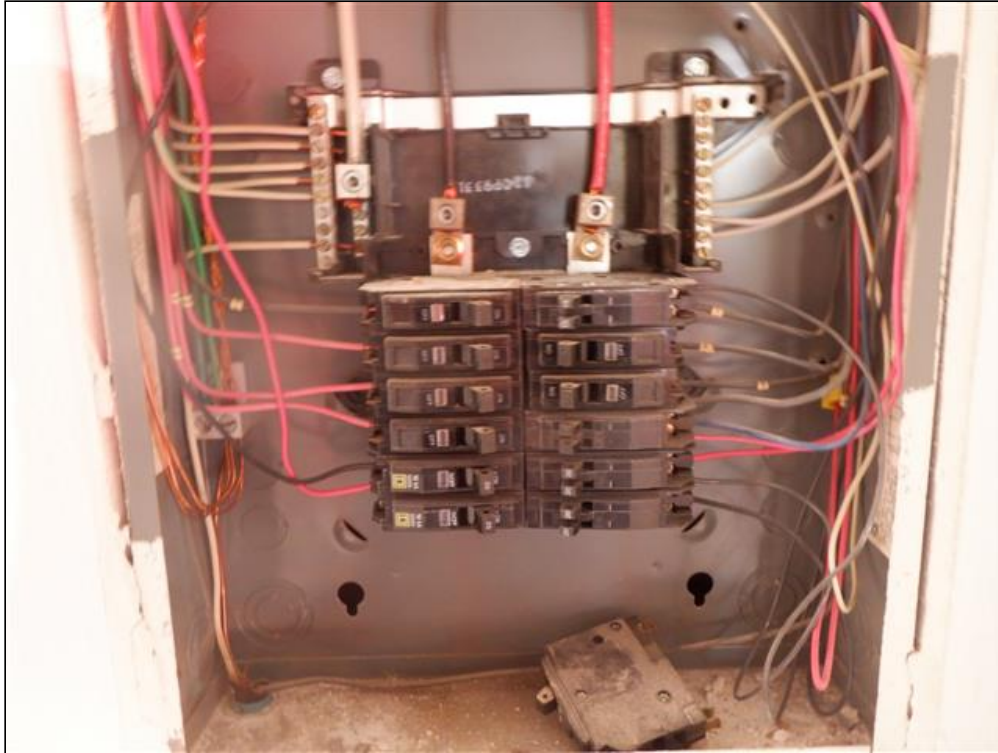
9.1 Item 9(Picture) Electrical Sub Panel Breakers/Conductors

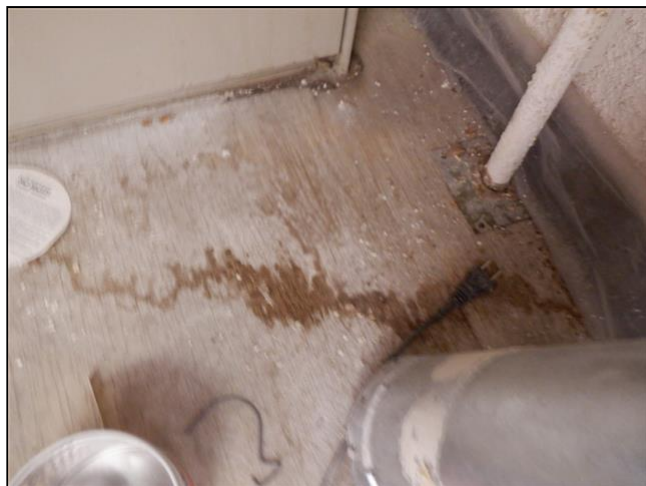
We noted moisture staining on the furnace landing around both of the heating units. We believe that these units have been leaking condensate. Recommend evaluation and servicing by a licensed HVAC contractor to confirm that condensate lines are clear of debris and draining properly.

10.3.A Item 2(Picture) Moisture Stains Furnace Landing

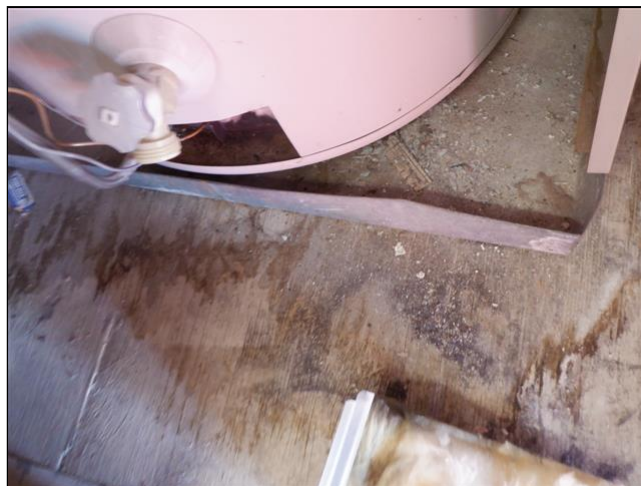
10.3.A Item 3(Picture) Moisture Stains Furnace Landing

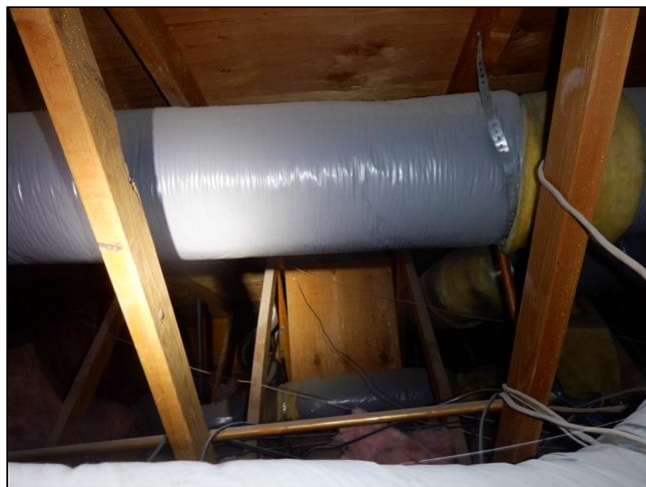
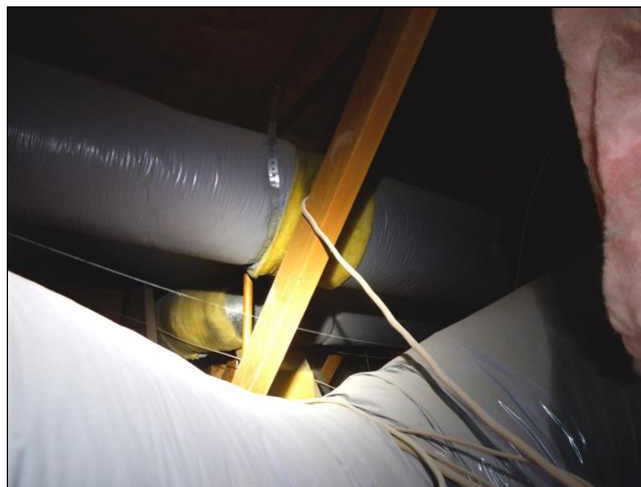
Although the HVAC ducting in this home was providing air to the registers we believe that this ducting material is older. These ducts should be tested and evaluated by a licensed HVAC contractor for integrity. Recommend evaluation and testing of ducts by a licensed HVAC contractor repair if needed.

10.4.A Item 1(Picture) HVAC Ducting

10.4.A Item 2(Picture) HVAC Ducting

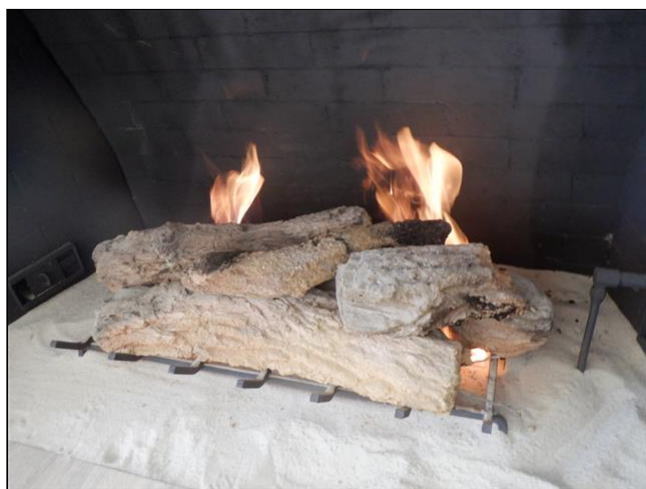
Level 2 fireplace inspection is required upon the sale or transfer of a property or after an operation malfunction or external event that is likely to have caused damage to the chimney. Building fires, chimney fires, seismic events as well as weather events are all indicators that this level of inspection is warranted. There are no specialty tools (i.e. demolition equipment) required to open doors, panels or coverings in performing a Level 2 inspection. A Level 2 inspection shall also include a visual inspection by video scanning or other means in order to examine the internal surfaces and joints of all flue liners incorporated within the chimney. No removal or destruction of permanently attached portions of the chimney or building structure or finish shall be required by a Level 2 inspection. We highly recommend a level 2 fireplace inspection by a licensed fireplace specialist. Call all seasons Fireplaces at 760.365.6668 Rick Newsom.

10.7.A Item 1(Picture) Fireplace

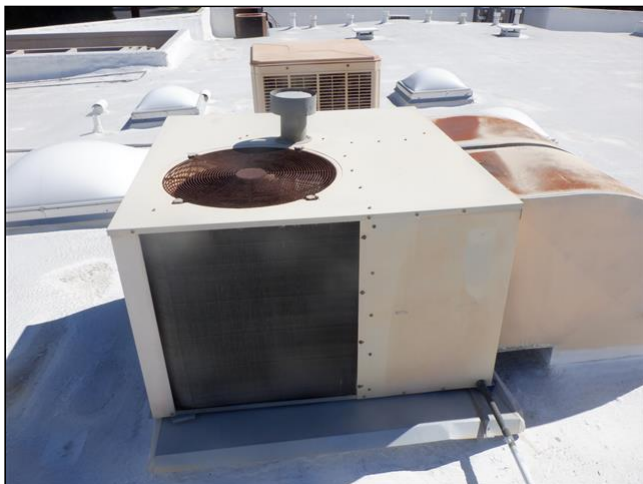
10.0.B Item 1(Picture) Heating Unit 1 Flex Fuel Line

Although these heater were functioning properly at time of inspection we noted the Installation of a flex hose for the fuel line through the cabinet wall and without some kind of protection this is considered dangerous. Although possibly not a requirement at the time of construction a solid pipe should be installed through the cabinet wall where the flex hose can be used or some kind of impact resistant none flammable protective sleeve should be installed over this flex hose. This safety concern should be corrected one way or another. Recommend evaluation/repair/replace by an licensed HVAC contractor. FYI these units are older at 36 years.

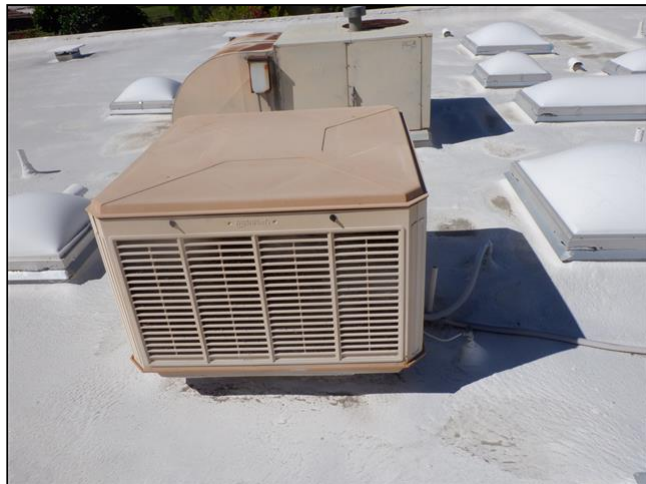
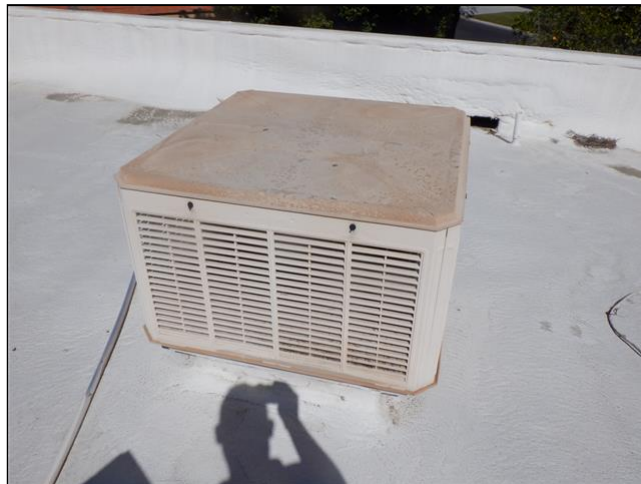
We noted 2 evaporative coolers on the roof of this home. We also noted that there are no controls on the interior of this home for these units. We believe that these units have been abandon. Recommend removal of units.

10.4.B Item 1(Picture) Evaporative Cooler 1

10.4.B Item 2(Picture) Evaporative Cooler 2

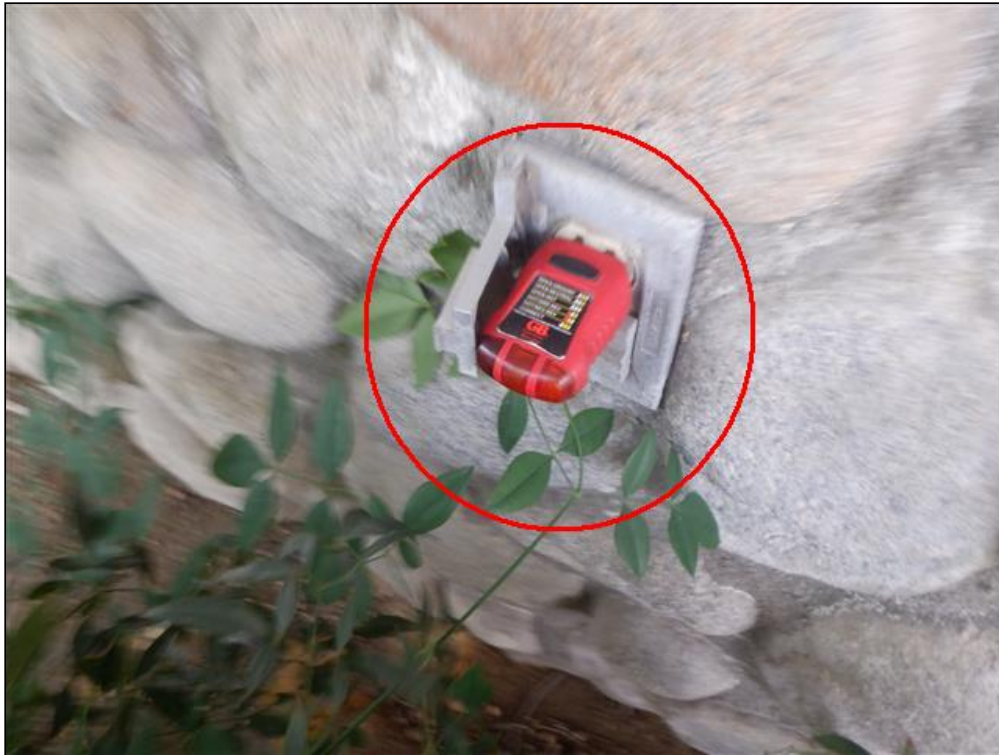
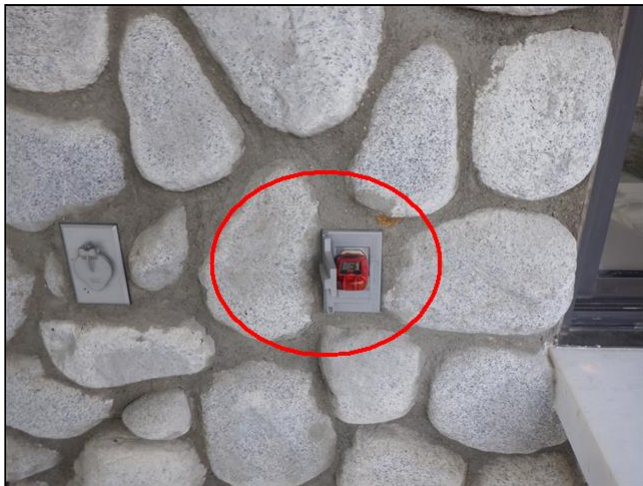
(2) We noted several exterior outlets that had no power, 2 on the north patio and 1 on the west patio, we also cannot confirm if these outlets are GFCI protected. Recommend evaluation by a licensed electrical contractor to restore power and confirm GFCI protection repair replace as needed.

2.7 Item 4(Picture) North Patio Outlet No Power

2.7 Item 5(Picture) North Patio Outlet No Power

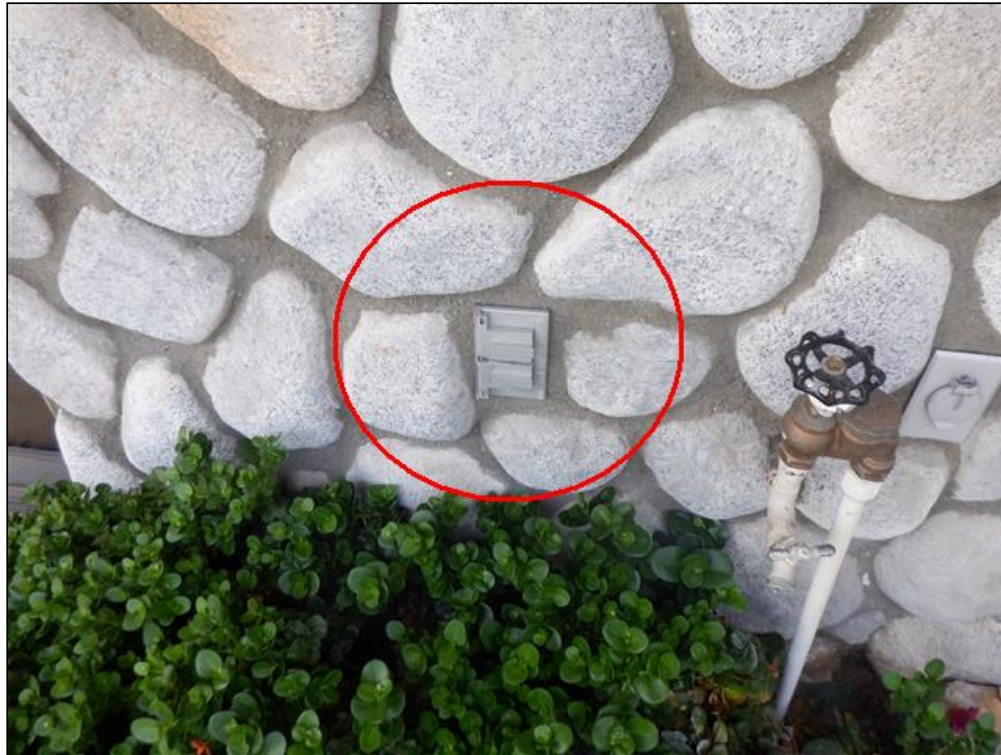
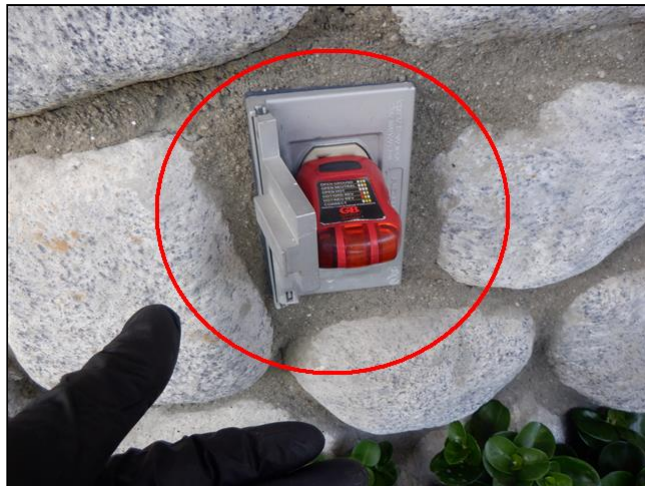
2.7 Item 6(Picture) West Patio Outlet No Power

2.7 Item 7(Picture) West Patio Outlet No Power
